C Boyd – Drilling Waste Disposal
Monitoring Programme
Annual Report
2013-2014

Technical Report 2014-81

October 2015

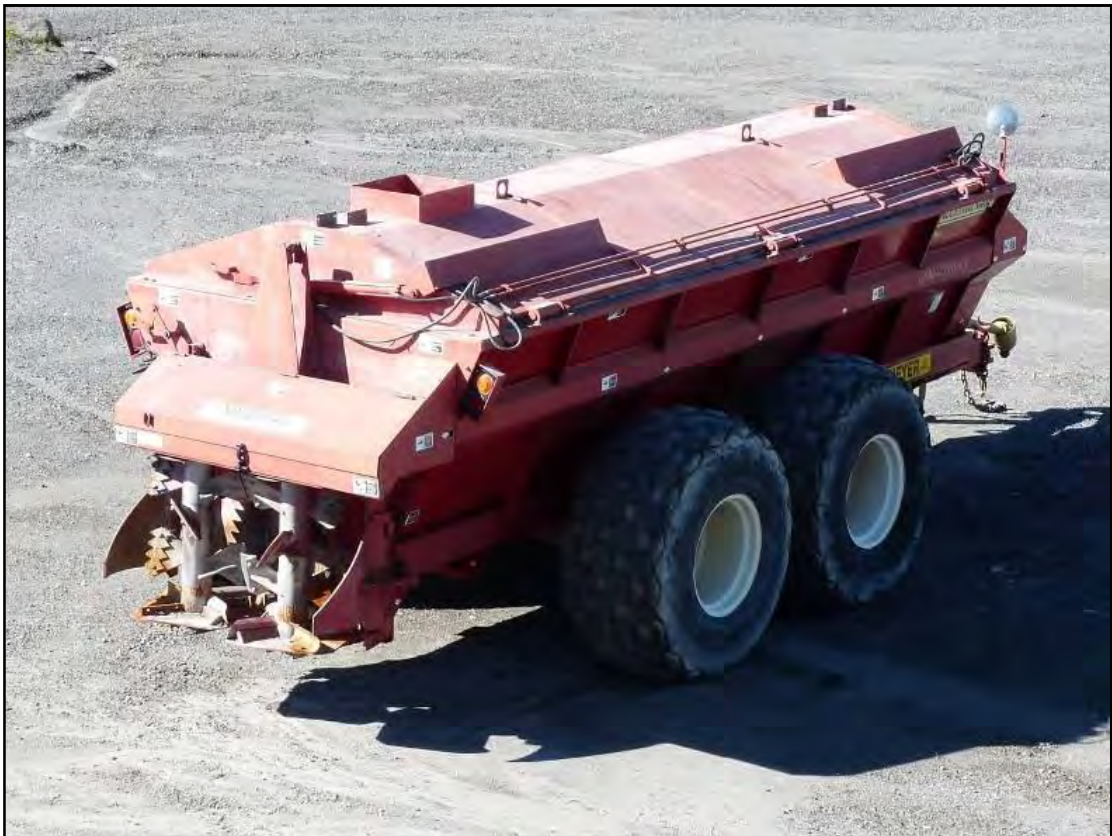
The preferred method for the treatment of drilling waste at Colin Boyd's property is via landspreading (under consent **7591-1**). A large muck spreader, shown in Photograph 1, is used for this purpose.

Photo 1 Spreader unit utilised for landspreading operations at Colin Boyd's property

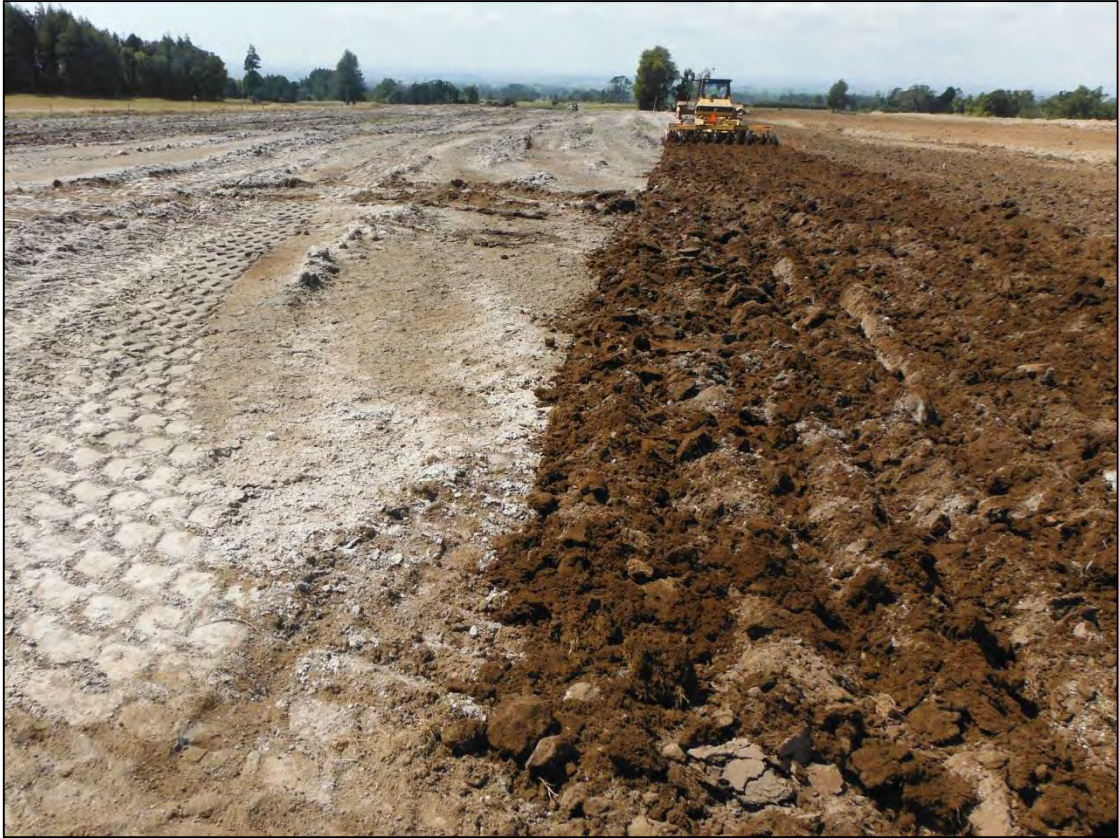
An auger in the base of the spreader conveys material back and through an opening (where the size is controlled by a sliding plate) where it contacts two rapidly rotating augers and is flung up to 10 metres on either side. The deposition rate is controlled by the size of the opening at the rear of the unit and the speed of forward travel by the tractor. The waste is deposited onto existing pasture in small fragments, which are allowed some time to dry out before chain harrows and roman discs are used to till and break-up the waste which is dispersed back into the soil, shown in Photograph 2.

Photo 2 Tilling at Colin's Boyd's property post landspreading. The left of the frame shows landspread area yet to be tilled

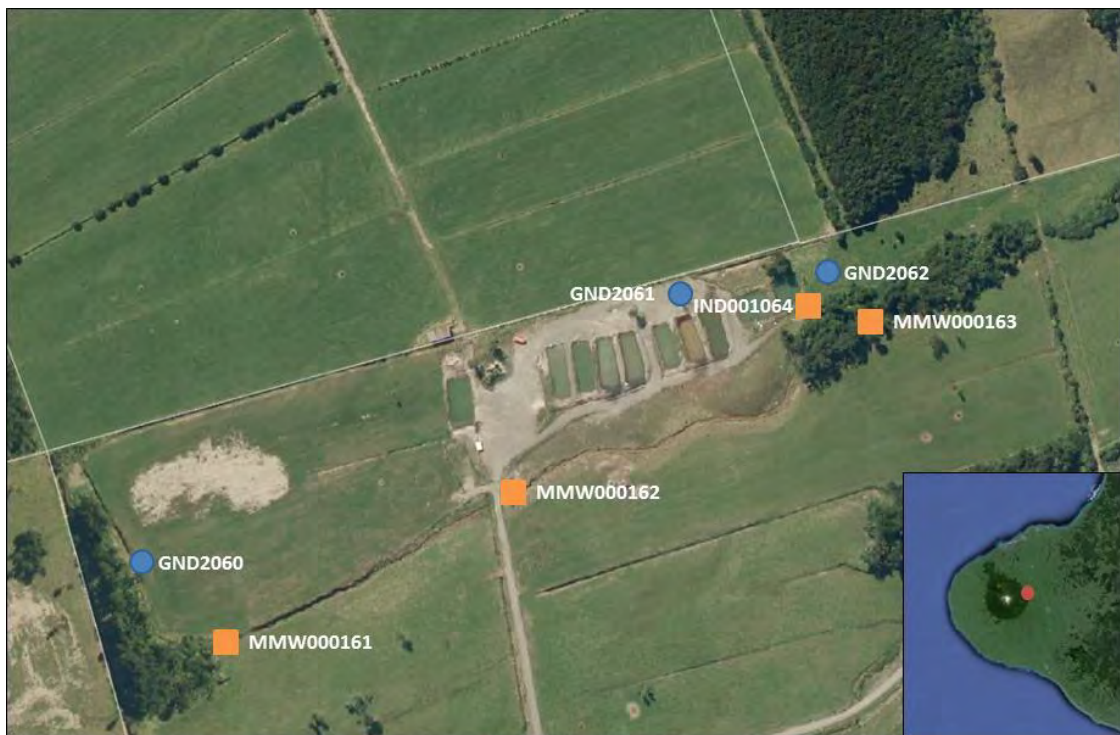
Figure 2 Aerial photograph of the Derby Road North stockpiling facility, showing locations of the storage pits and sampling sites, with approximate regional location (inset)

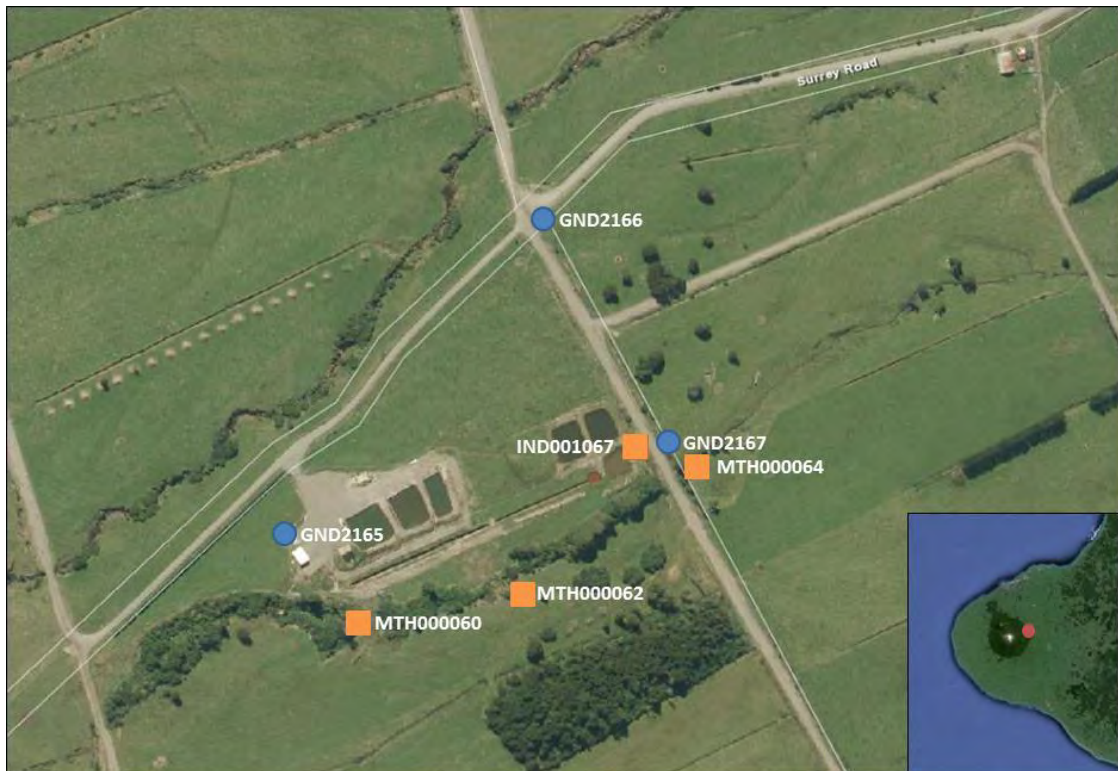
Figure 4 Aerial photograph of the Surrey Road stockpiling facility, showing locations of the storage pits and sampling sites, with approximate regional location (inset)

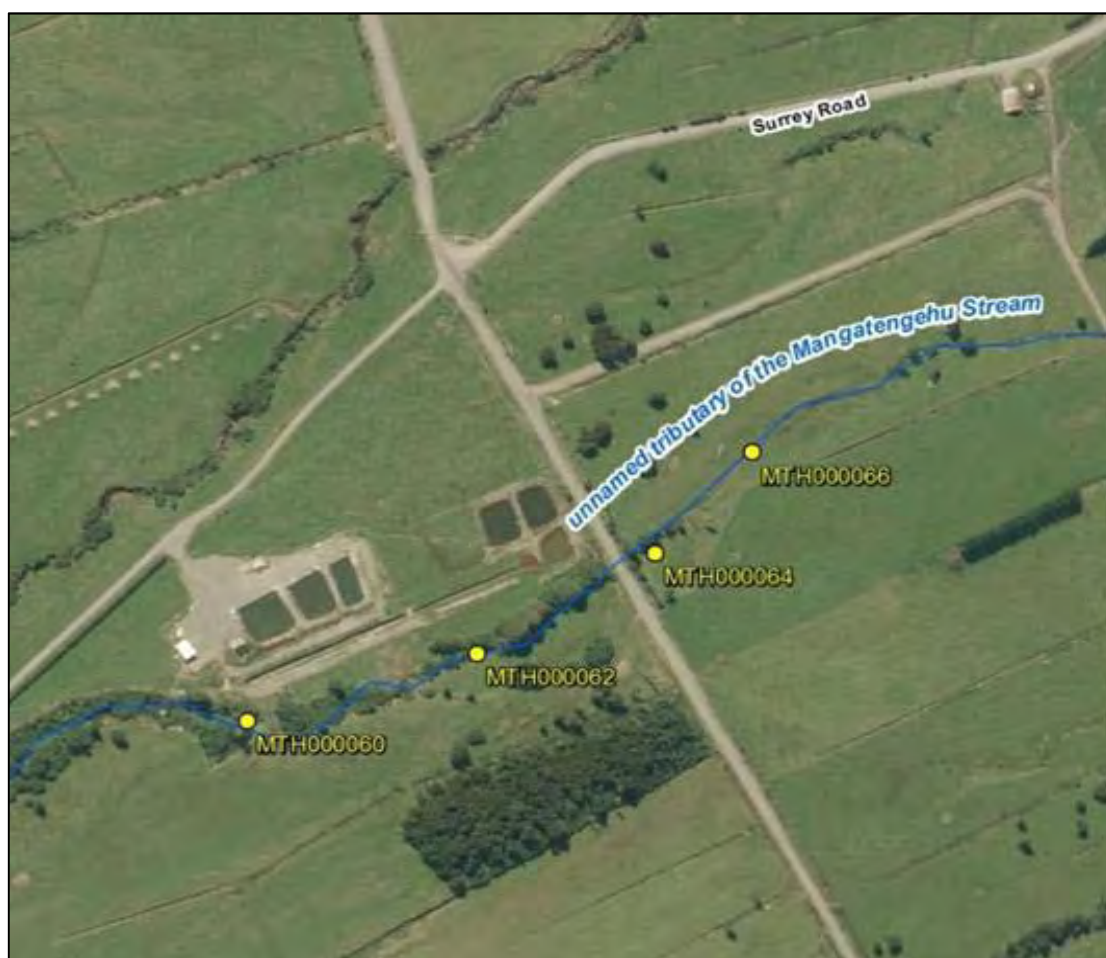
Figure 5 Biomonitoring sites in an unnamed tributary of the Mangatengehu Stream in relation to the Surrey Road stockpiling facility
