Waste Remediation Services Limited
Symes Manawapou Landfarm
Monitoring Programme
Annual Report
2013-2014

Technical Report 2014-118

September 2015

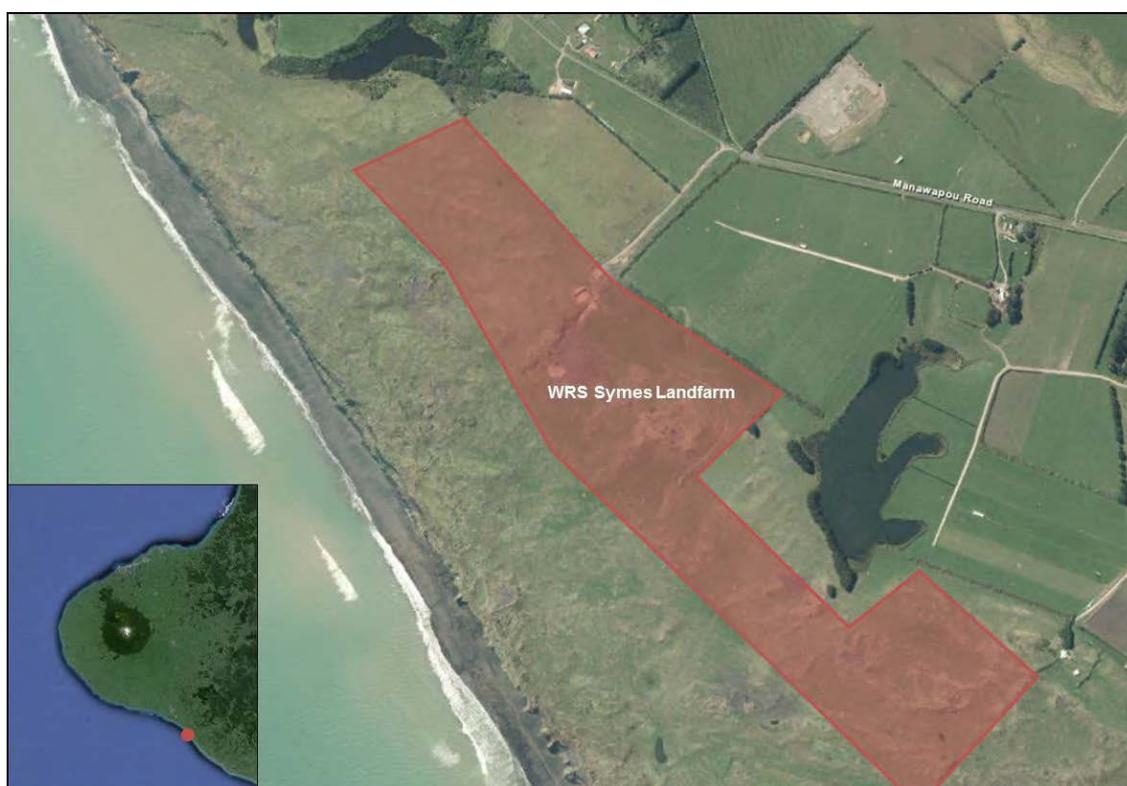
Figure 1 Aerial photograph showing the location and approximate extent of the Symes Manawapou Landfarm and approximate regional location (inset)

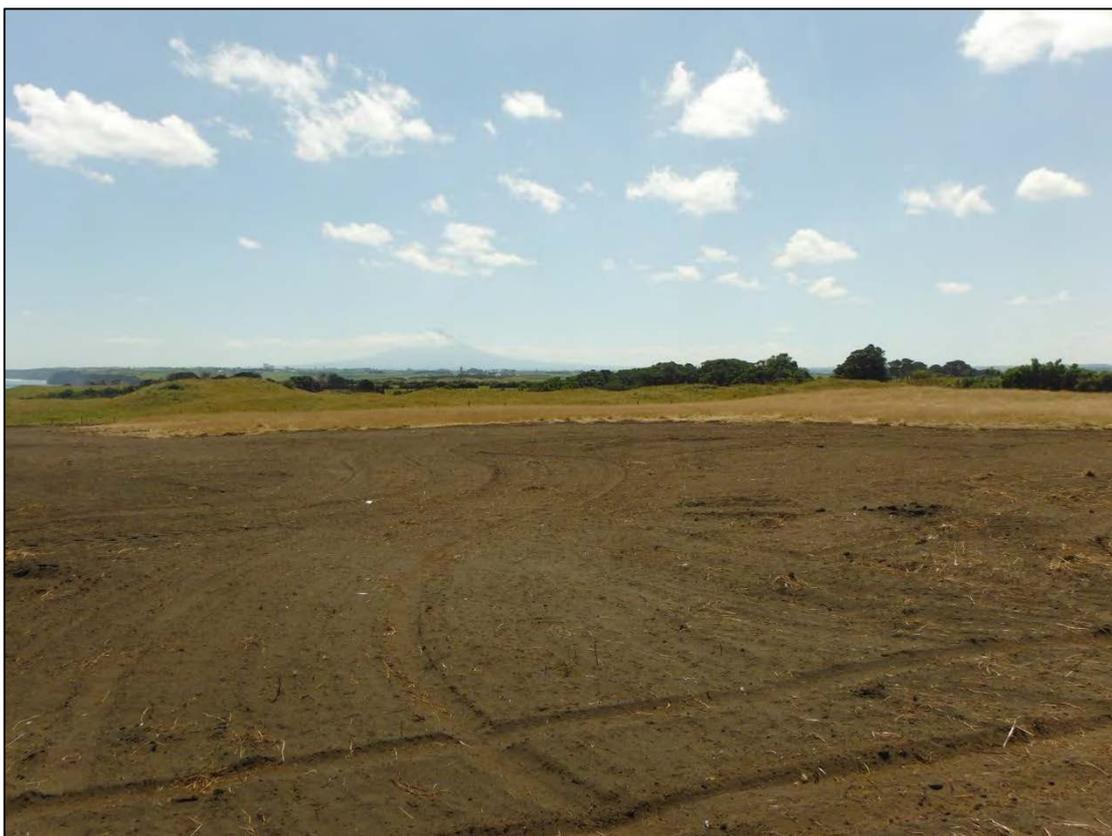
Photo 1 Topsoil re-applied to spreading area Stage 3 post spreading activities, taken 17 February 2014

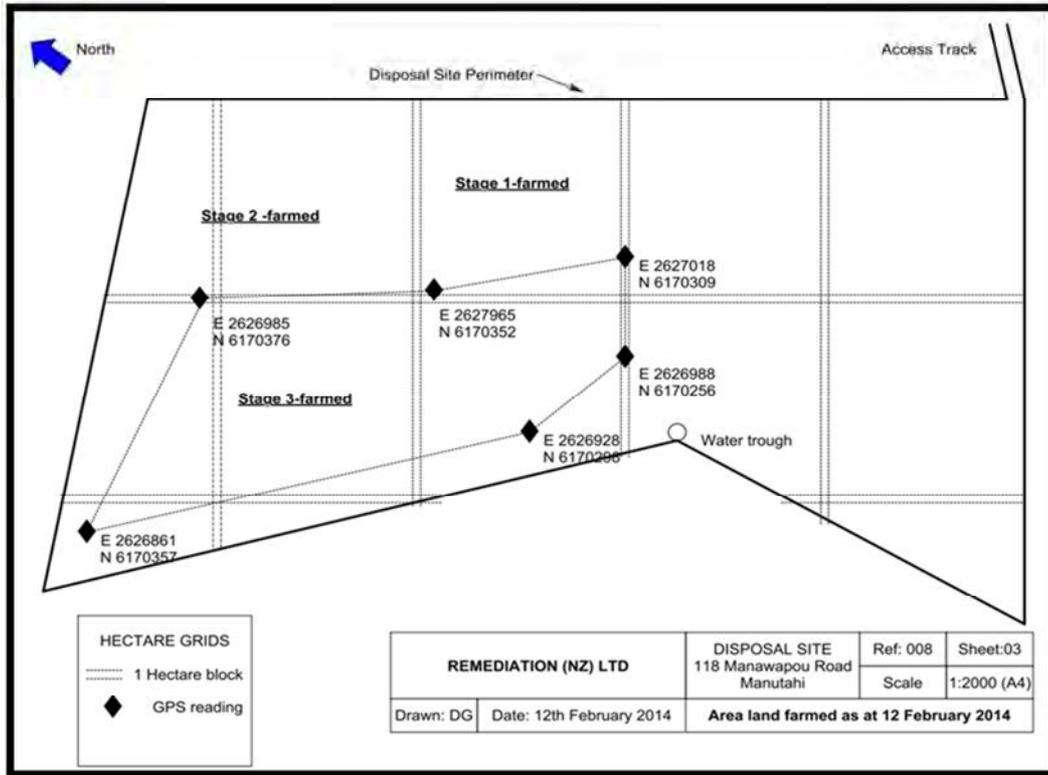
The consent holder utilised the area of the site described as Stage 3, whereby the material was landfarmed on multiple occasions through out the monitoring year, 27 August 2013, 19 September 2013, 12 October 2013 and 2 February 2014.

Figure 2 Remediation (NZ) Limited supplied map showing previously spread and completed areas Stage 1 & 2, and the recently spread area Stage 3 which was spread in the 2013-2014 monitoring period

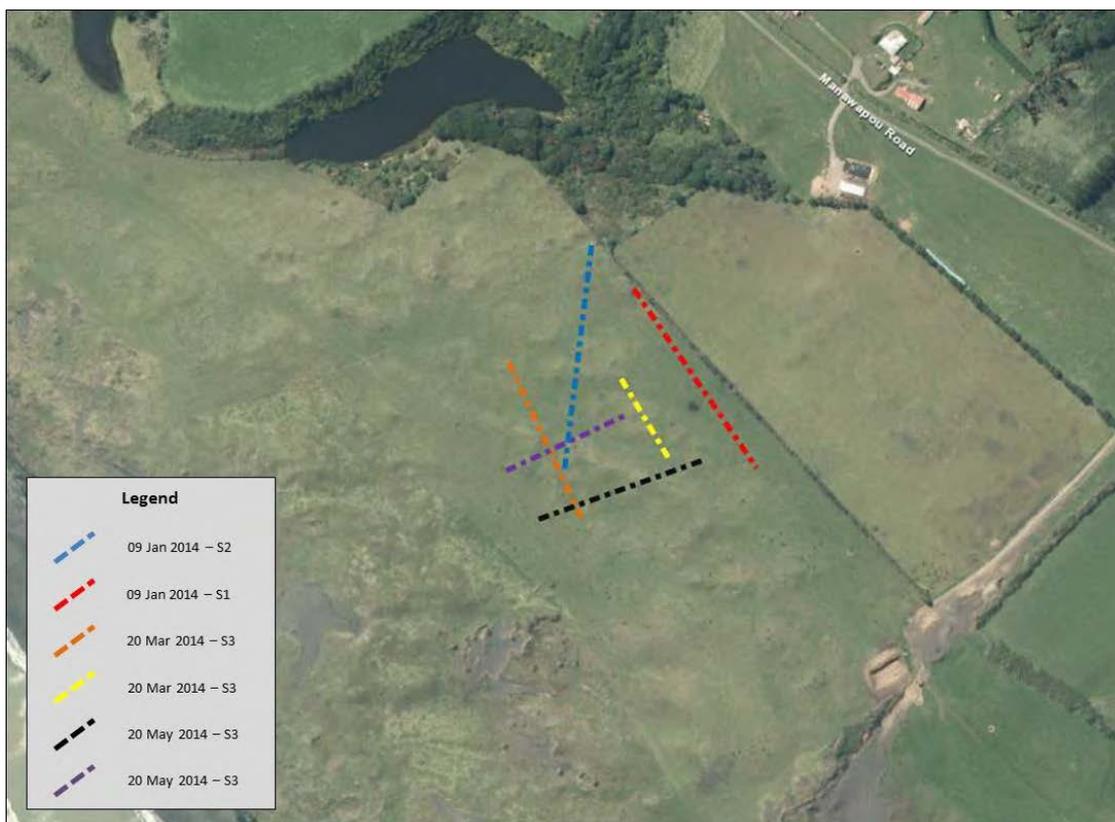
During the monitoring year, six composite soil samples were collected by sub-sampling along transects at 10 m intervals to a depth of 250 mm in spreading areas Stage 1, Stage 2 and Stage 3 (Figure 3). The results are presented below in Table 2.

Figure 3 Council soil sampling transect locations at the Symes Manawapou Landfarm during the 2013-2014 monitoring period

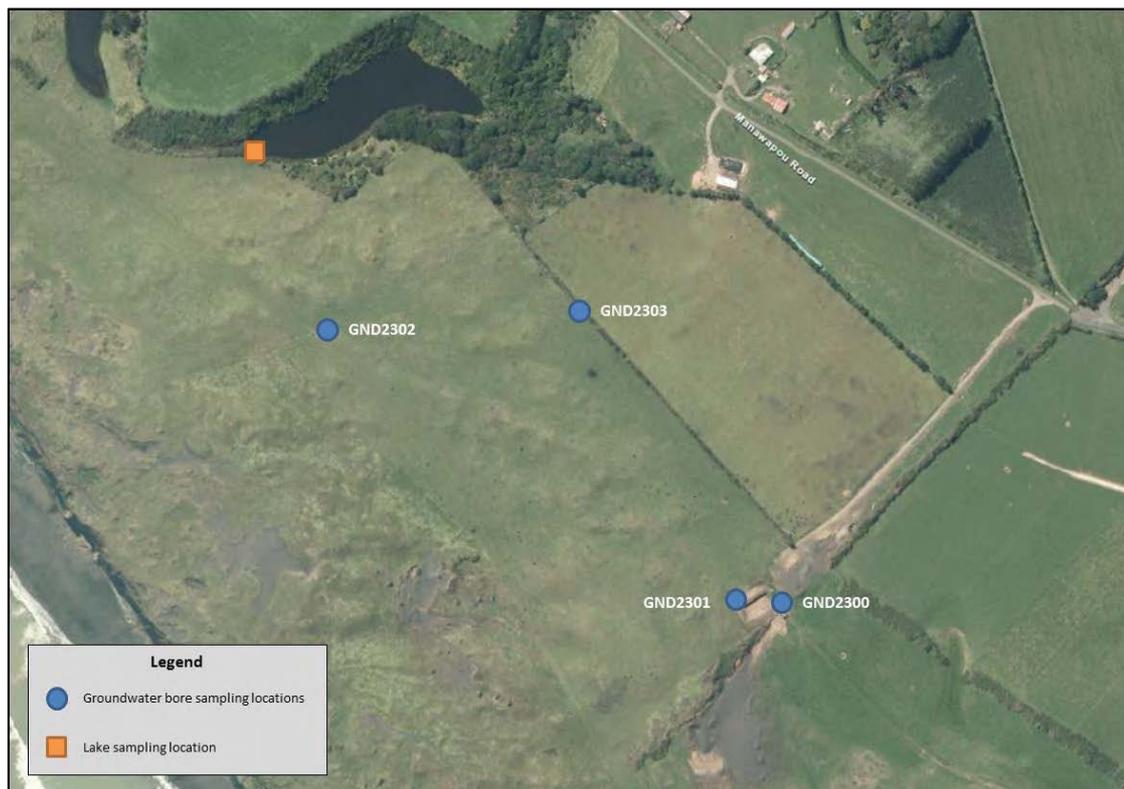
During the 2013-2014 monitoring period, the Council undertook groundwater sampling across the groundwater monitoring bore network at the site. The locations of the monitoring bores are detailed in Figure 4. Monitoring Bores GND2300 and 2301 were installed to monitor the integrity of the storage pits, while GND 2302 and 2303 are located on the site boundaries to detect any potential offsite migration. The results for each of the bores are presented in Tables 4 to 7.

Figure 4 Groundwater monitoring bore sampling sites at the Symes Manawapou Landfarm

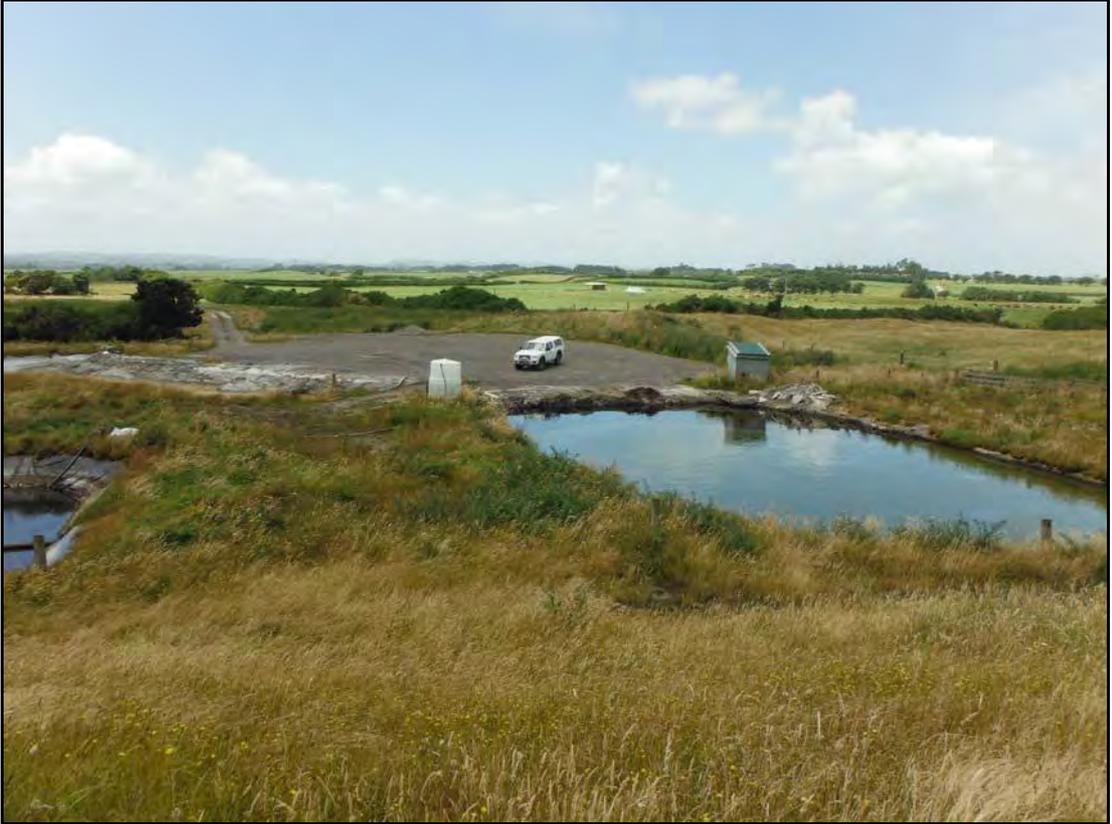
An abatement notice (number 20118) was issued to Remediation (NZ) Limited regarding elevated levels of benzene, chloride, toluene and total dissolved solids detected within groundwater monitoring bore GND2301 sampled on 9 January 2014 and 23 January 2014. This contravened special conditions 18 and 19 of resource consent 7795-1, which stipulates that

It was suspected that the liner of the storage pit adjacent to groundwater monitoring bore GND2301 had sustained a tear/hole and thus the integrity of the liner was questionable. The abatement notice required Remediation (NZ) Limited to undertake works to empty the contents of said pit and to undertake works to ensure the integrity of the pit liner. Remediation (NZ) Limited was prompt to respond and remedy the situation. The Council continued to sample groundwater monitoring bore GND2301 on a monthly basis until results returned levels that reflected background concentrations for those particular parameters.

Photo 2 Storage pit (to the right) prior to the repair of the liner, as seen from groundwater monitoring bore GND2301, taken on 6 January 2014

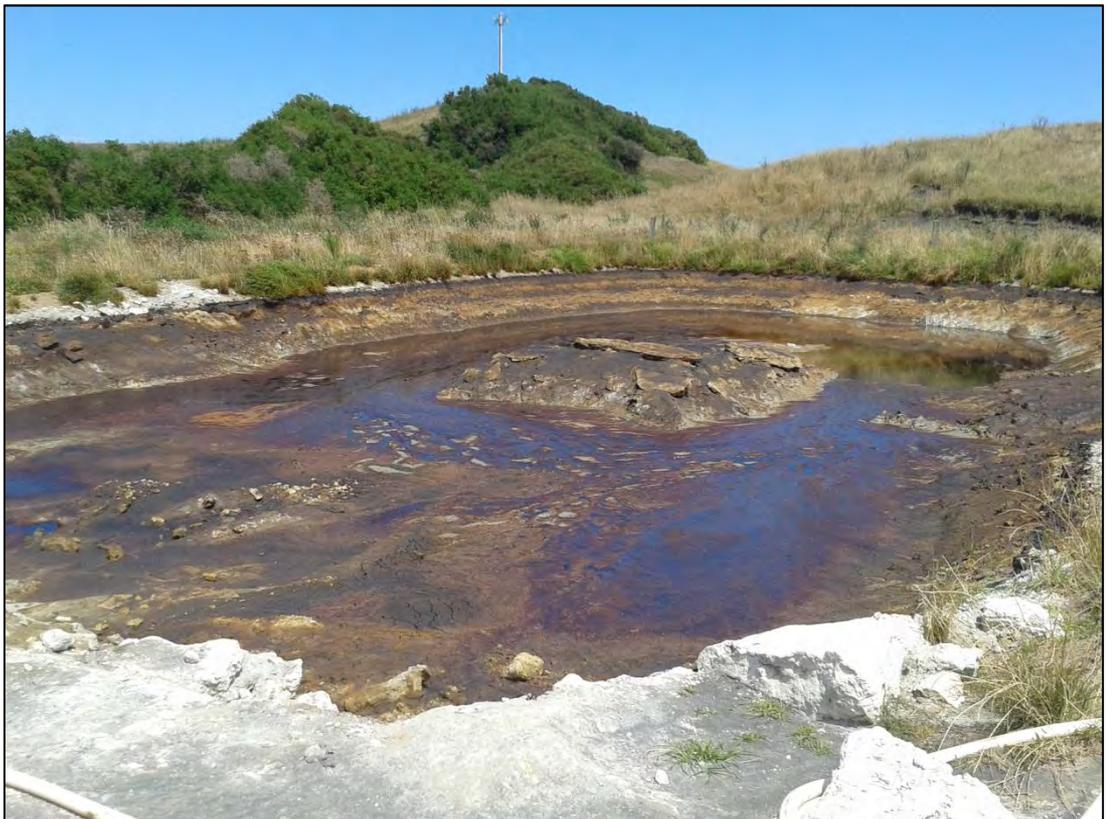
No objectionable odours or visible emissions were detected at the time of inspection. However, hydrocarbon odours were noted down wind of pits. The integrity of storage pit liner one was inspected, the repair around balance pipe looked OK, a lot of surface oils were still present within the pit. The other two storage pits had a small amount of surface oiling and plenty of freeboard was available. No recent spreading had occurred at the time of inspection. Previous application areas appeared stable and the pasture strike looked good. Muds were visible within the soil profile, yet no hydrocarbon odours were noted. No ponded liquids were present and the delivery area appeared tidy.

Photo 3 Storage pit post repair of the liner, taken on 4 February 2014
