CD Boyd Drilling Waste Stockpiling
and Landfarm/Landspread
Monitoring Programme
Annual Report
2014-2015

Technical Report 2015-86

May 2016

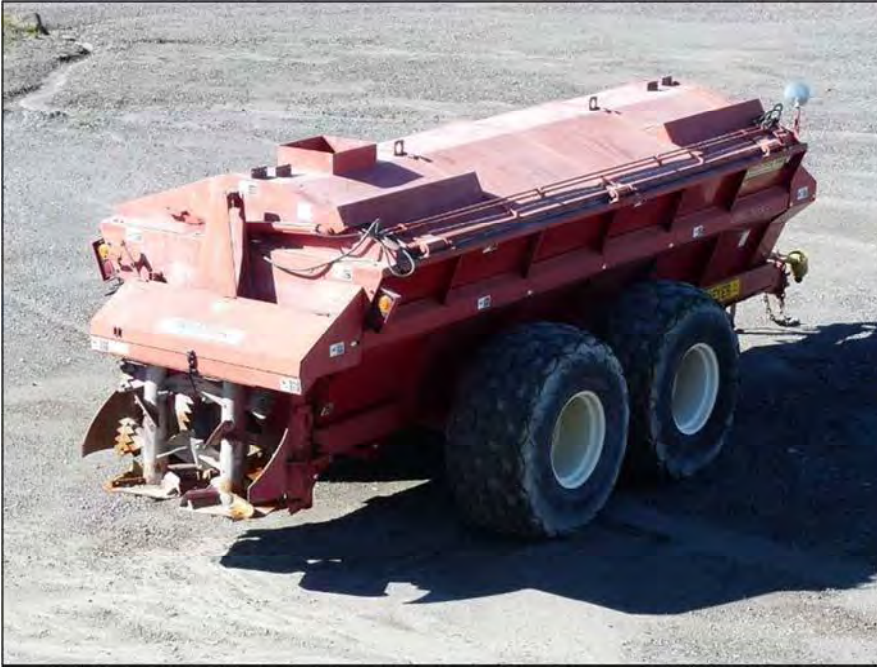
The preferred method for the treatment and disposal of drilling material at the consent holders property is via landspreading (under consent 7591-1). A large muck spreader, detailed in Photograph 1, is used for this purpose.

Photo 1 The unit utilised for landspreading operations at the consent holders facility

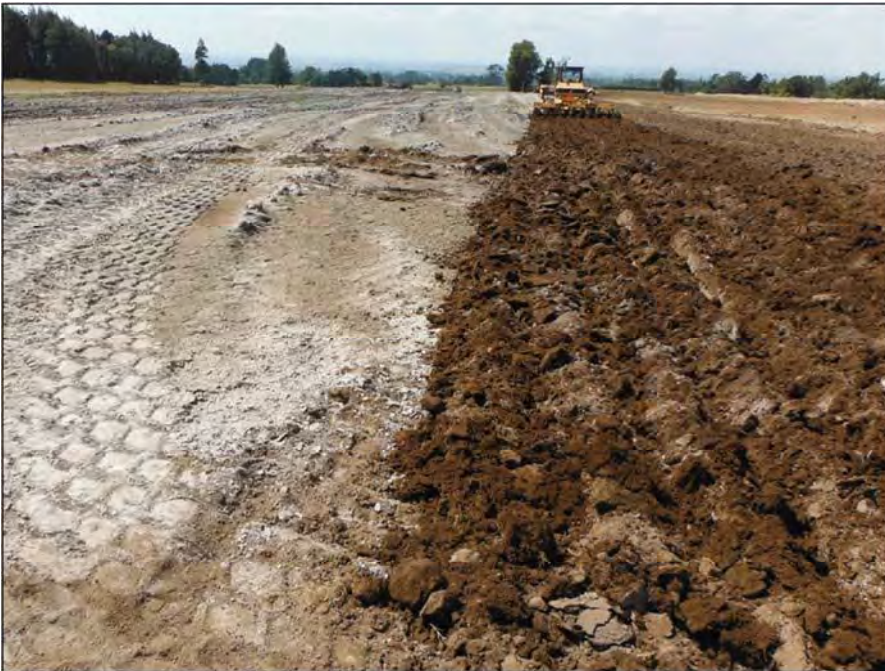
An auger in the base of the spreader conveys material back and through an opening (where the size is controlled by a sliding plate) where it contacts two rapidly rotating augers and is applied up to 10 meters on either side. The deposition rate is controlled by the size of the opening at the rear of the unit and the speed of forward travel by the tractor. The waste is deposited onto existing pasture in small fragments, which are allowed some time to dry out before chain harrows and roman discs are used to till and break-up the waste which is dispersed back into the soil, shown in Photograph 2.

Photo 2 Tilling of the soil post application of the landspreading unit.

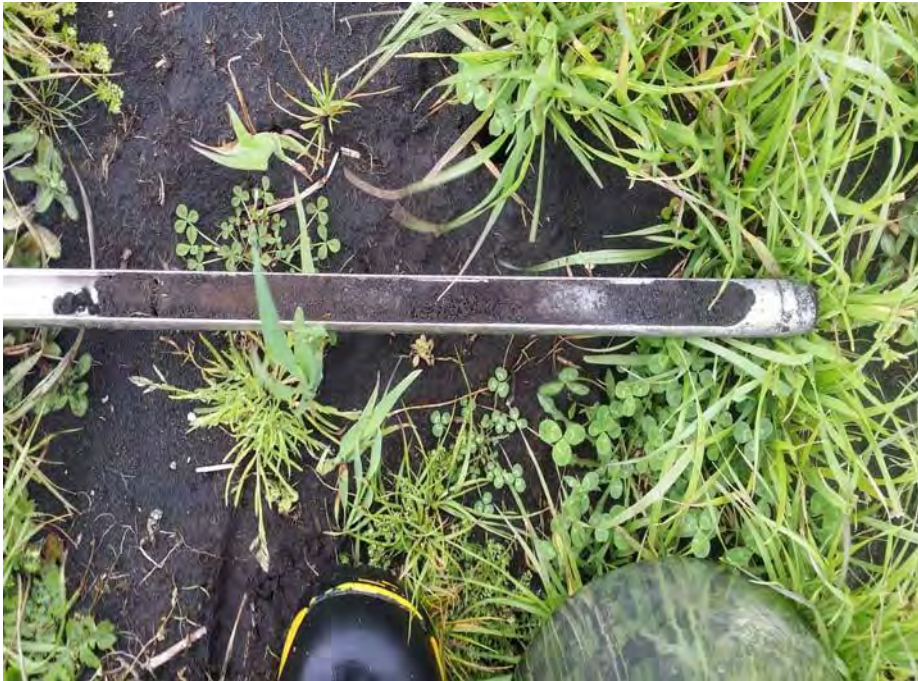
In total, six composite soil samples from specific disposal areas were collected by Council staff. The methodology utilised is adapted from the Guidelines for the Safe Application of Biosolids to Land in New Zealand (2003). This is undertaken through the compositing of 10 soil cores (Photo 3) (500 mm+/- depth to encompass the zone of application) taken at 10 m intervals along transects through an application area.

Photo 3 An example of a soil core

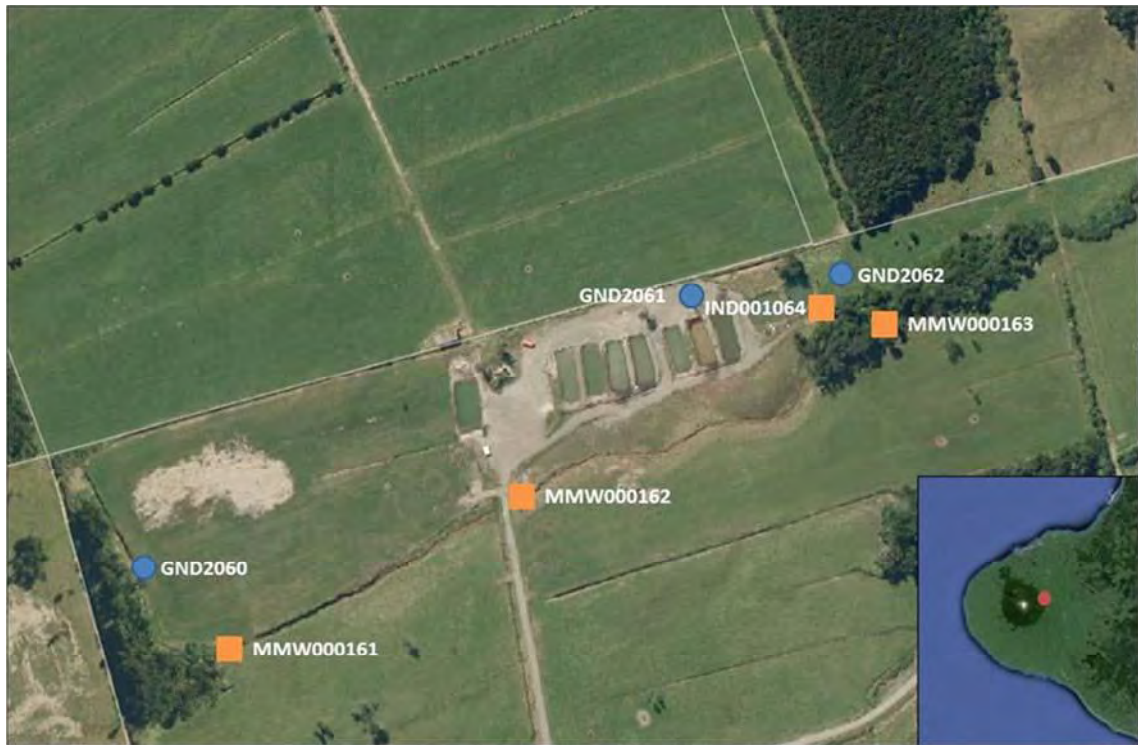
Figure 2 Aerial photograph of the Derby Road North stockpiling facility, it details the storage cells, sampling sites and the approximate regional location (inset)

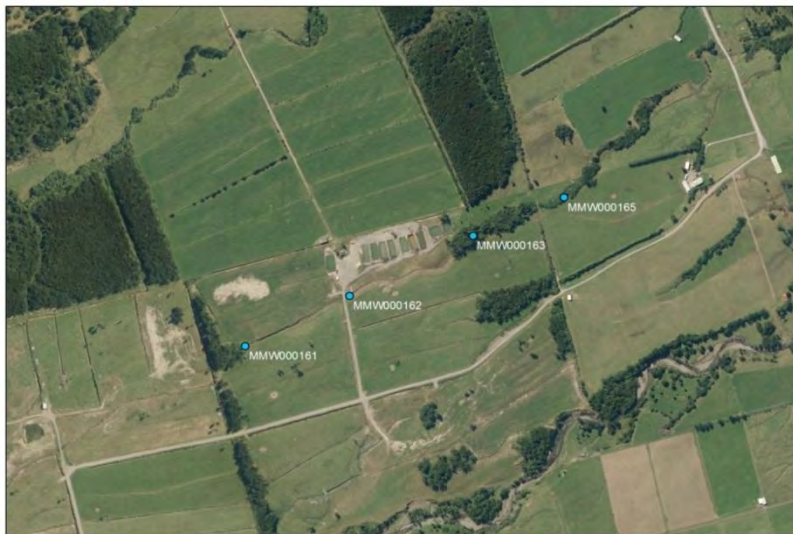
Figure 3 Biomonitoring sites in an unnamed tributary of the Mangamawhete Stream in relation to the Derby Road drilling waste stockpiling activities

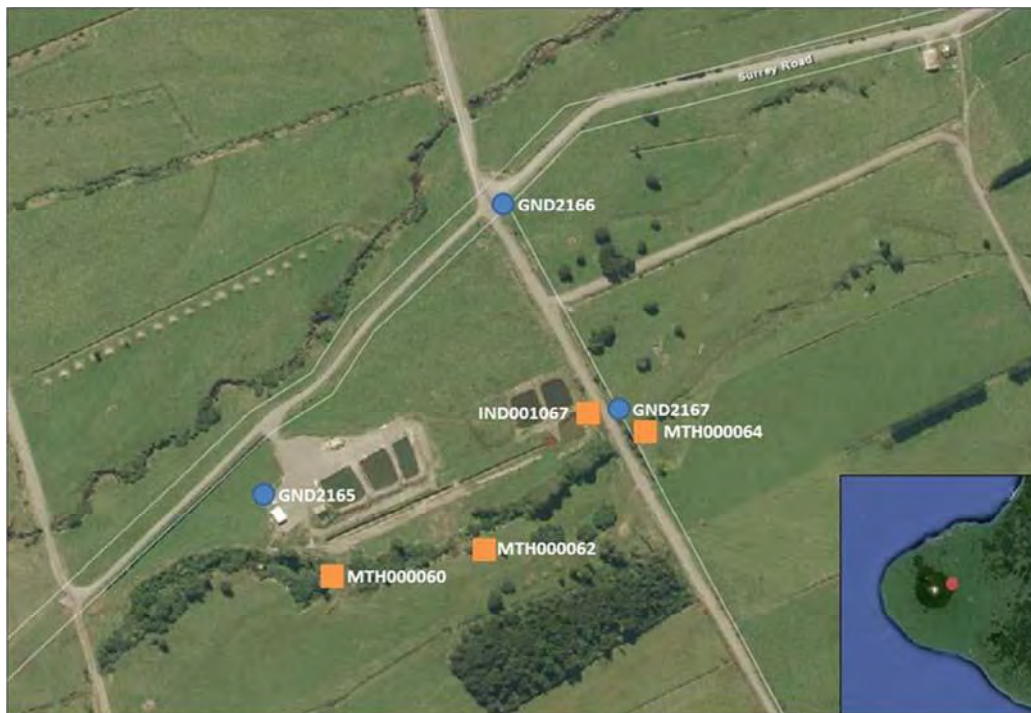
Figure 4 Aerial photograph of the Surrey Road stockpiling facility, storage cells as well as sample locations are detailed, including the regional location

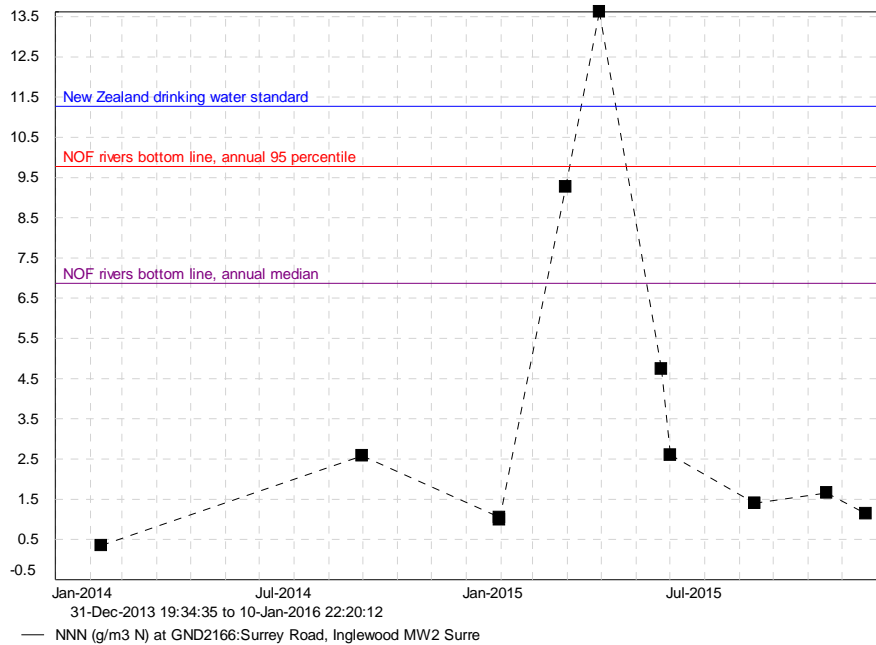
The results returned one significant reading in this period. The level of nitrate increased dramatically in monitoring well GND2165, whereby it peaked at 9.30 g/m³ N in March 2015 before falling to 4.77 g/m³ N. Analysis of samples collected in the following monitoring year suggests that this concentration has returned to baseline levels when taking into account the overall record.

Figure 5 Nitrite/ nitrate nitrogen in groundwater GND2166

Discussion with the site manager suggested that this peak in nitrate (Figure 5) could be a result of fertiliser application of urea in the vicinity of the monitoring well (Figure 4). The farm manager had been contacted and the source was confirmed. Neither of the other two monitoring wells picked up this peak, as such it is most likely the result of a localised application of urea fertiliser, as have been seen on other landfarming facilities.

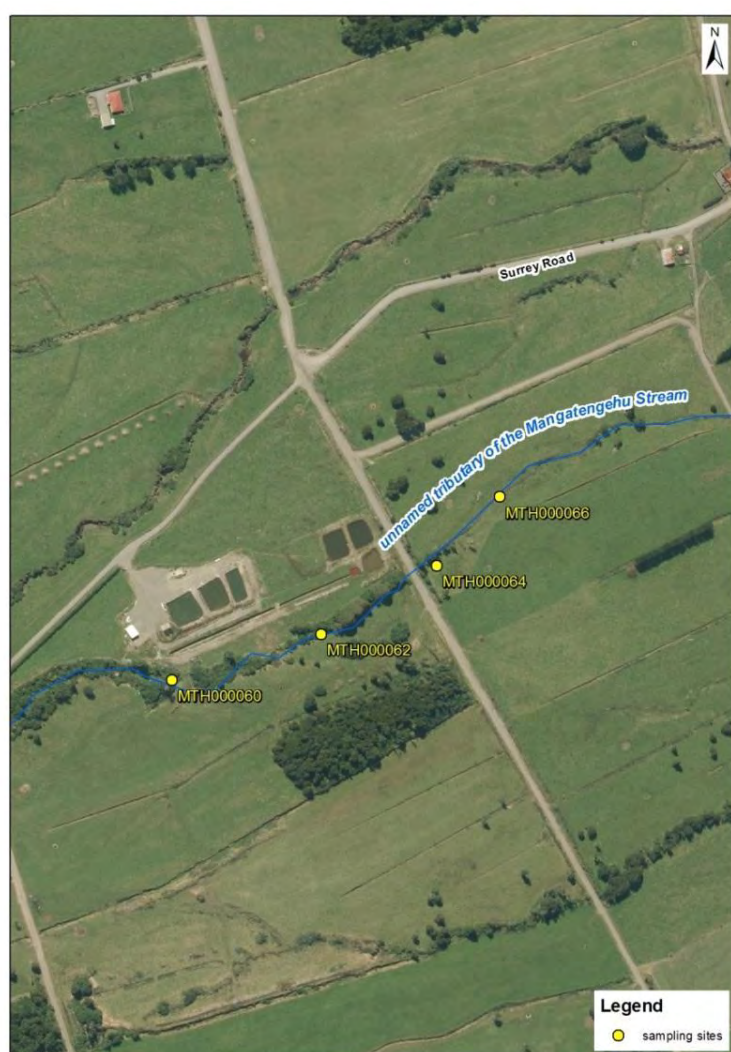
Figure 1 Biomonitoring sites in an unnamed tributary of the Mangatengehu Stream, sampled in relation to the Surrey Road drilling waste stockpiling site

Site Number	Site code	Grid reference (NZTM)	Location	Altitude (masl)
1	MTH000060	E1701830 N5651430	Upstream of drilling waste stockpiling site	495
2	MTH000062	E1701954 N5651468	Approximately 85 metres upstream of the spring and skimmer pit discharge	495
3	MTH000064	E1702050 N5651525	Approximately 35 metres downstream of the skimmer pit discharge	490
4	MTH000066	E1702102 N5651582	Approximately 100 metres downstream, of the skimmer pit discharge	485

This scheduled biomonitoring survey was undertaken at four sites on 2 March 2015 (Table 1 and Figure 1). At the time of the initial survey undertaken in April 2010, site 1 was established as a 'control site', upstream of the drilling stockpile area and sites 2 and 3 were established downstream of the skimmer pit discharge. During an inspection of the site in mid-2010, an unauthorised discharge of hydrocarbons was observed entering the stream. As a consequence of this inspection, changes were made to the on site drainage. These changes were made between the April 2010 and November 2010 surveys. The result was that site 2 was located upstream of any discharge from the sites, and site 3 became the primary impact site. The stormwater discharge from the site now enters the unnamed tributary immediately upstream of the race crossing, approximately 35 metres upstream of site 3. A new, secondary impact site (site 4) was established 100 metres downstream of the stormwater discharge during the May 2012 survey.
