Waste Remediation Services Limited  
Waikaikai Landfarm  
Monitoring Programme  
Annual Report  
2014-2015

Technical Report 2015-95

May 2016

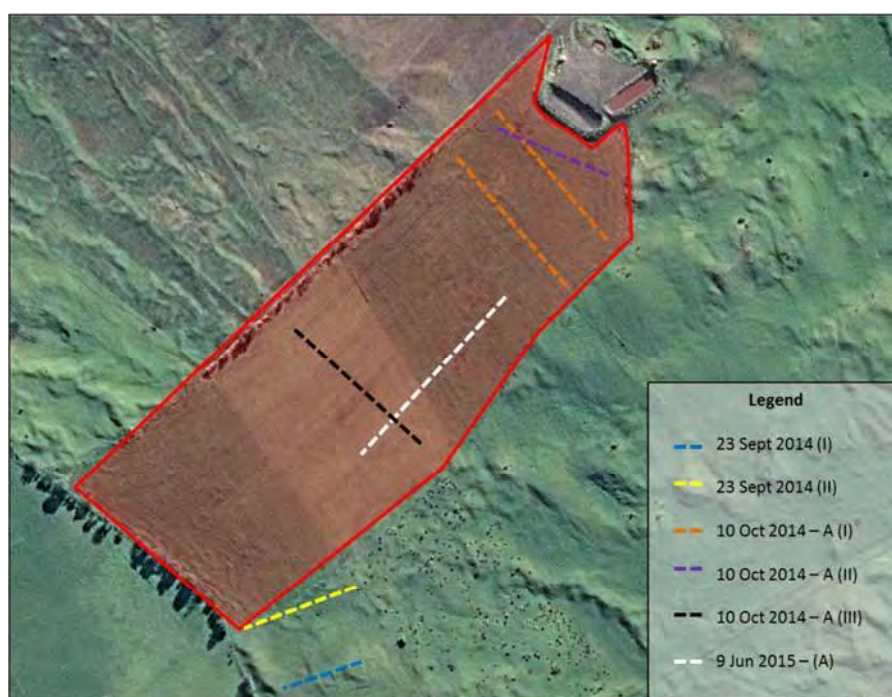
**Figure 2** Council soil sample transects

Soil samples collected and analysed by the Council in this monitoring period are detailed above in Table 2 and locations are depicted in Figure 2. The analysis detailed no exceedance in comparison to the stipulated consent conditions with respect to chloride, conductivity, sodium and total soluble salts. However, metal analysis and speciation of hydrocarbon is undertaken by the Company and this is provided in the following section.

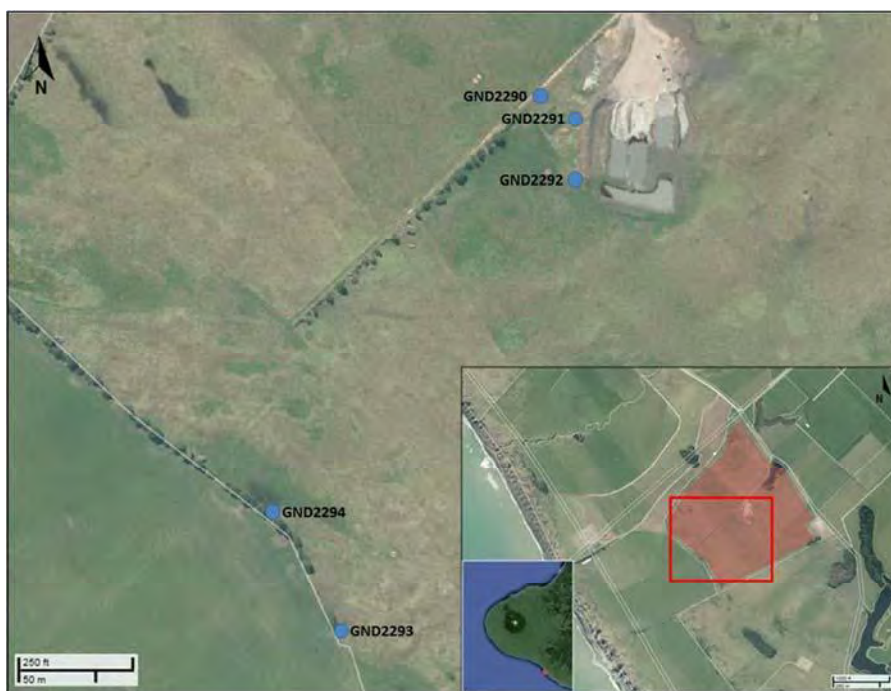
**Figure 3** Groundwater monitoring well locations with respect to the site

The locations of the monitoring wells are detailed in Figure 3. GND 2290-2292 are located in close proximity to the storage cells, while GND 2293 and 2294 are located at the down gradient perimeter to ascertain the potential for offsite effects.

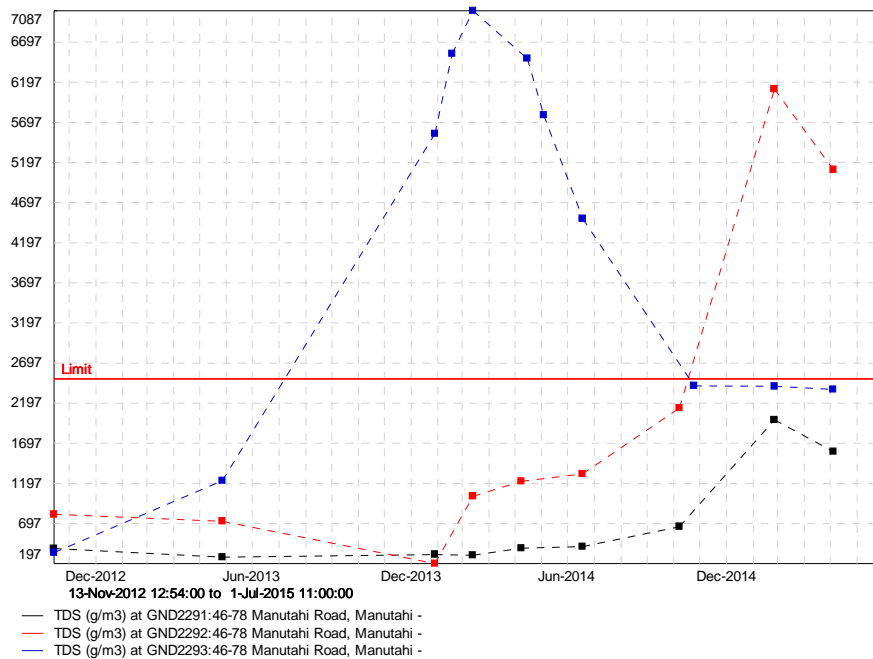
**Figure 4** Long term TDS concentrations at the Waikaikai Landfarm

The long term TDS record is provided in Figure 4. In the previous period the degree of salt concentration was evident at the boundary line and specifically GND2293. In this period the concentration has decreased. However, in the same period the TDS concentration in GND2292 has increased above the conditional limit of 2,500 g/m<sup>3</sup> and constitutes a non-conformance with consent conditions as already discussed.

As the facility contains an unlined contingency cell which was observed in this monitoring period to have contained drilling mud, there is the potential that this unlined storage pit may be contributing to the increased salt concentration
