Freshwater contact recreational
water quality at Taranaki sites
State of the Environment Monitoring
Annual Report
2018-2019

Technical Report 2019-01

Taranaki Regional Council
Private Bag 713
STRATFORD
September 2019

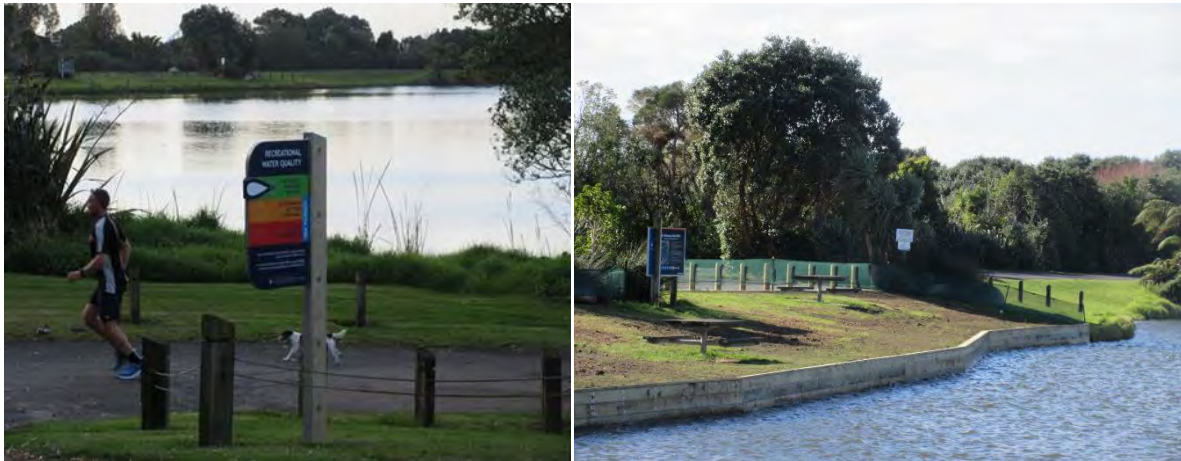
Photo 1 Signs at Lake Rotomanu, June 2017 and August 2018

Ducks were present on the lake or in the vicinity of the lake edge throughout most the period. Public feeding of the ducks has been observed previously. Gulls were present or common on the banks on several occasions. The lake level was lowered in early January 2019 for the inlet channel to be cleared of debris and silt (under consent 0298-3, on 21 January), and further in mid-March for repairs to the outlet pipe, which eventually were carried out in mid-May 2019. A wetland had been created several years ago at Peringa Park to improve the quality of stormwater runoff entering the lake. A bank retaining wall was emplaced at the western beach sampling site in August 2018 (Photo 1).

A recreational water quality advisory sign was erected by NPDC on the access road to the lake in June 2017, in addition to the existing TRC sign at the monitoring site (Photo 1, the original sign on the right is in the far background on the left).

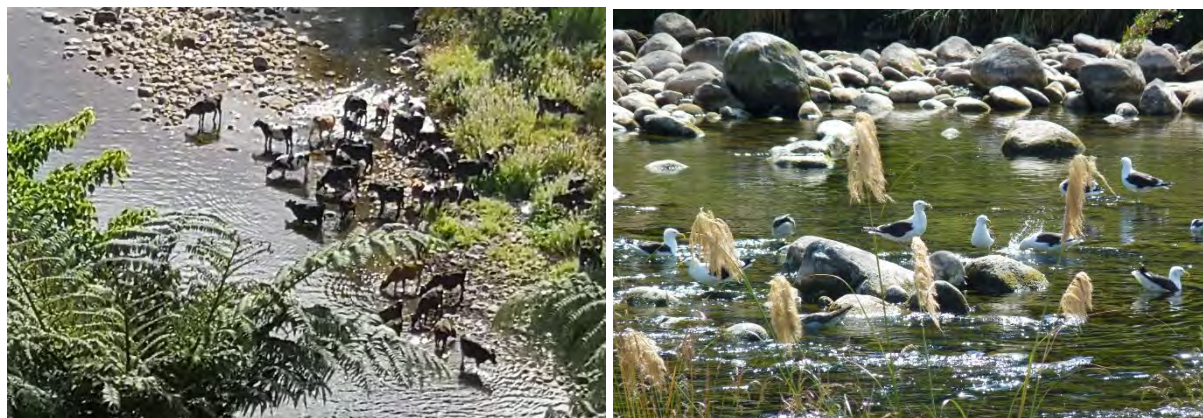
Photo 2 and Photo 3 Cattle and gulls in Waiwhakaiho River above Merrilands Domain, January 2019

After the first elevated *E. coli* result, investigations by inspection and additional water testing led to the discovery of cattle entering the river about 3 km upstream. This was addressed with the farmer concerned. Gulls were also found, bathing in the river (Photo 2 and Photo 3).

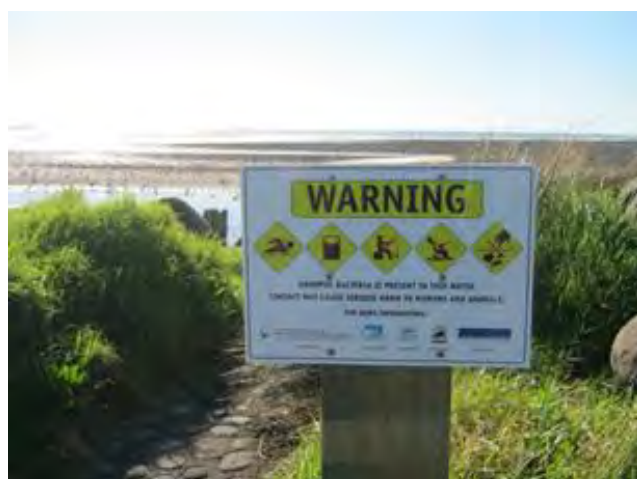
Photo 7 Health risk signage, lower Waiwhakaiho River

Nine single samples were recorded within the 'Action' mode and four samples in the 'Alert' mode during the season. Bacteriological water quality measured at this site was seldom within the acceptable standard for contact recreational usage through the survey period and therefore appropriate warning signage was required at this site adjacent to the walkway throughout the survey period (Photo 7). Appropriately worded signage should be retained on a permanent basis in future.

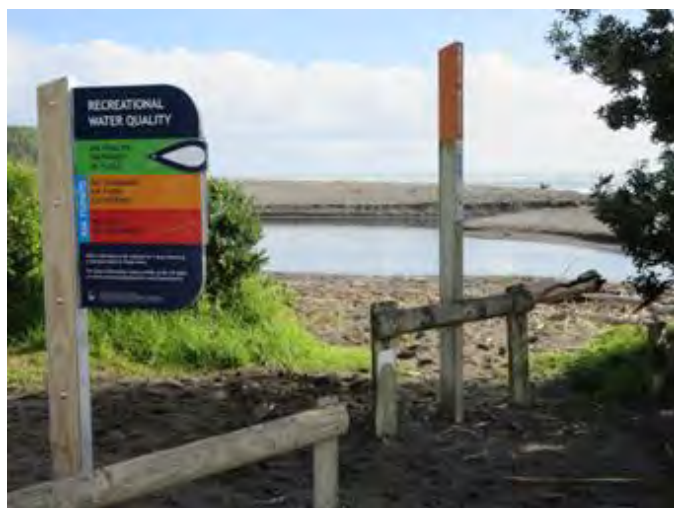
A recreational water quality advisory sign was erected by NPDC at the car park adjacent to the monitoring site in summer 2016-2017 (Photo 8).

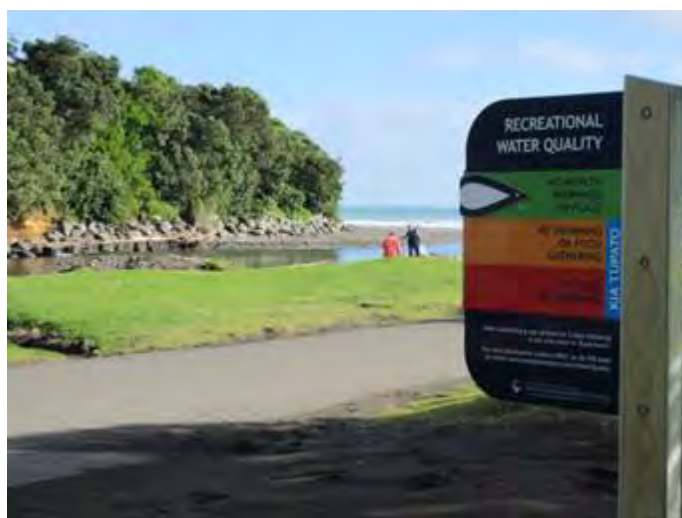
A recreational water quality advisory sign was erected by NPDC at the car park adjacent to the monitoring site in summer 2016-2017 (Photo 9).

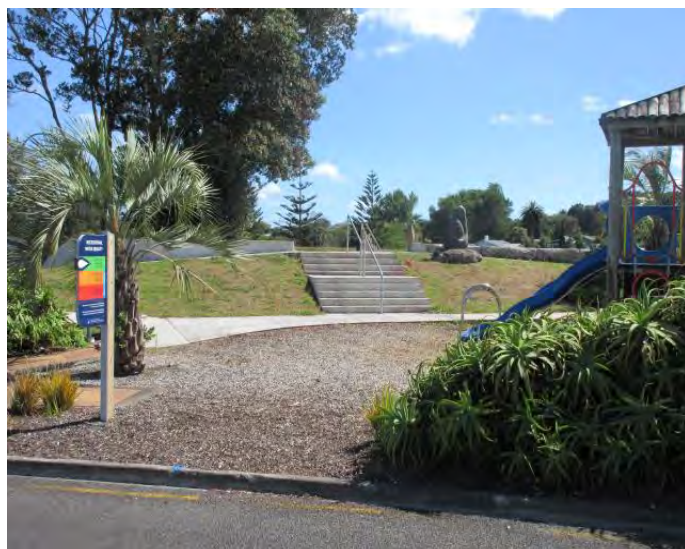
These issues were discussed with the Area Health Board and NPDC staff and appropriately worded health warning signage was permanently installed at the town wharf prior to the 2010-2011 season. However, the permanency of this signage was problematic due in part to vandalism. A new, recreational water quality advisory sign was erected by NPDC at the entrance to the town wharf in summer 2016-2017 (Photo 10).
