Freshwater contact recreational water quality at Taranaki sites

State of the Environment Monitoring
Annual Report
2019-2020

Technical Report 2020-01

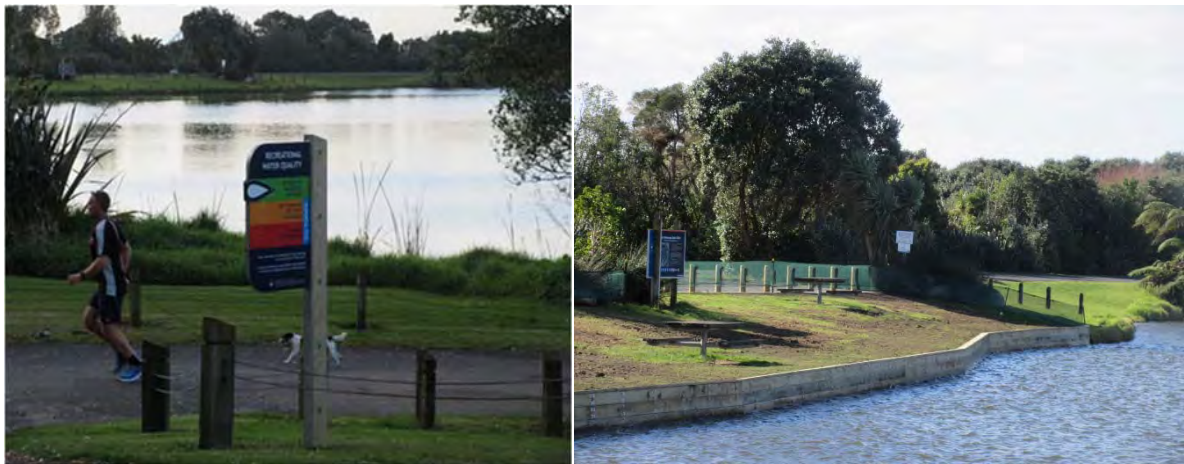
Photo 1 Signs at Lake Rotomanu

Ducks were present on the lake or in the vicinity of the lake edge throughout most the period. Public feeding of the ducks has been observed previously. Gulls were present or common on the banks on several occasions. A wetland had been created several years ago at Peringa Park to improve the quality of stormwater runoff entering the lake. A bank retaining wall was emplaced at the western beach sampling site in August 2018 (Photo 1).

A recreational water quality advisory sign was erected by NPDC on the access road to the lake in June 2017, in addition to the existing TRC sign at the monitoring site (Photo 1, the original sign on the right is in the far background on the left).

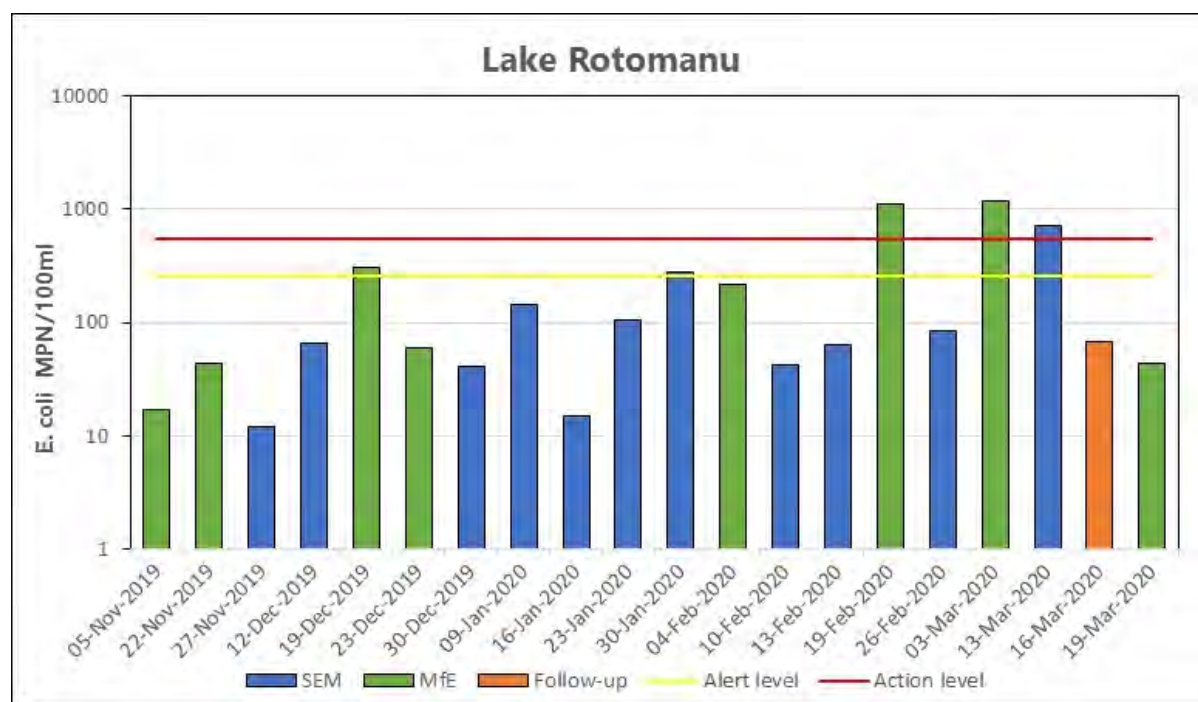
Figure 2 *E. coli* results for Lake Rotomanu

All *E. coli* data for this site, from the 2019-2020 summer period, are presented in Figure 2. The complete survey results are presented in Appendix I and summarised in Table 7.

Generally, bacteriological quality was relatively good considering that the inflow to the lake is from the lower reaches of a river draining a developed catchment. However, elevated numbers of *E. coli* (in the 'Action' mode) were found on three occasions, in February and March 2020, the first after wet weather, the latter two in dry weather. Run-off from recent light rainfall may have affected the first result. Ducks, which were common on the water around the sampling point on the second sampling occasion, were a likely source for the other events. NPDC adjusted the signage to reflect the increased health risk from recreational use of the lake. Resampling was undertaken as soon as weather permitted in each instance, twice as part of

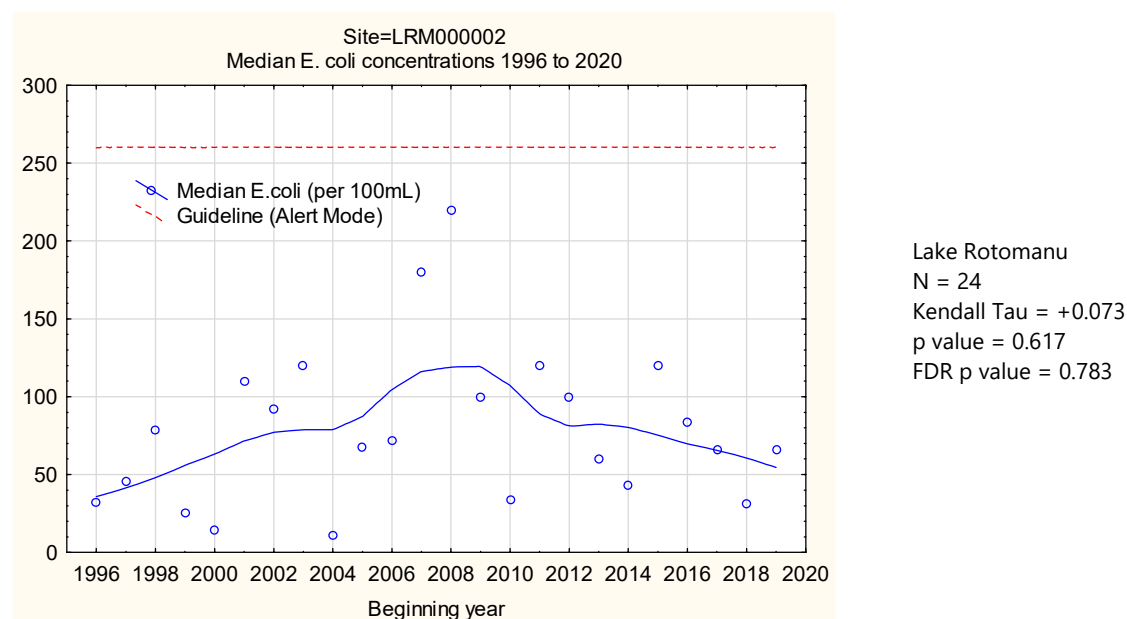
Figure 4 LOWESS trend analysis of median *E. coli* data at Lake Rotomanu

Trend analysis was performed by applying a LOWESS fit (tension 0.4) to a time scatterplot of the median *E. coli* data for 24 summer seasons (Figure 4) and testing the significance of any trend using the Mann-Kendall test at the 5% level, followed by Benjamini-Hochberg False Discovery Rate (FDR) analysis.

Overall, a positive trend, but not statistically significant or important increase in median *E. coli* numbers, has been found over the twenty-four seasons of monitoring. None of these seasonal medians has exceeded the 'Alert' or 'Action' modes.

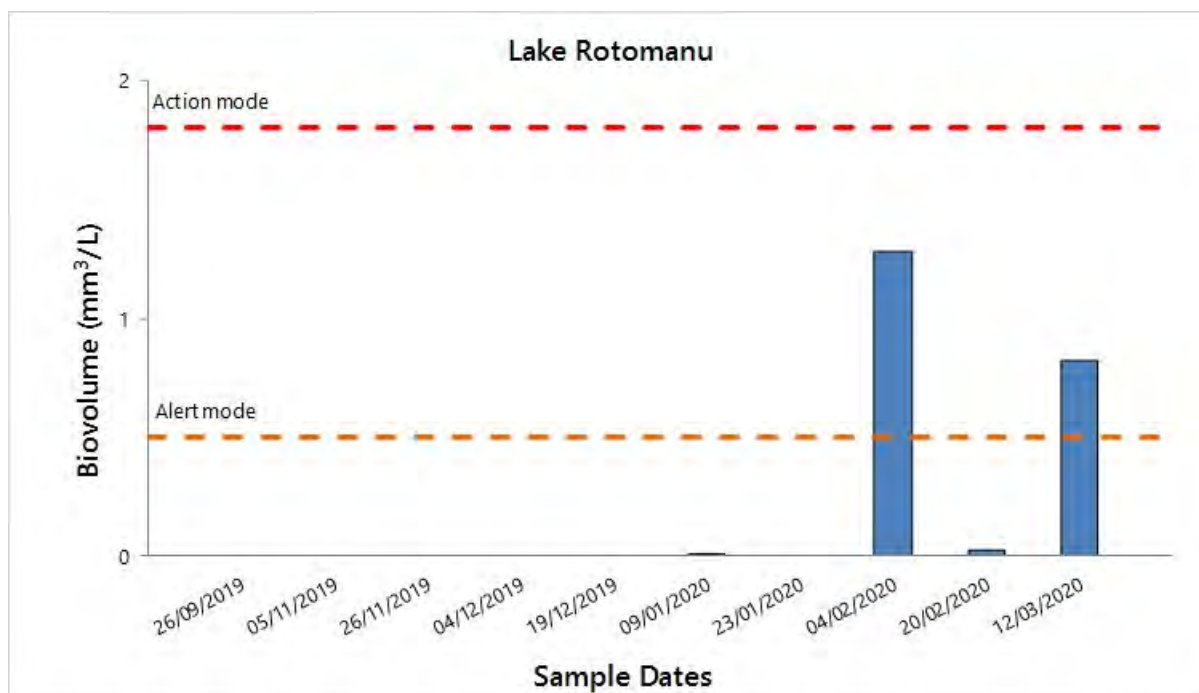
Figure 5 Cyanobacteria bio-volume at Lake Rotomanu [Health warning: > 1.8 mm³/l]

Date	Cyanobacteria total cell count (cells/ml)	Bio-volume (mm ³ /l)	Principal species by biovolume	Mode
12/03/2020	2000000	0.82	Picocyanobacteria	Alert

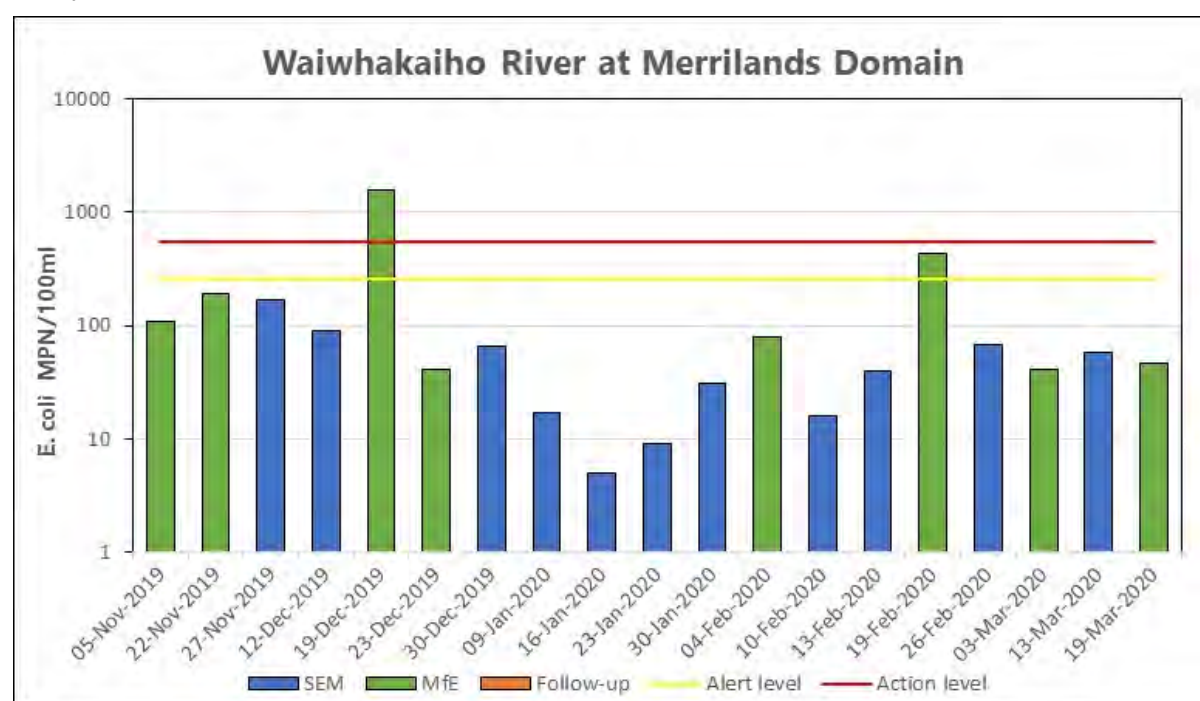
Figure 6 *E. coli* results for the Waiwhakaiho River at Merrilands Domain

All *E. coli* data for this site, from the 2019-2020 summer period, are presented in Figure 6. The complete survey results are presented in Appendix I and summarised in Table 10.

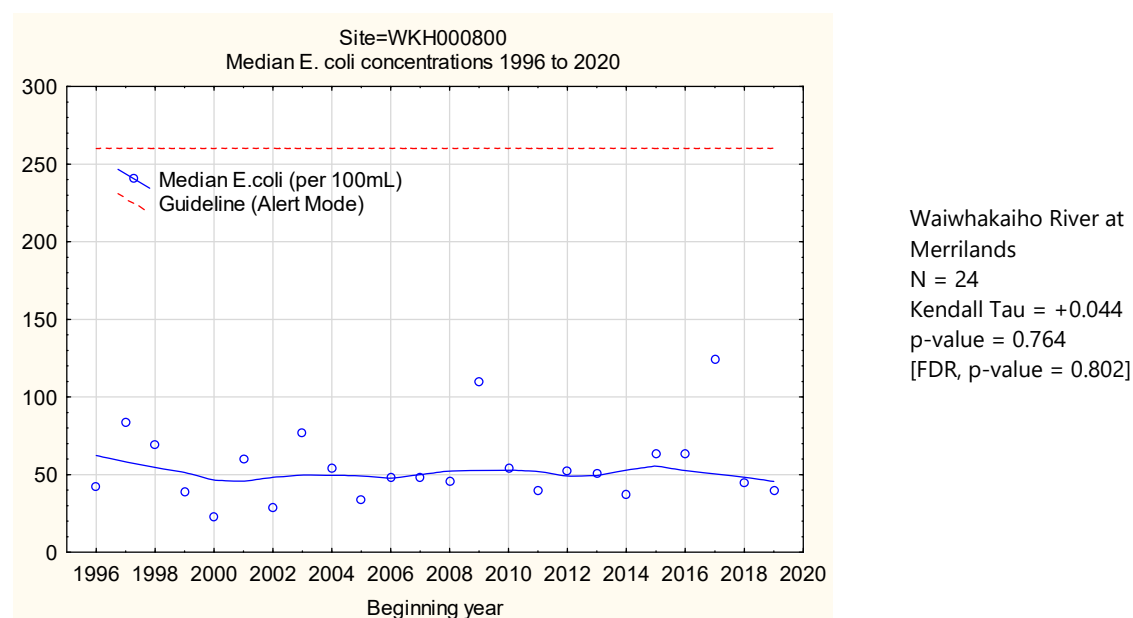
Figure 9 LOWESS trend analysis of median *E. coli* at the Waiwhakaiho River, Merrilands Domain

Trend analysis of these median *E.coli* numbers has been performed for the twenty-four seasons of data by applying a LOWESS fit (tension 0.4) to a time scatterplot of the median values (Figure 9) and testing the significance of any trend using the Mann-Kendall test at the 5% level followed by Benjamini-Hochberg False Discovery Rate (FDR) analysis.

A slight, unimportant and statistically insignificant increase in median *E.coli* numbers has been found over the twenty-four seasons of monitoring. None of these seasonal medians exceeded the 'Alert' or 'Action' modes.

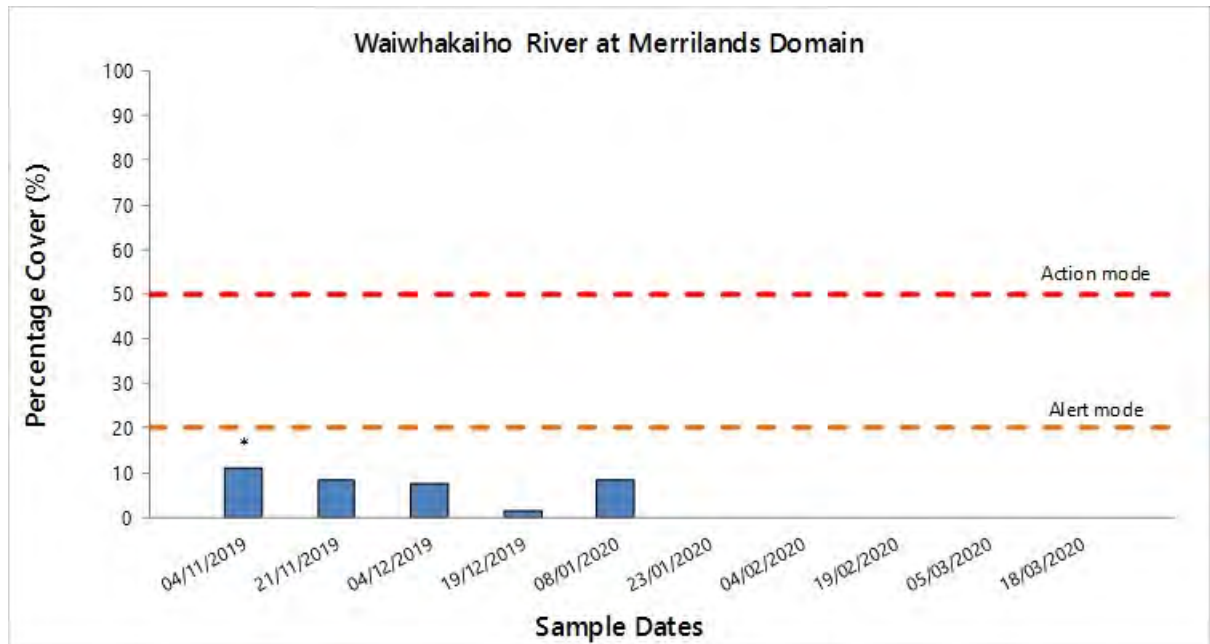
Figure 10 Percentage benthic cyanobacteria cover at the Waiwhakaiho River at Merrilands Domain site

Note that 'Action' and 'Alert' mode lines are for percentage cover only. The symbols * and + over a bar indicate where the status been raised to 'Alert' or 'Action' mode, respectively due to detaching or exposed mats.

Benthic cyanobacteria coverage was generally low throughout the season (ranging from 0 to 11%). The 'Action' or 'Alert' level was never exceeded for percentage cover. The benthic cyanobacteria found were *Microcoleus* sp. Detaching mats were not observed at either significant or minor levels. Minor levels of exposed mats were visible on one occasion which triggered the 'Alert' level. In total, the 'Alert' level was triggered on one occasion.

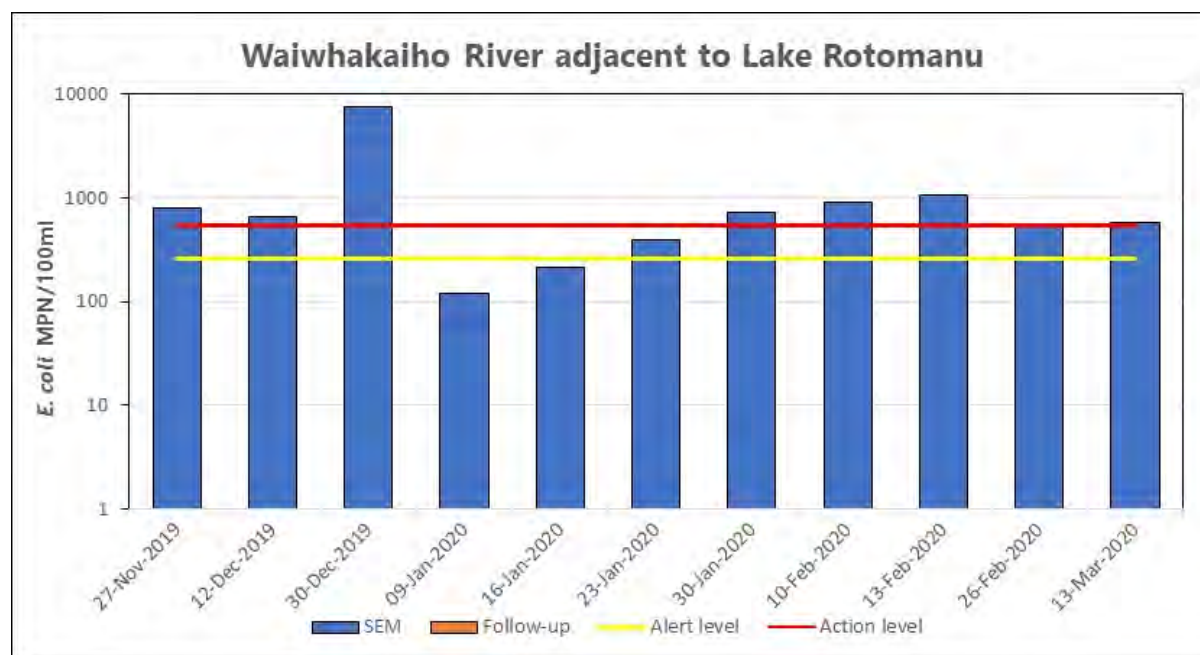
Figure 11 *E. coli* results for Waiwhakaiho River adjacent to Lake Rotomanu

All *E. coli* data for this site, from the 2019-2020 summer period, are presented in Figure 11. The complete survey results are presented in Appendix I and summarised in Table 13. River flow information is illustrated in Figure 11 as it is also applicable to this site.

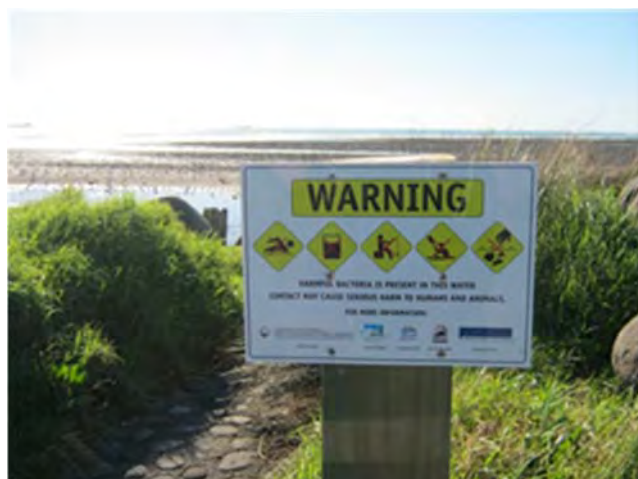
Photo 5 Health risk signage, lower Waiwhakaiho River

Eight single samples were recorded within the 'Action' mode and one sample in the 'Alert' mode during the season. Bacteriological water quality measured at this site was seldom within the acceptable standard for contact recreational usage through the survey period and therefore appropriate warning signage was required at this site adjacent to the walkway throughout the survey period (Photo 5). Appropriately worded signage should be retained on a permanent basis in future.

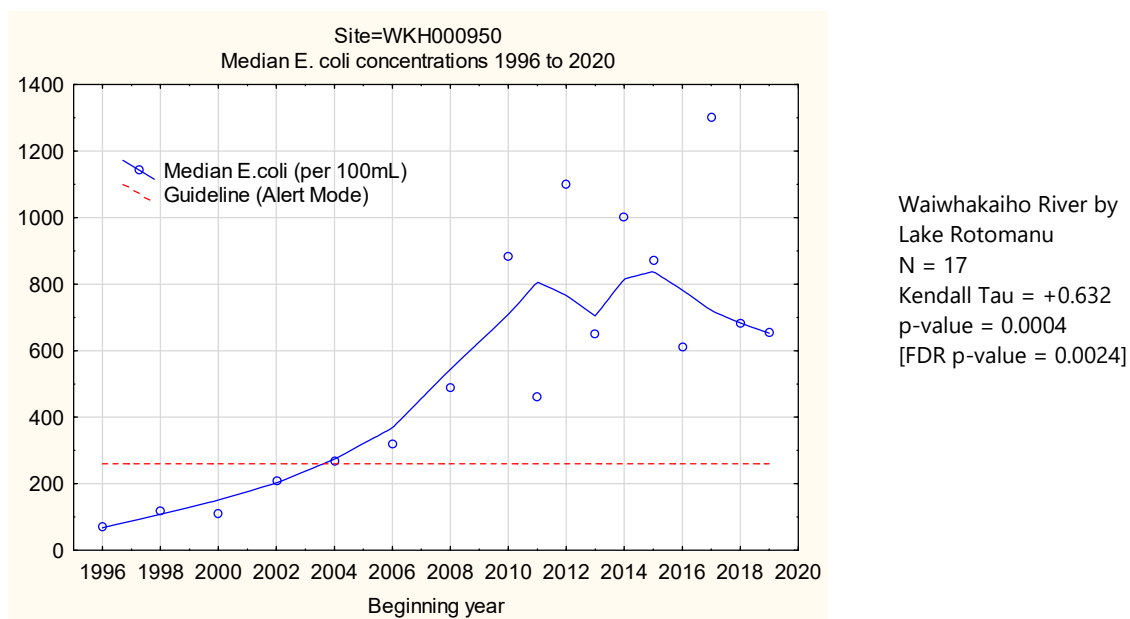
Figure 13 LOWESS trend plot of median *E. coli* data for the Waiwhakaiho River, adjacent to Lake Rotomanu

Trend analysis of these median *E. coli* numbers has been performed for the seventeen seasons of data (over 24 years) by applying a LOWESS fit (tension 0.4) to a time scatterplot of the median numbers (Figure 13). Testing the significance of any trend using the Mann-Kendall test at the 5% level followed by Benjamini-Hochberg False Discover Rate (FDR) analysis has been performed.

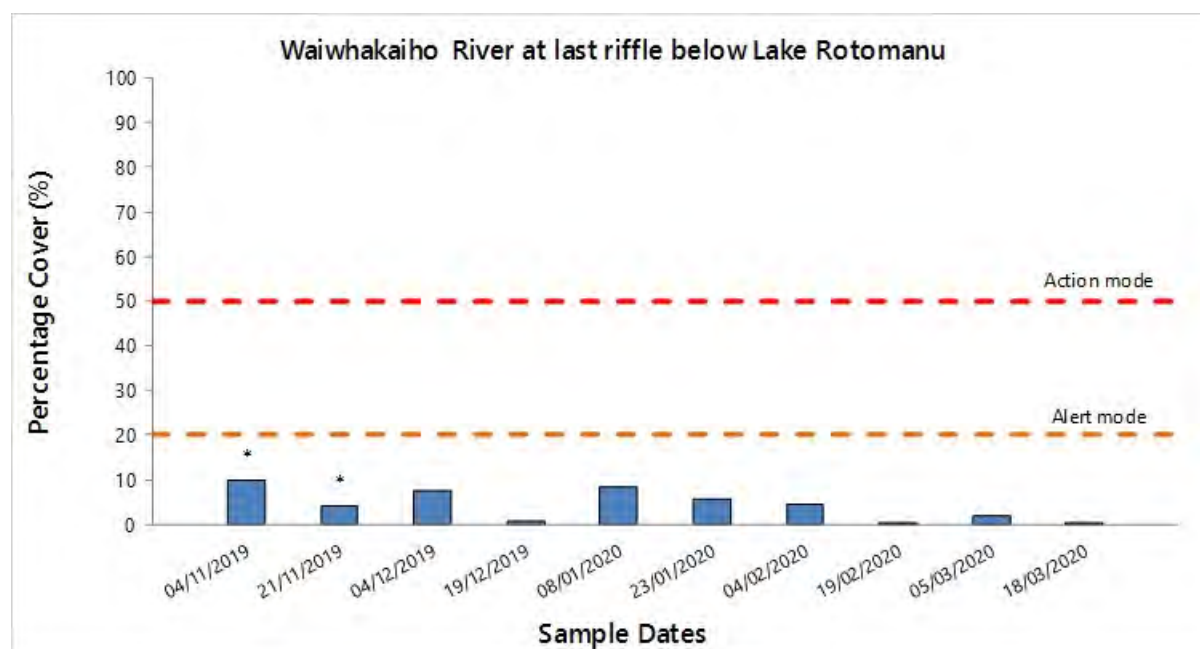
Figure 14 Percentage benthic cyanobacteria cover at Waiwhakaiho River at last riffle below Lake Rotomanu.

Date	Average cyanobacteria % cover	Detaching mats	Exposed mats	Mode
04/11/2019	10	No	Minor	Alert
15/11/2019	4	Minor	Minor	Alert
21/11/2019	8	No	No	Surveillance
04/12/2019	1	No	No	Surveillance
19/12/2019	8	No	No	Surveillance
08/01/2020	6	No	No	Surveillance
23/01/2020	5	No	No	Surveillance
04/02/2020	1	No	No	Surveillance
19/02/2020	2	No	No	Surveillance
05/03/2020	0	No	No	Surveillance
18/03/2020	0	No	No	Surveillance

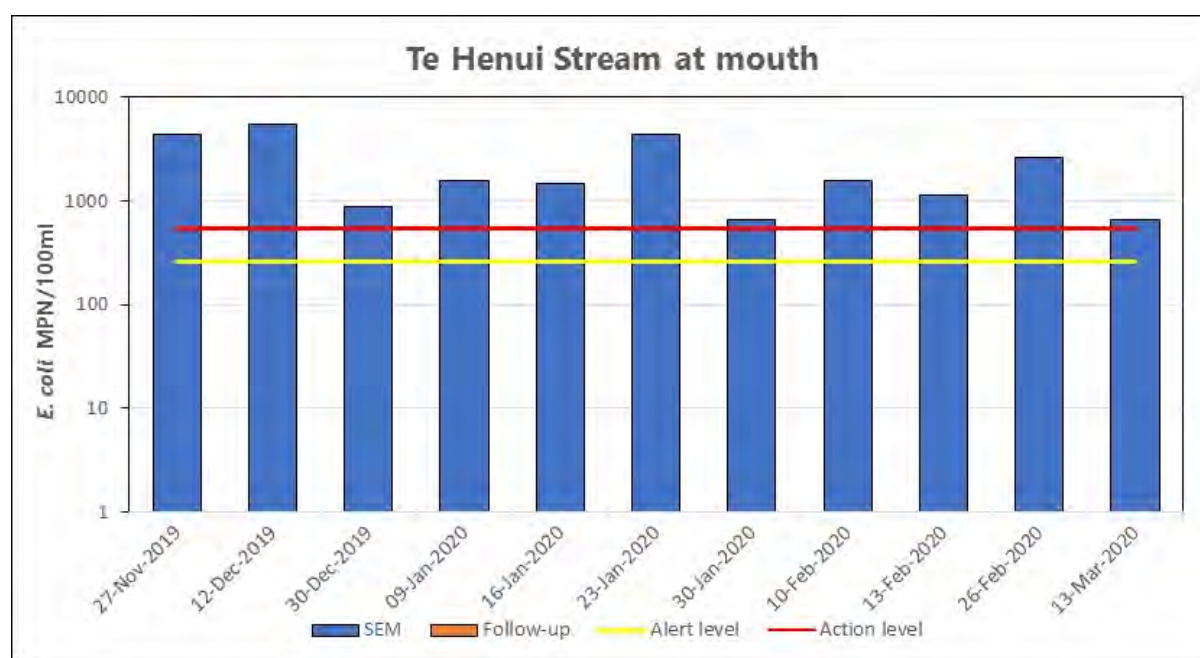
Figure 15 *E. coli* results for Te Henui Stream at mouth, East End

All *E. coli* data for this site, from the 2019-2020 summer period, are presented in Figure 15. The complete survey results are presented in Appendix I and summarised in Table 16.

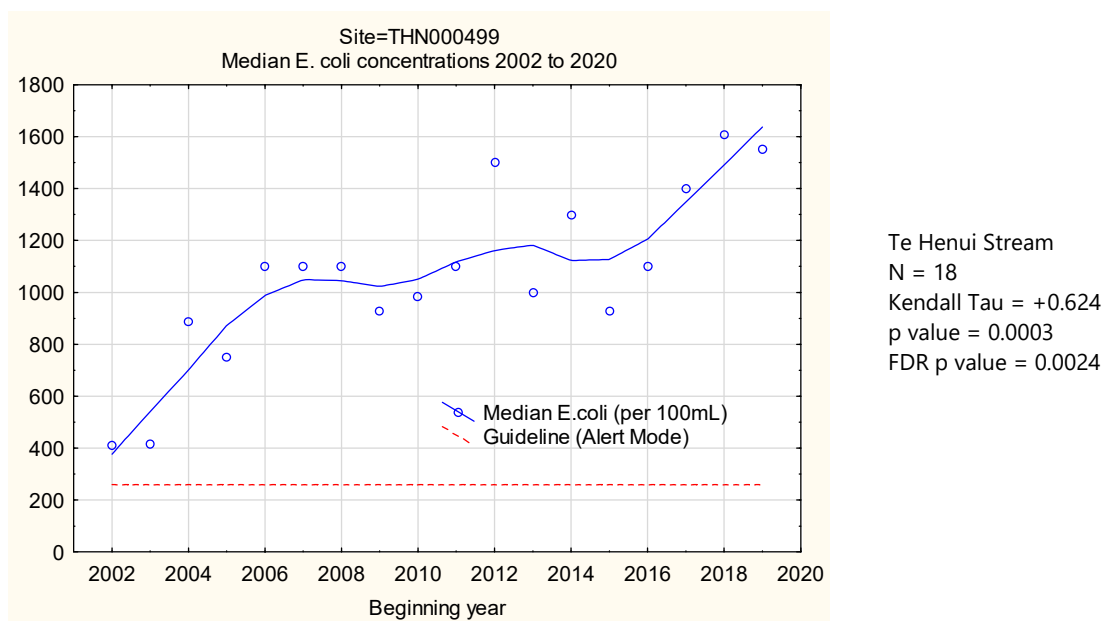
Figure 17 LOWESS trend analysis of median *E. coli* data at Te Henui Stream mouth, East End

Trend analysis of these median *E. coli* numbers has been performed for the eighteen seasons of data by first applying a LOWESS fit (tension 0.4) to a time scatterplot of the median numbers (Figure 17) and testing the significance of any trend using the Mann-Kendall test at the 5% level followed by Benjamini-Hochberg False Discovery Rate (FDR) analysis.

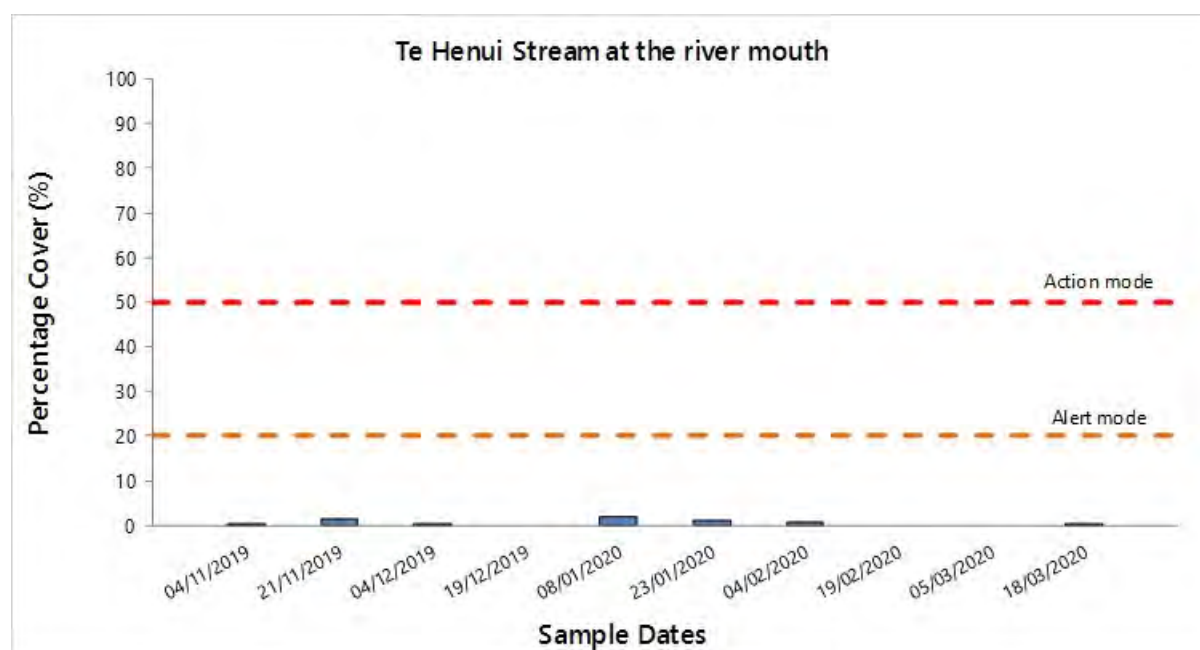
Figure 18 Percentage benthic cyanobacteria cover at Te Henui Stream at the mouth

Date	Average cyanobacteria % cover	Detaching mats	Exposed mats	Mode
04/11/2019	0	No	No	Surveillance
21/11/2019	0	No	No	Surveillance
04/12/2019	1	No	No	Surveillance
19/12/2019	0	No	No	Surveillance
08/01/2020	2	No	No	Surveillance
23/01/2020	0	No	No	Surveillance
04/02/2020	0	No	No	Surveillance
19/02/2020	0	No	No	Surveillance
05/03/2020	0	No	No	Surveillance
18/03/2020	0	No	No	Surveillance

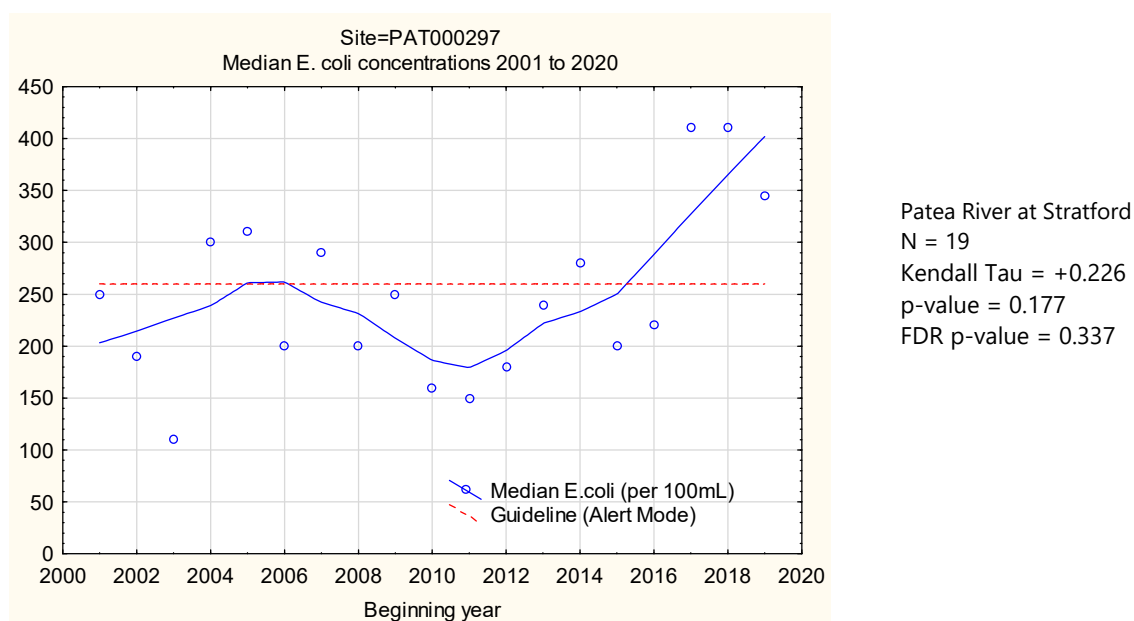
Figure 22 LOWESS trend plot of median E.coli data at the Patea River, King Edward Park, Stratford

Trend analysis of these median *E.coli* numbers has been performed for the nineteen seasons of data by first applying LOWESS fit (tension 0.4) to a time scatterplot of the median numbers (Figure 22) and testing the significance of any trend using the Mann-Kendall test at the 5% level followed by Benjamini-Hochberg False Discovery Rate (FDR) analysis.

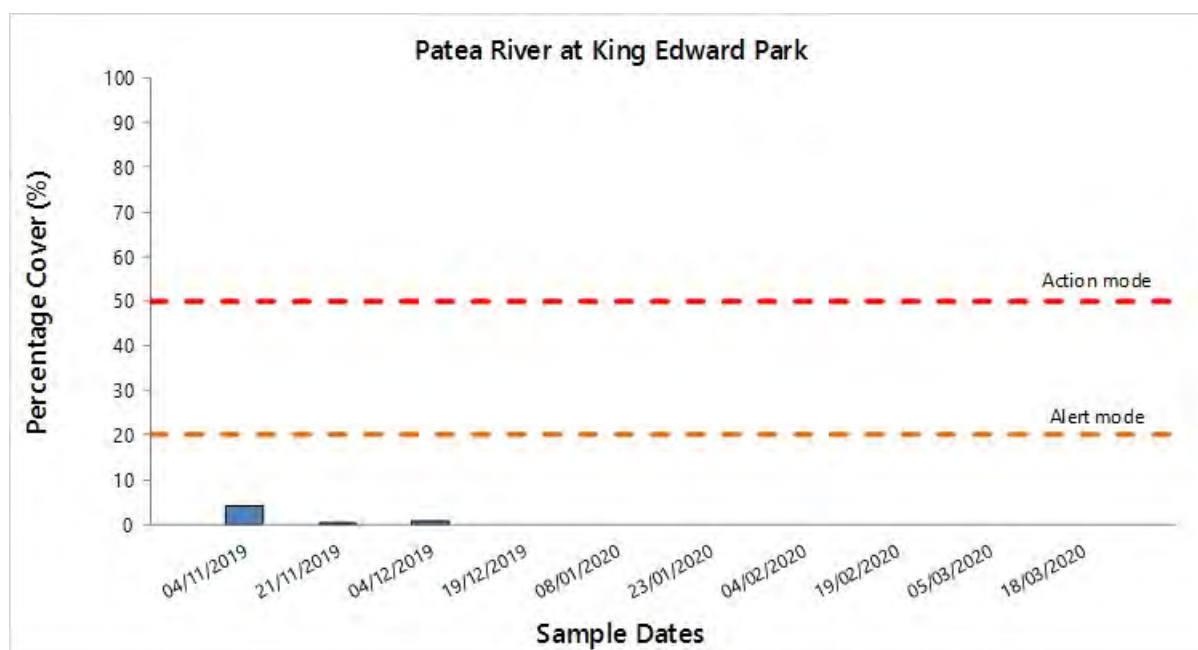
Figure 23 Percentage benthic cyanobacteria cover at the Patea River, Edward Park site.

Date	Average cyanobacteria % cover	Detaching mats	Exposed mats	Mode
04/11/2019	4	No	No	Surveillance
21/11/2019	0	No	No	Surveillance
04/12/2019	1	No	No	Surveillance
19/12/2019	0	No	No	Surveillance
08/01/2020	0	No	No	Surveillance
23/01/2020	0	No	No	Surveillance
04/02/2020	0	No	No	Surveillance
19/02/2020	0	No	No	Surveillance
05/03/2020	0	No	No	Surveillance
18/03/2020	0	No	No	Surveillance

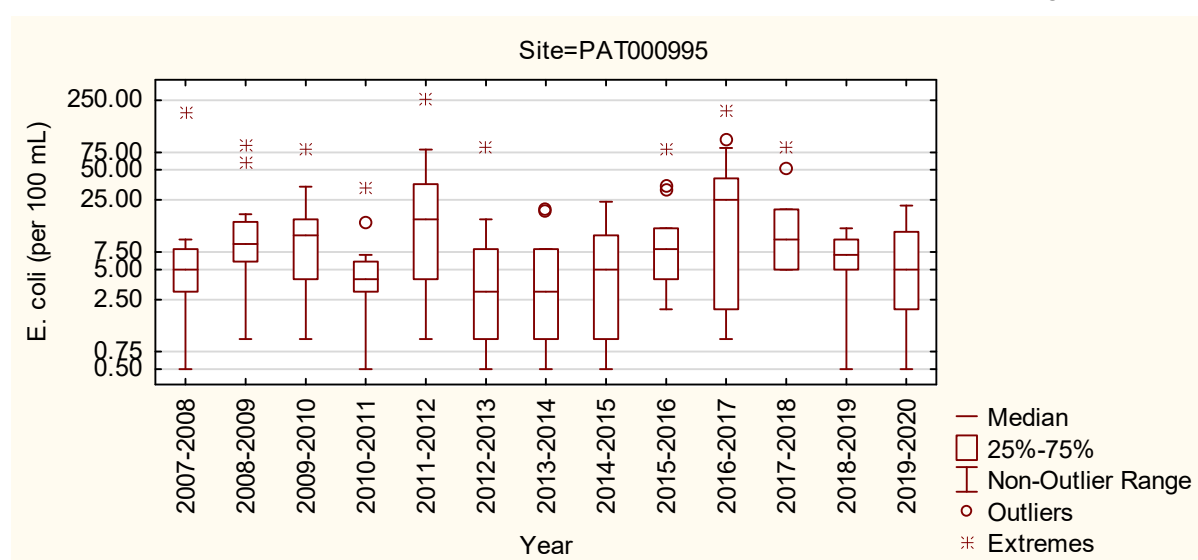
Figure 25 Box & whisker plots of *E. coli* for all summer SEM surveys of Patea River at boat ramp, Patea

Twelve previous SEM sampling seasons have been surveyed at this site. Otherwise, prior sampling has been confined to consent monitoring surveys (TRC 2020, in prep). A statistical comparison of all summers' survey data is presented graphically in Appendix VI for all sites. A much shorter data period exists for this Patea River site (at Patea boat ramp) which was added in 2007-2008. These data are illustrated in Figure 25.

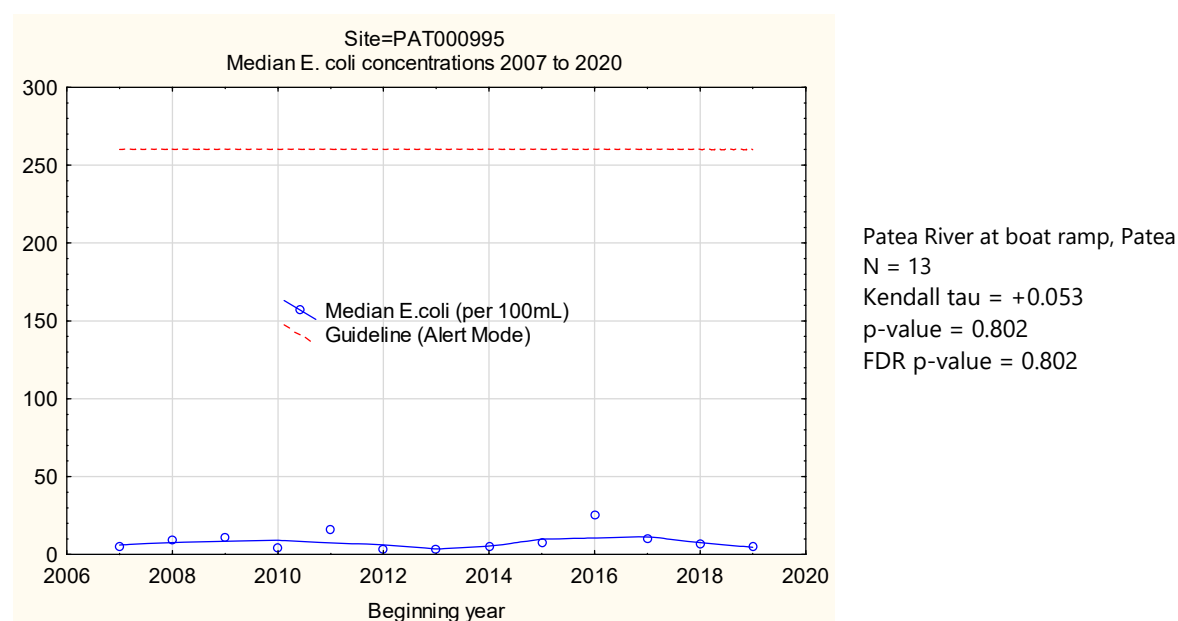
Figure 26 LOWESS trend plot of median *E. coli* data for Patea River at boat ramp, Patea

Trend analysis of these median *E. coli* numbers has been performed for the thirteen seasons of data by first applying LOWESS fit (tension 0.4) to a time scatterplot of the median numbers (Figure 26) and testing the significance of any trend using the Mann-Kendall test at the 5% level followed by Benjamin-Hochberg False Discovery Rate (FDR) analysis.

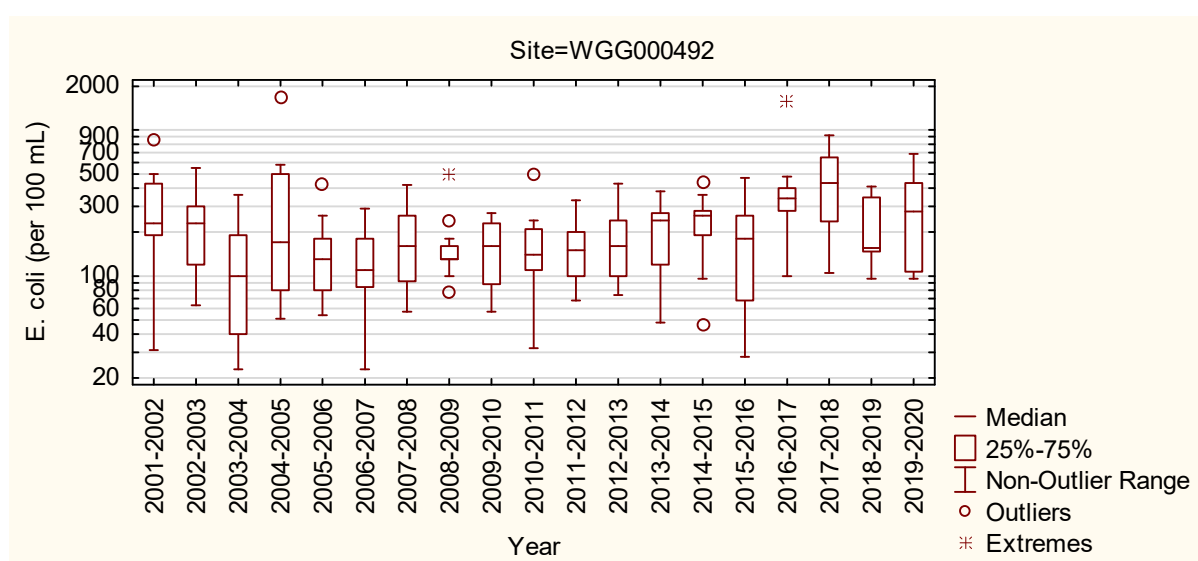
Figure 29 Box and whisker plots of *E. coli* for all summer surveys in Waingongoro River at Eltham Camp

Summary statistics for the SEM *E. coli* data collected at Waingongoro River at Eltham camp over 19 summers is presented in Figure 29.

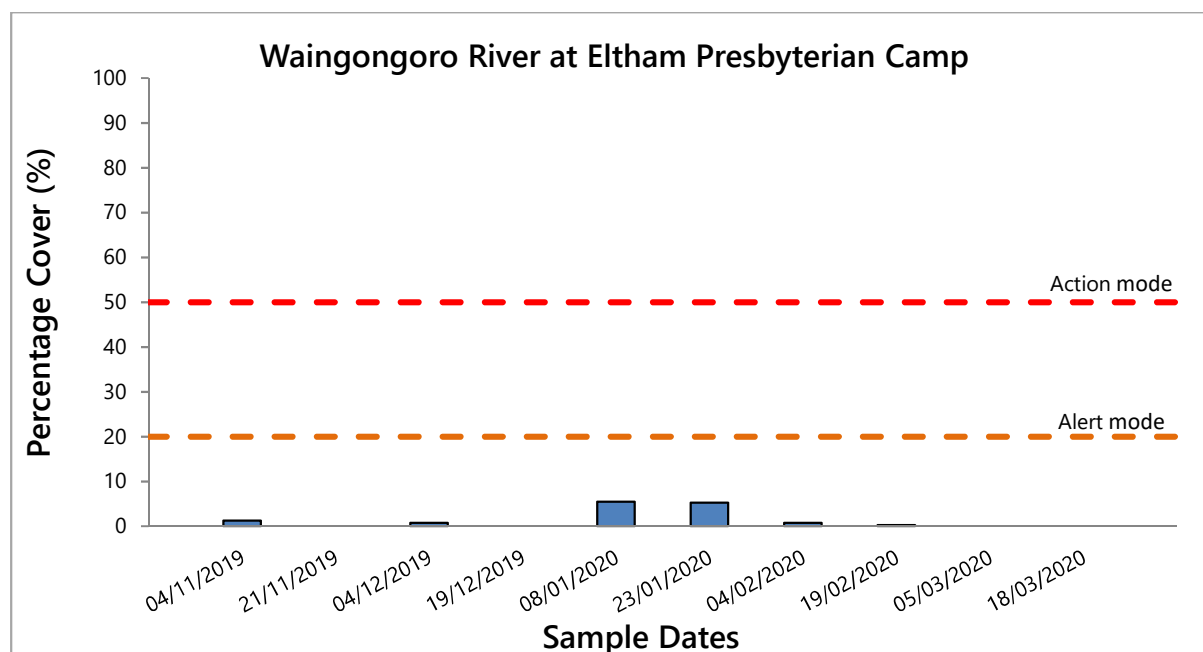
Note: 'Action' and 'Alert' mode lines are for percentage cover only. * and + symbols over a bar indicate where the status has been raised to 'Alert' or 'Action' mode respectively due to detaching or exposed mats

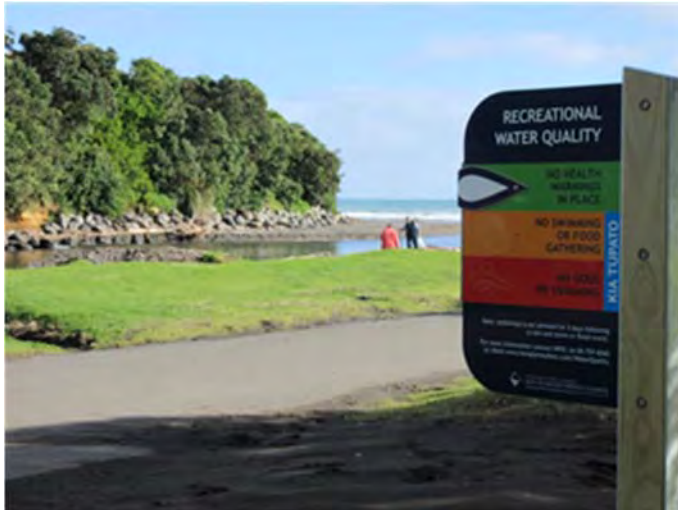
Photo 7 Sign at Oakura River mouth

A recreational water quality advisory sign was erected by NPDC at the car park adjacent to the monitoring site in summer 2016-2017 (Photo 7).

The adjustable cursor may be set to "no health warning in place" (green) "no swimming or food gathering" (orange alert) or "no dogs or swimming" (red alert for cyanobacteria). No alert was indicated during the summer 2019-2020 monitoring period.

Three single samples fell within the 'Alert' mode, and no sample entered the 'Action' mode. Health warning signage (Photo 7) was not required to be displayed at this site by NPDC.

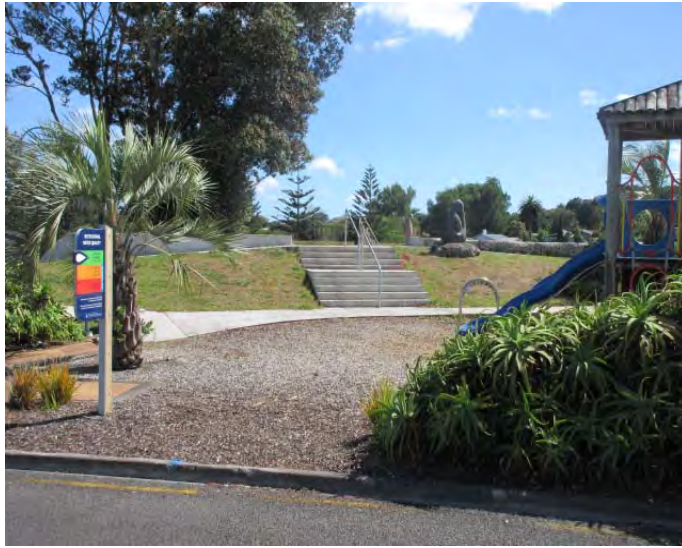
Photo 8 Sign at entrance to Waitara town wharf

These issues were discussed with the Area Health Board and NPDC staff and appropriately worded health warning signage was permanently installed at the town wharf prior to the 2010-2011 season. However, the permanency of this signage was problematic due in part to vandalism. A new, recreational water quality advisory sign was erected by NPDC at the entrance to the town wharf in summer 2016-2017 (Photo 8).
