South Taranaki District Council  
Waverley, Kaponga, Manaia and Patea  
Municipal Wastewater Treatment Plant Systems  
Monitoring Programmes  
Annual Report  
2012-2013

Technical Report 2013 -16

November 2013

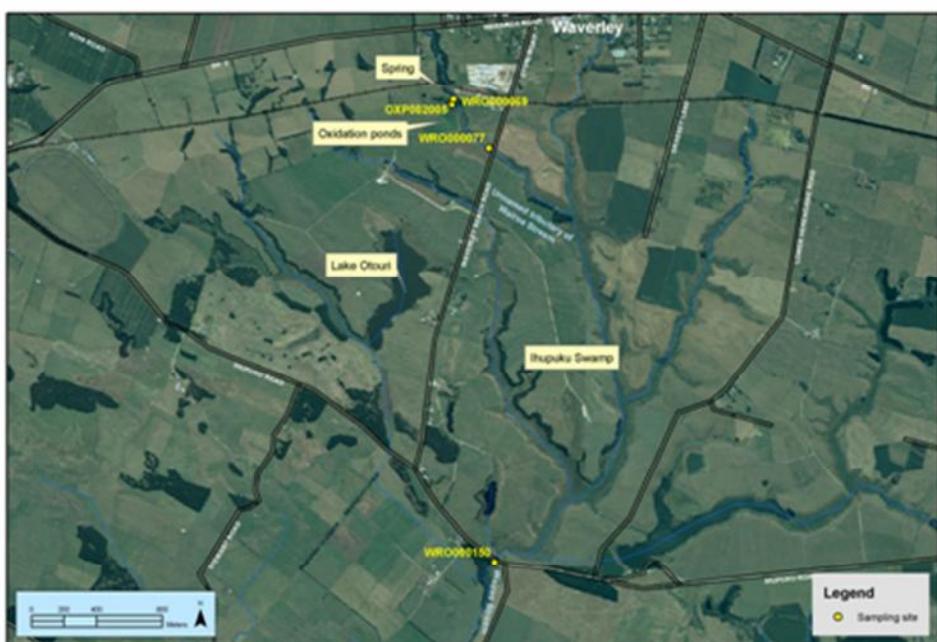
**Figure 2** Aerial location map of sites in relation to Waverley oxidation ponds

An early autumn assessment of the impact of the oxidation ponds' effluent discharge on the receiving waters of an unnamed tributary of the Wairoa Stream was performed on 4 April 2013 during fine weather, a light northerly wind, and low flow conditions after a very dry late summer. The sampling sites' locations are shown in Figures 1 and 2 and listed in Table 2.

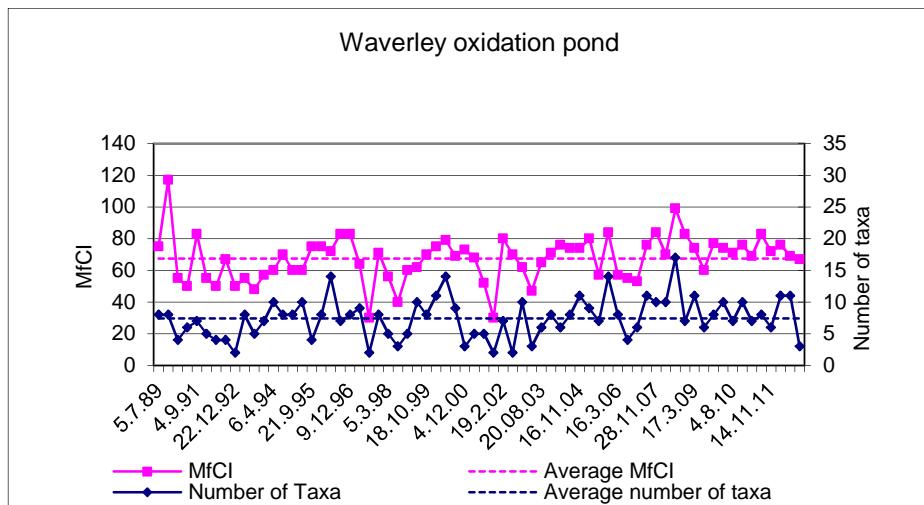
**Figure 3** MfCI and number of taxa recorded in the Waverley oxidation pond since July 1989

The Waverley oxidation pond has supported one of the lowest algal richnesses (a median of 7 taxa) of all the treatment systems surveyed by the Taranaki Regional Council since July 1989. The numbers of taxa recorded in the upgraded Waverley pond in the first half of the 2012-2013 monitoring year varied widely (from 3 to 11 taxa), 4 taxa either side of this median for this system on the three sampling occasions (Table 5). However, the limited microflora of this pond historically may have been attributable to low nutrient levels as a result of under-loading. Under-loaded ponds may also provide more suitable conditions for a range of zooplankton, which can significantly reduce algal densities by grazing. High densities of cladocera (one such zooplankton group) have been observed in the past in this pond although not recently. For example in September 1998 *Daphnia* was abundant in the pond, resulting in lower diversity and microfloral community index (MfCI) scores during the monitoring year.

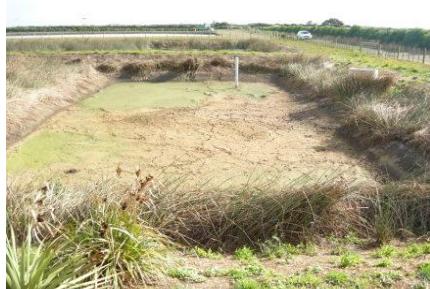
**Photo 1** Low southern wetland pond levels March, 2013

The wetlands component was tidy with both sections achieving an equal balance in wastewater levels during the first half of the monitoring period but levels decreased in both wetlands in dry late summer conditions with the southern wetland almost dried out by autumn (Photo 1).

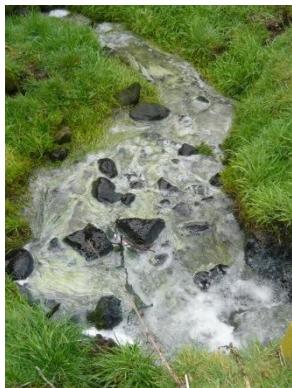
**Photo 2** 'Sewage fungus' growths on bed of outlet channel, August 2012

Inspections noted the presence of 'sewage fungus' growths on the 5 metre long effluent open channel prior to discharge to the Manaia Creek (Photo 2). It was suggested to the consent holder that additional rock rip-rap be constructed as a filter in this reach which should also be fenced to prevent direct stock access. The consent holder advised that after discussions with the landowner, these works would be undertaken together with planting of the channel banks (STDC, pers comm., December 2012).

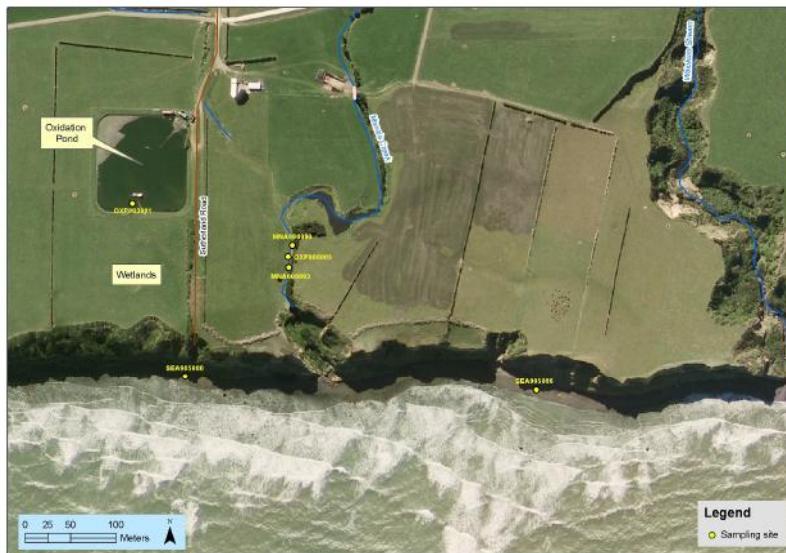
**Figure 8** Aerial location map of sites in relation to Manaia wastewater treatment system

Sampling sites' locations in relation to the pond system are illustrated in Figures 7 and 8.

Sampling was performed under moderate stream flow condition. Coastal sampling was timed around mid tide conditions on each of two inspection occasions. Results are presented and discussed as follows for each of the receiving water surveys.

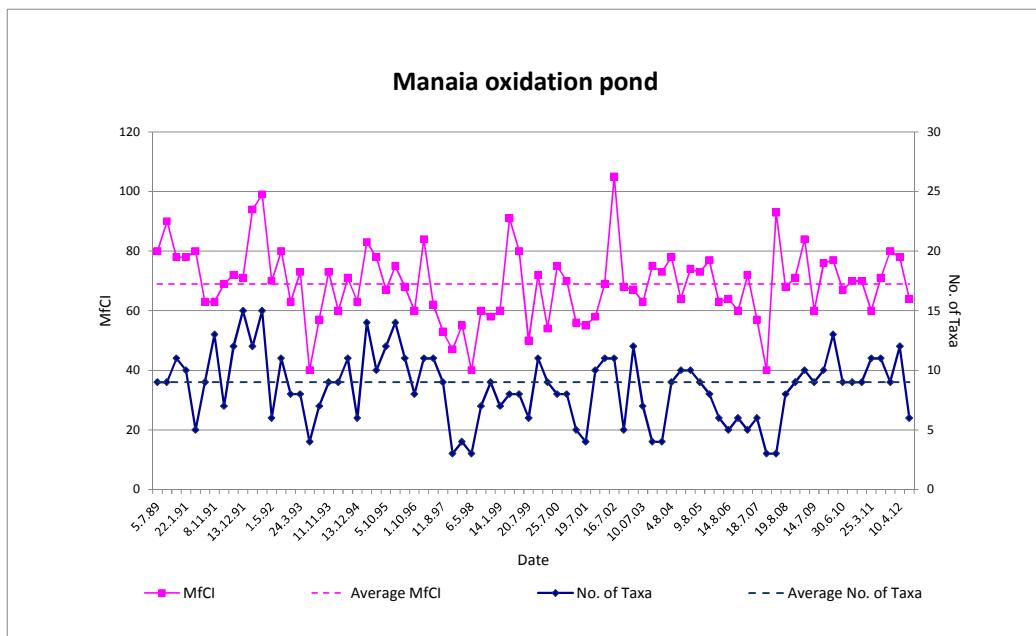
**Figure 9** Numbers of taxa and MfCI values for the Manaia oxidation pond since monitoring began in 1989

The Manaia pond usually supports algae which rarely occur in overloaded ponds and this has contributed to relatively high average and median pond MfCI results (Figure 10). The average MfCI value (69) and median value (70) from the Manaia pond were similar to average and median MfCI values recorded from other well performing

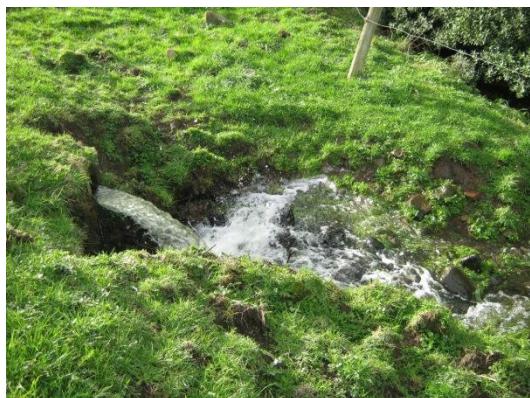
**Photo 3** The discharge from the oxidation pond/wetlands prior to the stream

At the time of the inspection the effluent from the oxidation pond/wetland system was discharging at a relatively high rate. The discharge was slightly green in colour and had no noticeable odour. No 'sewage fungus' was present either before or after the stream confluence. The tributary receiving the discharge had yet to be fenced and have rocks added in order to reduce the risk of sewage fungus growth (Photo 3 and Section 4.2). The stream was in high flow during the inspection.

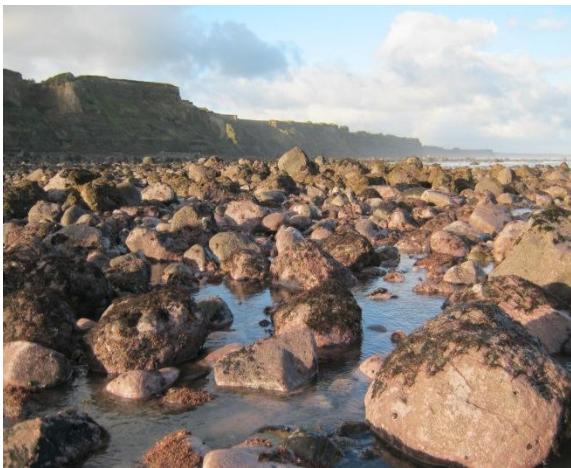
**Photo 4** Abundant *Corallina* (pink paint colouration) covering boulders within the influence of the stream on the lower region of the intertidal zone

At the top of the intertidal region, within the vicinity of the stream, the community was dominated by the gastropods *Austrolittorina cincta* and *Diloma* spp. and the little black mussel *Xenostrobus pulex*. The only algal species present were *Ralfsia* sp. and *Ulva* sp. These animal and algal species are typical of high shore environments and are tolerant of low salinity. Other species became more abundant further away from the stream, including the limpet *Cellana radians*, the gastropods *Haustrum scobina*, *Haustrum haustorium* and *Melagrapgia aeithiops*, and the barnacle *Austrominius modestus*.

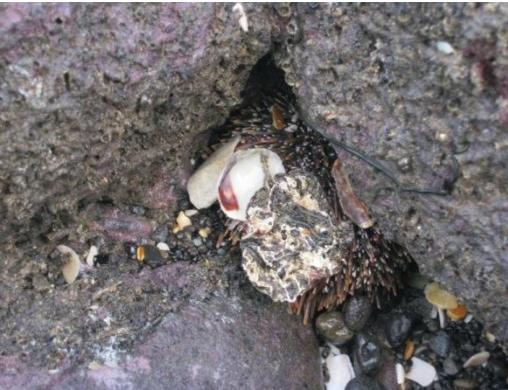
**Photo 5** Sea urchin *Evechinus chloroticus* present on the lower shore away from the influence of the stream

A total of thirty seven species was found more than 50 m to the north west of the stream in the mid and low shore regions, with an obvious change in the appearance of the reef and the diversity of species. Species only found away from the influence of the stream included: the seaweed *Carpophyllum* sp., chitons *Acanthochitona zelandica* and *Chiton glaucus*, gastropods *Diloma bicanaliculata*, *Dicathis orbita*, and *Haustrum haustorium*, starfish *Patiriella regularis* and sea urchin *Evechinus chloroticus* (Photo 5).

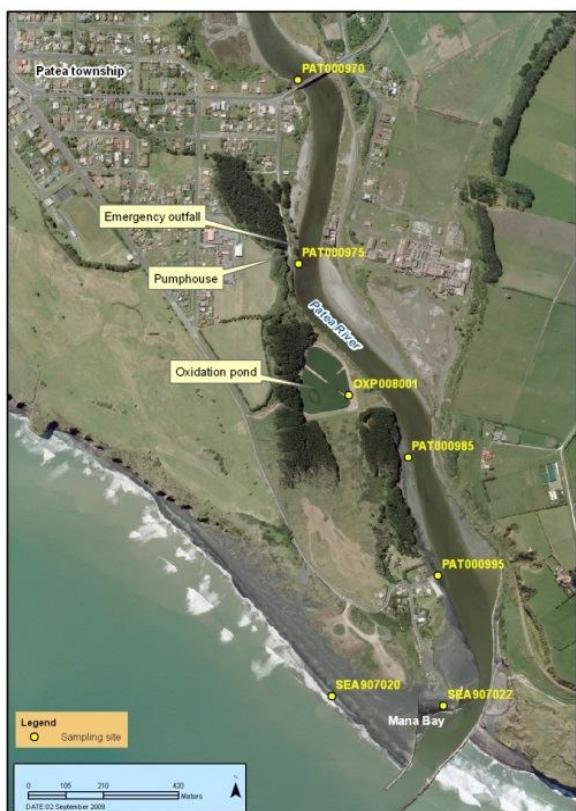
**Figure 10** Aerial location map of sampling sites in relation to the Patea upgraded three cell oxidation pond system

Assessments of the impact of the pond's effluent discharge on the bacteriological quality of the receiving waters of the lower tidal reaches of the Patea River were undertaken on two of the three inspection occasions toward low tide conditions. The sampling sites for these surveys are listed in Table 29 and sampling sites' locations in relation to the pond system are illustrated in Figure 10. Sampling sites associated with the bacteriological recreational monitoring programme (SEA 907022 and SEA 907020) are also listed in Table 29.

Site 2 was added to the programme as a consequence of raw sewage overflow discharges during the 1995-96 monitoring period (see section 5.1) and has been retained as a necessary component of receiving water surveys in relation to the renewed consents.

Two sites were included in the consent monitoring programme (see Table 29 and Figure 10), one in the lower river at the Motor Camp boat ramp (PAT000995) and the other in the nearby coastal waters at Mana Bay (SEA907022). Another site at Patea Beach (SEA 907020) is included at three-yearly intervals in the Council's recreational monitoring programme and was also surveyed over the 2012-2013 period (TRC, 2013b). Sampling at these sites during the Council's defined recreational monitoring period occurred between early November 2012 and late March 2013 (TRC, 2013), and although concentrated on high tide conditions (13 samples), also included low tidal conditions at these sites on 8 other occasions at the site in the lower river and 7 occasions at 'Mana' Bay. The results are summarised in Tables 32, 33, and 34 and illustrated in Figures 11, 12, and 13.

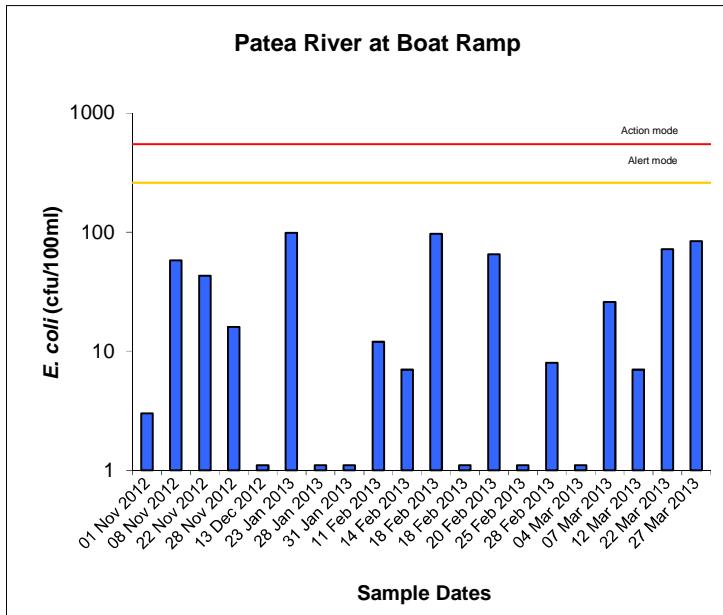
**Figure 11** *E.coli* numbers for the lower Patea River at the boat ramp during the survey period

Bacteriological water quality was typical of the lower reaches of a large ringplain-eastern hill country catchment with moderate numbers under river (freshwater) dominated conditions but improved bacteriological quality when influenced by saline penetration of the coastal seawater. No exceedances of the 'Action' limit or the 'Alert' mode were recorded under low and high tide conditions; and the 'Alert' limit was not approached under low tide conditions. These data were indicative of good bacteriological water quality conditions coincident with an improved effluent quality discharged upstream from the upgraded wastewater treatment system. Bathing activity was noted only once at this site which was used mainly for boating access and occasionally for fishing and walking. [Note: Taranaki Regional Council had undertaken microbial source tracking (MST) using DNA marker techniques over the 2011-2012 period at this site and at the upstream site at SH3 bridge on two occasions (high and low tides) (see TRC, 2012). Faecal coliform bacteria were found to have been sourced predominantly from cattle on both occasions at the two sites while gulls contributed to populations at the boat ramp site under both tidal conditions. A faint trace of human source derivation was found (downstream of the Patea WWTP treated discharge) at the boatramp site only under low tidal flow conditions].

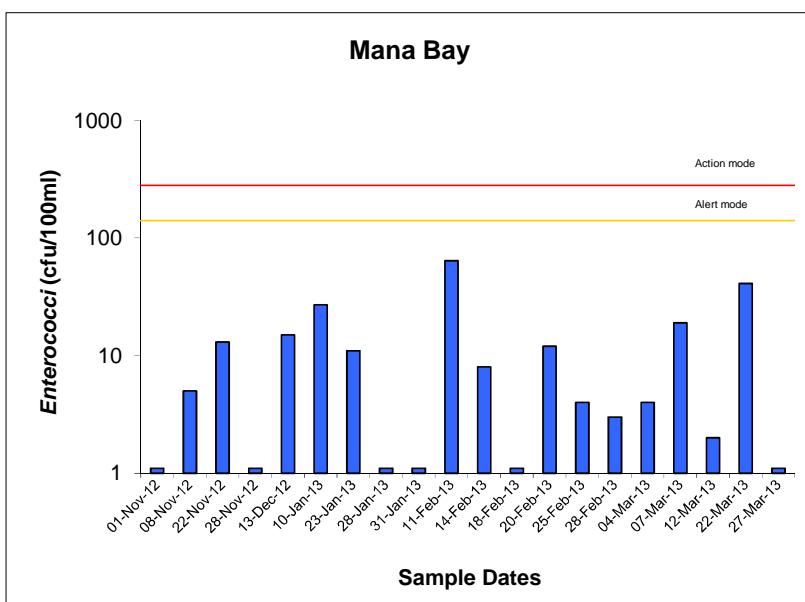
**Figure 12** Enterococci numbers for 'Mana' Bay during the survey period

Bacterial water quality at this well patronized site (particularly by children) was very good considering the proximity of the river. Very similar bacterial quality (median: 4 *E coli*/100 ml and 4 enterococci/100 ml) was recorded under high tide conditions when the river had limited influence at this site. No two consecutive enterococci results entered the 'Action' mode and no counts exceeded the 'Alert' limit (Figure 13). Higher counts (median: 13 enterococci/100ml and 58 *E.coli*/100ml) were recorded close to low tide times. Even under these low tide conditions, the *E. coli* 'Alert' limit (for freshwater) was not exceeded on any sampling occasion during the period.

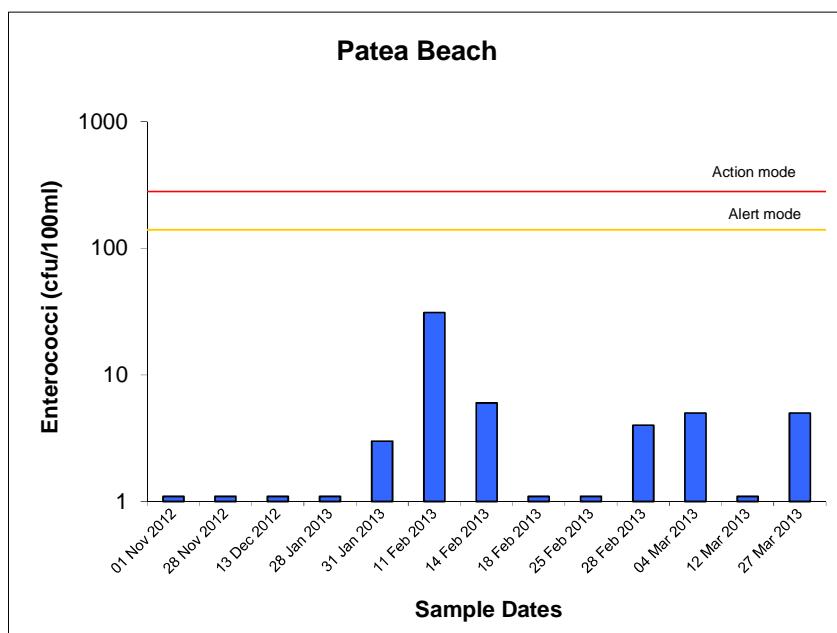
**Figure 13** Enterococci numbers for Patea Beach during the survey period

The bacterial water quality of this coastal beach site was very good throughout the entire period under high tide conditions. No incursion into the 'Alert' mode occurred and no counts entered the 'Action' mode on any sampling occasion. Previous annual recreational monitoring surveys, performed at three-yearly intervals since 1997-1998, have recorded similarly very good bacteriological water quality (medians ranging from 3 to 8 enterococci/100ml) with minimal incursions into either 'Alert' or 'Action' modes of the MfE contact recreational guidelines (TRC, 2013b).

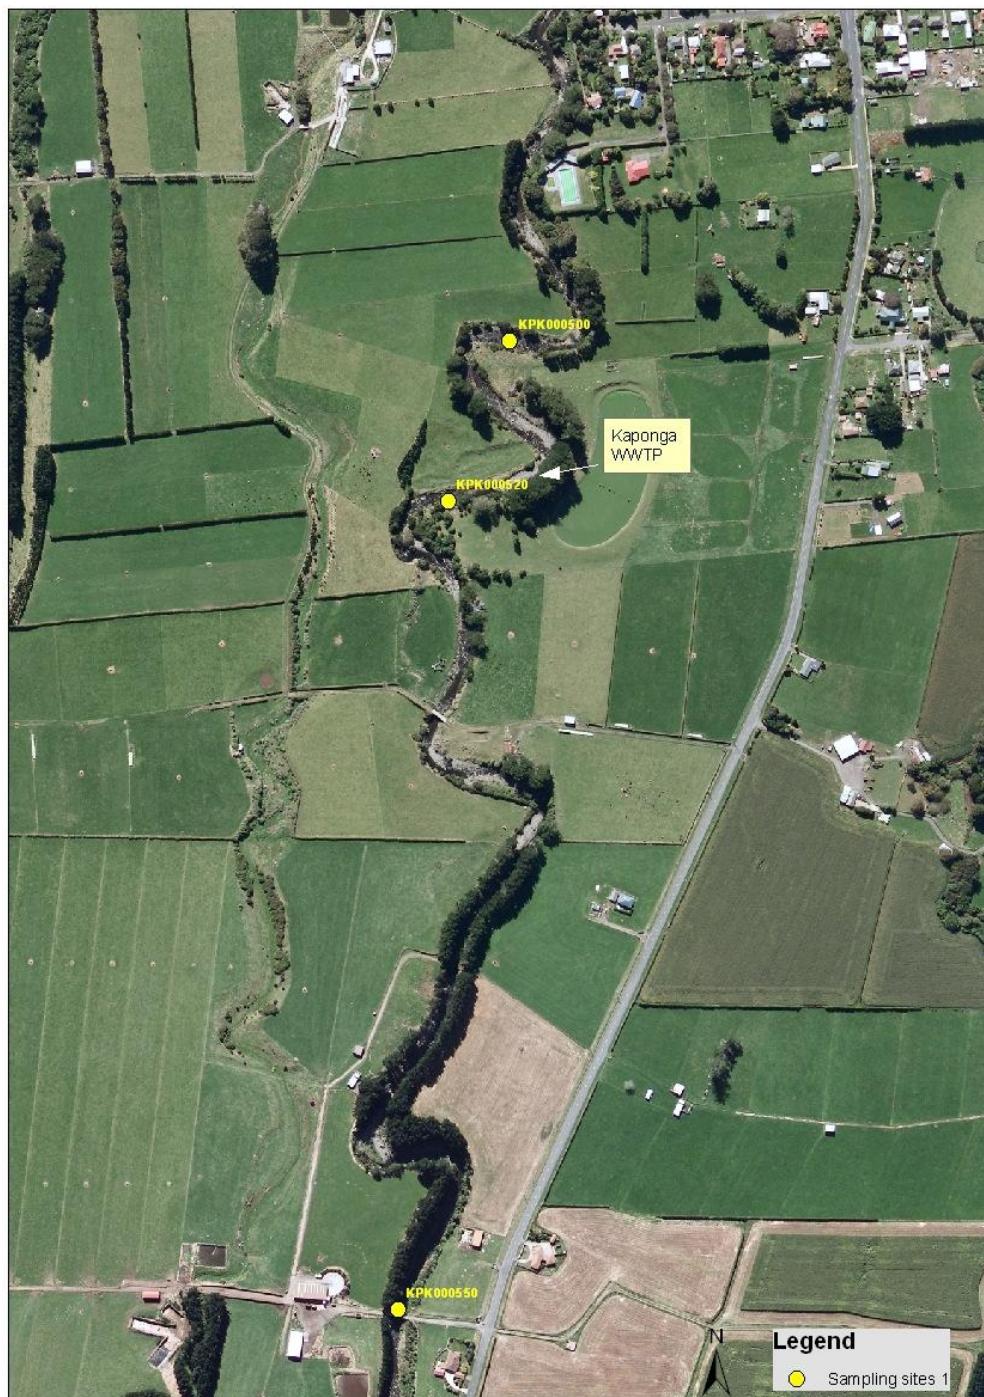
**Figure 1** Biomonitoring sites in the Kaupokonui River in relation to Kaponga oxidation ponds system

The standard '400 ml kick sampling' technique was used to collect streambed (benthic) macroinvertebrates from three established sampling sites in the Kaupokonui River in the vicinity of the Kaponga oxidation ponds' system (illustrated in Figure 1), on 15 February 2013.
