South Taranaki District Council  
Waverley, Kaponga, Manaia and Patea  
Municipal Wastewater Treatment Plant Systems  
Monitoring Programmes  
Annual Report  
2013-2014

Technical Report 2014 -18

October 2014

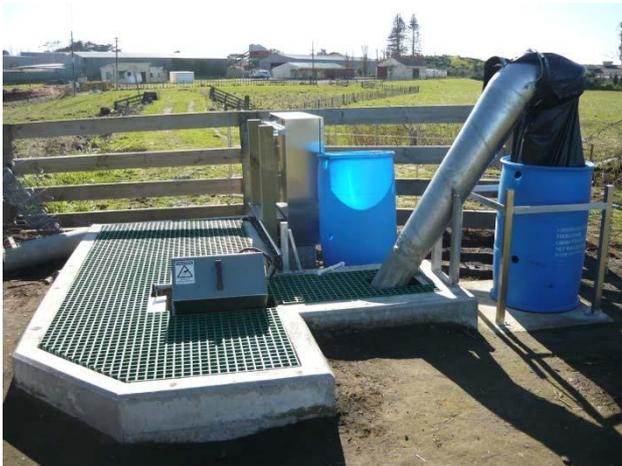
**Photo 1** Step screen on the Waverley WWTP inlet

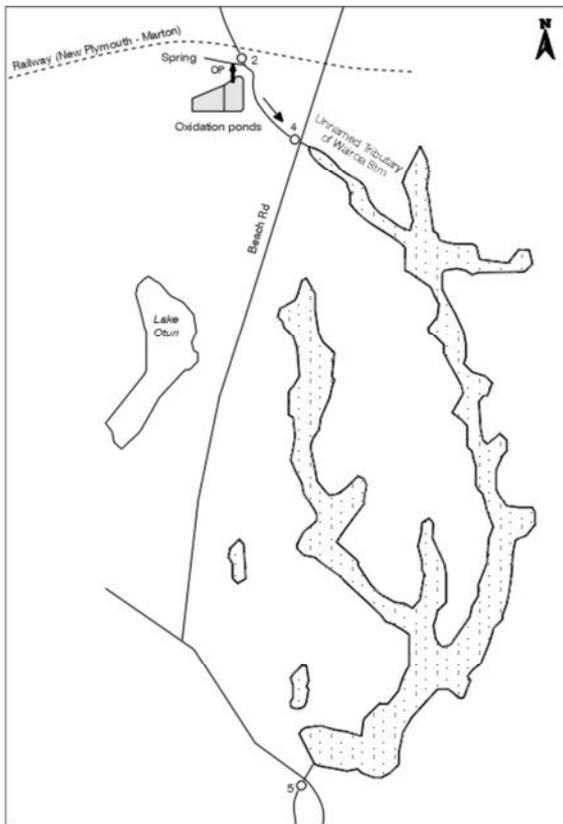
Site 2 is located upstream and site 4 downstream of the oxidation pond discharge. Site 5 has been established to provide an indication of the overall impact of the discharge on the Wairoa Stream in its mid reaches after seepage through the extensive wetlands (i.e. the 9 hectare Ihupuku Swamp) which characterises this drainage system.

**Figure 1** Sampling sites in an unnamed tributary of the Wairoa Stream in relation to Waverley oxidation ponds

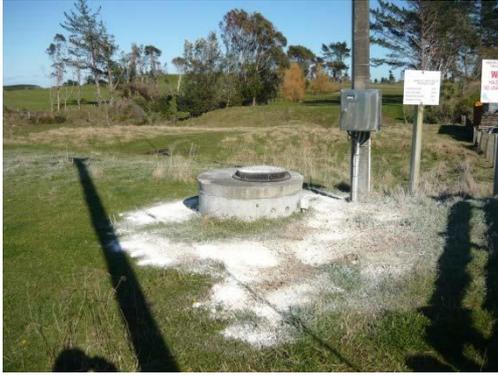
**Photo 2** Inlet blockage and manhole overflow, September 2013

In the 2013-2014 year, there was one incident recorded by the Council that were associated with the consent holder at the WWTP site and none at the stock truck wastewater disposal site.

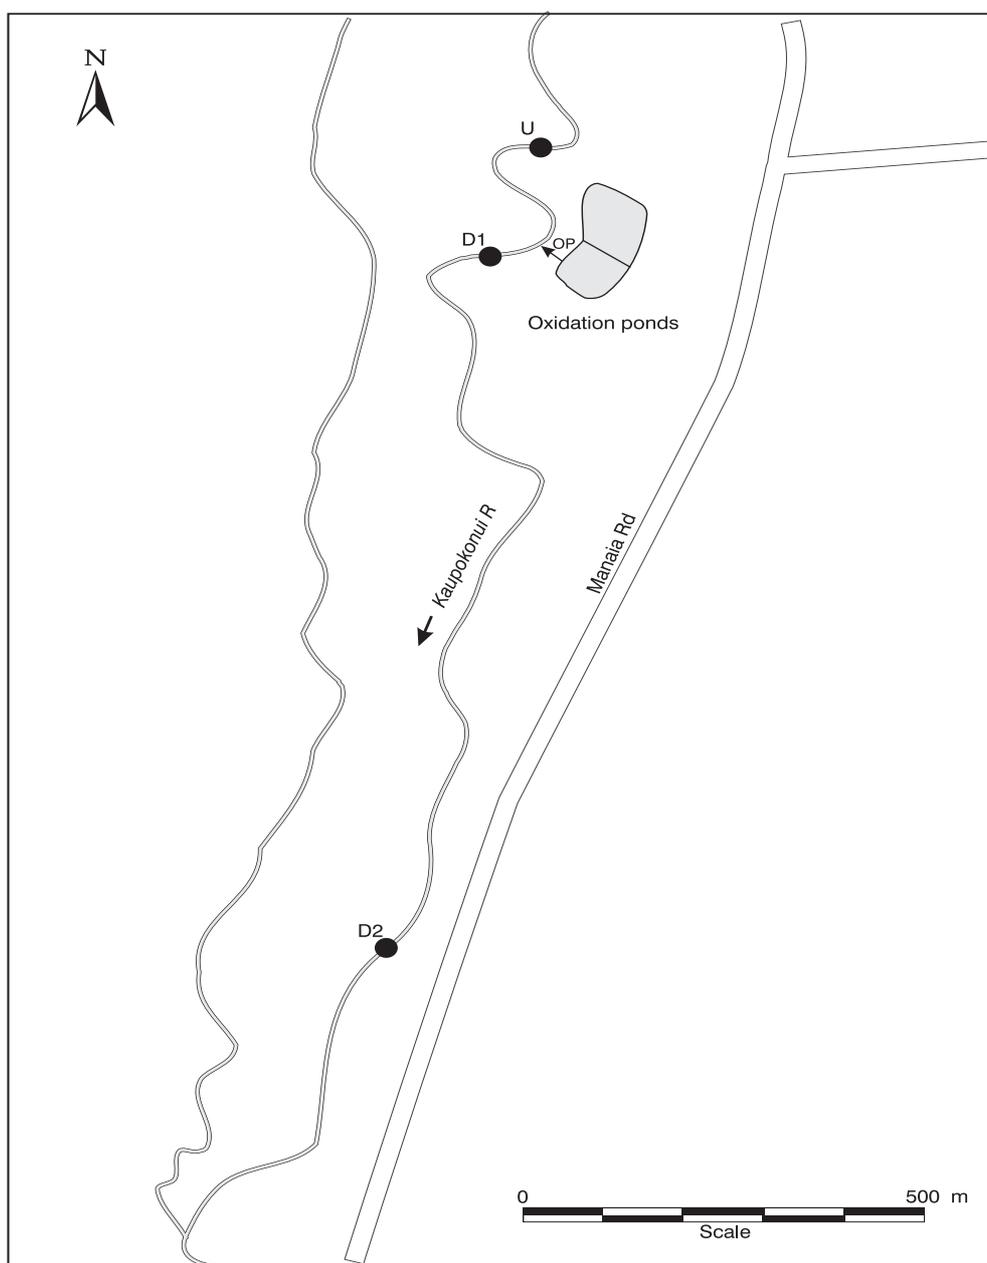
**Figure 3** Sampling sites for Kaponga oxidation ponds survey

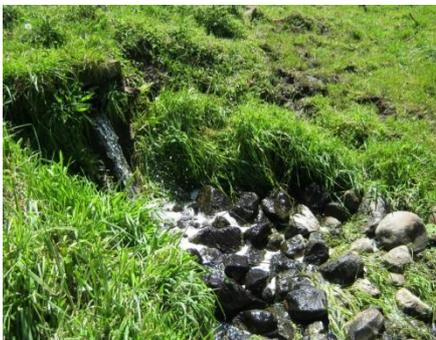
**Photo 3** Additional rock rip-rap in the wetlands discharge channel, November 2013

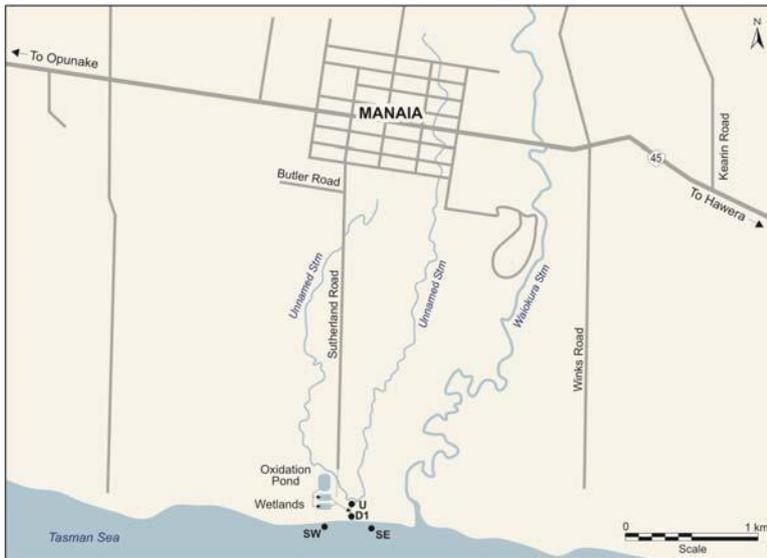
**Figure 5** Location of Manaia oxidation pond-wetlands system and sampling sites

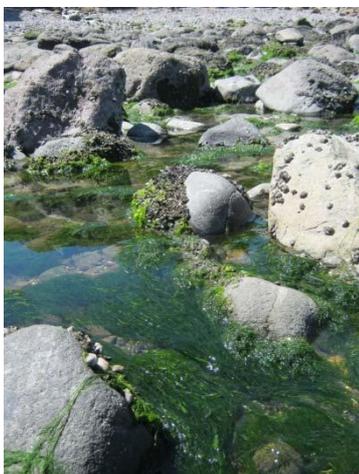
Dense cover of the green macroalgal species *Enteromorpha intestinalis* and *Ulva lactuca* stretched along the high tide mark approximately 30 m either side of the stream. These algal species are typical of freshwater influence and thrive under nutrient rich conditions. At the top of the intertidal region within the vicinity of the stream, the gastropods *Austrolittorina cincta* and *Diloma* spp. were abundant. Other species became

**Photo 4** Dense cover of *Enteromorpha intestinalis* in the 'Manaia Creek' at mid shore

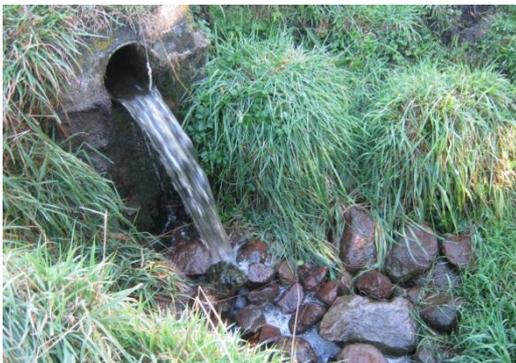
At the time of the inspection the effluent from the oxidation pond-wetland system was discharging at a moderate rate. The discharge had a brown tinge and slight sewage odour. No 'sewage fungus' was present in the Manaia Creek stream below the discharge. The discharge channel below the pipe outfall had not yet been fenced, but new posts had been put in place since the previous inspection in November 2013. Rocks were still in place within the channel in order to filter the wastes discharges (Photo 5). The Manaia Creek was in moderate flow during the inspection.

**Photo 5** The small discharge channel from the oxidation ponds wetlands system prior to the Manaia Creek

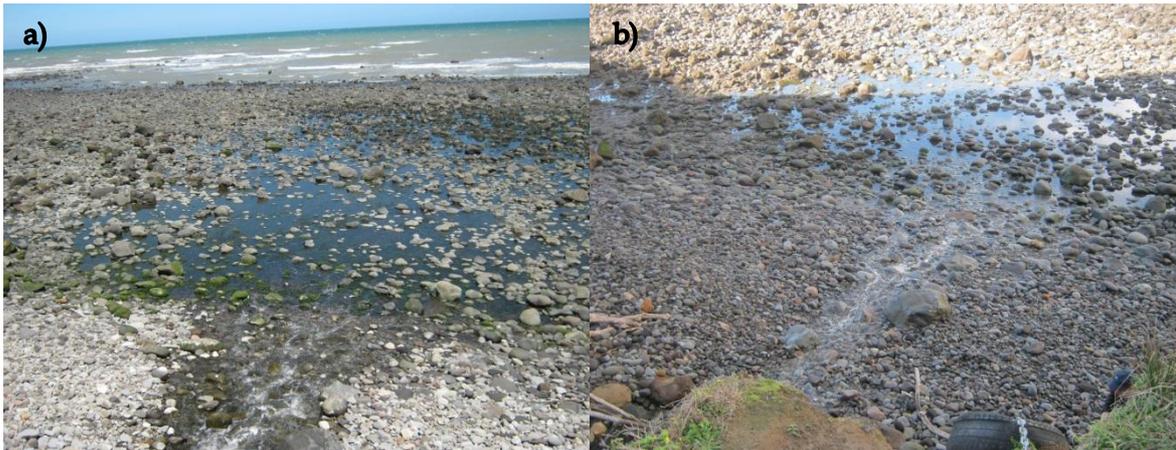
**Photo 6** Manaia Creek flowing over the intertidal reef [Note the difference in green macroalgae cover between a) November 2013 and b) April 2014]

Green macroalgal species *Enteromorpha intestinalis* and *Ulva lactuca* stretched along the high tide mark ~30 m either side of the stream, however, the cover was sparser during the April 2014 inspection than the November 2013 inspection (Photo 6). These algal species are typical of freshwater influence and thrive under nutrient rich conditions. At the top of the intertidal region within the vicinity of the stream, the gastropods *Austrolittorina cincta* and *Diloma* spp. were abundant. Other species became more abundant further away from the stream, including the limpet *Cellana radians*, the gastropods *Haustrum scobina* and *Melagraphia aeithiops*, and the barnacle *Austrominius modestus*.

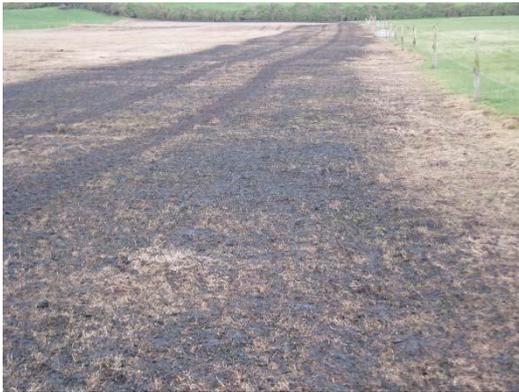
**Photo 7** Patea WWTP sludge land disposal, September 2013

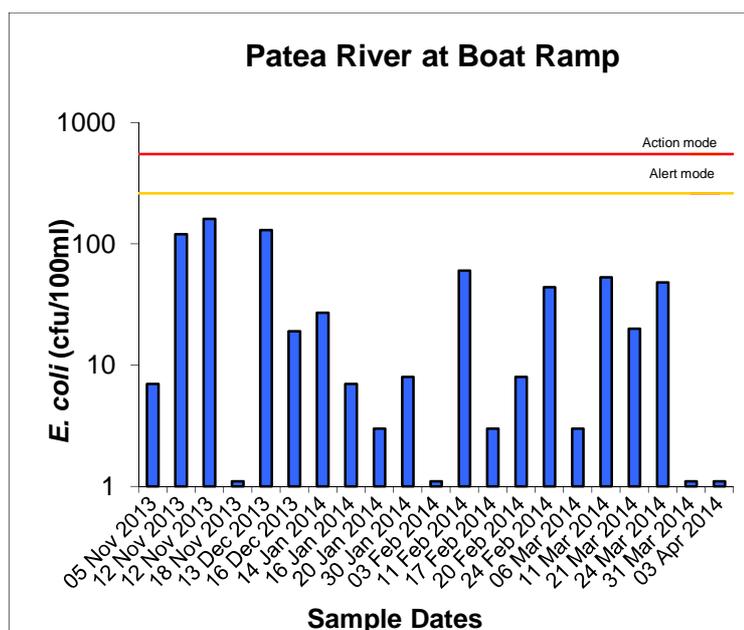
**Figure 8** *E. coli* numbers for the lower Patea River at the boat ramp during the survey period

Bacteriological water quality was typical of the lower reaches of a large ringplain-eastern hill country catchment with moderate numbers under river (freshwater) dominated conditions but improved bacteriological quality when influenced by saline penetration of the coastal seawater. No exceedances of either the 'Action' limit or the 'Alert' mode were recorded under low and high tide conditions; neither was the 'Alert' limit approached under low tide conditions. These data were indicative of good bacteriological water quality conditions coincident with an improved effluent quality discharged upstream from the upgraded wastewater treatment system. No bathing activity was noted during the 2013-2014 period at this site which was used mainly for boating access and occasionally for fishing and walking. [Note: The Council had undertaken microbial source tracking (MST) using DNA marker techniques over the 2011-2012 period at this site and at the upstream site at SH3 bridge on two occasions (high and low tides) (see TRC, 2012). Faecal coliform bacteria were found to have been sourced predominantly from cattle on both occasions at the two sites while gulls contributed to populations at the boat ramp site under both tidal conditions. A faint trace of human source derivation was found (downstream of the Patea WWTP treated discharge) at the boatramp site only under low tidal flow conditions].

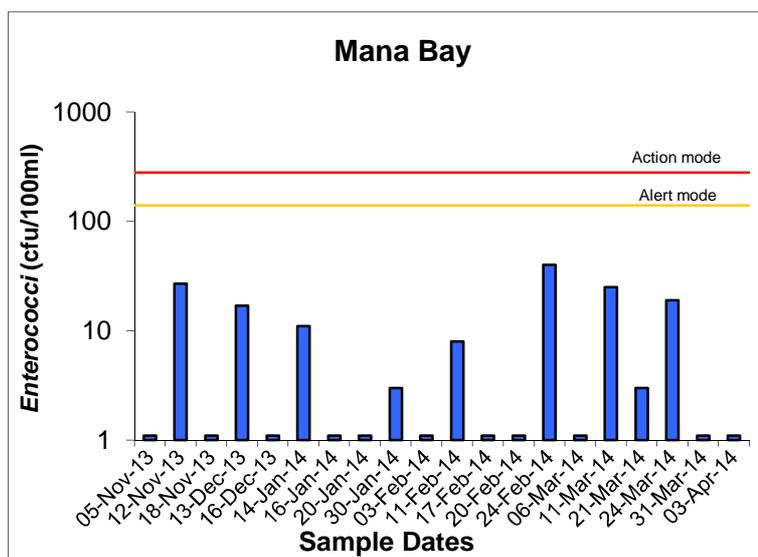
**Figure 9** Enterococci numbers for Mana Bay during the survey period

Bacterial water quality at this well patronized site (particularly by children) was very good considering the proximity and influence of the river. Better bacterial quality (ranges: 17 *E. coli*/100 ml and 3 enterococci/100 ml) was recorded under high tide conditions when the river had limited influence at this site. No two consecutive enterococci results entered the 'Action' mode and no counts exceeded the 'Alert' limit (Figure 13). Higher counts (median: 19 enterococci/100ml and 51 *E. coli*/100ml) were recorded close to low tide times. Even under these low tide conditions, the *E. coli* 'Alert' limit (for freshwater) was not exceeded on any sampling occasion during the period.

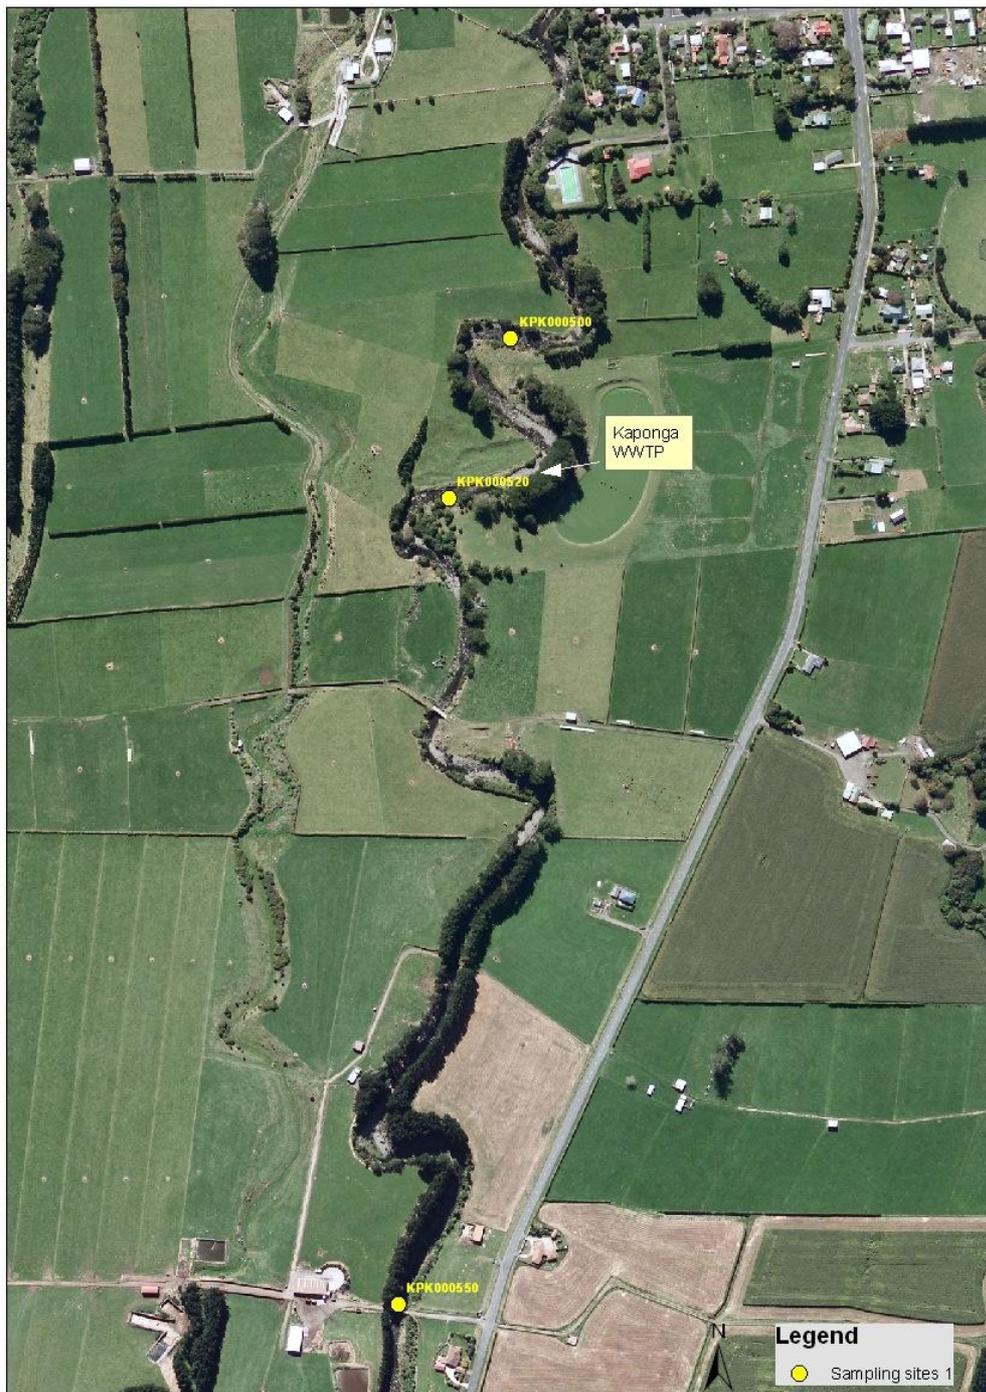
**Figure 1** Biomonitoring sites in the Kaipokonui River in relation to Kaponga oxidation ponds system

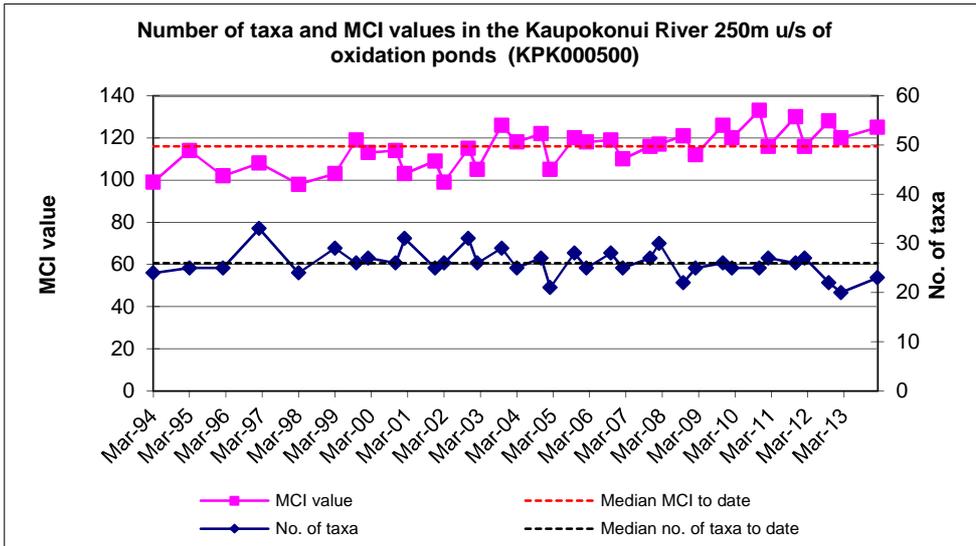
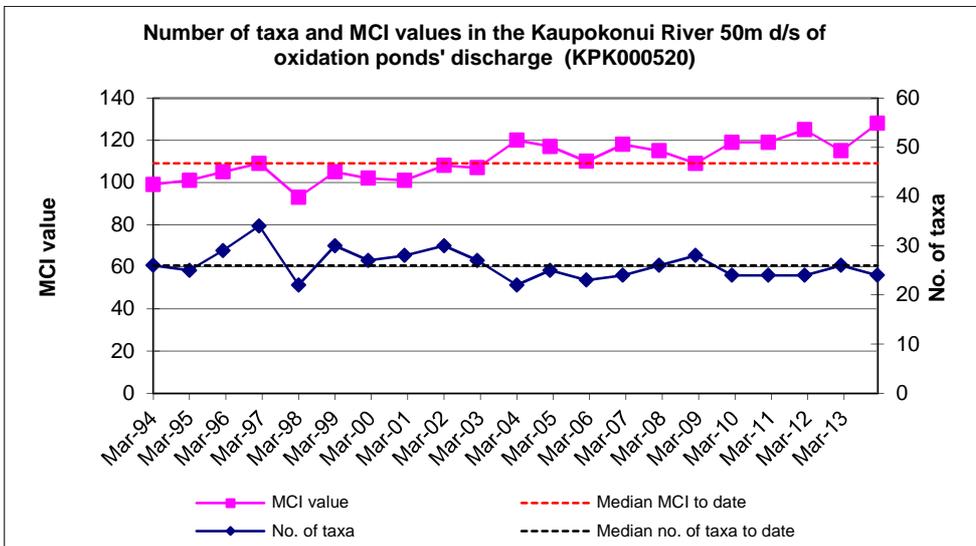
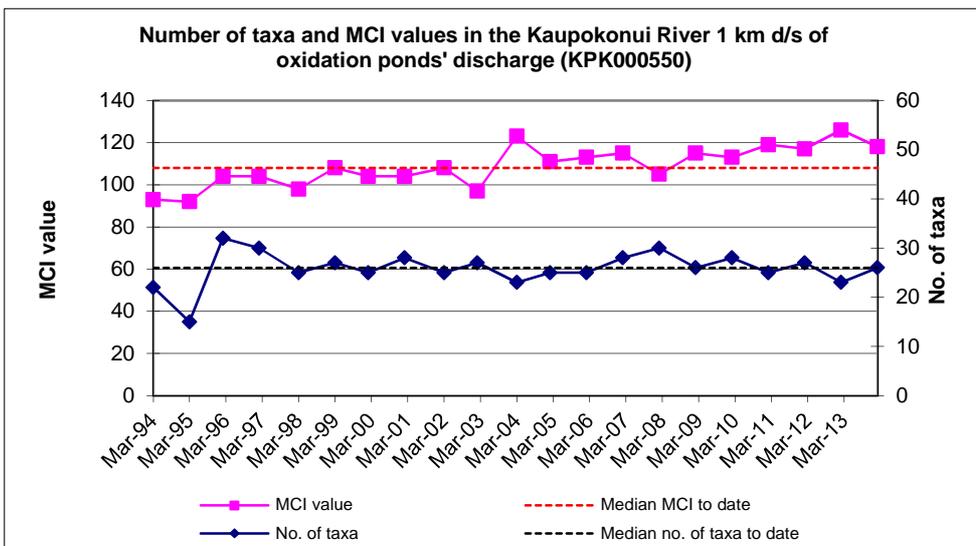
The results of the current survey are presented in Table 3 and illustrated in Figure 2.

**Figure 2** Taxa richness and MCI values at the three sampling sites to date
