Wai-iti Motor Camp
Monitoring Programme
Annual Report
2014-2015

Technical Report 2015-15

Taranaki Regional Council
Private Bag 713
STRATFORD

September 2015

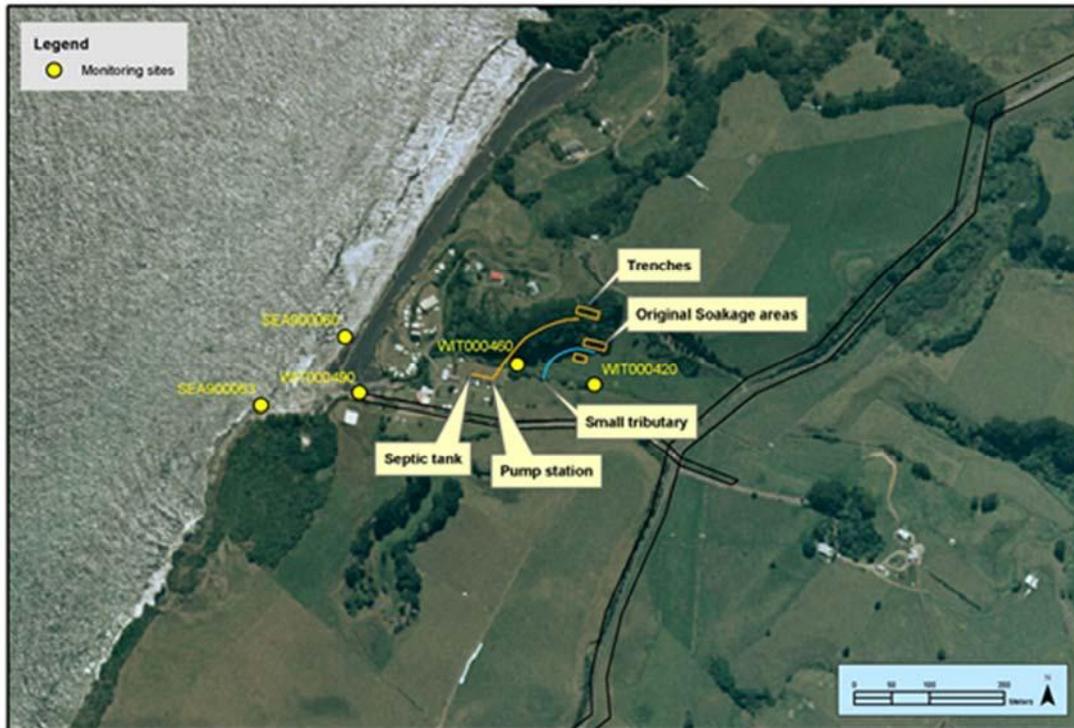
Figure 1 Location of sewage treatment system and sampling sites at the Wai-iti Motor Camp

All wastewaters from the camping ground enter a septic tank of 143 m³ capacity. The effluent is then pumped via a 50 mm alkathene pipe across the Wai-iti Stream and into soakage trenches situated on a wooded hillside approximately 30 metres from the stream.

These multiple soakage trenches work on a rotational basis and were first commissioned in 1991 in response to inadequate treatment of the effluent by the previous system. There have been no significant problems since installation of the new system.

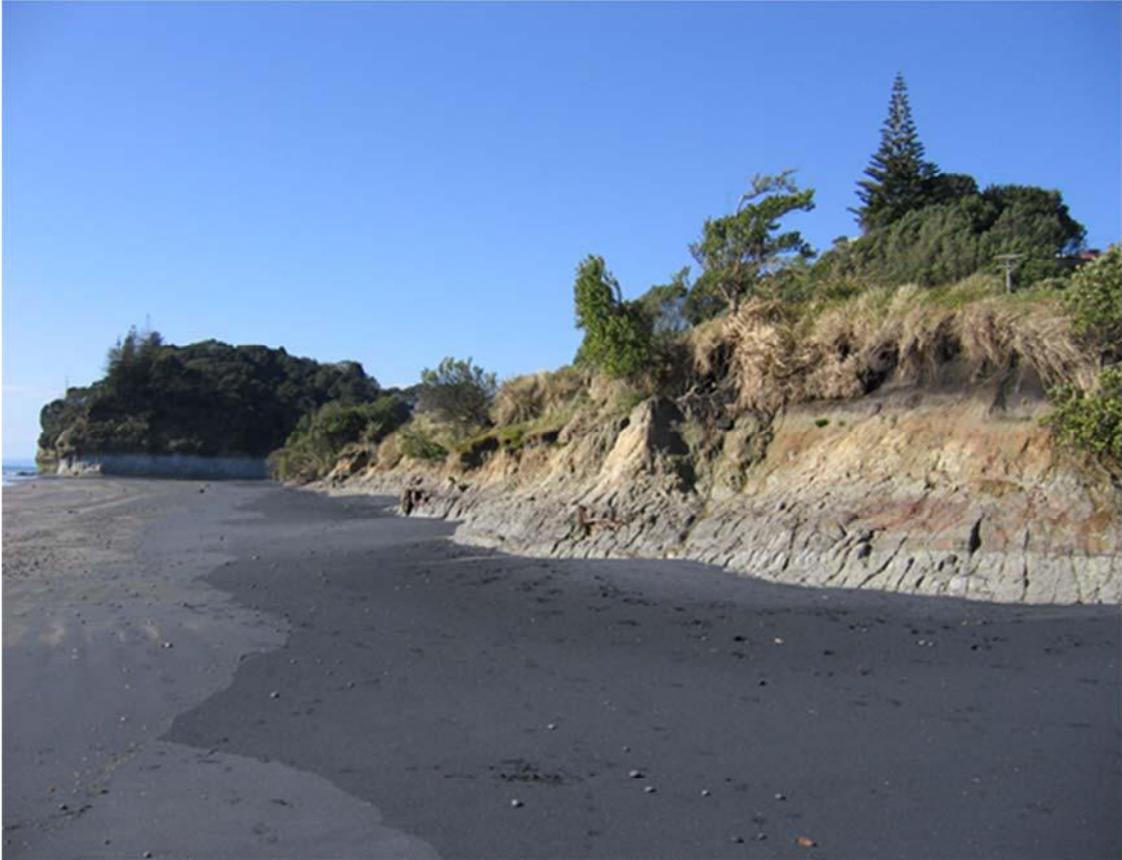
Over the summer and autumn months of 2004, rough seas combined with high tides reached the beach toe of the coastal banks and sand dunes that front the motor camp. Fresh erosion scarps were cut into these banks for nearly the full beach frontage where no system of protection existed (Photograph 3).

Photo 3 Erosion on Wai-iti foreshore prior to construction of the rock rip rap seawall

In 2005 an application was received for a resource consent to provide boulder rip rap protection over a total distance of 293 metres from the stream at the south end of Wai-iti Beach to an area of existing large boulder protection in the north. This consent was granted in July 2005. To mitigate any possible end effects, the area between the public entrance and the river was also protected using the boulder rip rap method.

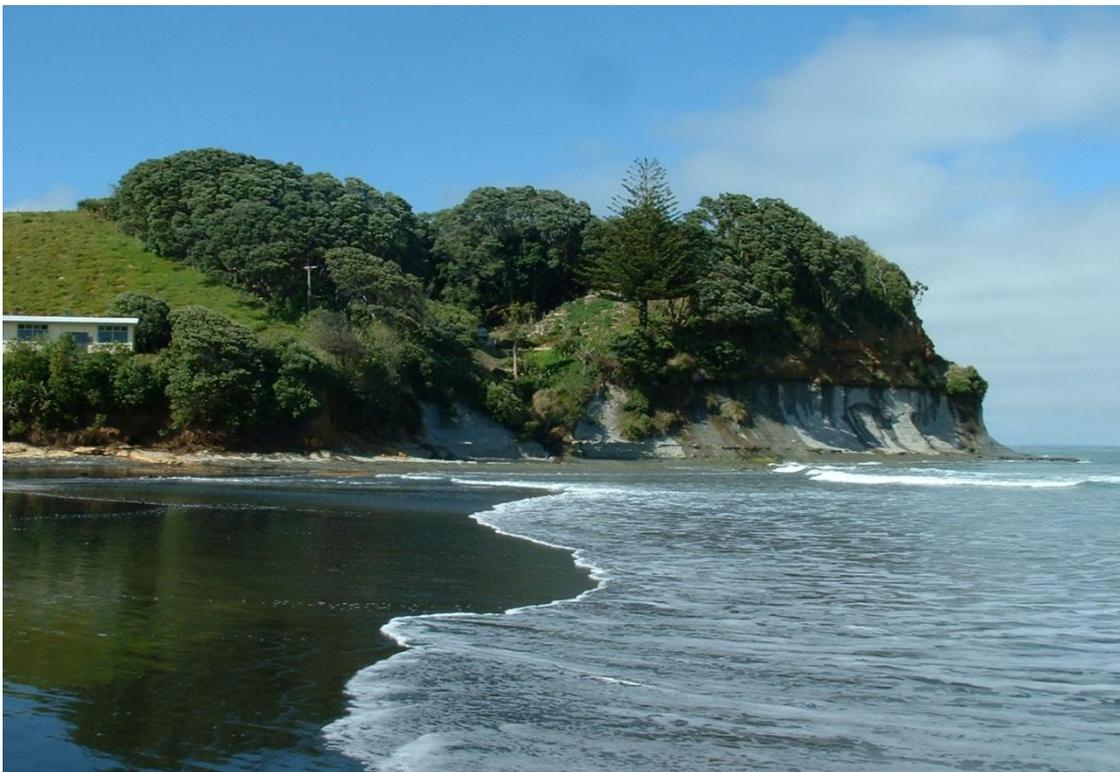
Photo 4 Taken at site 4, looking towards site 5, with the Wai-iti Stream entering from centre left

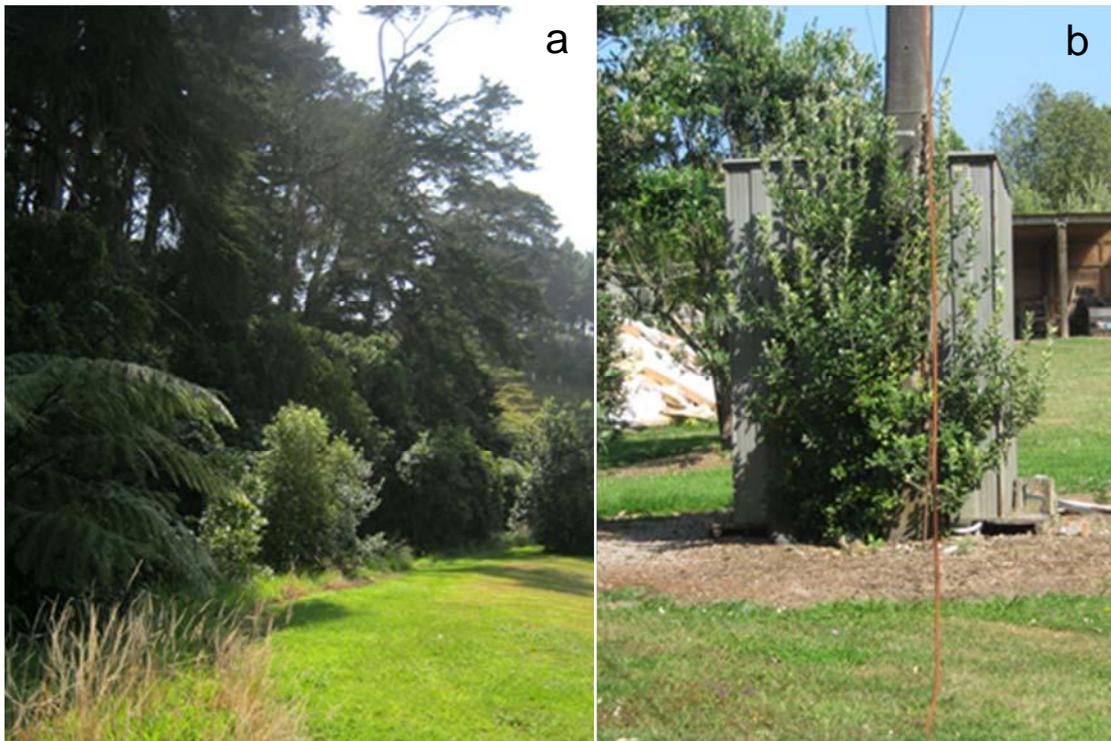
The first inspection was undertaken prior to peak usage. The camp was very quiet and there did not appear to be any people staying in the cabins. No odours were detected at the pump station or trenches (Photograph 5). The camp manager was absent at the time of the inspection.

Photo 5 Wai-iti Motor Camp Limited wastewater treatment system, a) trenches on hillside covered with trees, b) pump station

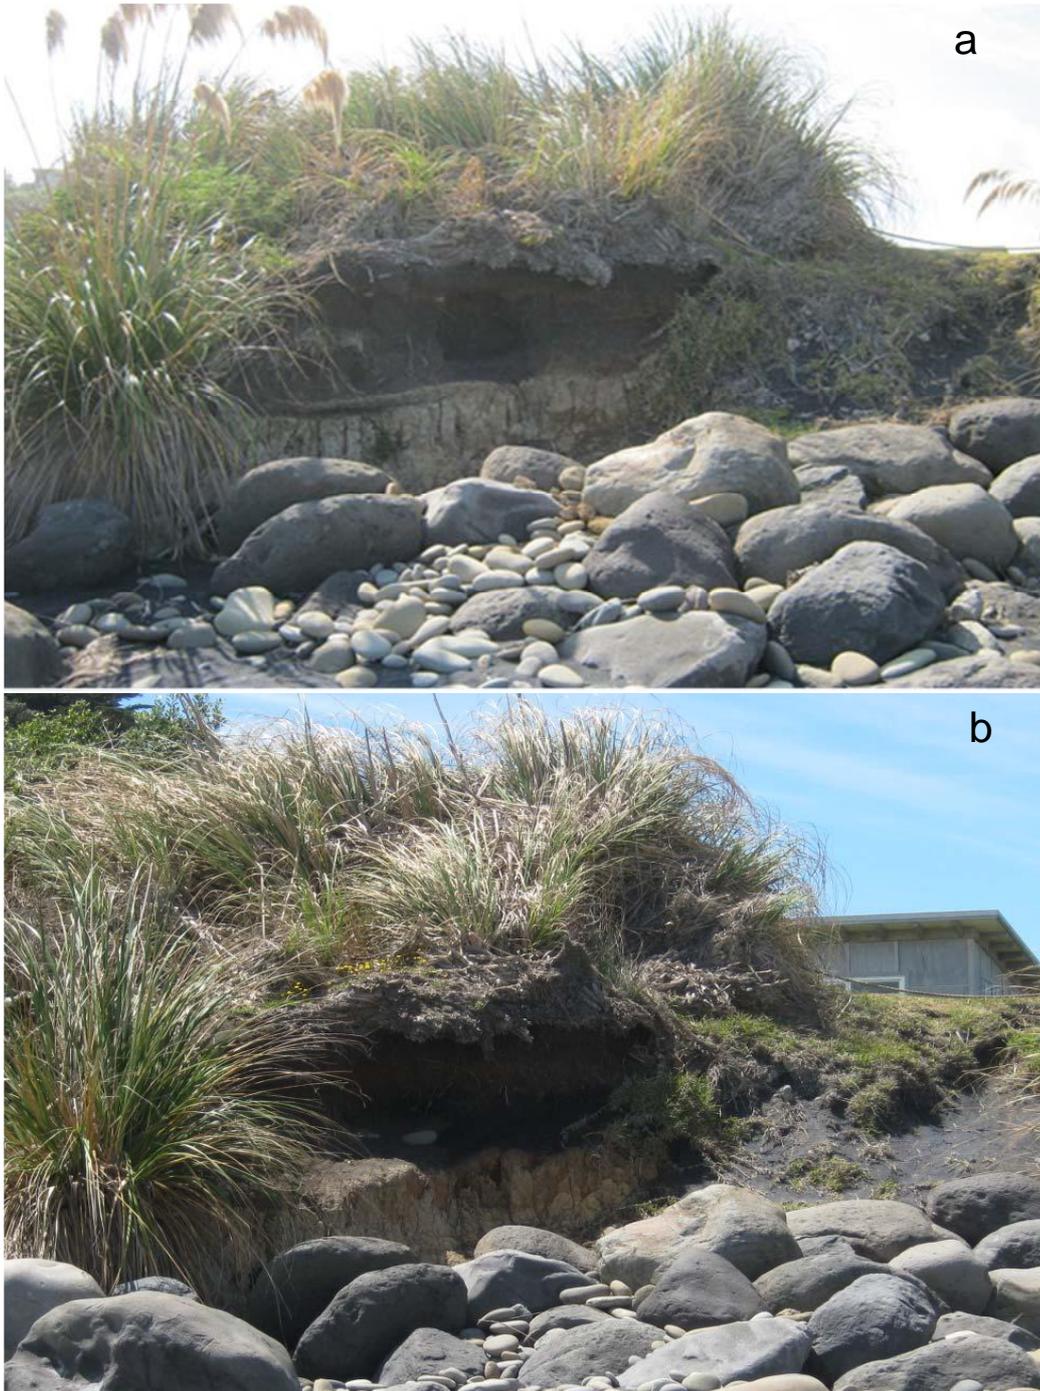
In general, the rock rip rap seawall appeared to be structurally sound, however, there were signs of continued erosion at the top of the wall towards the southern end of the beach. The large tree trunks were still in place and appeared to be providing a degree of protection for the banks behind them. Signage was still in place informing the public of the erosion and the dune replanting efforts.

As part of the first inspection, the rock wall was checked for evidence of erosion. The large tree trunks near the river mouth were still in place from the previous inspection and appeared to be minimising the effects of erosion. There was evidence of continued erosion towards the south west end of the beach (Photograph 6). Penguin footprints were present on some sections of the banks which were being used as access points to nesting areas (Photograph 7). Signs informing the public of dune replanting and erosion control were present at appropriate locations (areas of erosion) along the bank and rock wall.

Photo 6 Erosion along the top of the rock wall on, a) 19 February 2014, compared with, b) on the 16 December 2014

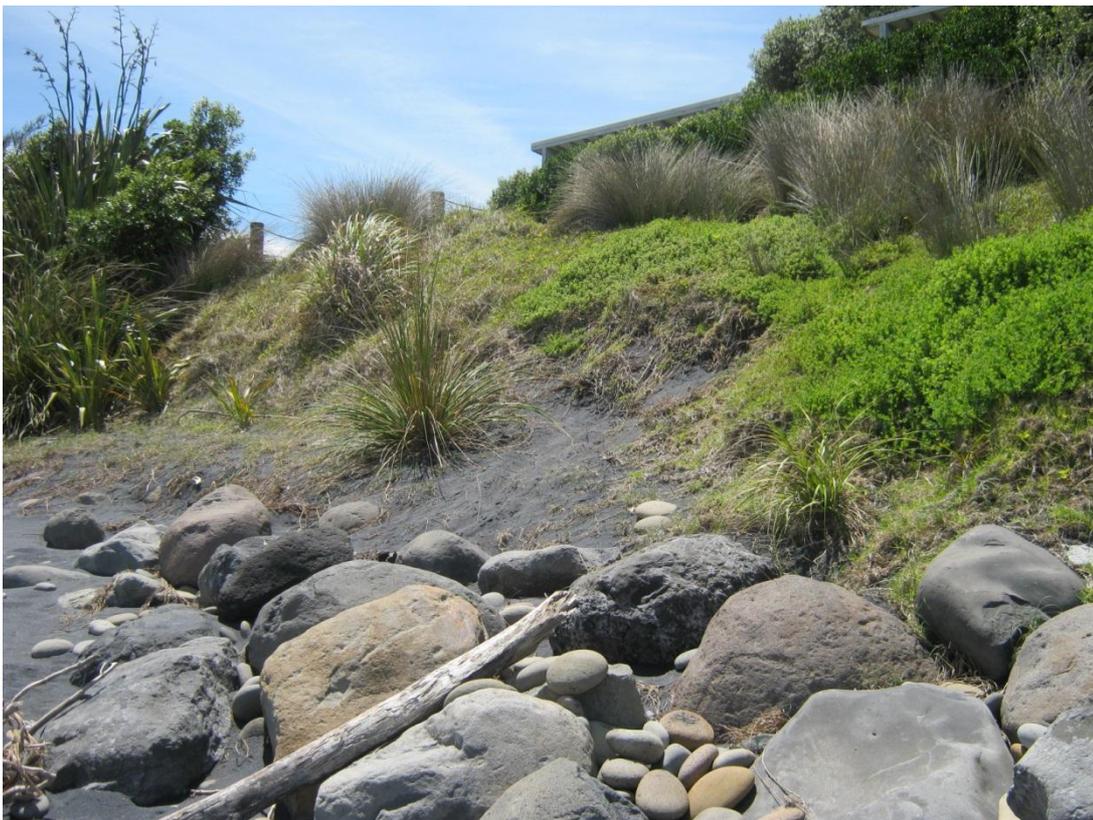
Photo 7 Penguin access to nesting site (16 December 2014)

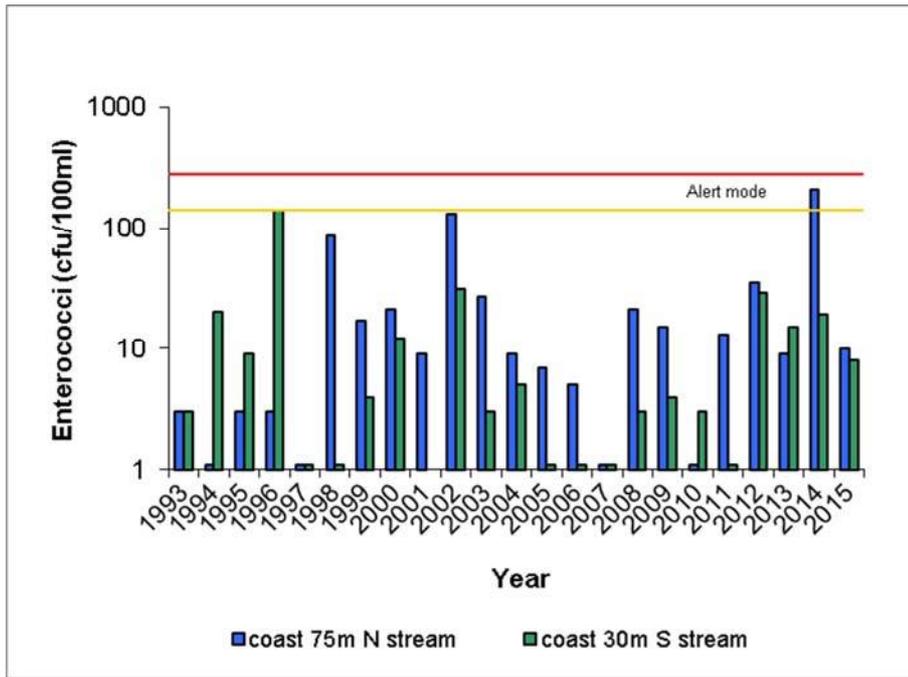
Figure 2 Coastal enterococci (cfu/100 ml) results since 1993
