South Taranaki District Council  
Waverley, Kaponga, Manaia and Patea  
Municipal Wastewater Treatment Plant Systems  
Monitoring Programmes  
Annual Report  
2015-2016

Technical Report 2016-30

March 2017

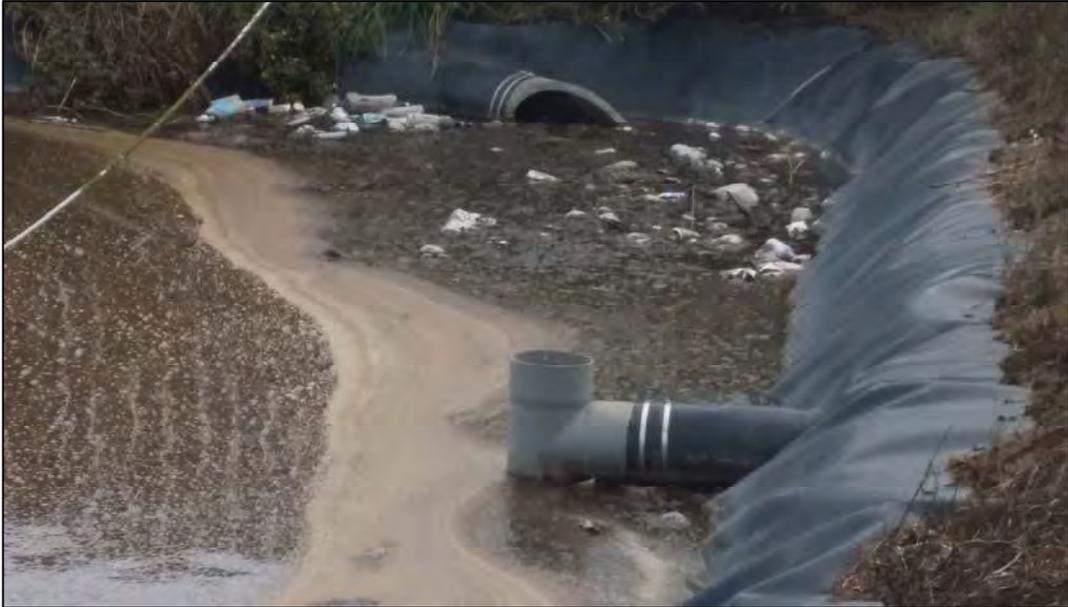
**Photo 1** Floatables on the Waverley stock truck wastes Pond 1, February 2016

It was noted in the February inspection that Pond 1 had some floatables (such as plastic bottles) on the surface which needed to be removed (Photo 1), this was undertaken immediately by the consent holder.

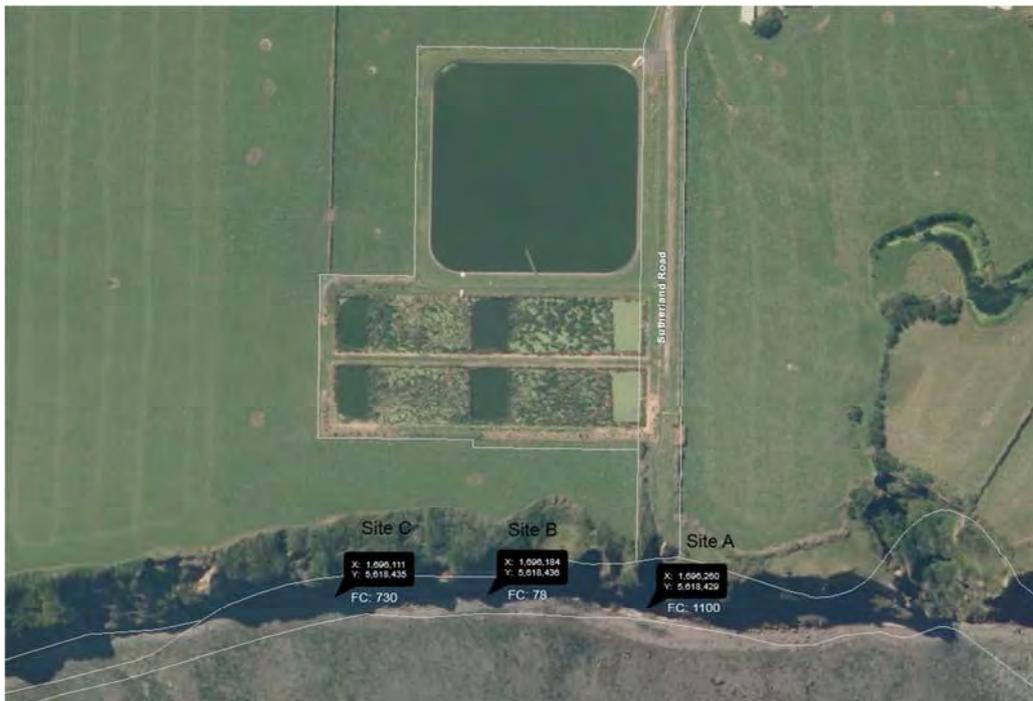
**Figure 4** Sample sites in relation to wetland seepage at the Manaia oxidation ponds

Early in 2016, following several months of lower than expected effluent levels and the absence of a discharge, the wetlands at the Manaia plant were discovered to be leaking. Seepage was observed during an inspection of the coastal area by Council staff (Photo 2). Samples were collected at three sites along the shoreline parallel to the wetland location (Figure 4), and the results of bacteriological analyses are presented in Table 25. The cliff side wetland was then taken out of service and an investigation for remedial actions was carried out by STDC to determine if any physical works were required.

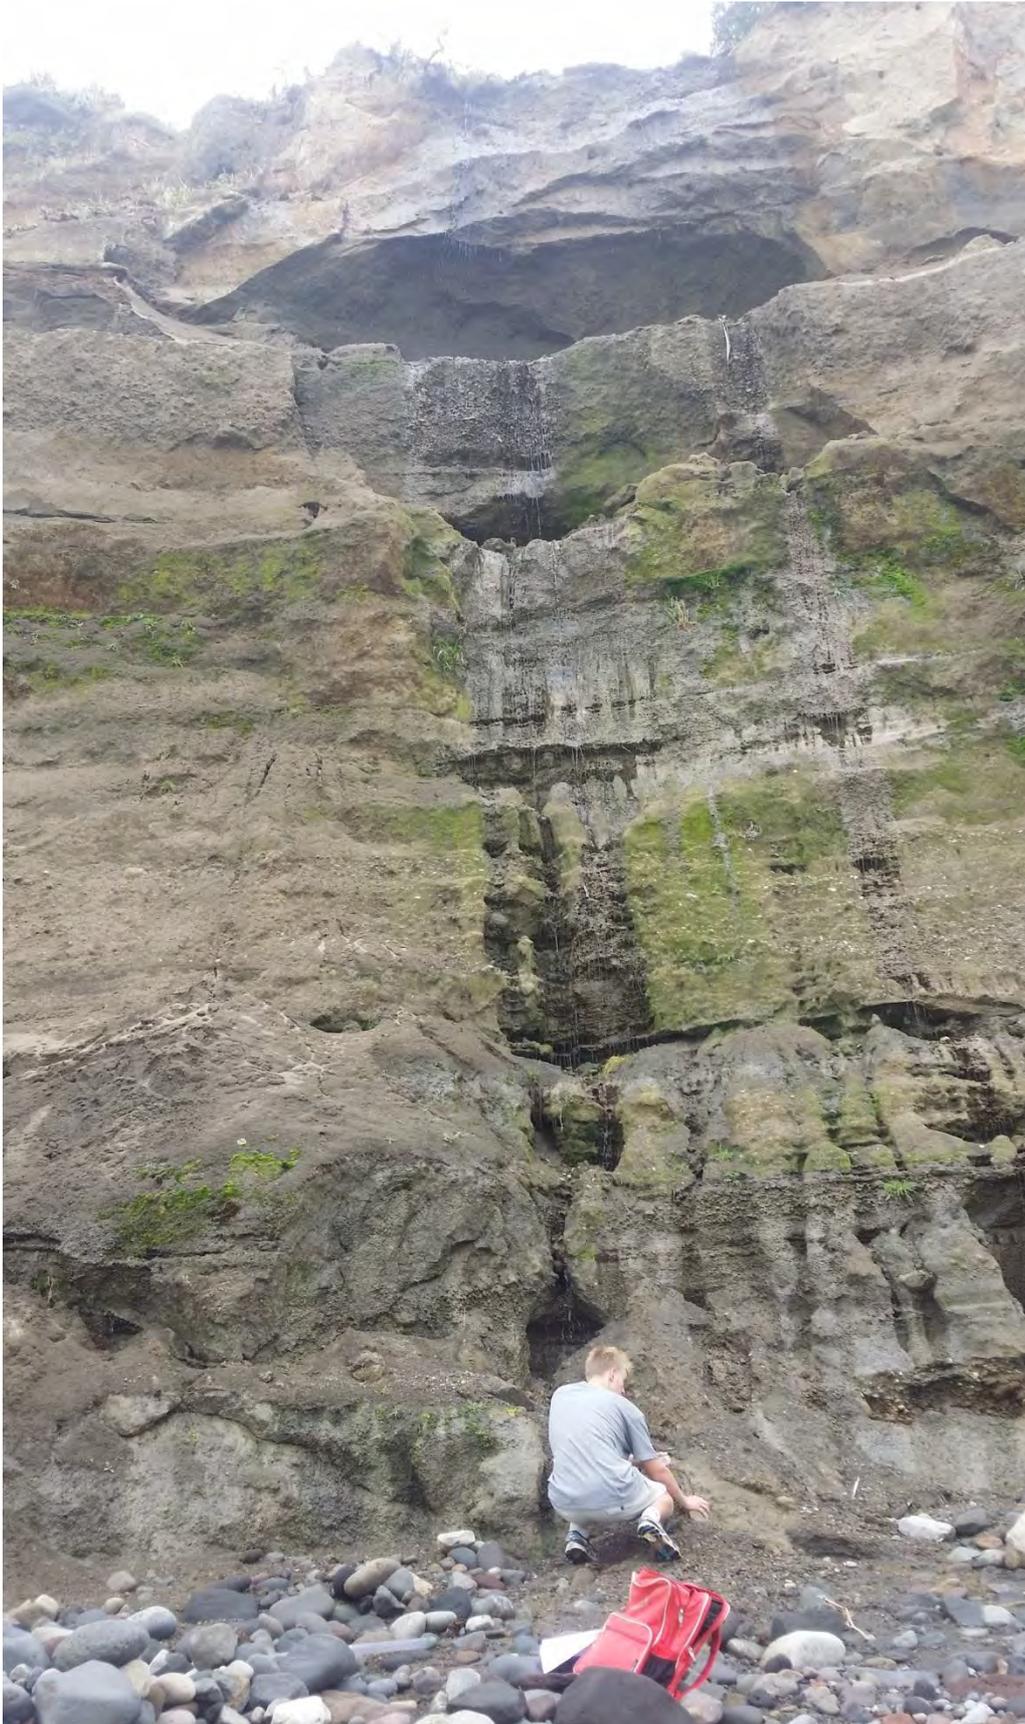
**Photo 2** Collecting samples of the cliff seepage in January 2016

Date	Site	Time NZST	Temperature °C	Faecal coliforms /100ml
27 January 2016	Site A	1010	20.1	1,100
	Site B	0945	20.1	78
	Site C	1000	19.7	730

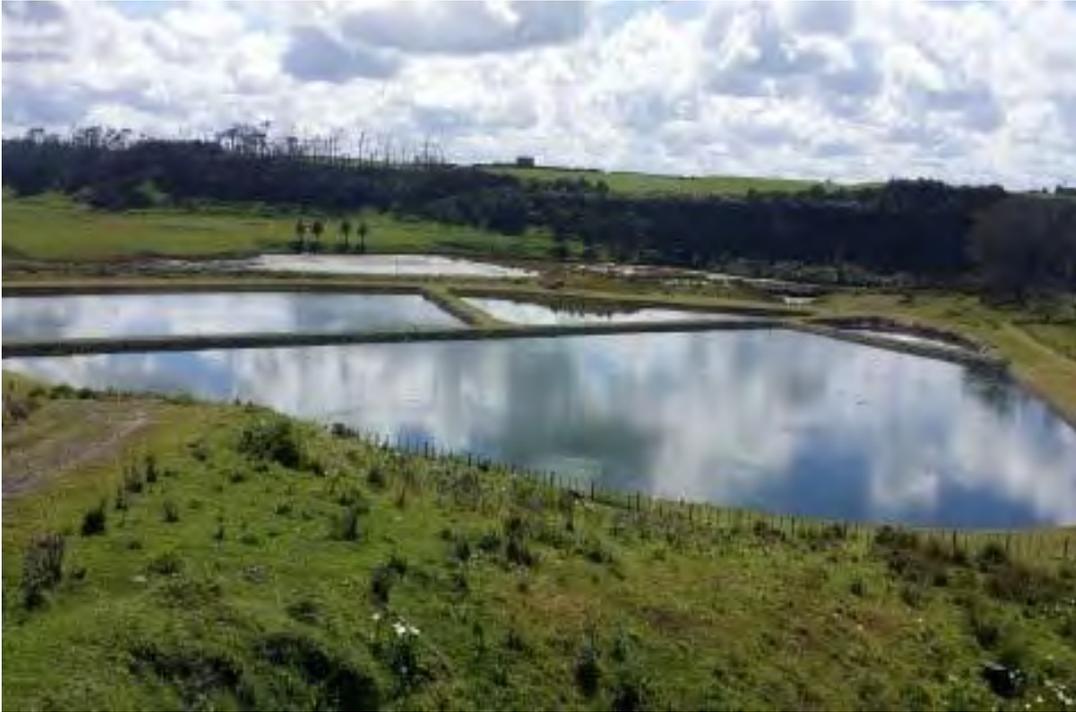
**Photo 3** General view of three cell system November 2014

Surface conditions on this, the final of the three re-configured cells, ranged from flat to light rippling under light wind conditions on inspection occasions. The cell wastewater appearance varied from pale green and relatively clear (late winter/early spring), to turbid dark green-brown (summer), to dark green (late autumn/early winter). There were no odours recorded on any occasion adjacent to this cell. The surrounds and wavebands were maintained in tidy conditions. No wildlife were present on this cell on two inspection occasions, a feature of this cell to date, with 14 ducks present in late winter/early spring.

The estimated discharge rate from this final cell via the rock riprap outfall to the river varied from 8 to 10 L/sec (late autumn/early winter and late winter/early spring) to 0.15 L/sec (in summer). There was no visual impact of the discharge on the receiving waters of the Patea River in the immediate vicinity of the outfall.

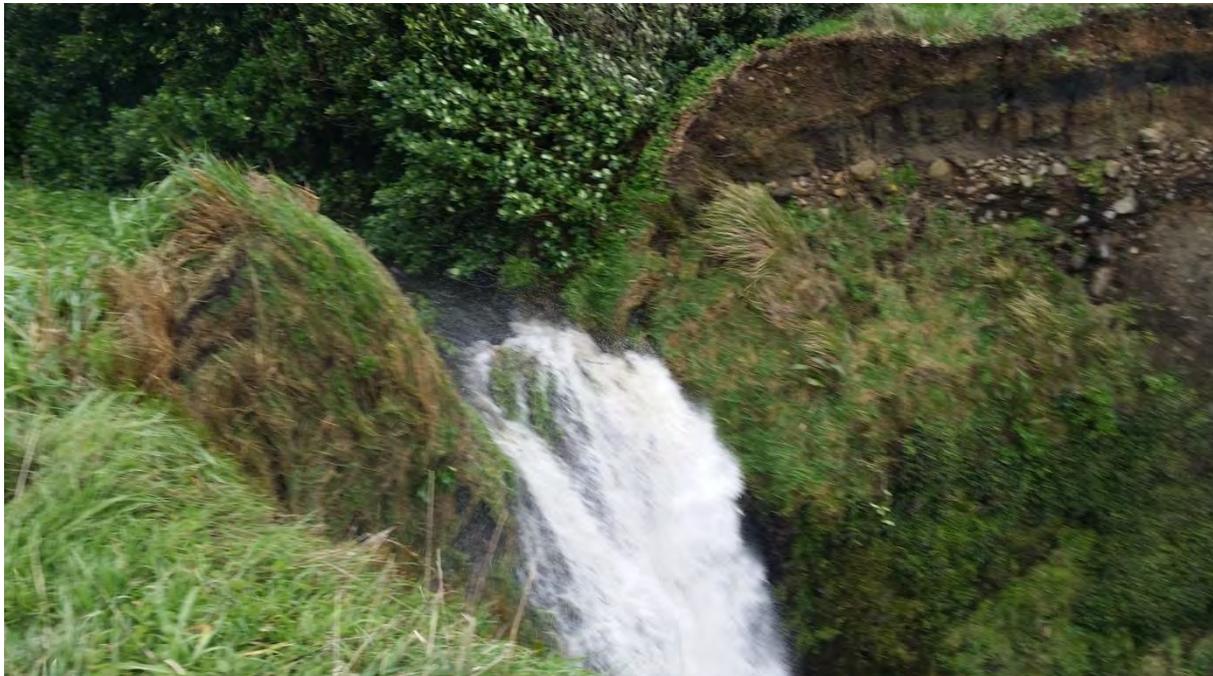
**Photograph 1** Waterfall from the Manaia Creek showing spray formed by the gale force SE wind

At the time of the inspection it was not possible to view the discharge point from the oxidation pond-wetland system due to high winds creating excessive spray from the waterfall (Photograph 1). The area surrounding the discharge channel had been fenced (Photograph 2). The Manaia Creek (Unnamed Stream 27, Consent 1204-4) was in high flow during the inspection.

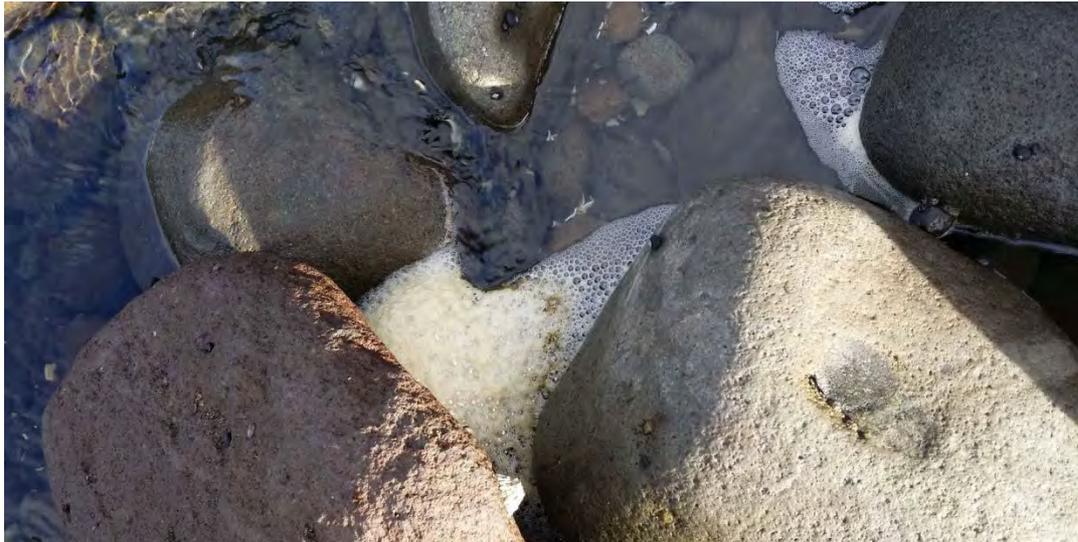
**Photograph 4** Foam from the Manaia Creek flowing over the intertidal reef at Manaia

(Photograph 4). Freshwater input was likely to have had a significant impact on the surrounding intertidal communities, particularly on the higher sections of the shore.

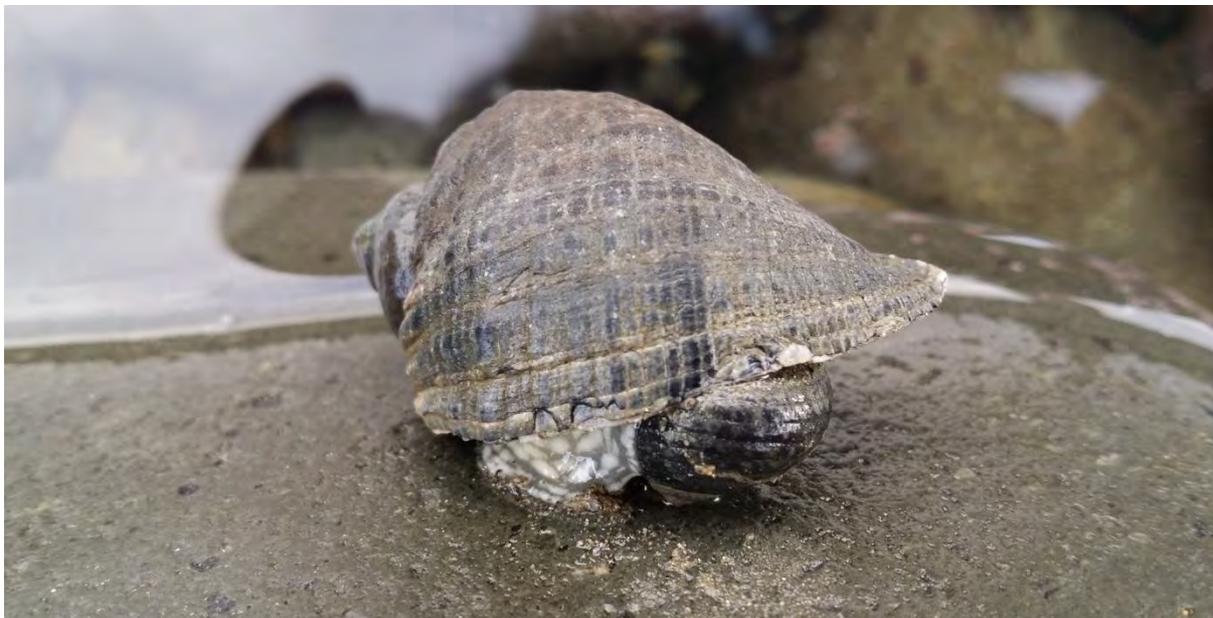
Green macroalgal species *Enteromorpha intestinalis* and *Ulva lactuca* stretched along the high tide mark ~20m either side of the stream, however, the cover was sparse relative to the December 2014 inspection. These algal species are typical of freshwater influence and thrive under nutrient rich conditions. At the top of the intertidal region within the vicinity of the stream, the gastropods *Austrolittorina cincta* and *Diloma* spp. were abundant. Other species became more abundant further away from the stream, including the limpet *Cellana radians*, the gastropods *Hastrum scobina* and *Melagraphia aeithiops*, and the barnacle *Austrominius modestus*.

**Photograph 5** Snails: *Hastrum haustorium* consuming *Melagraphia aeithiops*, midshore

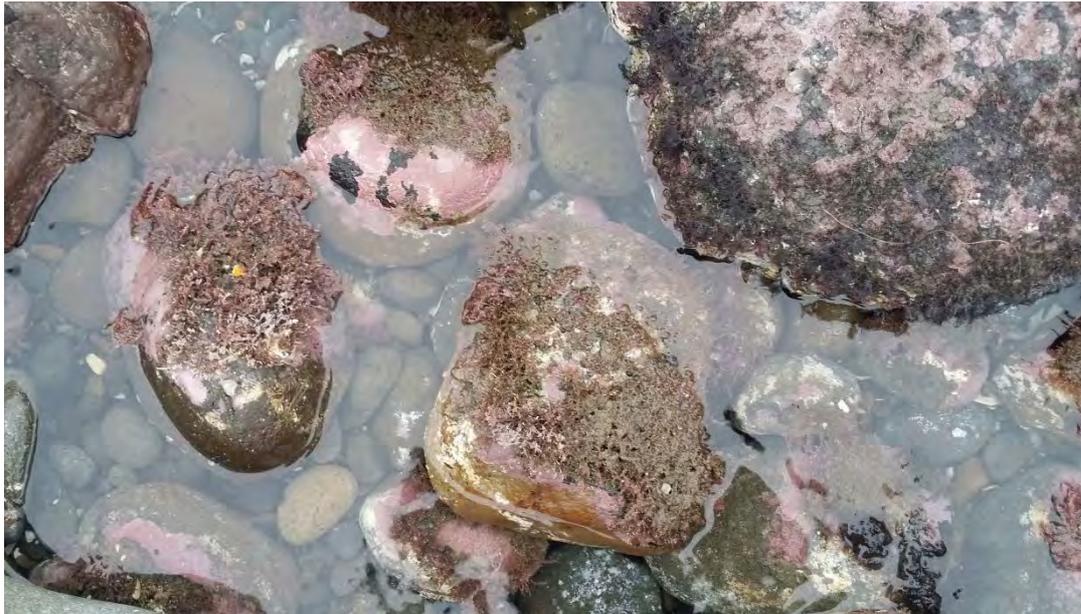
**Photograph 6** Macroalgal species at low shore, more abundant away from the influence of the stream

*Ralfsia* sp. and *Hormosira banksii* were present on boulders within the stream, becoming more abundant lower down the shore (Photograph 6).

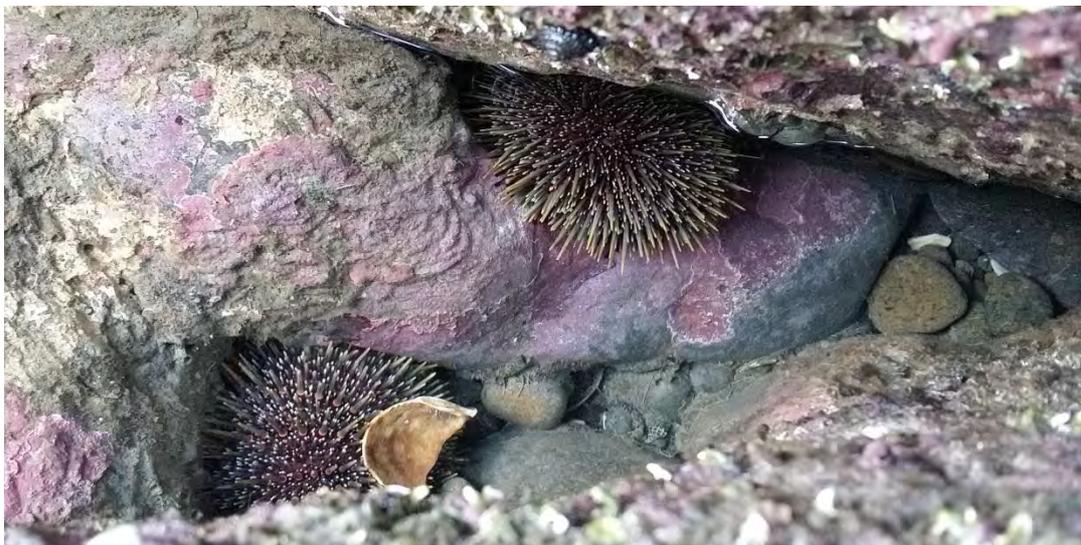
A greater diversity of algal and animal species occurred at the mid and low tidal regions, as typical of intertidal marine communities, and expected with the diminishing influence of the stream. At the mid and low shore elevations, 15 animal and algal species occurred within the vicinity of the stream. *Enteromorpha intestinalis* was present within the direct influence of the stream. The algal species *Corallina officinalis*, encrusting *Corallina* spp., *Geledium caulacanthum*

**Photograph 7** Kina *Evechinus chloroticus* present on the low shore away from the influence of the stream

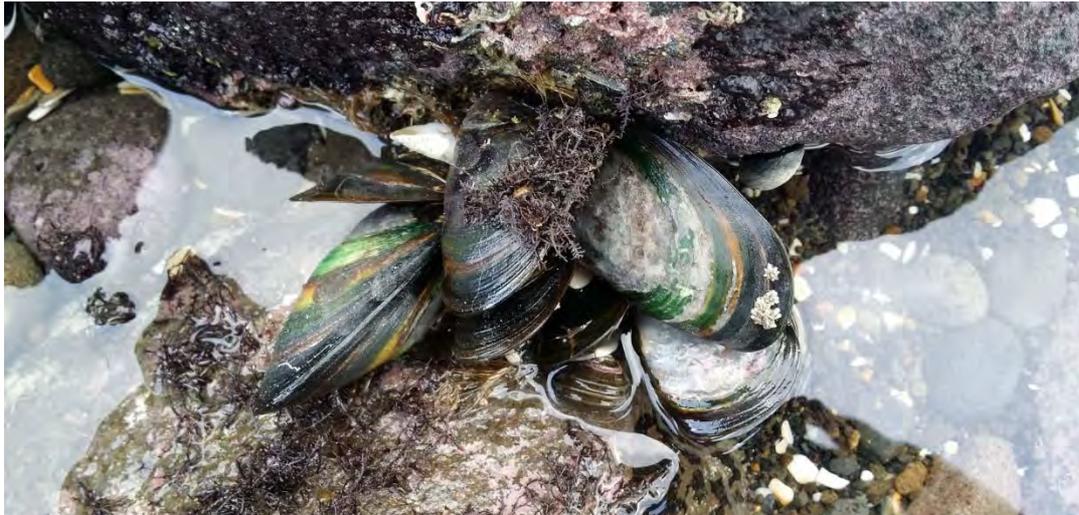
**Photograph 8** Green lipped mussel *Perna canaliculus* abundant on the lower shore

Twenty species were found more than 50 m to the north west of the stream in the mid and low shore regions, with an obvious change in the appearance of the reef and the diversity of species. Species only found away from the influence of the stream included: the seaweed *Echinothamnion* sp. and kina *Evechinus chloroticus* (Photograph 7). The green lipped mussel *Perna canaliculus* was abundant at low shore both within and away from the influence of the stream (Photograph 8)
