Wai-iti Beach Retreat
Monitoring Programme
Annual Report
2016-2017

Technical Report 2017-38

Taranaki Regional Council
Private Bag 713
STRATFORD
November 2017

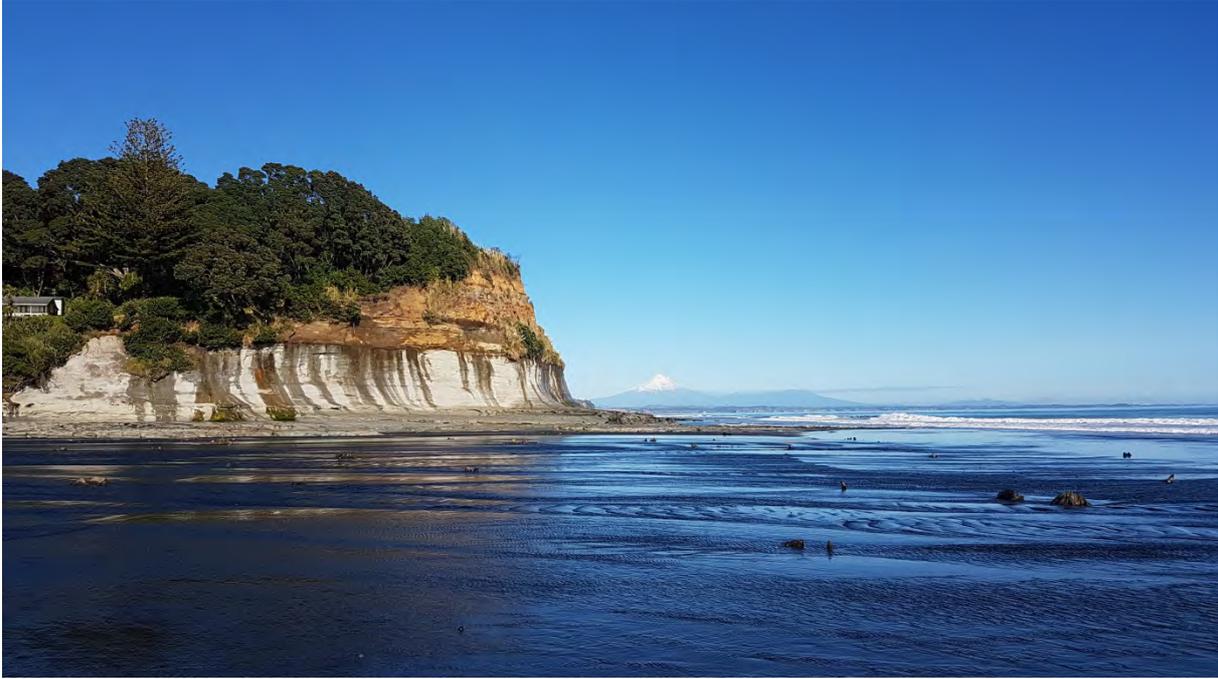
Photo 2 Wai-iti Beach, 22 May 2017

The seawall was also inspected during the visit. No obvious end effects were found. Neither the wall nor the land behind it appeared to be suffering from any obvious erosion or degradation. Sand had been pushed right up the shore at the northern end of the beach.

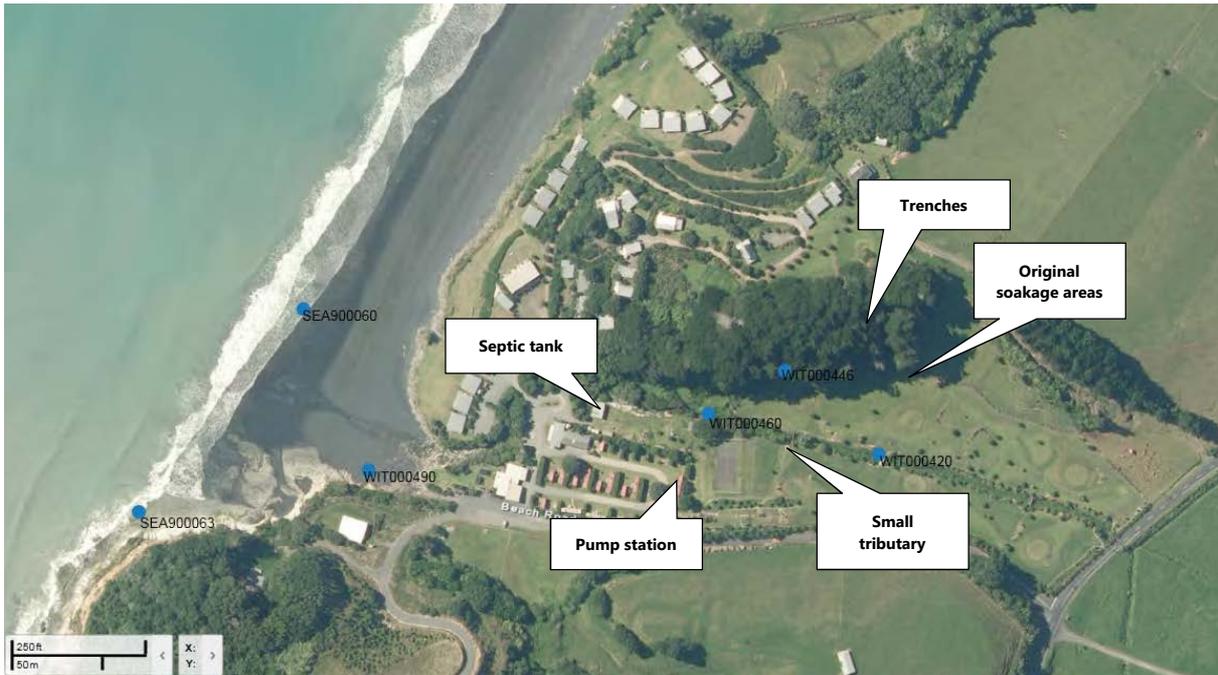
Figure 1 Location of sewage treatment system and sampling sites at the Wai-iti Beach Retreat

These multiple soakage trenches work on a rotational basis and were first commissioned in 1991 in response to inadequate treatment of the effluent by the previous system.

When previous proprietors took over the property in 1986-1987, the disposal system consisted of a seepage ditch situated near the base of the wooded hillside. Monitoring found that this trench system was not a suitable means of disposal, resulting in high faecal coliform counts at the mouth of the Wai-iti Stream. This inadequate treatment led to the development of the new multiple soakage trench system.

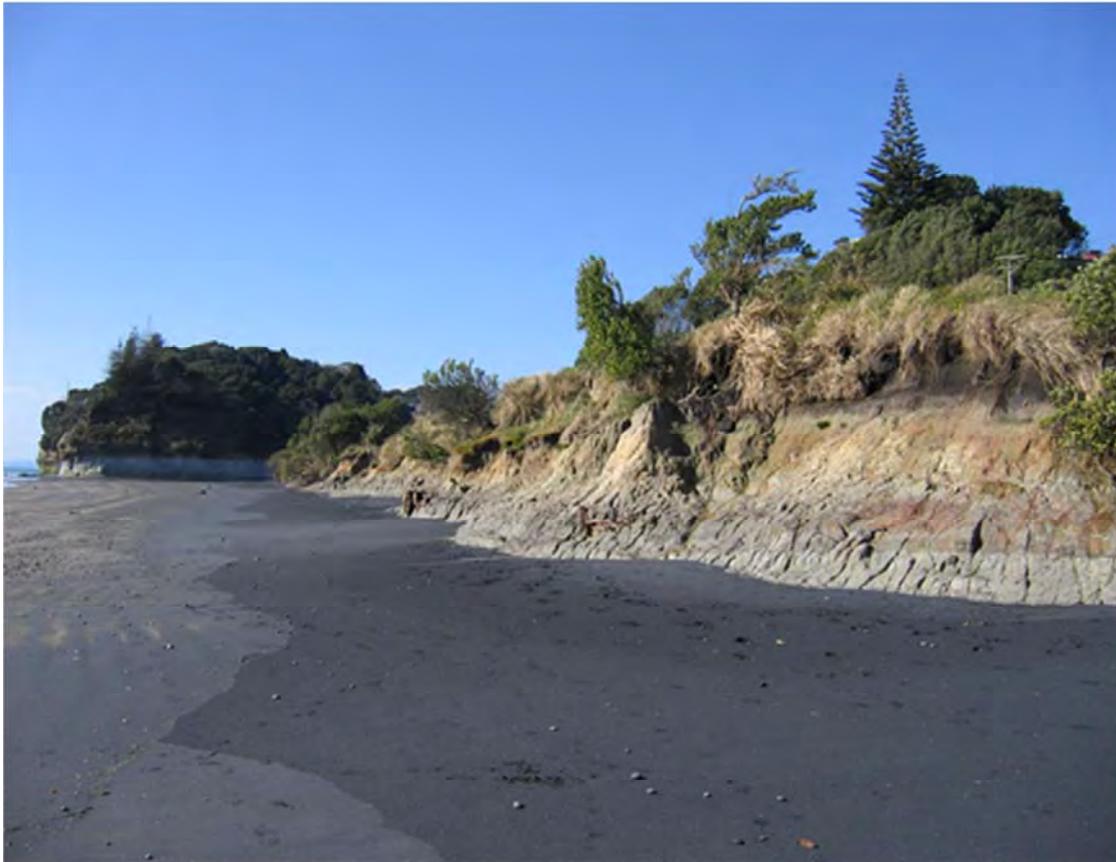
Photo 3 Erosion on Wai-iti foreshore prior to construction of the rock wall

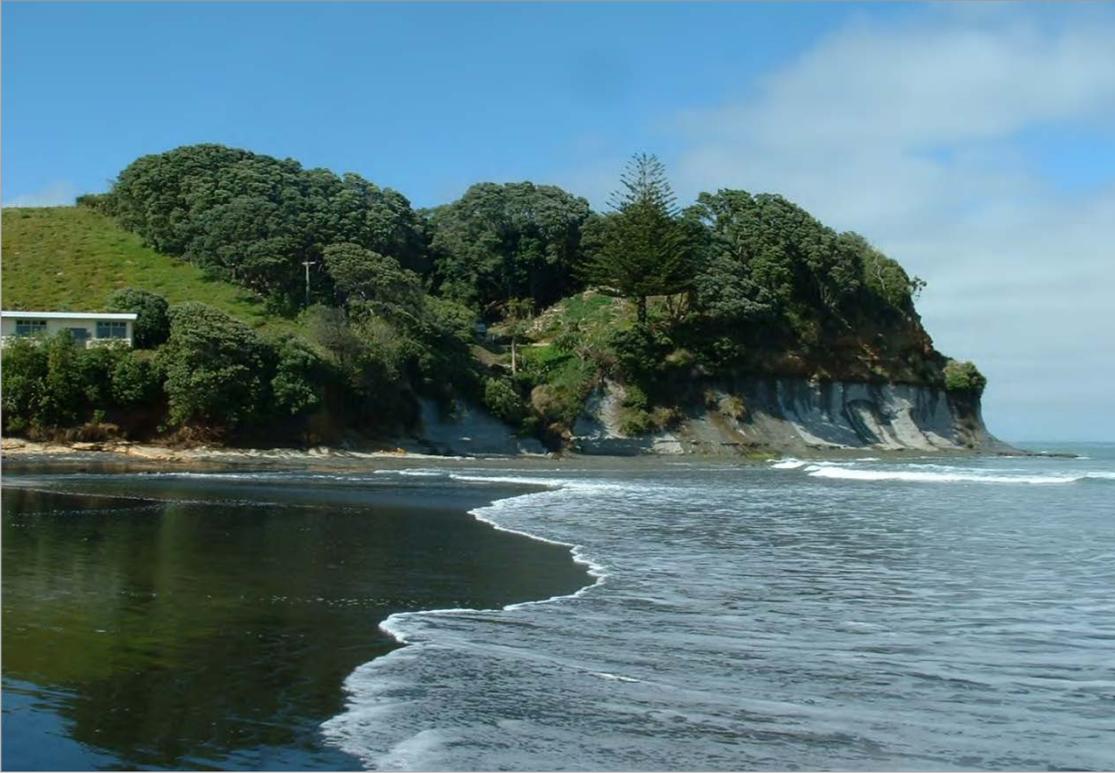
Photo 4 Taken at the coastal Site 4 at Wai-iti Beach, looking towards Site 5, with the Wai-iti Stream entering from center-left
