# **AGENDA**

## Consents & Regulatory

**Subject:** **Te Rūnanga o Ngāti Mutunga Mauri Compass Assessment of the Urenui and Mimitangiatua Rivers**

Te Rūnanga o Ngāti Mutunga  
Mauri Compass Assessment of the  
Urenui River and the Mimitangiatua River

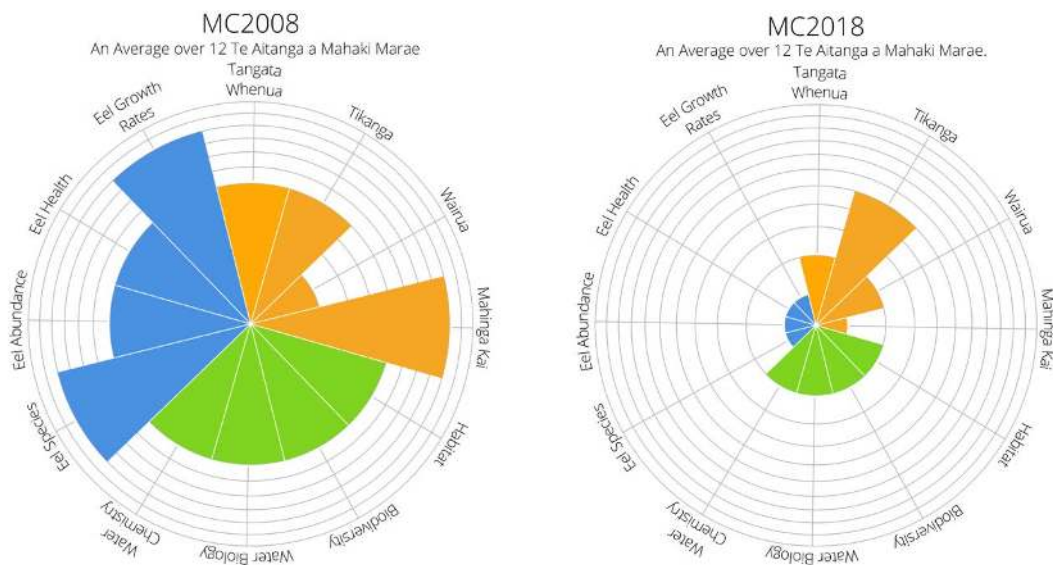
Comparing Mauri Compass Dashboards between 2008 and 2018 for the Waipaoa River Catchment (Turanganui a Kiwa / Gisborne). The assessment revealed the stark decline and degradation of the mauri of the Waipaoa River between 2008 and 2018.

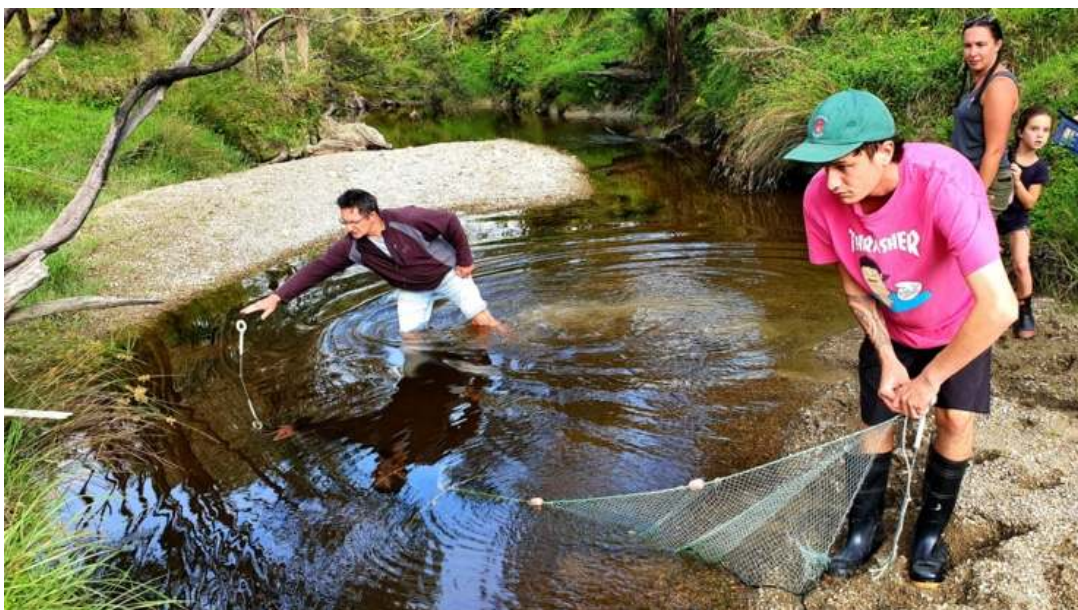
Rawiri McClutchie, Riaki Ruru, Anne-Maree McKay, Te Araroa McKay demonstrating text book net-setting techniques. All nets were unbaited, set perpendicular to the stream and retrieved the next morning.

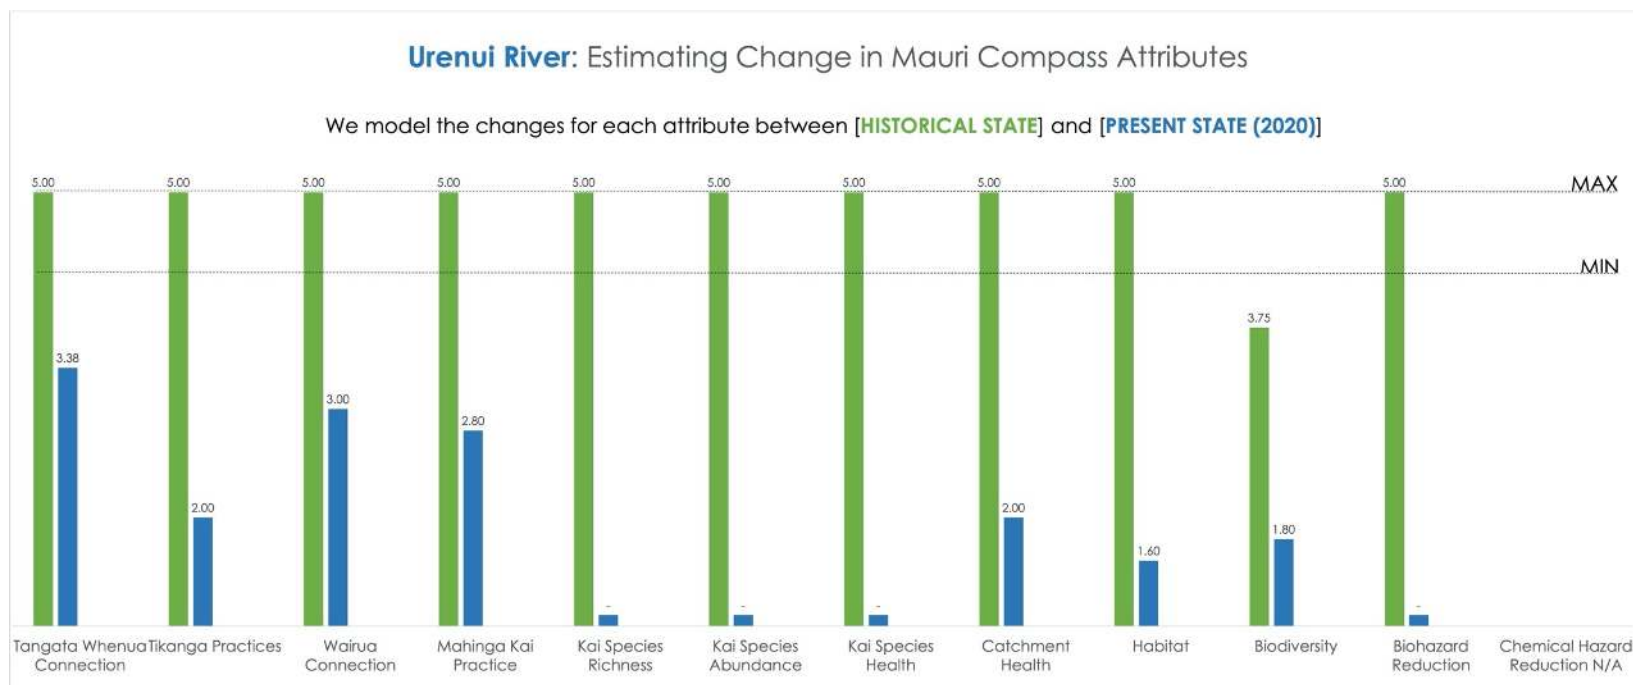
Figure 11: Urenui River Bar Chart.

Key messages from all Bar Charts include;

- Every attribute value has declined dramatically since pre-European settlement.
- The most significant declines related to Kai Species (Tuna) Richness, Tuna Abundance, and Tuna Health.
- The Biohazard attribute scored the absolute minimum value due to septic tank human sewage pollution.
- These are some of the causes of reduced Ngāti Mutunga connections with our awa.

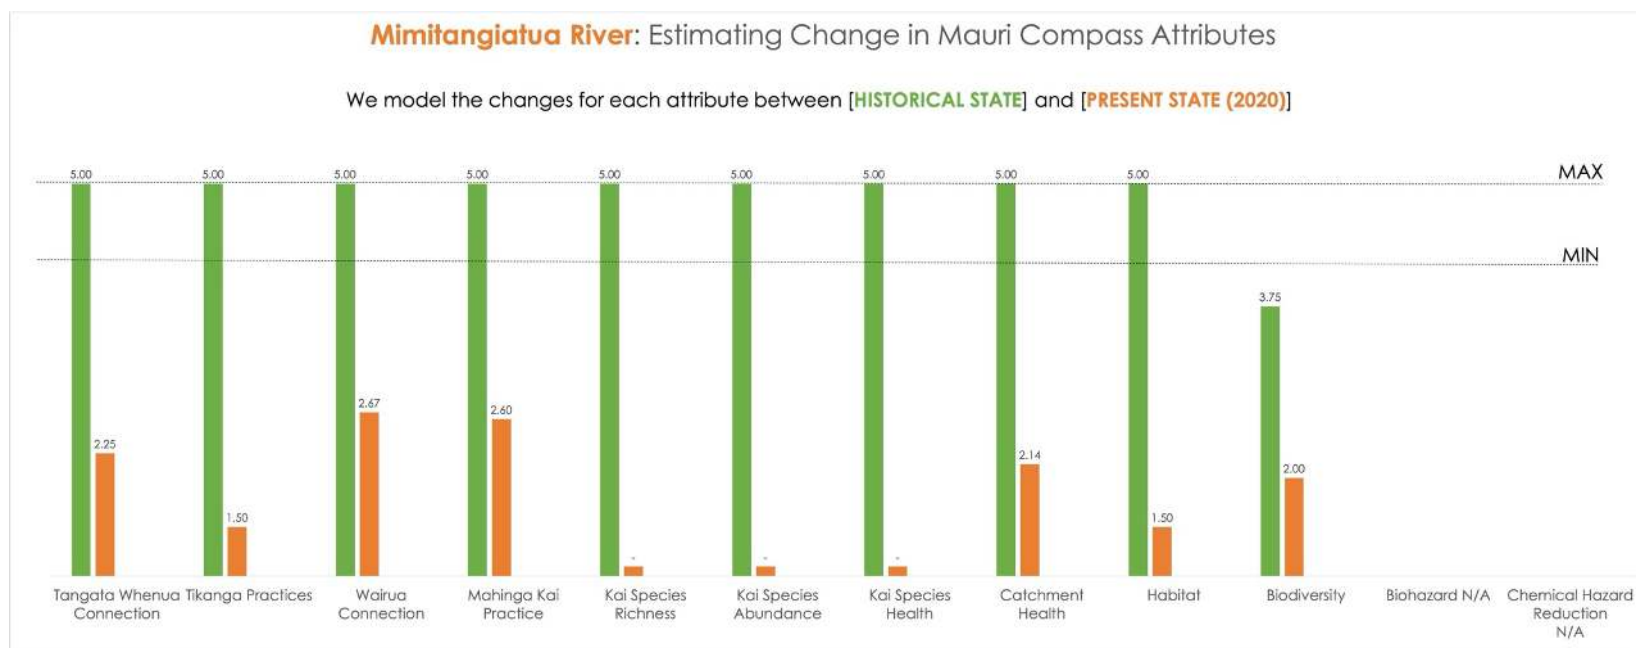
Figure 12: Mimitangiatua River Bar Chart.

Key messages from all Bar Charts include;

These are some of the causes of reduced Ngāti Mutunga connections with our awa.

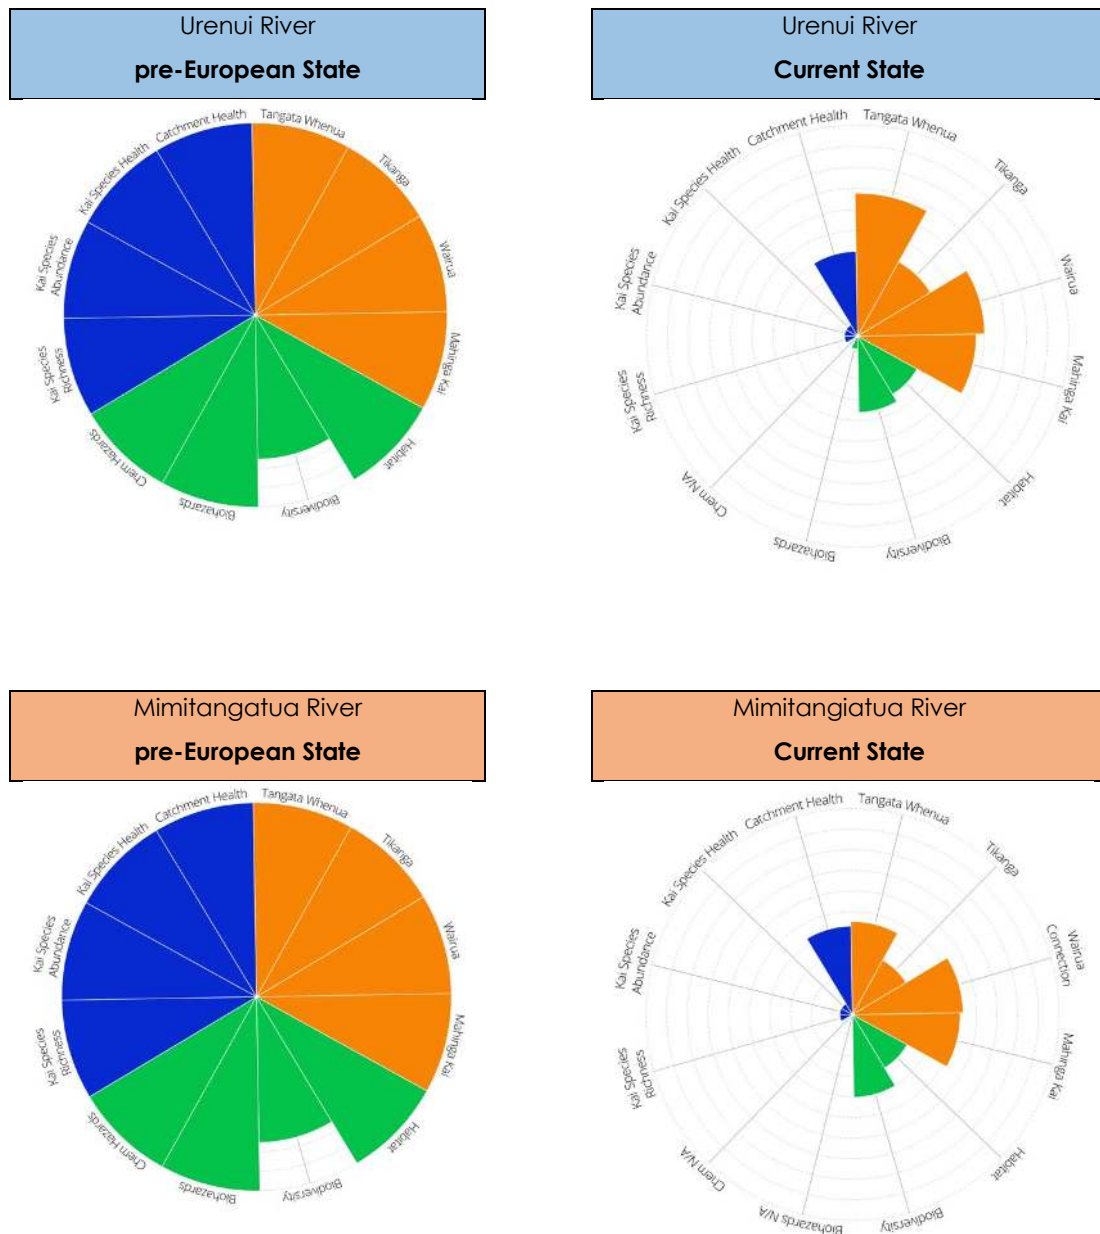
Figure 14: Dashboards comparing pre-European and current states.

Key observations from the Dashboards:

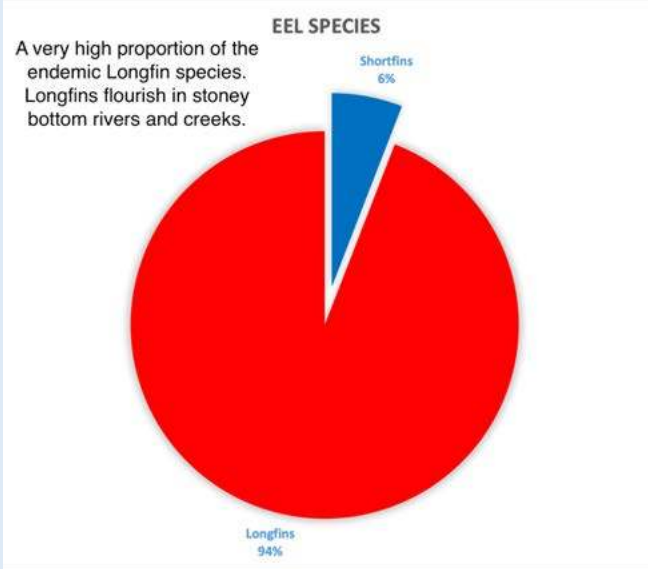
<b>Nga Tini A Tangaroa</b>						
<b>Indicator: Kai species richness</b>						
<div><p><b>EEL SPECIES</b></p><p>A very high proportion of the endemic Longfin species. Longfins flourish in stoney bottom rivers and creeks.</p>

<table><tr><th>Species</th><th>Percentage</th></tr><tr><td>Longfins</td><td>94%</td></tr></table>

Our mahinga kai research confirmed the almost total absence of our taonga freshwater tuna species. Extremely low numbers were observed and the species ratio was 94% Longfin and 6% Shortfin.
