# **AGENDA**

## Operations & Regulatory

# A review of the Taranaki Regional Council Riparian Programme

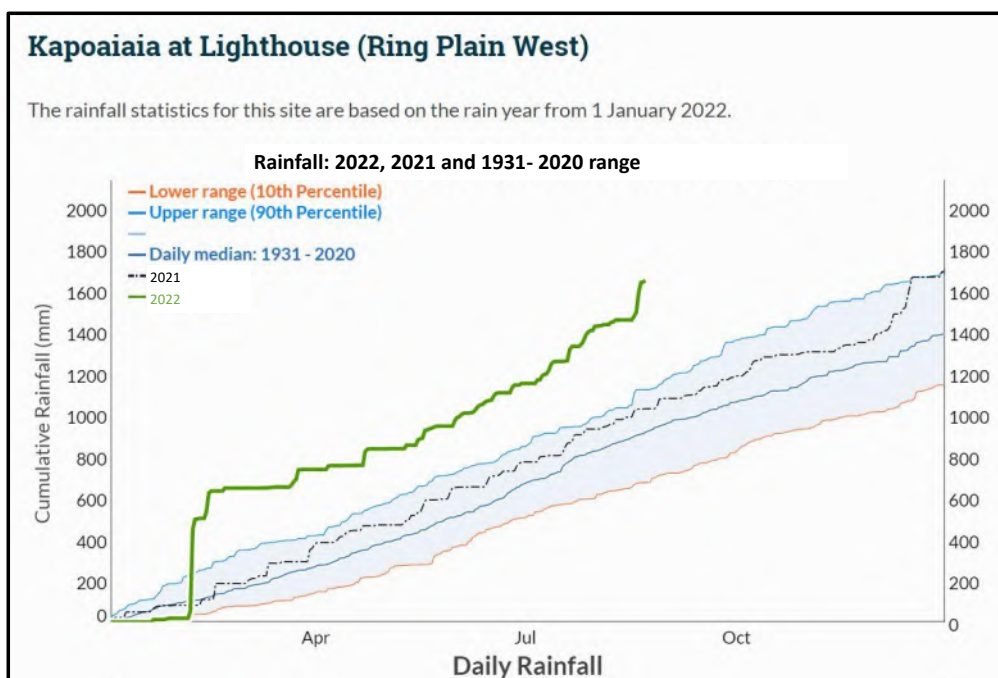
**Figure 3.** Kapoiaia (Lighthouse) station cumulative rainfall for 2022 following the storm event compared with the long-term cumulative rainfall 1931 to 2020.

Similarly for the Taranaki event, recorded rainfall indicates that the event produced rainfall well above the 90<sup>th</sup> percentile and was greater for the Lighthouse station on the coast than the Kahui Hut station in the mountain (Figure 3).

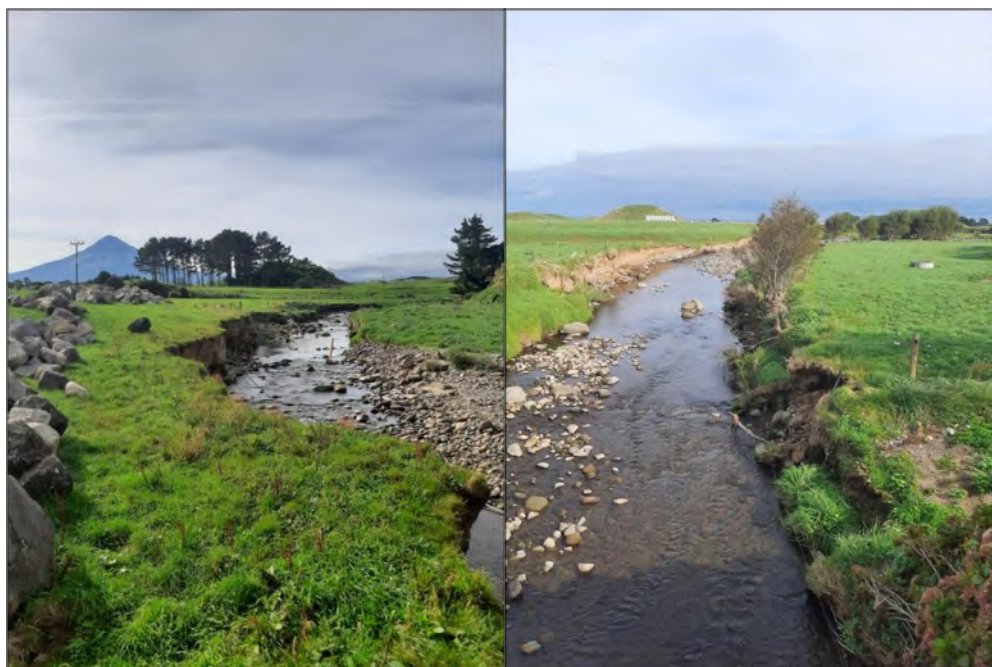
*Figure 4. Examples of bank erosion.*

Examples of bank erosion are shown in **Figure 4**, fallen large trees and in-stream debris (**Figure 5**), and on-bank deposited debris (**Figure 6**).

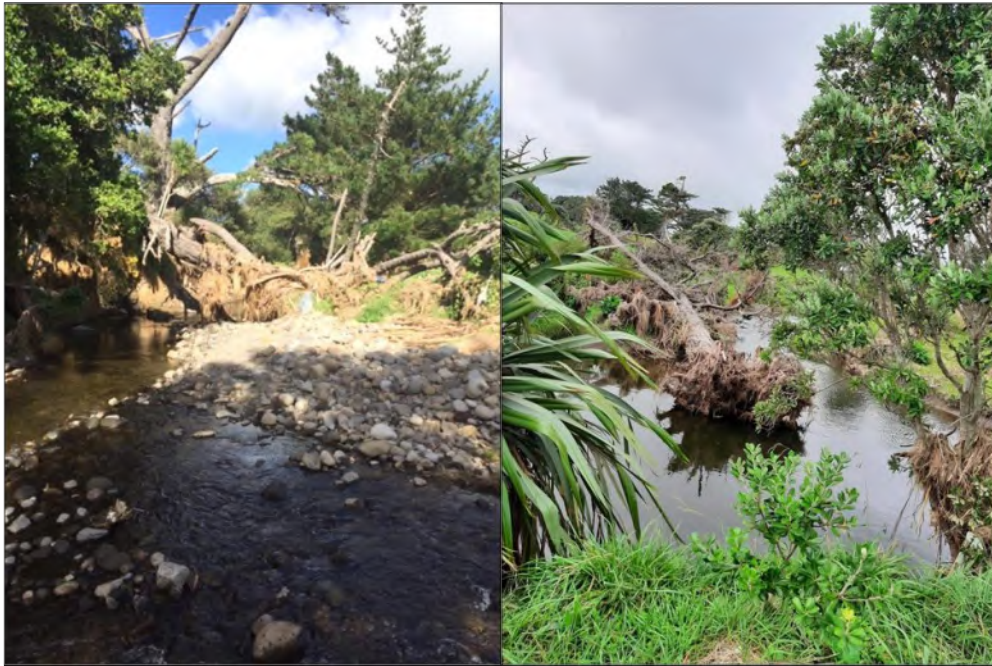
**Figure 5.** Examples of fallen large trees and instream debris.

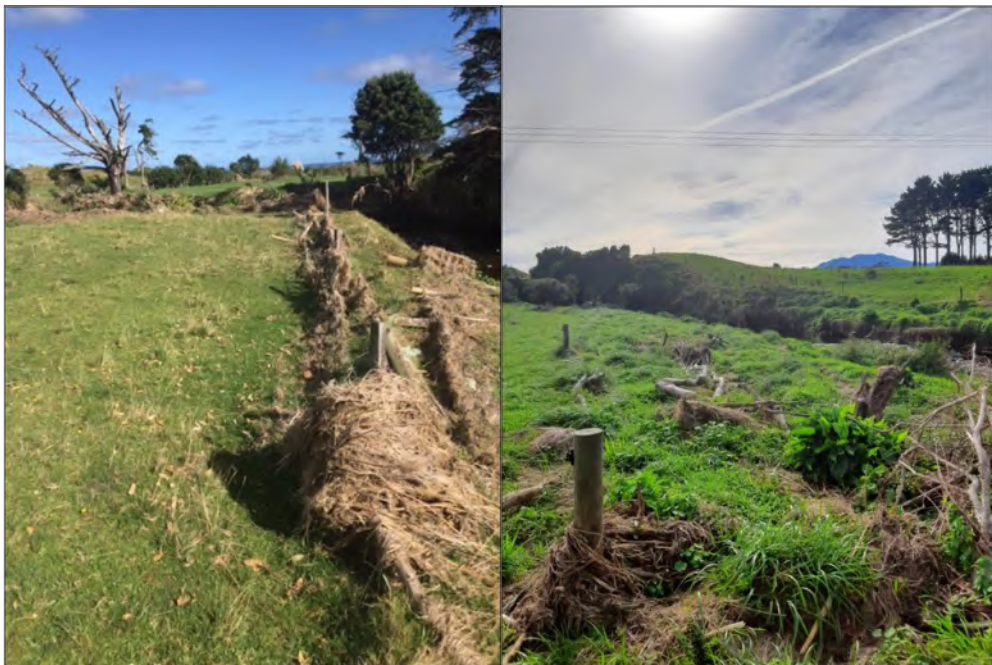
**Figure 6.** Examples of on-bank deposited debris

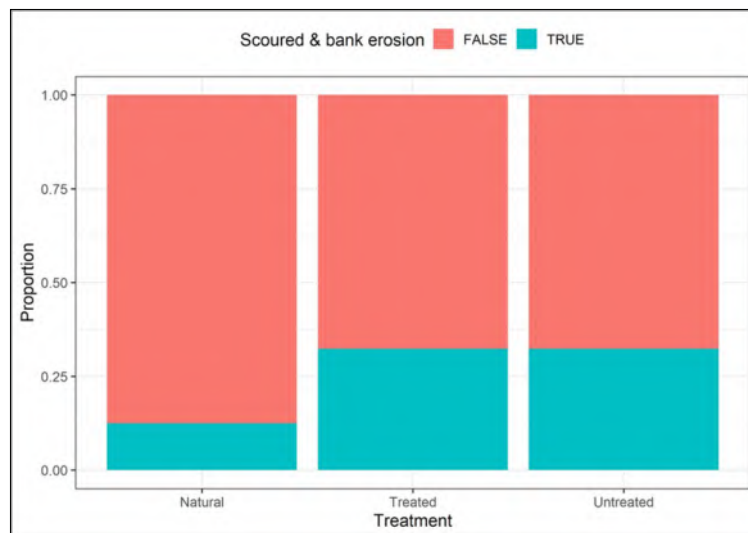
**Figure 18.** Proportion of erosion by treatment.

**Figure 18** shows the proportion of erosion for natural, TRC treated and untreated samples.

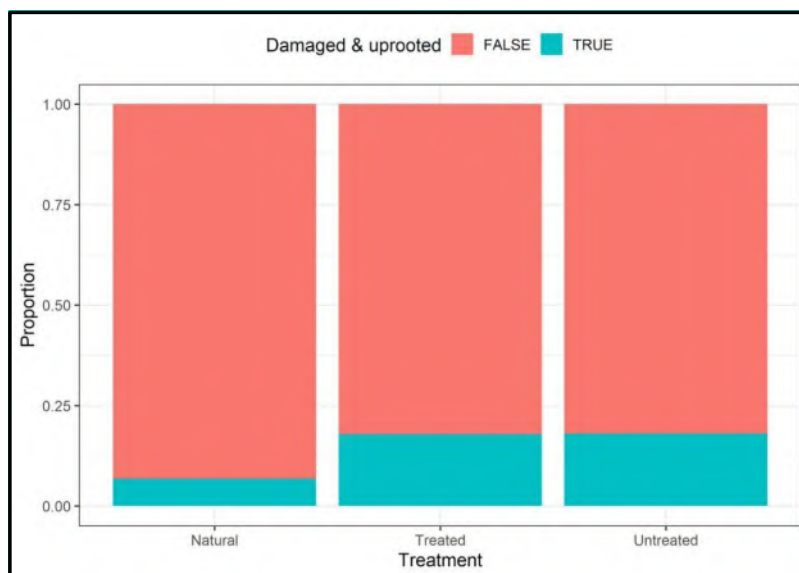
**Figure 23.** Proportion of samples with and without vegetation damage by treatment.

Vegetation damage was similar for TRC treated sites compared with untreated sites, and both had greater vegetation damage than for natural vegetation. TRC treated samples are likely to have a greater amount of planted riparian vegetation than untreated samples, hence have greater potential for vegetation damage, (especially when the plantings are young). TRC treated samples were predominantly in the mid and lower catchment where flows were greater and likely targeted high energy reaches with potential for bank erosion (and resulting damage to vegetation). Additionally, the majority of the TRC treated samples still had young vegetation (as indicated by the vegetation height distributions shown in **Figure 24**) which was yet to establish and remains prone to damage and uprooting during very high flows.

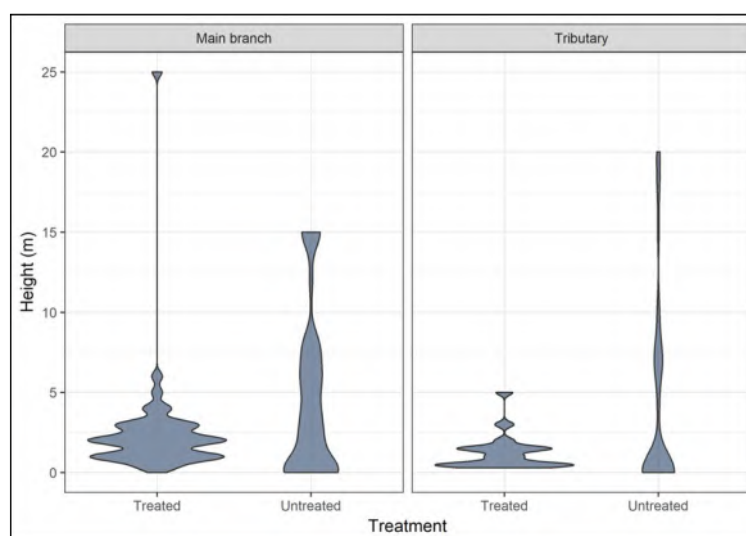
**Figure 24.** Vegetation height distributions for treated and untreated samples.

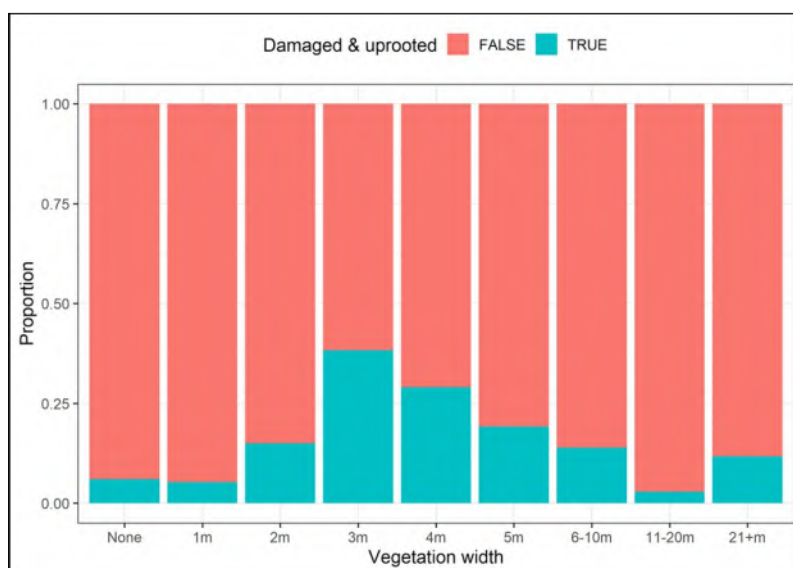
**Figure 40.** Proportion of samples with and without vegetation damage by vegetation width.

**Figure 40** shows the proportion of samples with and without vegetation damage by vegetation width. Of note is the higher proportion of erosion for samples with no woody vegetation (“none”) compared with samples for 1 m and 2 m vegetation width. Also, it is likely that the increased proportion of erosion for samples with 3 m and 4 m is likely to be associated with wider channels (either larger tributary or smaller main branch channels) which will have greater peak flows and erosive potential.

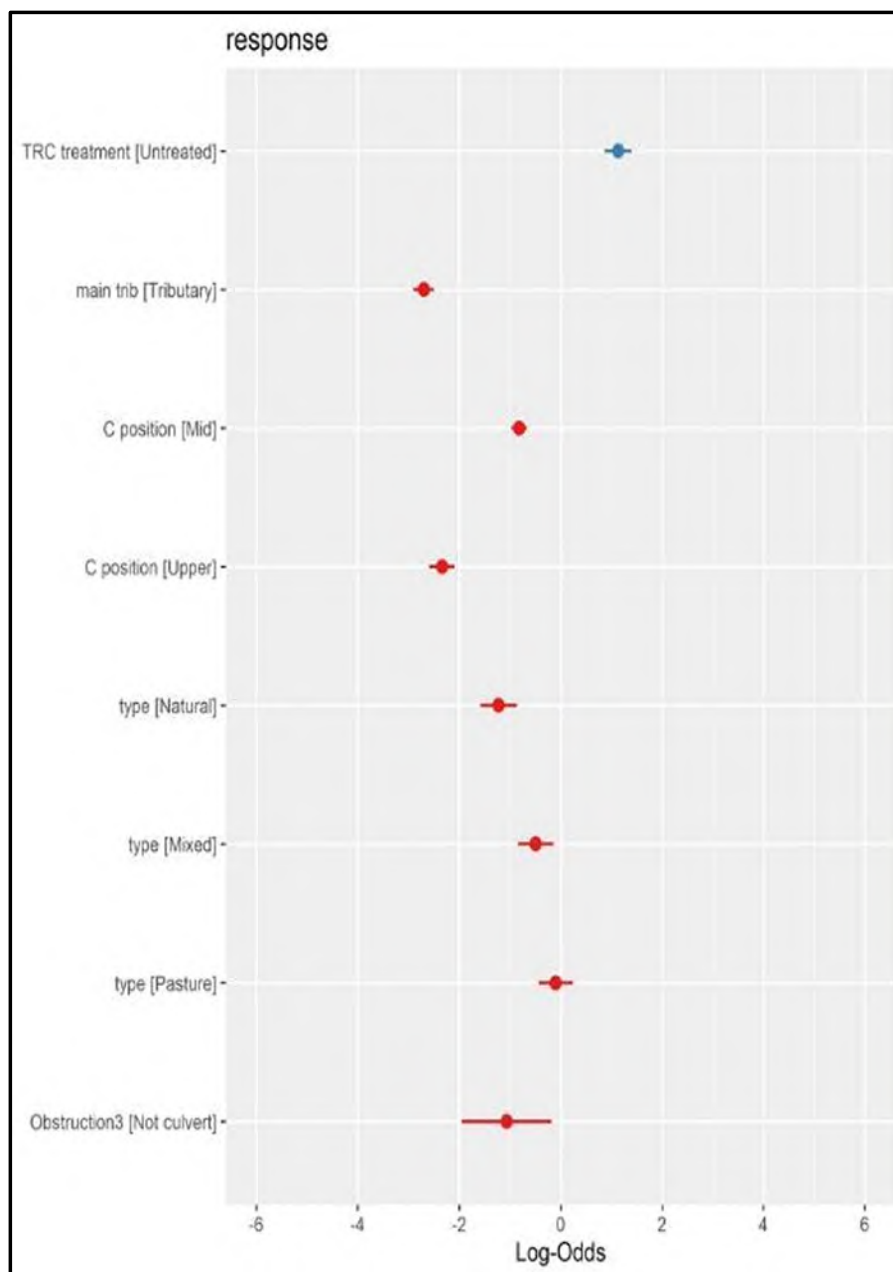
**Figure 49.** Log-Odds plot for erosion.

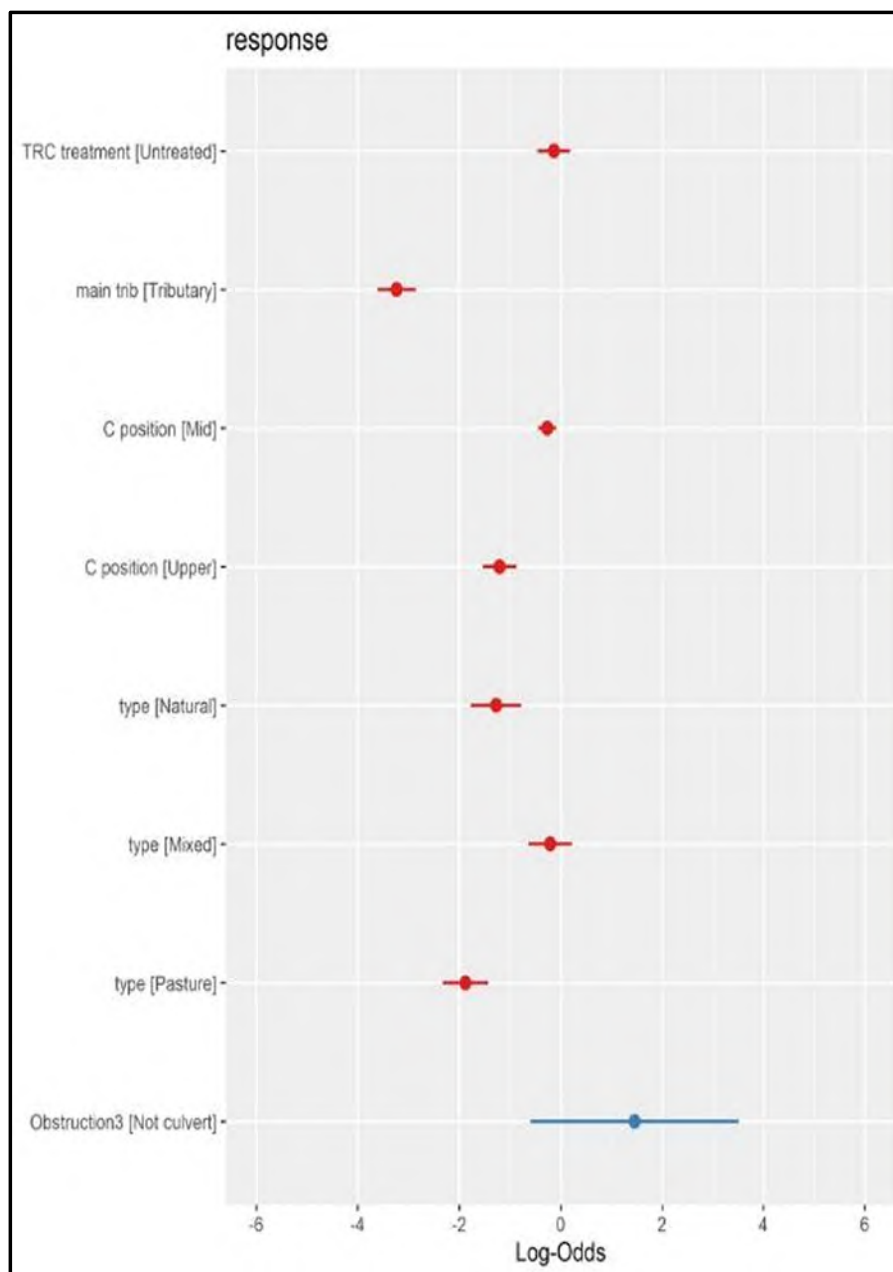
**Figure 51.** Log-Odds plot for vegetation damage.

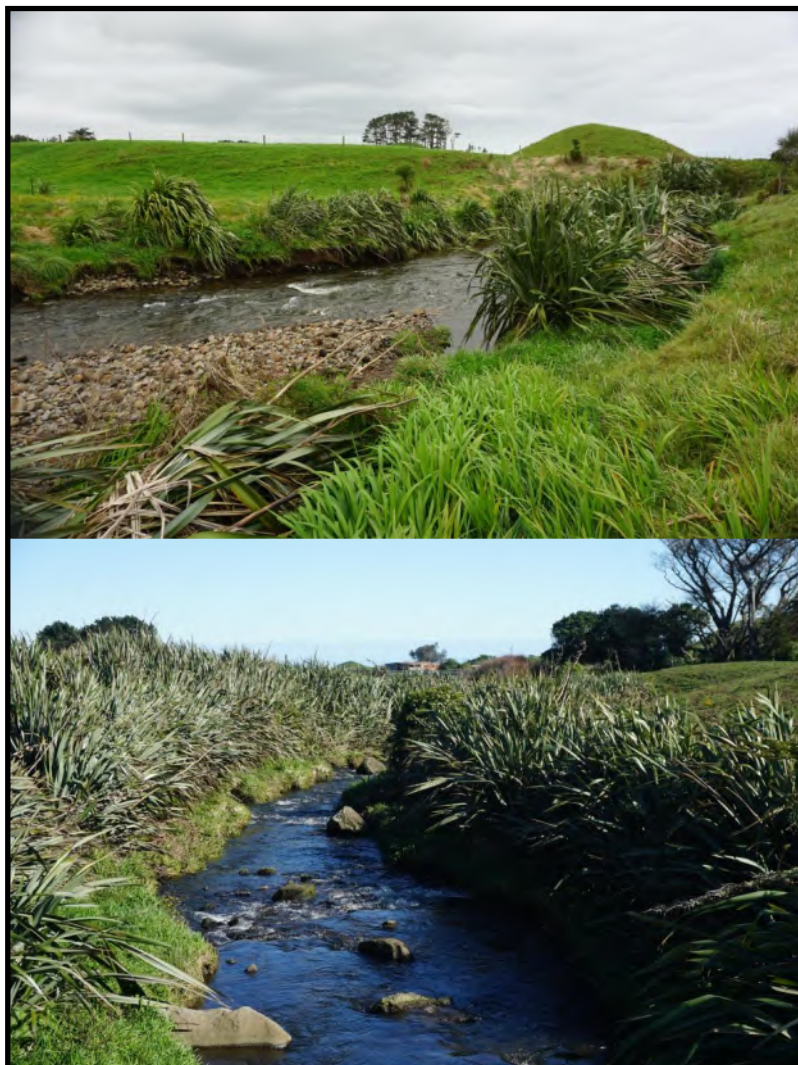
**Figure 52.** *Examples of riparian margins planted with flax.*

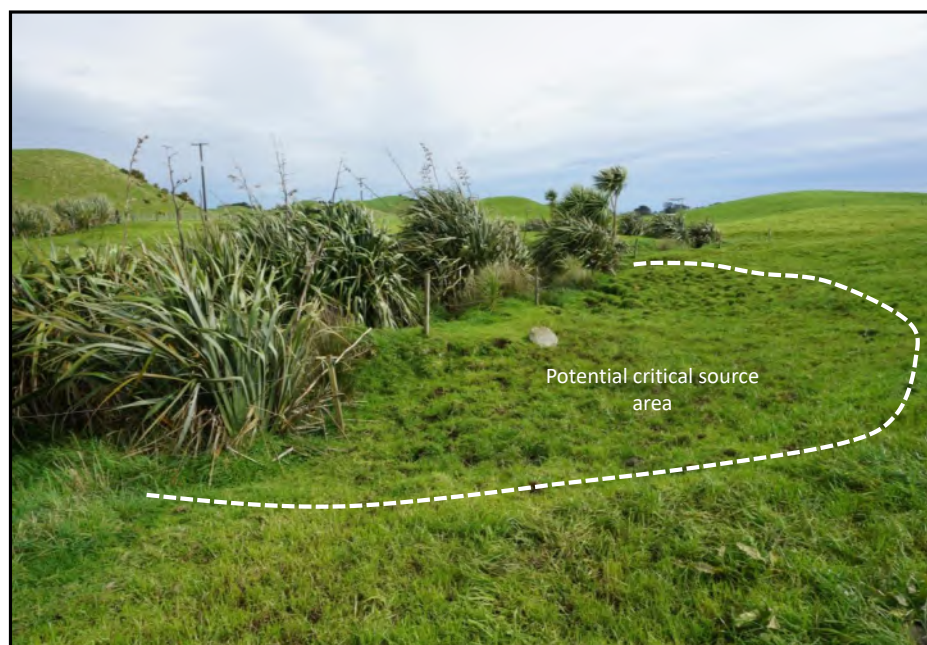
**Figure 53.** Example of riparian buffer not following the contour and creating a potential critical source area.

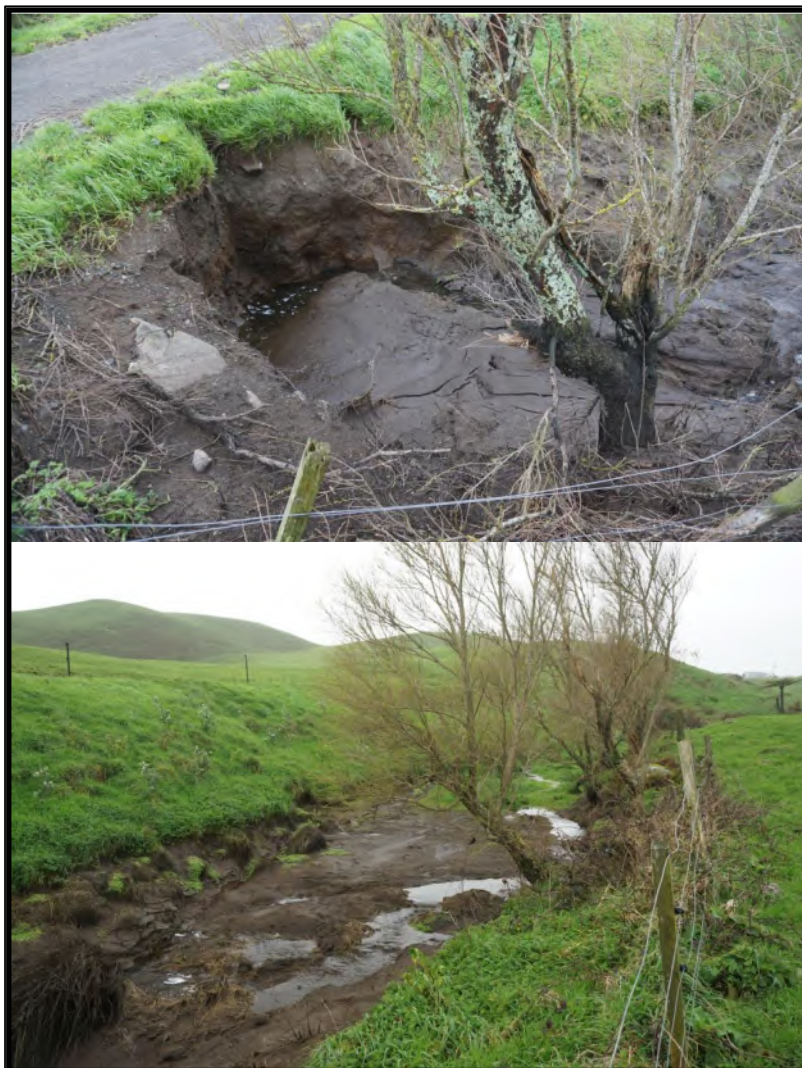
**Figure 54.** Example of a blocked culvert creating localised sedimentation.

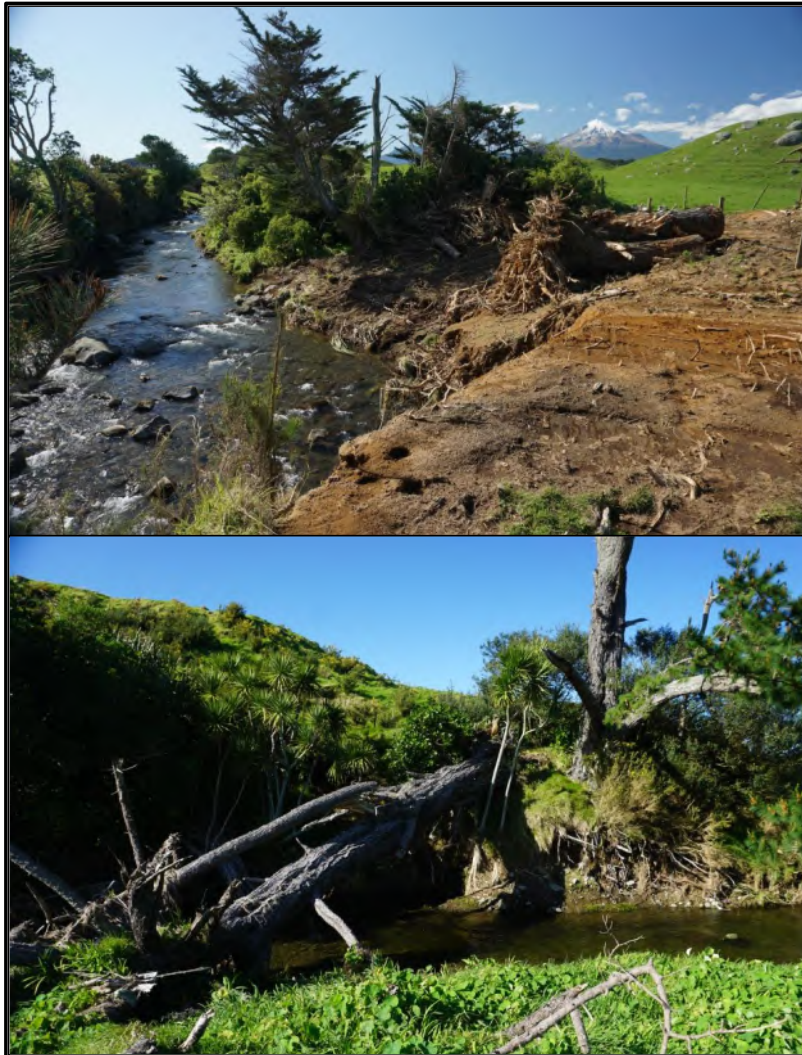
**Figure 55.** *Examples of large trees diverting stream flow and creating localised erosion.*

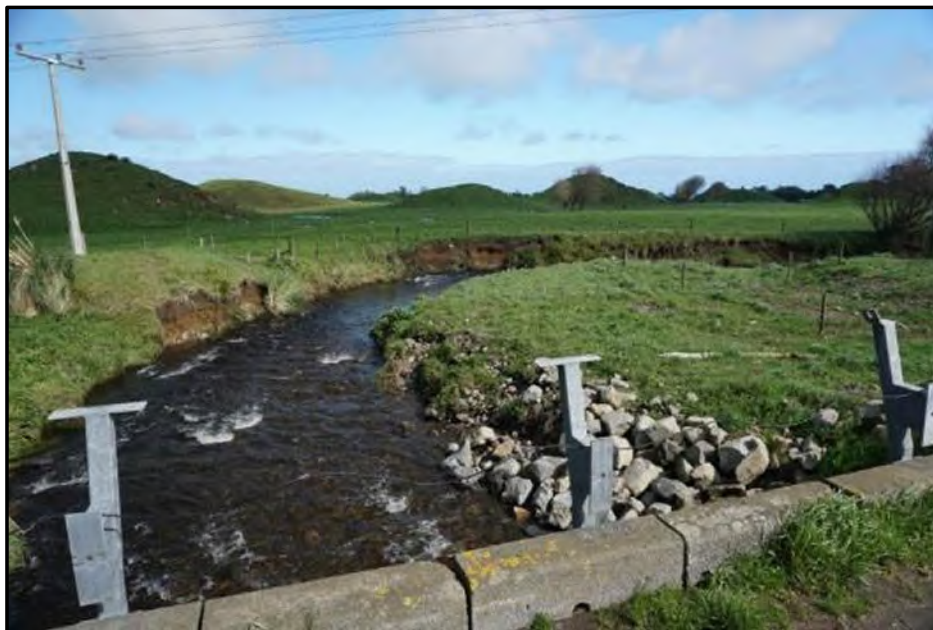
**Figure 56.** Example of hard structure (bridge) with localised erosion.
