# Taranaki Regional Council Marine Oil Spill Tier 2 Response – AWE/Prosafe FPSO Spill - Okato Beaches – October 2007

# Introduction

- 1. In October 2007 a crude oil spill of approximately 23 tonnes was washed up on Okato beaches, extending from Bayley Road in the south and Perth Road in the north and affecting almost 15 kilometres of coastline.
- 2. The spill was sourced to Umuroa Floating Loading Storage and Off-loading (FPSO) facility, operated by Prosafe, for the Tui oilfield. The field is managed by Australia Worldwide Exploration (AWE) 60 kilometres off the coast of Taranaki (Figure 1).

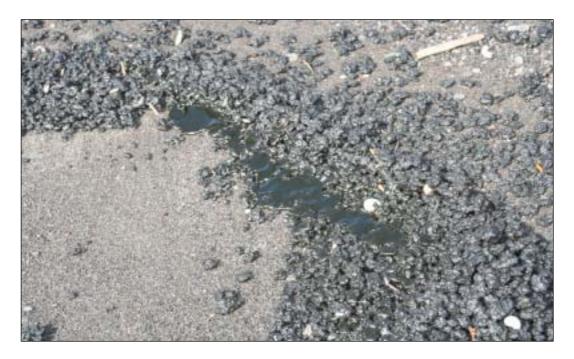
Photograph 1 - Oil on beach at Komene Road 24 October 2007

7. The consistency of the oil was waxy, mostly in the form of small tar balls that melted in temperatures above 23 °C.

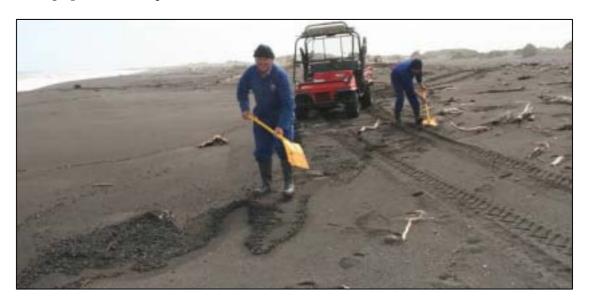
Photograph 2 - Clean up on beach at Komene Road 24 October 2007

- 23. Inspection of the beaches at the end of Kaihihi and Komene roads were immediately undertaken and this found that oil on the beach at Komene Road was quite heavy and the oil on the Kaihihi beach was noticeable but not nearly as heavy.

24. Clean-up on this first day concentrated on the heavy areas on the Komene Road beach

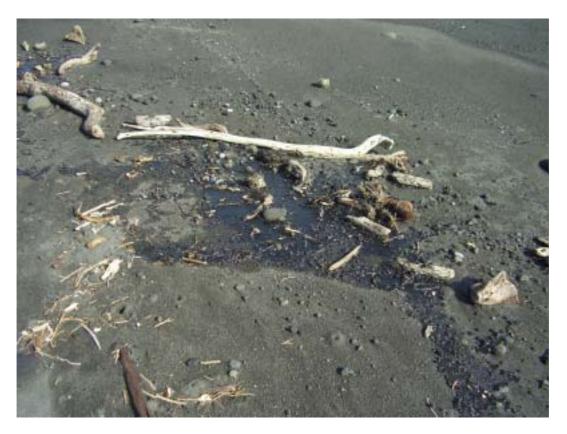
were taken. Aged tar balls were seen to be washed ashore and a significant amount of oil and tar balls were evident between the rocks.

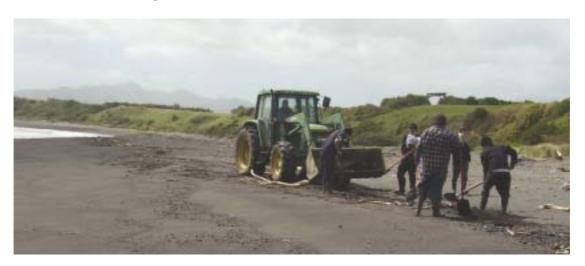
Photograph 4 – Clean up team on the beach

- 54. Bruce Pope and Bruce Colgan undertook a full inspection of the Komene Road and Kaihihi Road beach areas.
- 55. Oil was still evident on these beaches at the high tide mark.
- 56. At this stage AWE, had accepted responsibility for the spill and agreed to supply further personnel and equipment to carry out the manual clean-up operation on the beach and rocky shoreline areas under the supervision of Council staff. This occurred during that day and clean-up teams remained on the beach until 5 pm, supervised by Bruce Pope, Glen Candy, Bruce Colgan and Mike Nager.

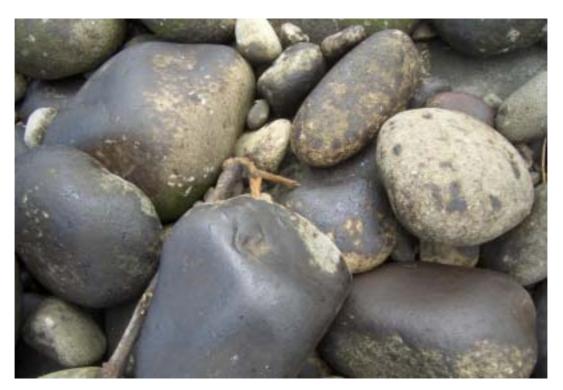
Photograph 5 – Oil on rocks Paora Road 7 November 2007

86. Bevan Chapman undertook an inspection of the beaches and rocky areas from Perth Road to Bayley Road. He found that small spots of oil continued to be present on the beach in the area of Perth Road. The Hampton Road beach area was clear of oil. At the Kaihihi Road beach AWE staff were found to be continuing with clean-up of the oiled areas. A waste skip was located at the end of the road. Oil staining on the beach was similar to that found at Perth Road. At Komene Road it was noted that the waste stock pile had been removed from the end of the road. An AWE clean-up crew was still operating in this area and staff outlined that oil was still coming ashore. Well aged tar balls were present; however there also appeared to be fresh oil deposited on the beach. The beach areas at the end of Paora and Rongomai roads were also checked. Surfers were noted off the end of Paora Road. Fresh deposits of tar balls were present on the beach in amongst the rocks. Inspection of the Bayley Road area and boat ramp found staining on rocks similar to that previously reported on Friday 2 November 2007.

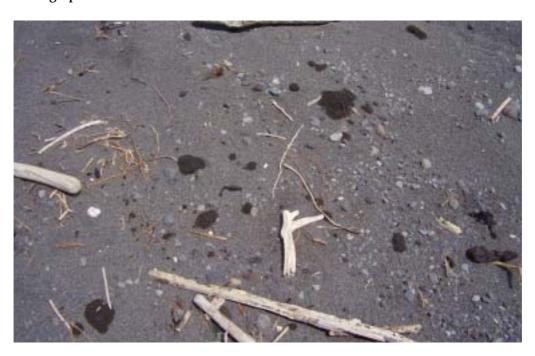
Photograph 6 – Oil still evident on Kaihihi Beach 28 December 2007

119. Bruce Pope inspected the beaches at the end of Komene and Kaihihi roads in the morning. Some oil was evident on Kaihihi Beach.

120. AWE personnel continued with clean-up operations on Kaihihi Beach.

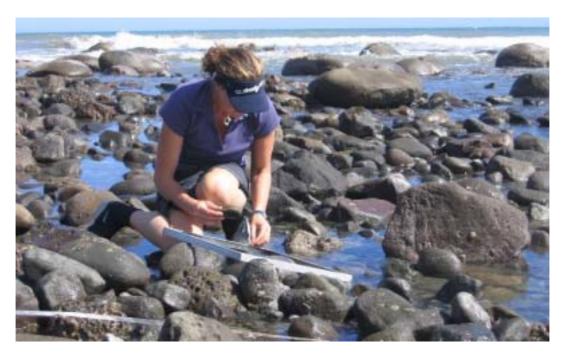
Photograph 8 – Water sampling

138. Kate Giles undertook water column sampling at Greenwood Road (control), Kaihihi Beach, Komene Beach, the end of Paora and Manihi roads (controls). Results showed there were no elevated levels of hydrocarbons.
