Patea Freezing Works Tank Removal

1.0 Introduction

Taranaki Regional Council (TRC) engaged Pattle Delamore Partners Limited (PDP) to carry out an environmental site assessment during the removal of two petroleum underground storage tanks (USTs) and at the location of a previously removed petroleum UST at the former Patea Freezing Works (the 'site'). The assessment has been carried out to describe the extent of any petroleum impacts to soil in the vicinity of the former Underground Petroleum Storage Systems (UPSS), and to provide an assessment of the possible environmental effects of any residual petroleum hydrocarbons.

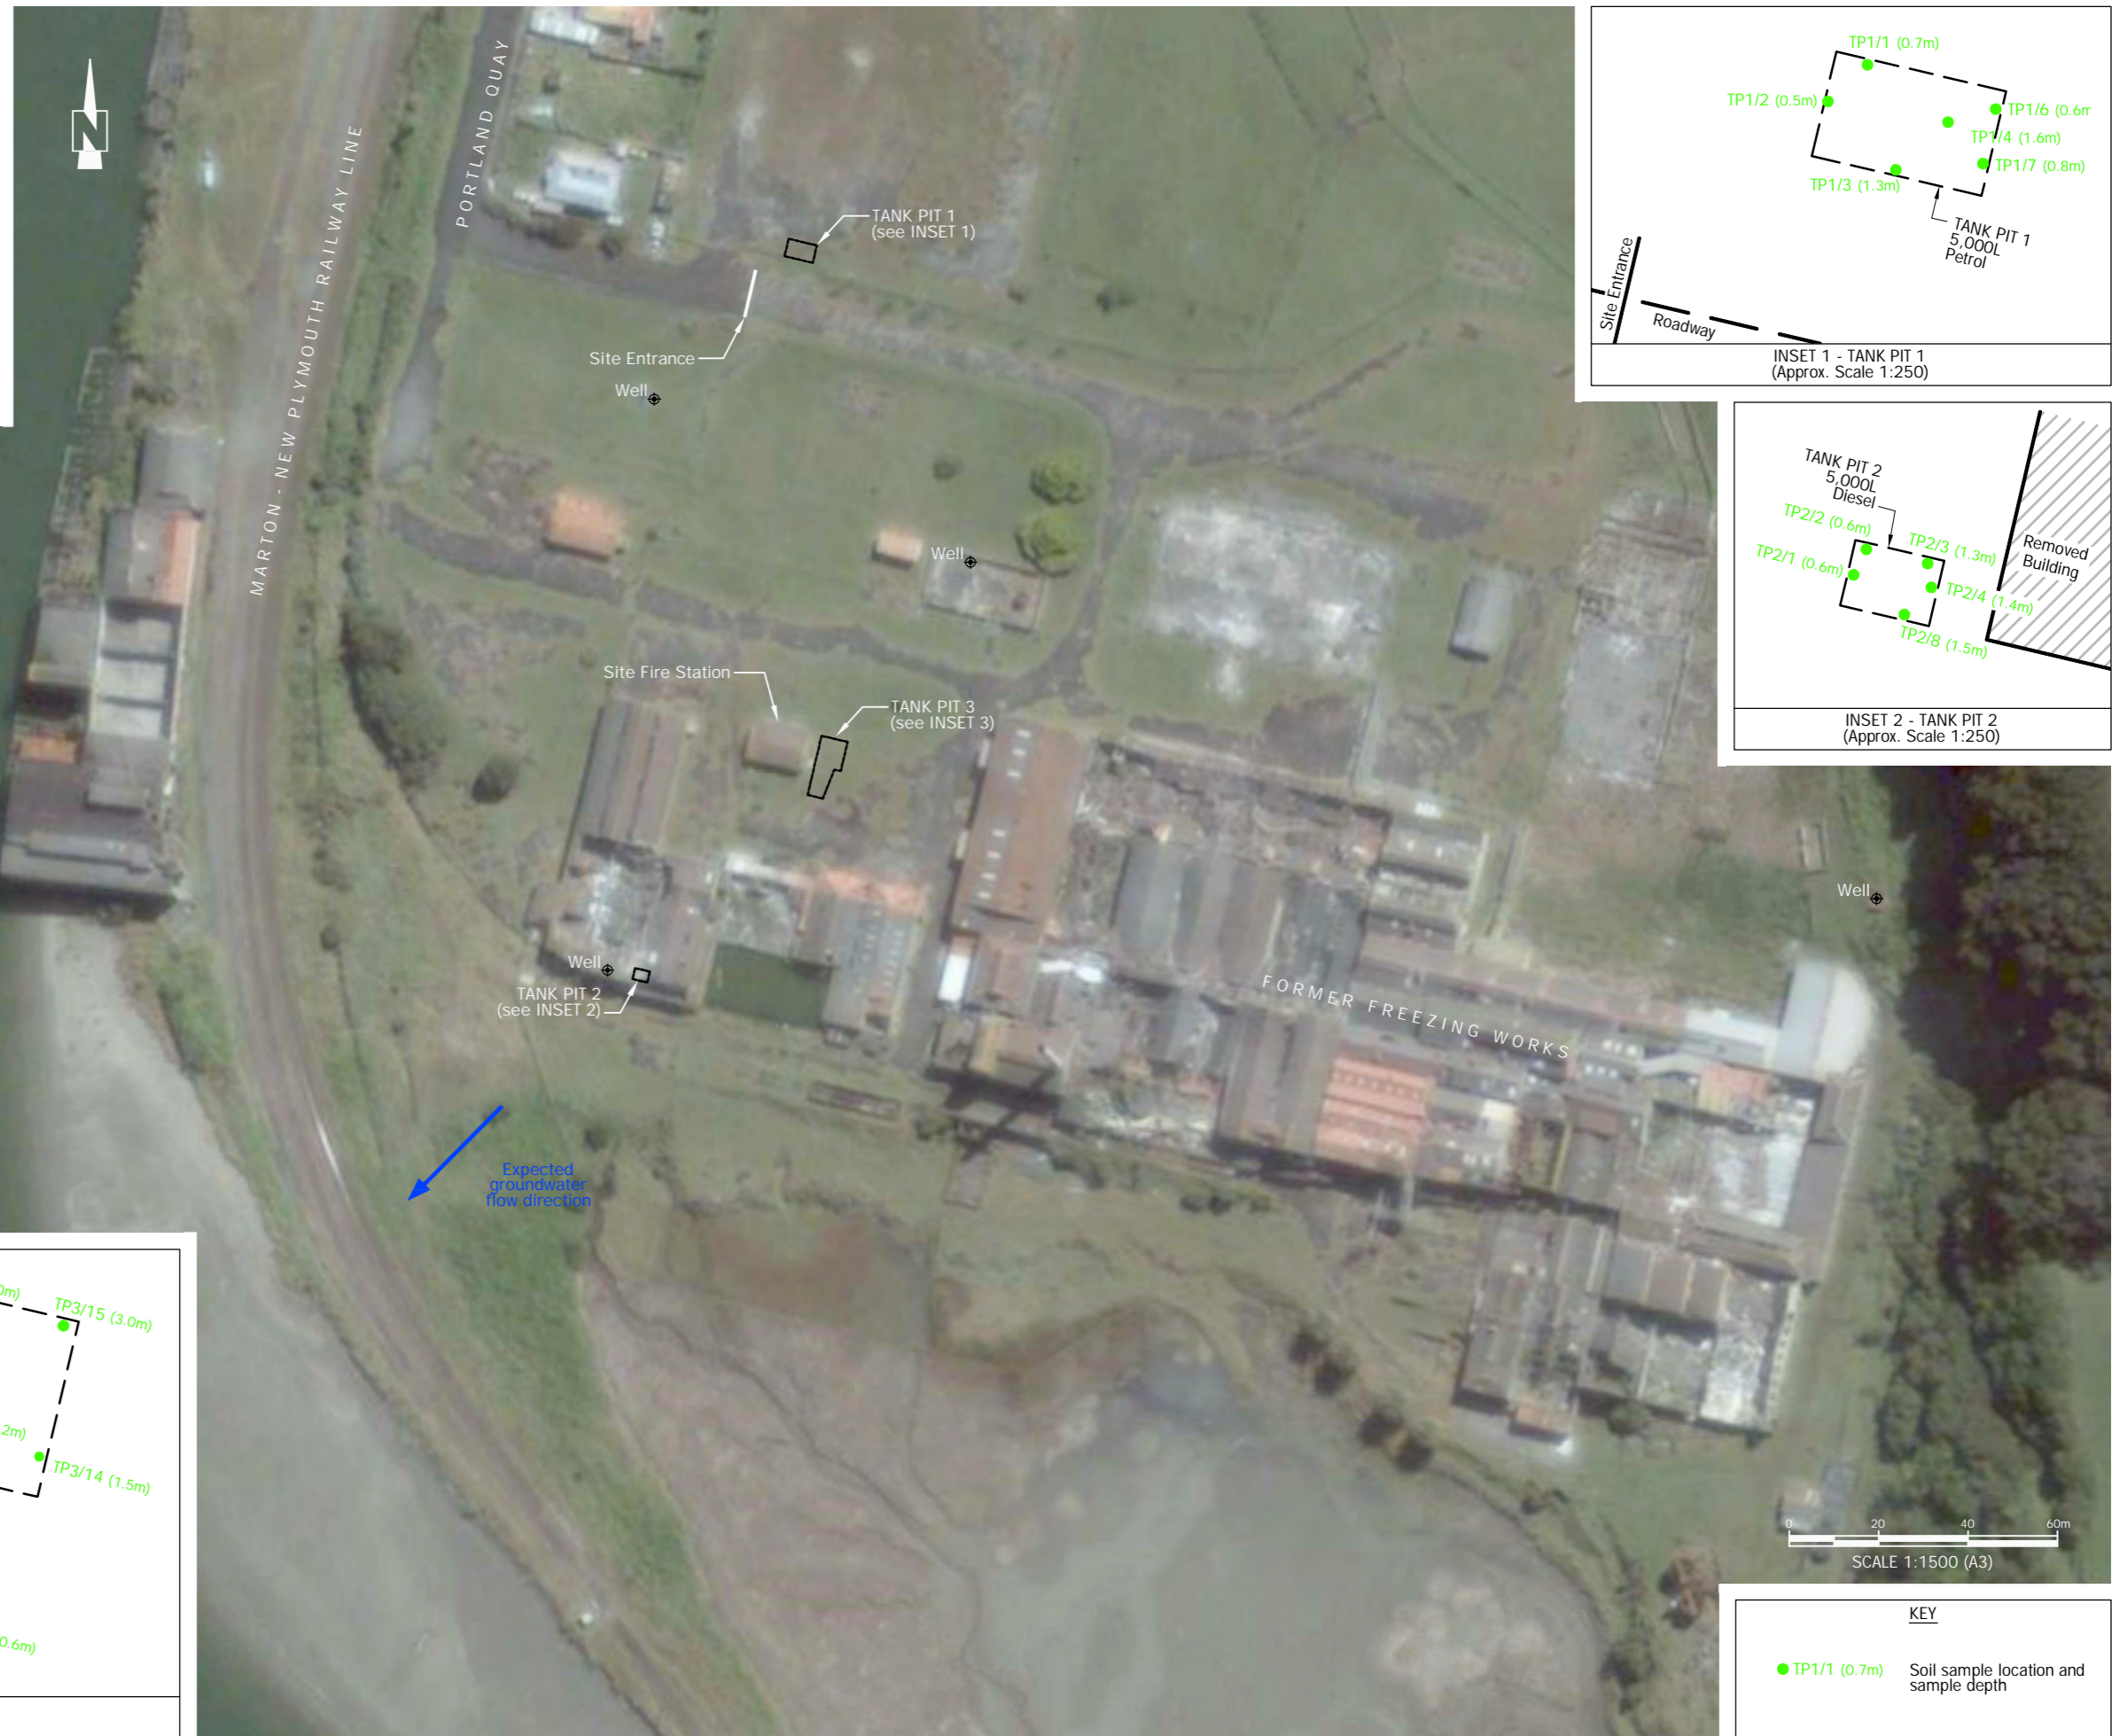
Figure 1 : SITE PLAN

The site is located at the southern end of Portland Quay, approximately 1 km south-east of Patea town centre (Figure 1). The former freezing works occupying the site has been derelict for a number of years. The overall site boundary is not clearly defined, either legally or physically. The site is located on relatively flat ground. The majority of buildings associated with the freezing works were located along the southern edge of the site. A large fire at the site on 6 February 2008 destroyed many of the buildings, although the USTs were not directly affected by the fire.

Historic site plans indicated that there were three USTs on the site (see Figure 1 for approximately locations): Tank 1 was located adjacent to the site entrance next to the gatehouse and was suspected to be a petrol tank; Tank 2 was a diesel tank located adjacent to an internal railway track, leading from the site to the main railway, and was used to supply a shunting engine; and Tank 3 was a petrol tank located next to the on-site fire station.

The 5,000 L steel tank was removed from an unlined tank pit which was excavated to a depth of 1.7 m below ground level (bgl). Figure 1 shows the location and layout of the tank pit. The tank pit was approximately 6.5 m in length and 4 m wide. The area surrounding the tank pit was grassed and there were no pipes, dispensers, fill points or vents remaining in the vicinity of the tank pit. The geology observed in the tank pit consisted of grey fine sand extending to a depth of at least 1.4m. In the southern end of the tank pit, the sand was underlain by grey clay from 1.4 m depth to the base of the pit. The clay was not present in the northern part of the tank pit, where the fine sand extended to the base of the tank pit. Following the removal of the tank, groundwater was observed at a depth of approximately 1.6 m bgl. A detailed geological log and photos of the tank pit are appended.

Samples were taken from the walls and floor of the tank pit at depths between 0.5 and 1.6 m below ground level. The sampling locations are shown in Inset 1 on Figure 1. Portions of each sample were also screened in the field for

The soil was stockpiled immediately to the east of Tank Pit 3 (see Figure 1). Under the supervision of TRC, the soil was placed in windrows and, over a period of two weeks, occasionally turned over with an excavator. On 31 March 2008, TRC collected 20 soil samples from the stockpile. The samples were composited into a single sample and

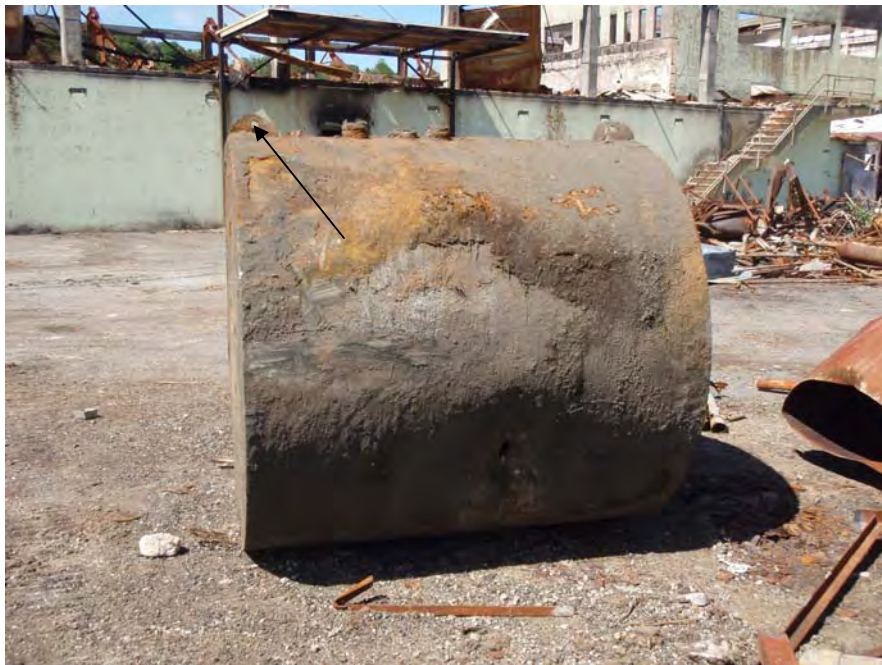
Photograph 2: Tank 1, 5000 L Diesel tank

5,000 L, suspected to be petrol, direct fill, steel UST. The tank, estimated at over 40 years old, was in good condition with moderate rust and minor pitting. No holes were observed in the tank (Photograph 2).

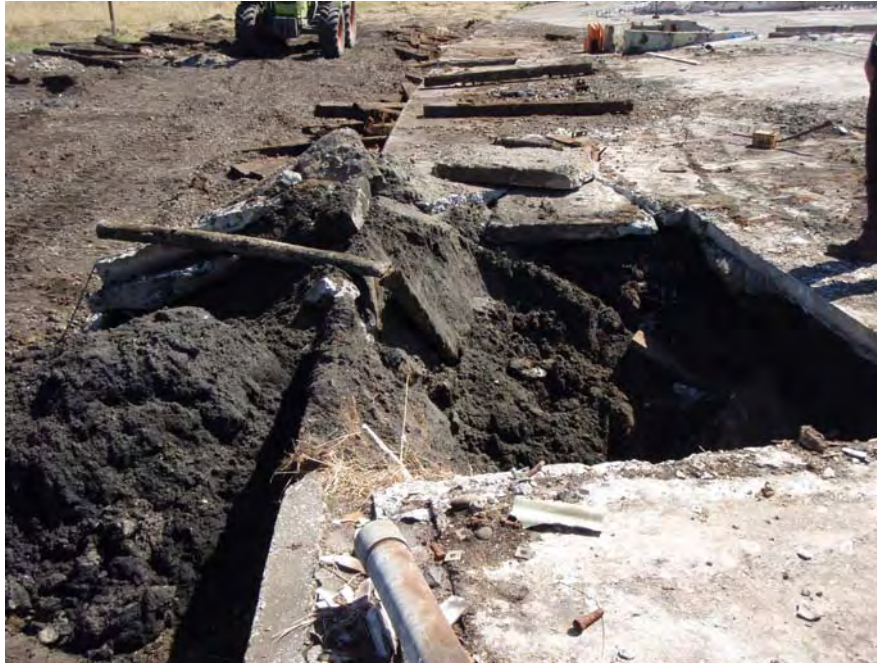
Photograph 3: Tank pit 2.

The 5000 L steel tank was removed from an unlined pit which was excavated to a depth of approximately 1.6 m. A concrete wall that was part of a railway platform formed the western wall for the tank pit (Photograph 3). The tank was under a 300mm reinforced concrete slab, which was broken out prior to the tank removal.

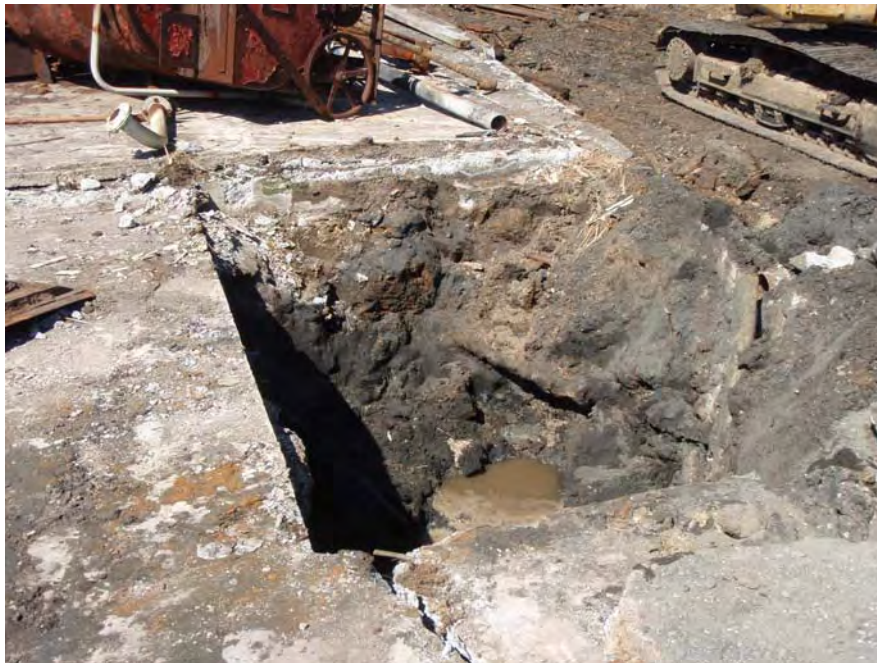
The geology observed in the tank pit appeared to be fill consisting of reworked natural sand and clay. Following the removal of the tank, groundwater was observed at a depth of approximately 1.5 m. A detailed geological log and photos of the tank pit are appended.

Photograph 4: Tank pit 2. Groundwater can be seen in base of tank pit.

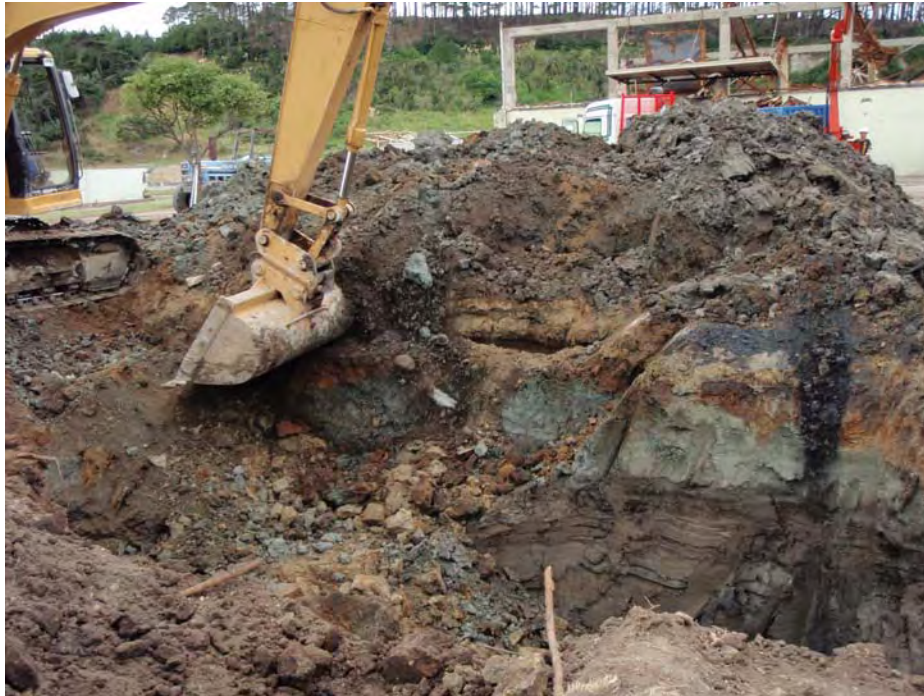
Photograph 5: Tank pit 3.

Tank 3 was located next to the former site fire station, which was demolished as part of the site clean-up operations after the fire. A large test pit was excavated in the area where the tank was thought to be located. Figure 1 shows the location and layout of the tank pit. The pit was approximately 13 m in length varied in width between 3.5 and 6 m, with a maximum depth of approximately 4 m. The geology encountered consisted of sand and sandy gravel to a depth of 0.5 m, below which a layer of firm clay extended to the base of the excavation. No tank was discovered, although there was metal scraps in the soil that indicated fill and there was evidence of petroleum hydrocarbon impacts with strong odours and elevated PID readings. It is assumed that the UST had been removed prior to this investigation. The potentially impacted material was placed in a temporary stockpile for further testing (see Section 3.3.5 below). The excavation was extended until the odour and PID readings were significantly reduced.

Minor groundwater seeps in the clay were observed at around 1.8 m bgl in the test pit, although no groundwater was observed in the base of the pit. The test pit was excavated to a depth of 4 m bgl and no groundwater, other than minor inflows was observed. Given the low permeability of the strata, it is possible that the groundwater table is present at a depth of less than 4 m but was not evident during the investigation due to low inflow rates.
