8 March 2024
Job No: 1017346.3000

Weld Road Pathway and Ahu Ahu Bridge Taranaki Regional Council Section 92 response (23-11174-1.0)

Penguin Management Plan for Weld Road

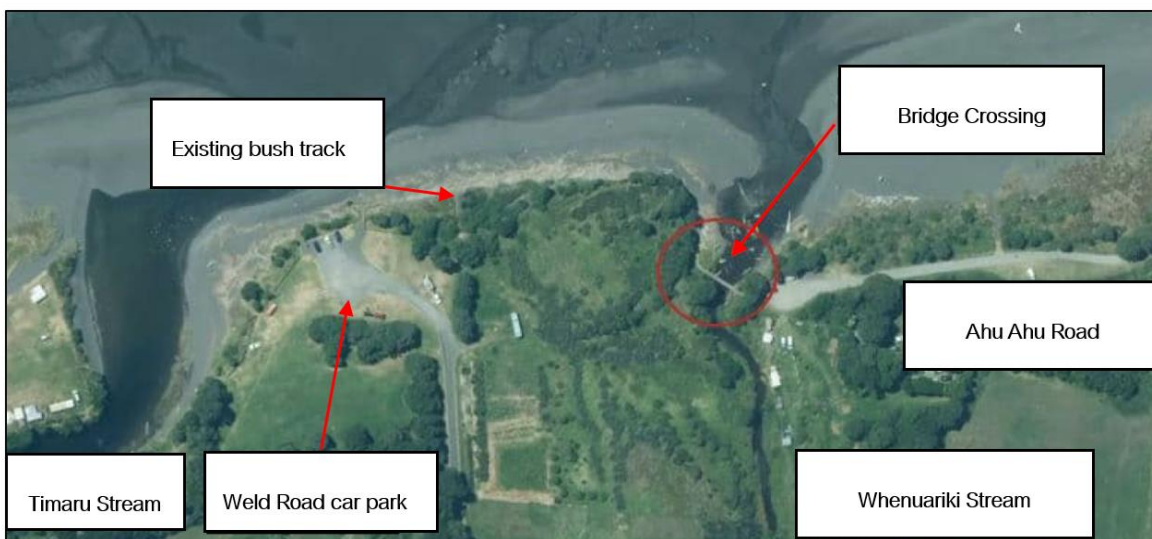
Figure 1.3: Bridge replacement location and surround areas.

The replacement bridge (outlined as 'bridge crossing' in Figure 1.3) will connect the Ahu Ahu road carpark area with the reposed coastal rock revetment pathway on the western side of the Whenuariki Stream, leading to the Weld Road car park (Figure 1.3).

Finalised detailed design and construction methodologies will be confirmed by a bridge specialist company closer to the time of construction. Current preliminary concept plans for the bridge replacement (provided by WSP to NPDC) propose increasing bridge length to approximately 21 m in length and allowing the east abutment to be relocated 1.5 m east of the original bridge. The abutment of the bridge is proposed to be raised approximately 0.7 m at the abutments. The new bridge deck will be flat while the original bridge had sagged of up to 0.8 m, therefore, the deck in the middle of the replacement bridge may be up to 1.5 m higher than the original.

To tie the replacement bridge into the Ahu Ahu carpark on the eastern side and coastal pathway on the western side, it has been recommended that the approach ramp be approximately 10 m (east) and 19 m (west).

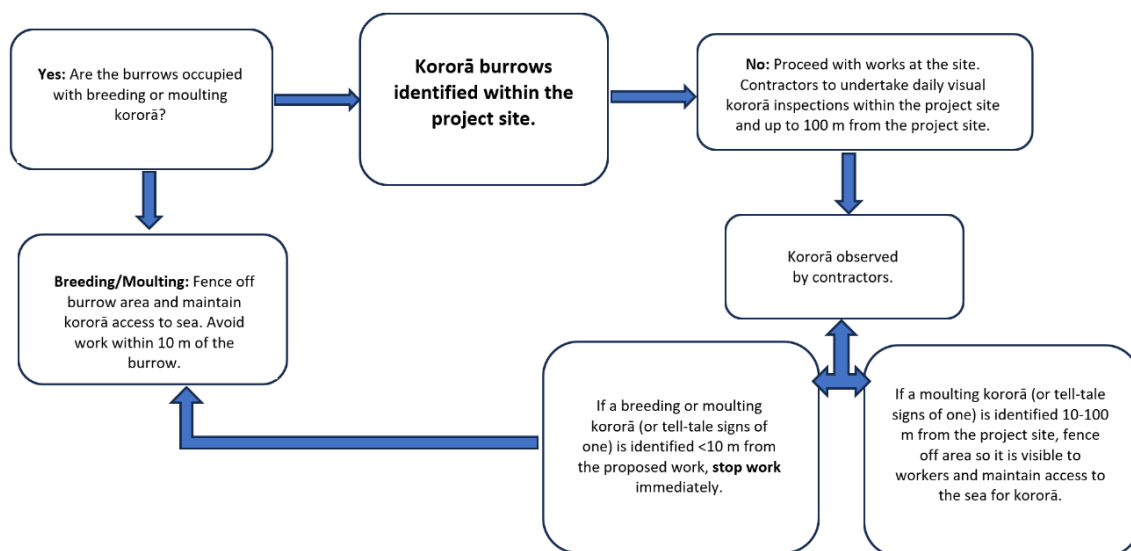
Figure 2.2: Process diagram for kororā management and mitigation of effects on kororā within the construction area.

Figure 2.2 below outlines a process diagram that will govern the overall decisions and the process to be followed to manage any identified kororā. The management actions consider the key dates and management periods for kororā as outlined in Section 2.2.5.

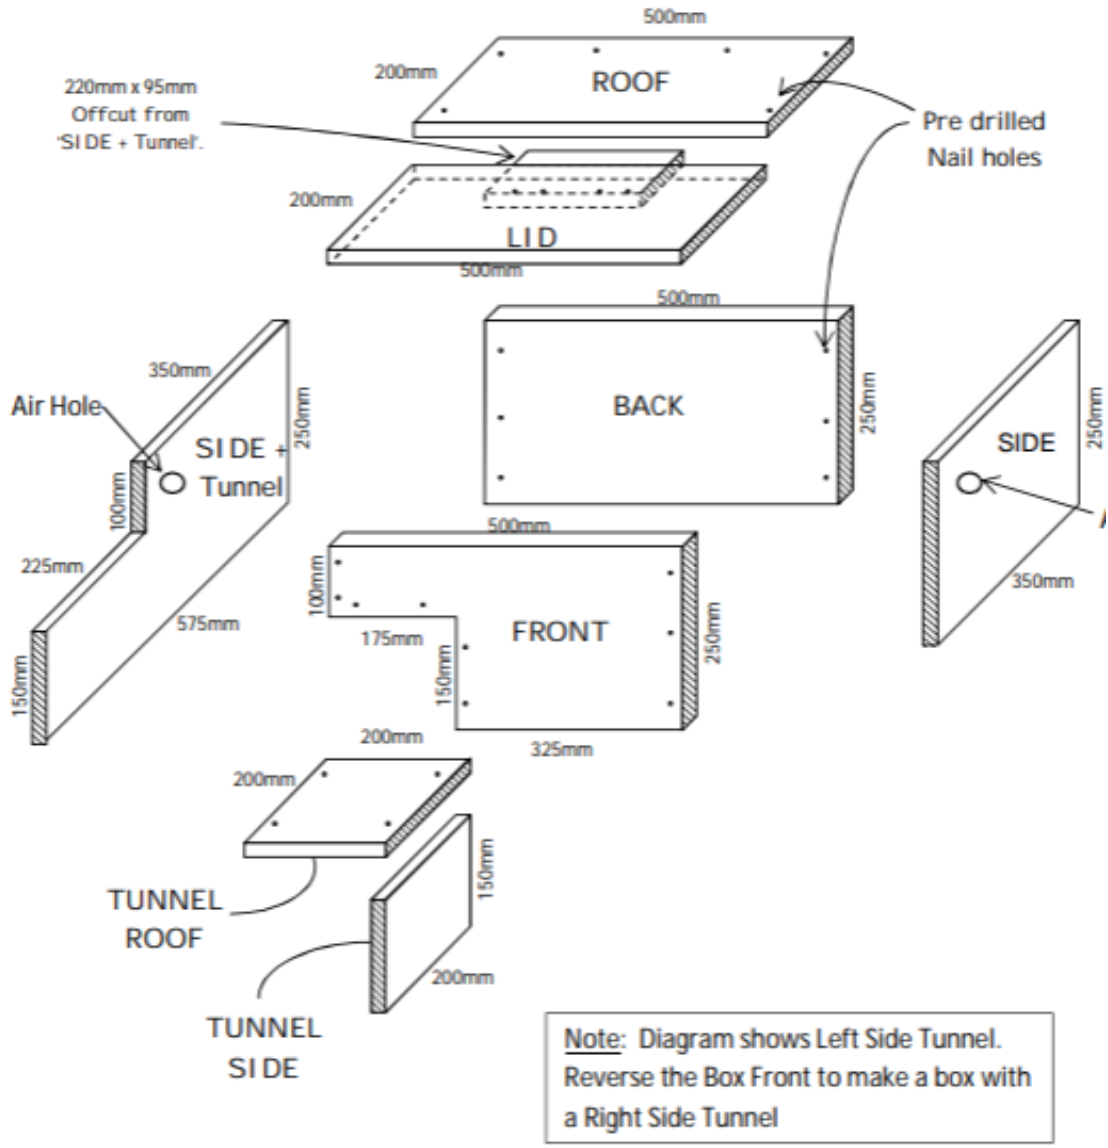
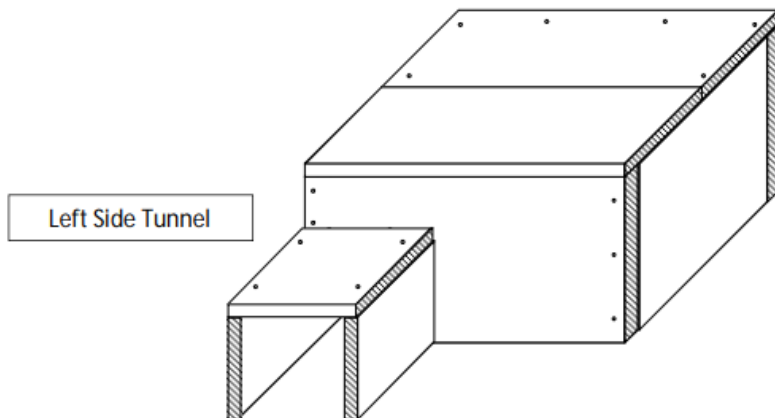
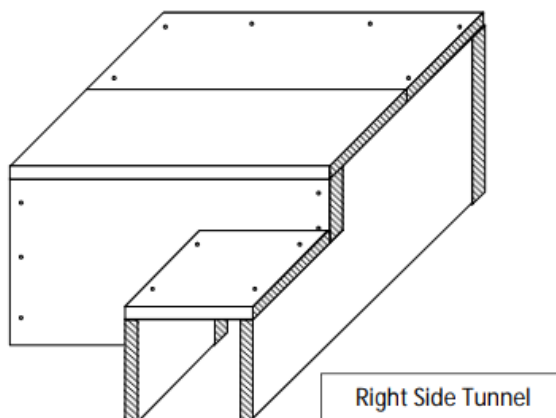
Little Penguin Nest Box

ALL TIMBER: 25mm thickness. H3 Treated. Rough sawn. Pinus Radiata.	
ROOF	500mm x 200mm
LID	500mm x 200mm
FRONT	500mm x 250mm
BACK	500mm x 250mm
SIDE	350mm x 250mm
SIDE - Tunnel	575mm x 250mm
TUNNEL ROOF	200mm x 200mm
TUNNEL SIDE	200mm x 150mm

TIMBER REQUIREMENTS:		
	Timber for 1 Box:	Timber for 30 boxes:
250mm x 25mm	2025mm	60.75 meters
200mm x 25mm	1300mm	39.00 meters
150mm x 25mm	220mm	06.60 meters

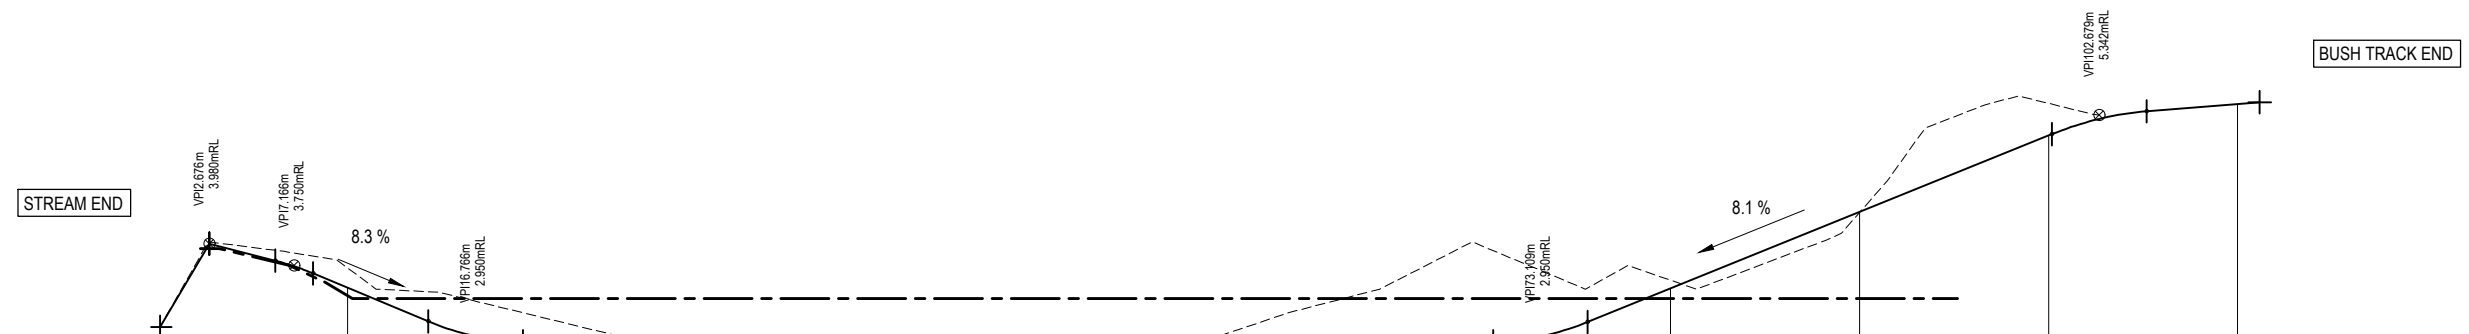
1. ALL DIMENSIONS IN METRES UNLESS NOTED OTHERWISE.
2. EXISTING GROUND SURFACE PROVIDED BY WSP (RECEIVED 27/03/2023).
3. HEIGHTS ARE IN TERMS OF NZVD2016.

2023 SURVEYED RL (m)		3.72	3.21	2.95	1.0	2.51	3.26	3.95	3.59	4.31	5.47	
ROCK CREST RL (m)		3.43	3.40	3.40	3.40	3.40	3.40	3.40	3.40	3.40	3.40	
FINISHED PATH RL (m)		3.51	2.95	2.95	2.95	2.95	2.95	2.95	3.51	4.32	5.12	5.46
CHAINAGE (m)	0.00	10.00	20.00	30.00	40.00	50.00	60.00	70.00	80.00	90.00	100.00	110.00

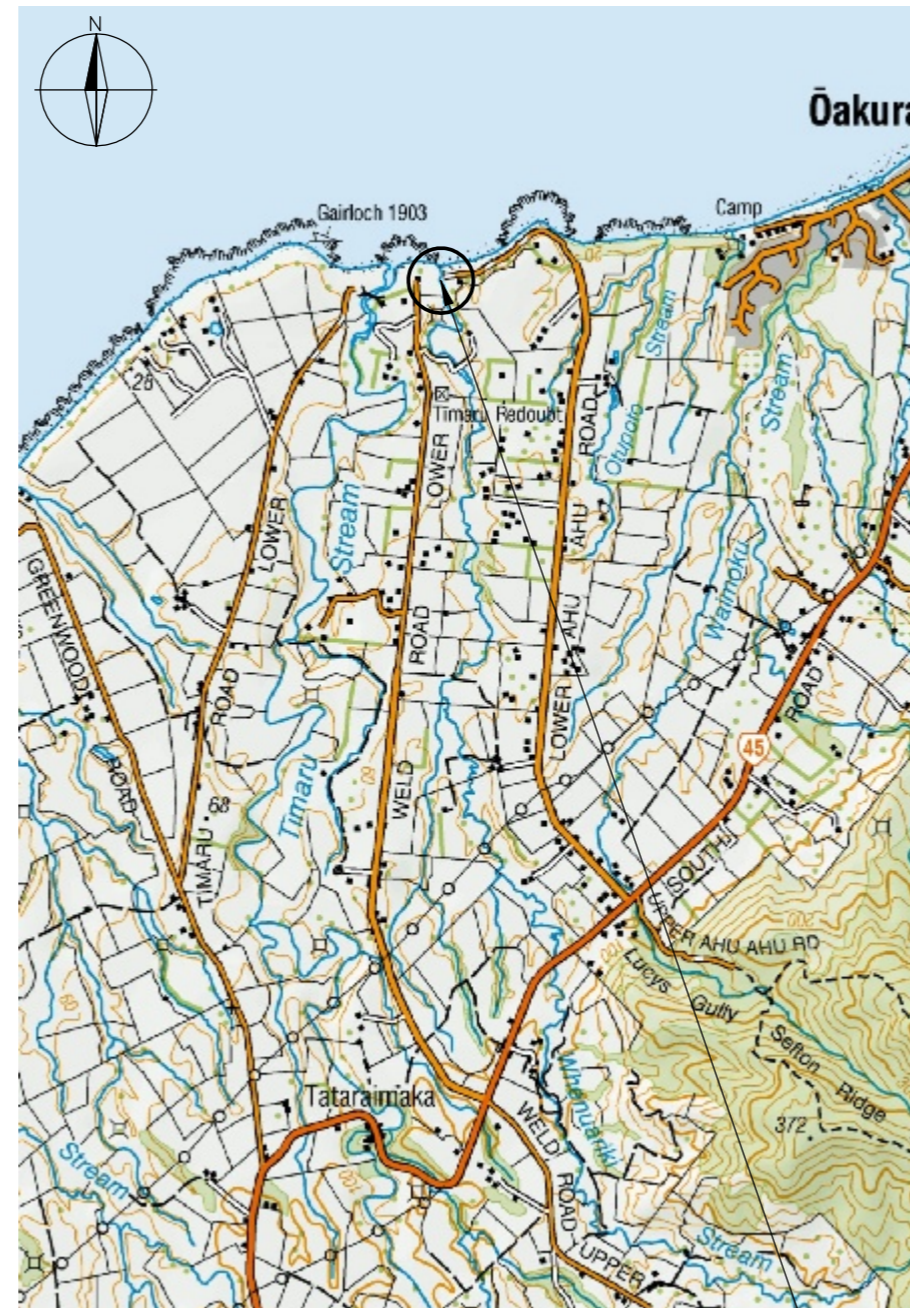
20.9m Suspension bridge

DESIGN PARAMETERS	
Standard	SNZ HB 8630:2004
User Group	2. Short Stop Traveller
Deck Length	20.9m
Deck Design Load	10 Person
Fall Surface	Favourable
Effective Fall Height	~3m
Barrier Type	A
Load Test	TBC

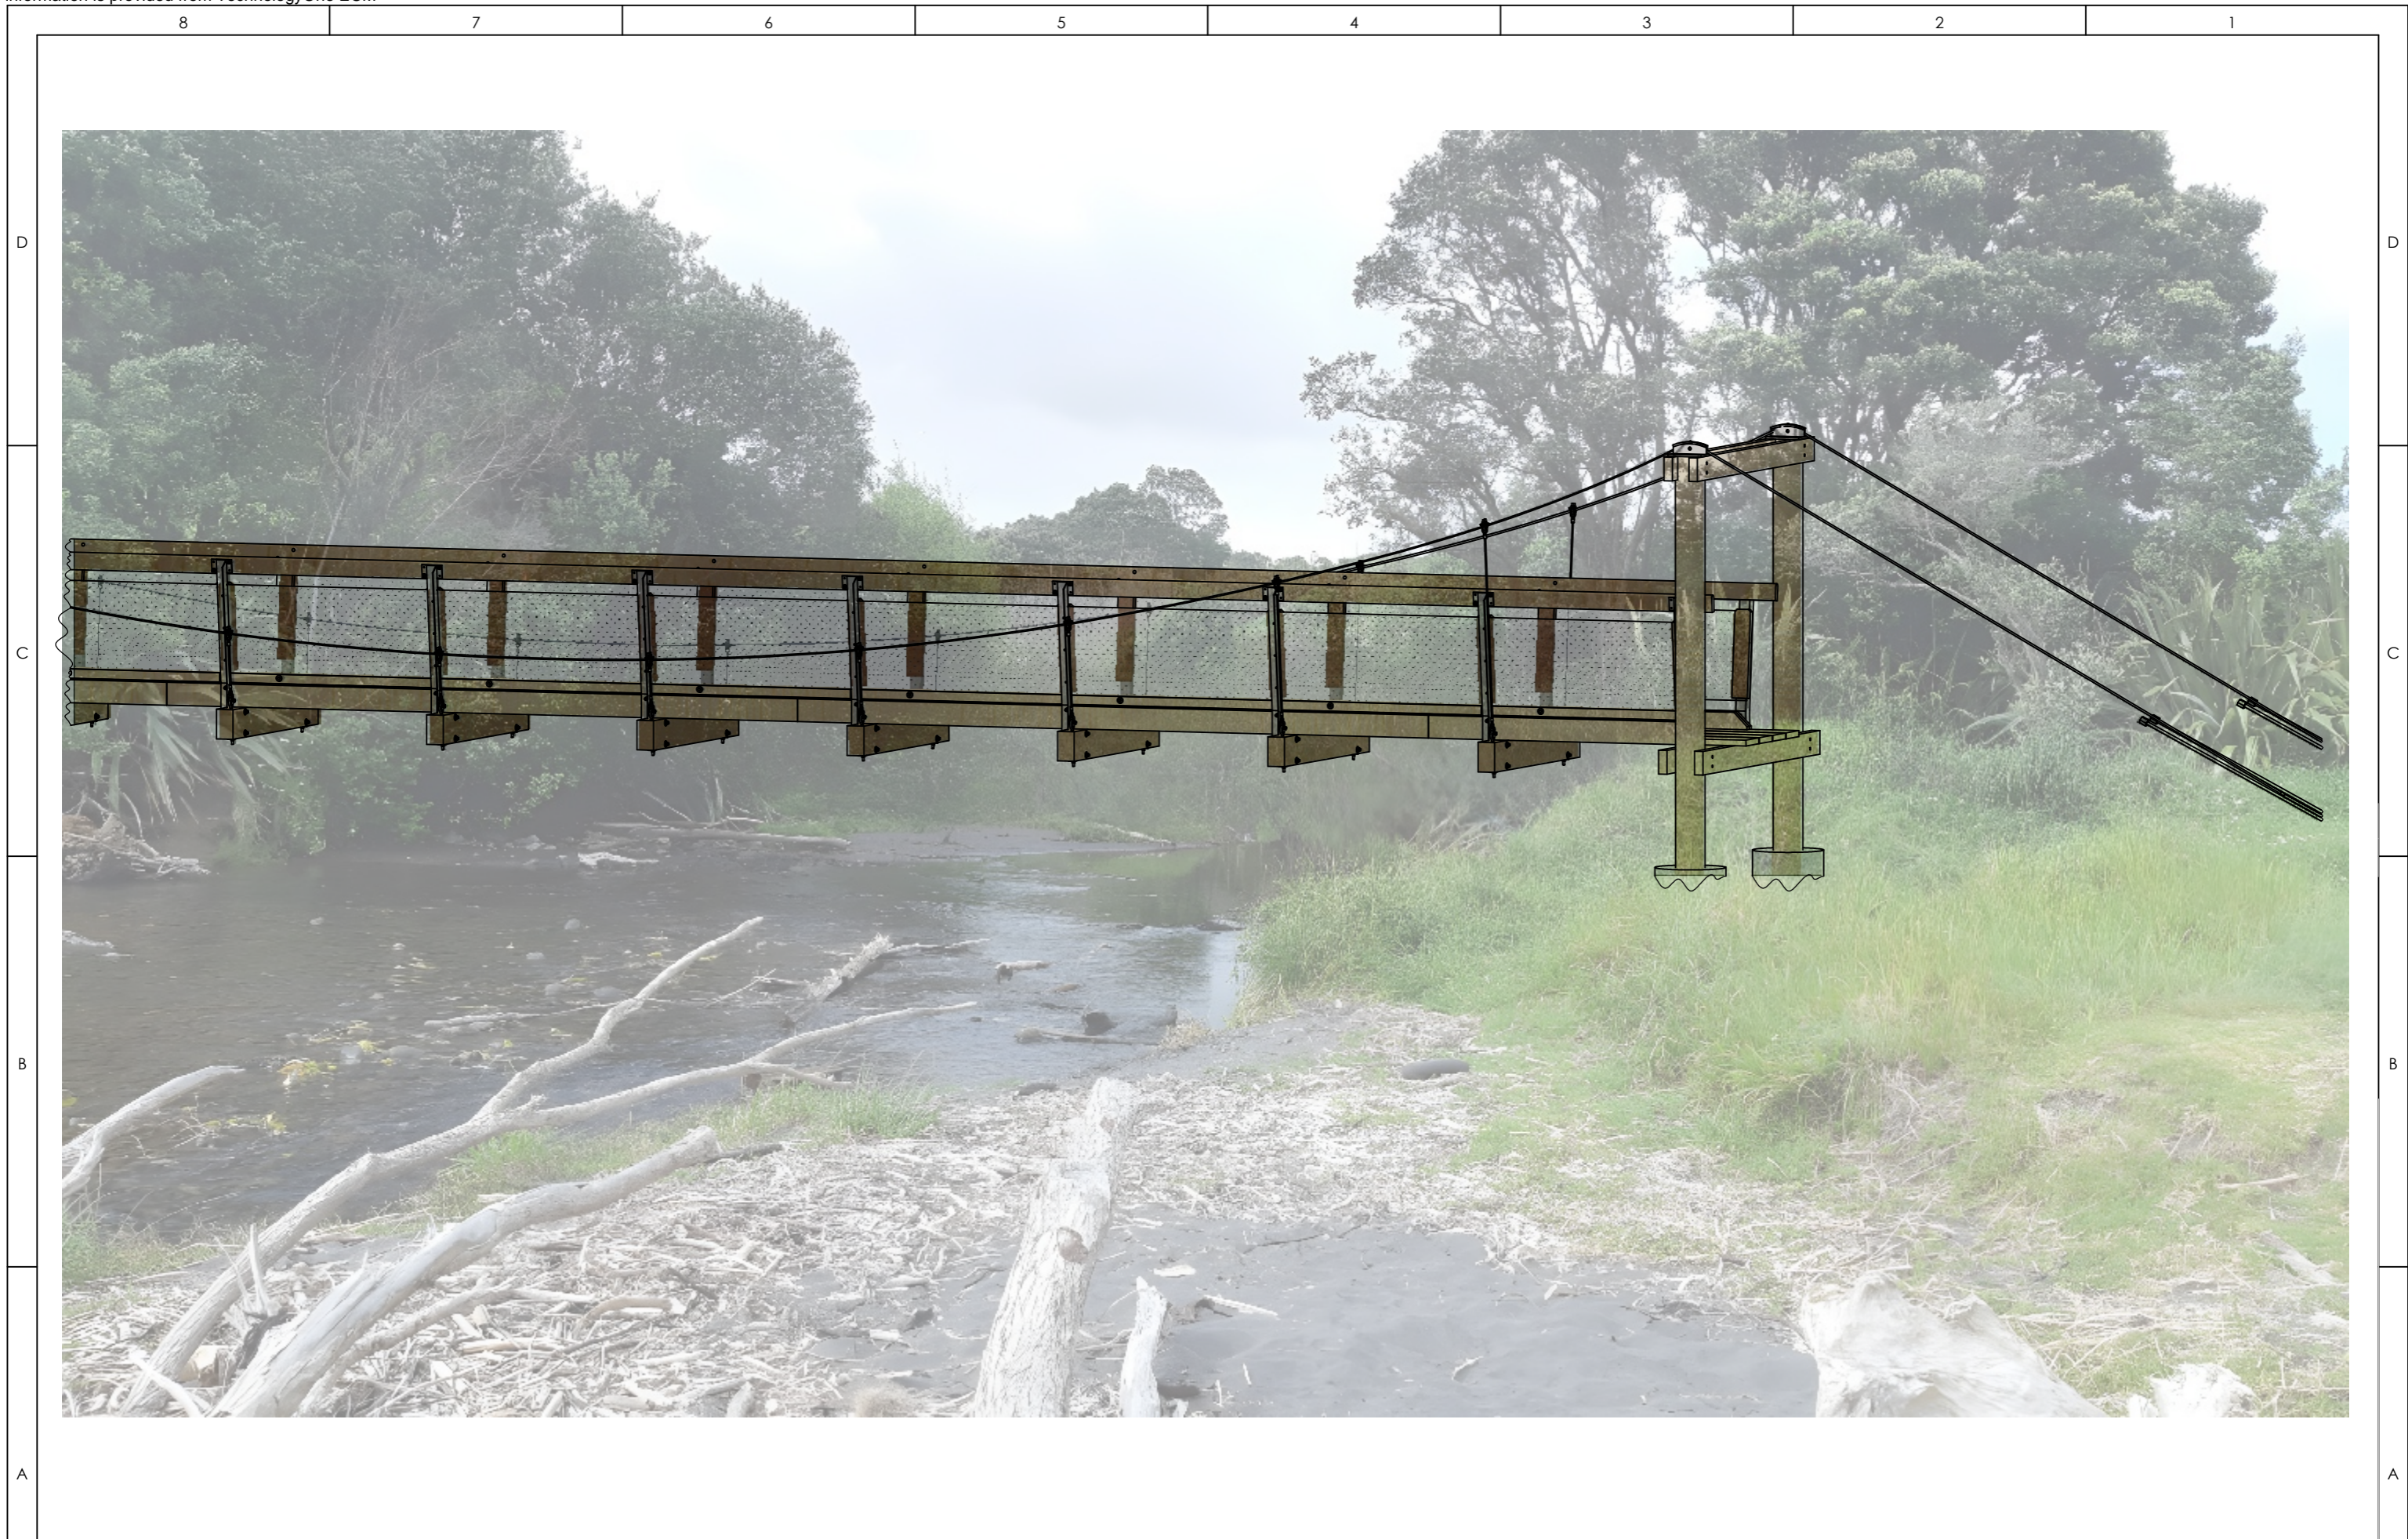
Sheet Title	Concept Drawing Set
	Concept Render 1 (TL)
