Remediation New Zealand Ltd

Uruti composting facility

Monitoring Programme

Technical Report 2023-05

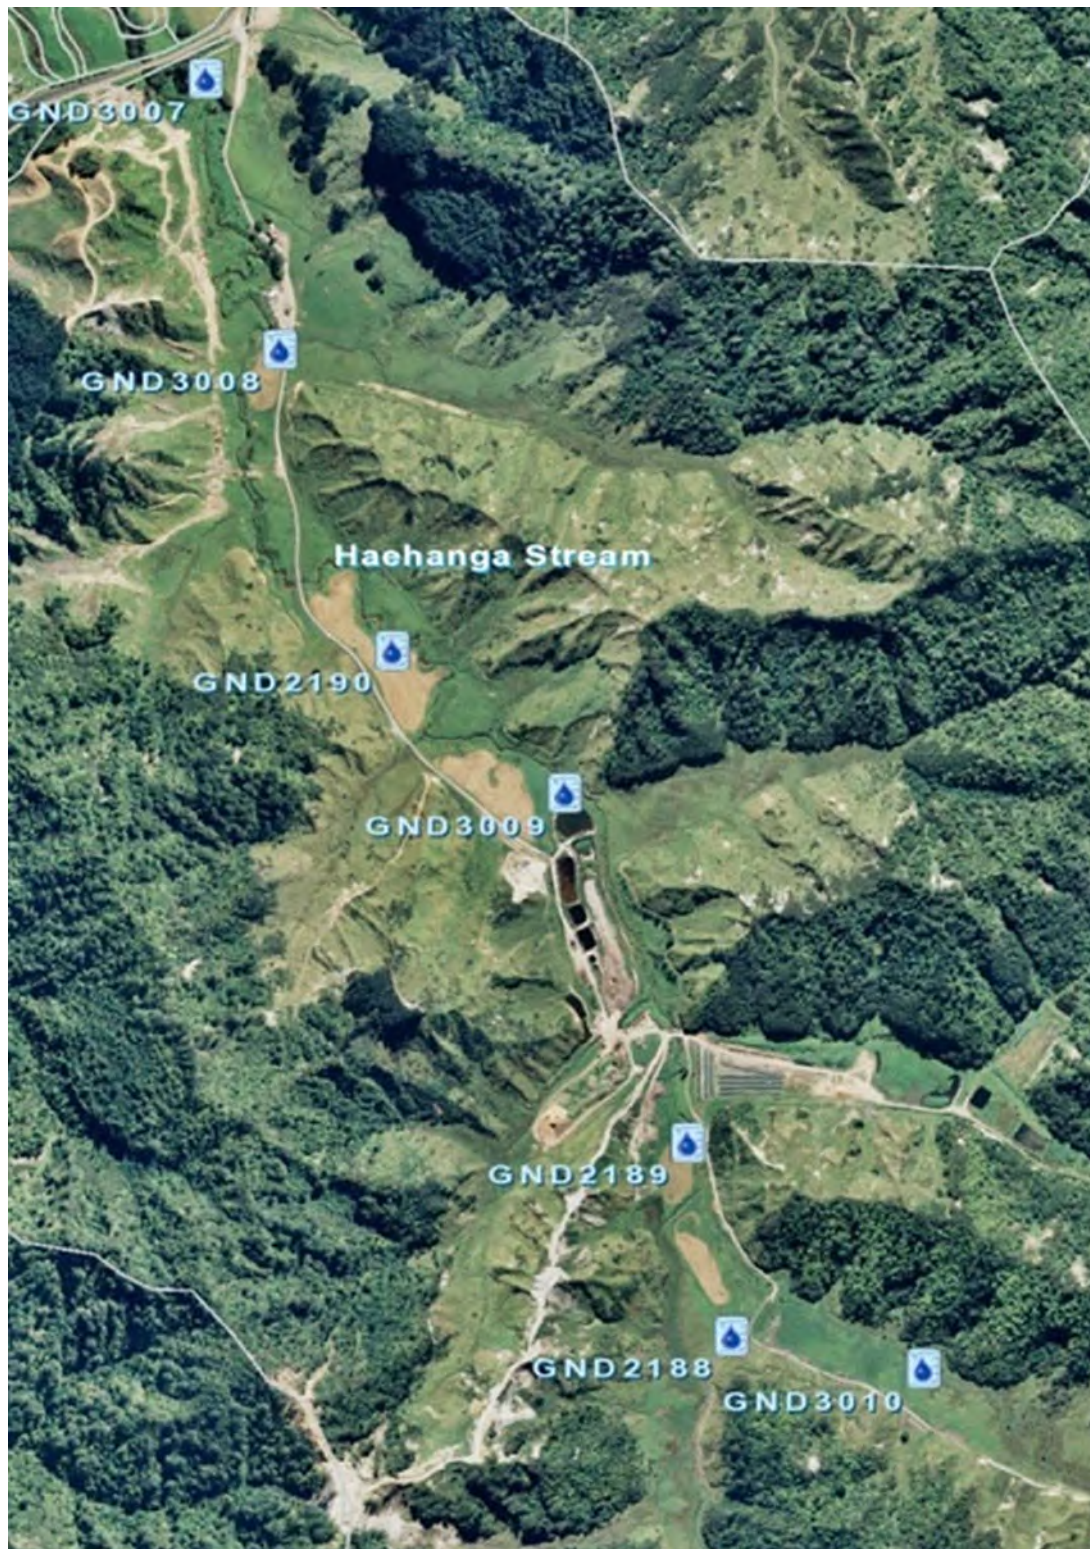
Figure 8 Locations of groundwater monitoring wells RNZ Uruti

The irrigation records provided by RNZ indicate that prior to the second Council survey undertaken across the period 1-6 June 2023, irrigation areas L2, L3, L4, and L6 had received light to moderate loadings of irrigation wastewater. In particular, on 31 May, 48 m³ had been applied to each of the four areas. Groundwater quality beneath L2 is monitored by GND2190; L3 by GND 3009; and L6 by GND3008.

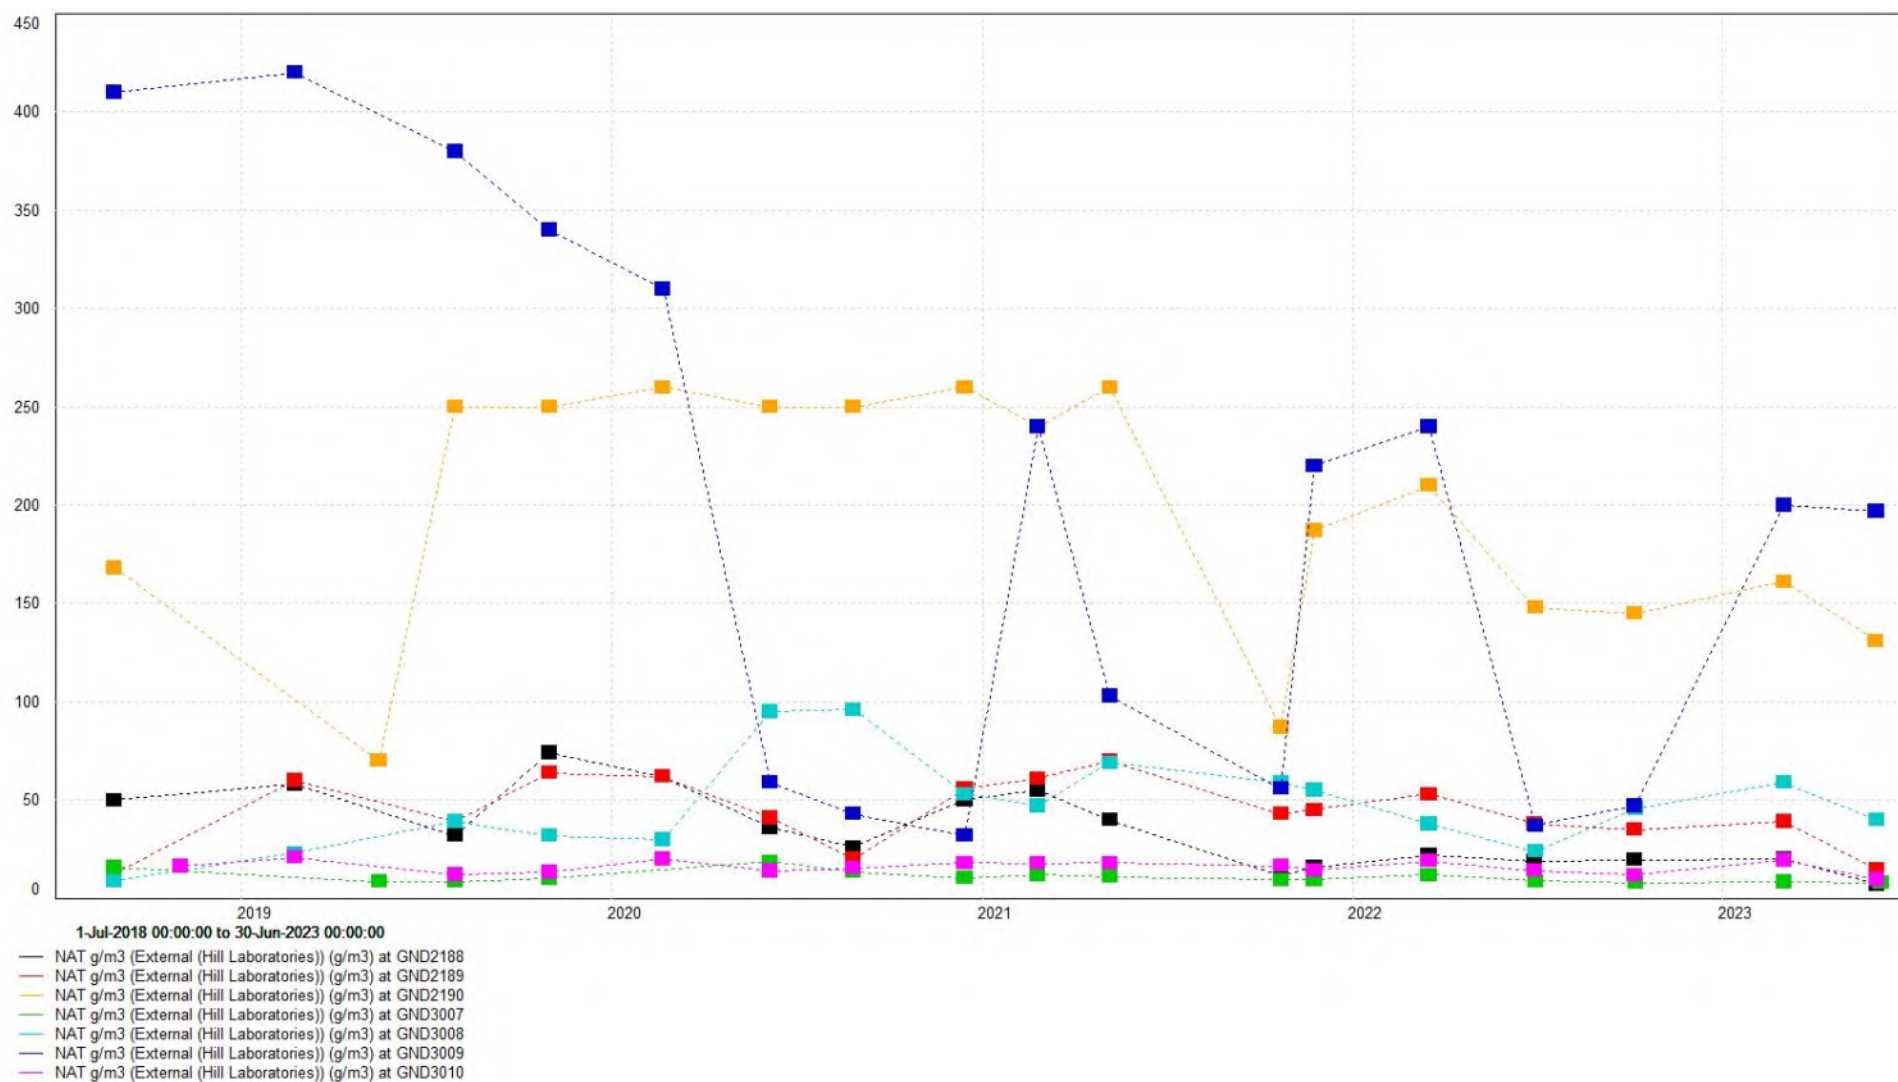
Figure 10 Total ionic sodium concentrations in groundwater 2018-2023

The conductivity graph is displaying an overall general decrease in concentration across all bores from 2011–2022. Bores GND3008 and GND3009 appeared to increase slightly during 2020 to late 2021, but appear to be reducing slowly since then.

For conductivity, the highest readings have been in bores GND2190 (irrigation area L2), GND3008, and GND3009. Readings in all these bores have been reducing over the past 4 years. In the 2022-2023 year, bore GND 3009 had by far the highest readings. Readings of conductivity in groundwater under the upper irrigation areas are relatively low, although still double or more the conductivity found in GND3007, the roadside bore.
