# Remediation New Zealand Ltd

Uruti and Waitara Road  
Monitoring Programme  
Annual Report  
2019-2020

Technical Report 2020-84

ISSN: 1178-1467 (Online)  
Document: 2481806 (Word)  
Document: 2618686 (Pdf)  
July 2021

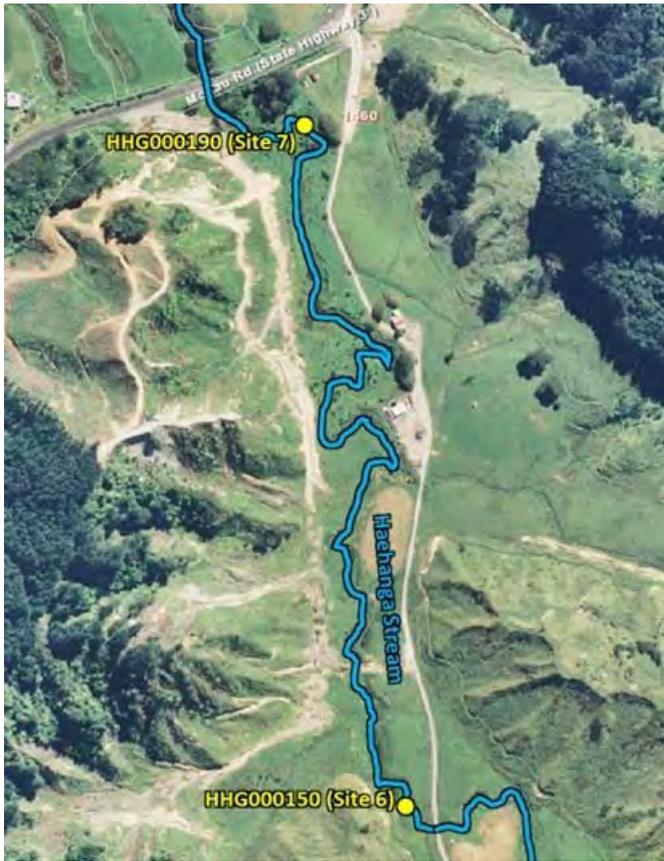
Figure 18 Map of lower biomonitors sites on the Haehanga Stream

The macroinvertebrate survey conducted on January 2020 observed flows in the Haehanga catchment to be very low, with no discernible flow at some sites. The water had a yellow tannin colouration at the head of the catchment, deteriorating to brown and cloudy at the most downstream site. The habitat limitation caused by the low flows resulted in reduced community richness at all sites.

Overall, this survey found that macroinvertebrate communities of the main stem sites were slightly below average health. Undesirable heterotrophic growths were not recorded at any of the seven sites in this survey.

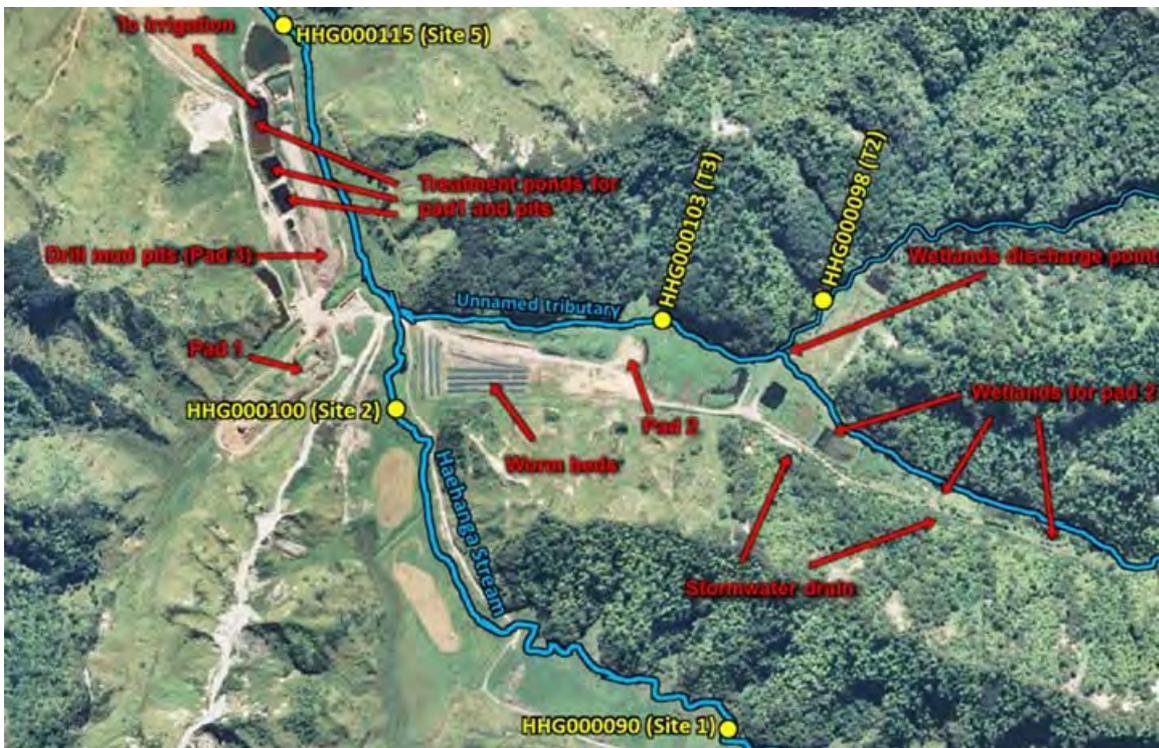
Figure 19 Map of upper biomonitors sites on the Haehanga Stream and associated unnamed tributaries

Site 1 (Figure 19) had exhibited consistently low macroinvertebrate health scores, as predicted, due to the poor habitat quality in the upper reach of the stream. This section of the stream is not fenced off from livestock and has been poorly managed. It is worth noting that the control site has been compromised multiple times in the past by major earthworks, new consented activities, and livestock damage. Because of this, the control site had been moved upstream to a highly variable site with poor macroinvertebrate habitat quality.

All sites in the main stem Haehanga lack bed shading during most of the day. This causes water temperature to rise up to 28°C in the summer, which is outside the thermal preference and, in some cases, tolerance of many stream dwelling species. Unshaded streambeds also promote algal and periphyton growths which were reported as abundant in the previous survey. Site T2 in the unnamed tributary historically has the highest macroinvertebrate health scores and has a mostly shaded bed with much lower temperatures in the Spring, Summer, and Autumn months compared to site 1 (Figure 19). The increased temperature and increased algal growth reported in previous reports is likely contributing to the negative trend in the macroinvertebrate community over the past few surveys.

It is recommended that the Company undertake actions to improve the habitat quality of the stream to match that of the upstream site T2 and T3. This could involve better maintenance of the riparian margin, through stock exclusion from all parts of the Haehanga Stream within the property, and additional riparian planting. These actions will help reduce the temperature of the stream to a reasonable level of seasonal variation to better support aquatic ecosystems. This may also help to reduce the amount of sedimentation that occurs at the lower sites and potentially reduce proliferation of periphyton.
