Remediation New Zealand Ltd

Uruti composting facility

Monitoring Programme

Technical Report 2021-81

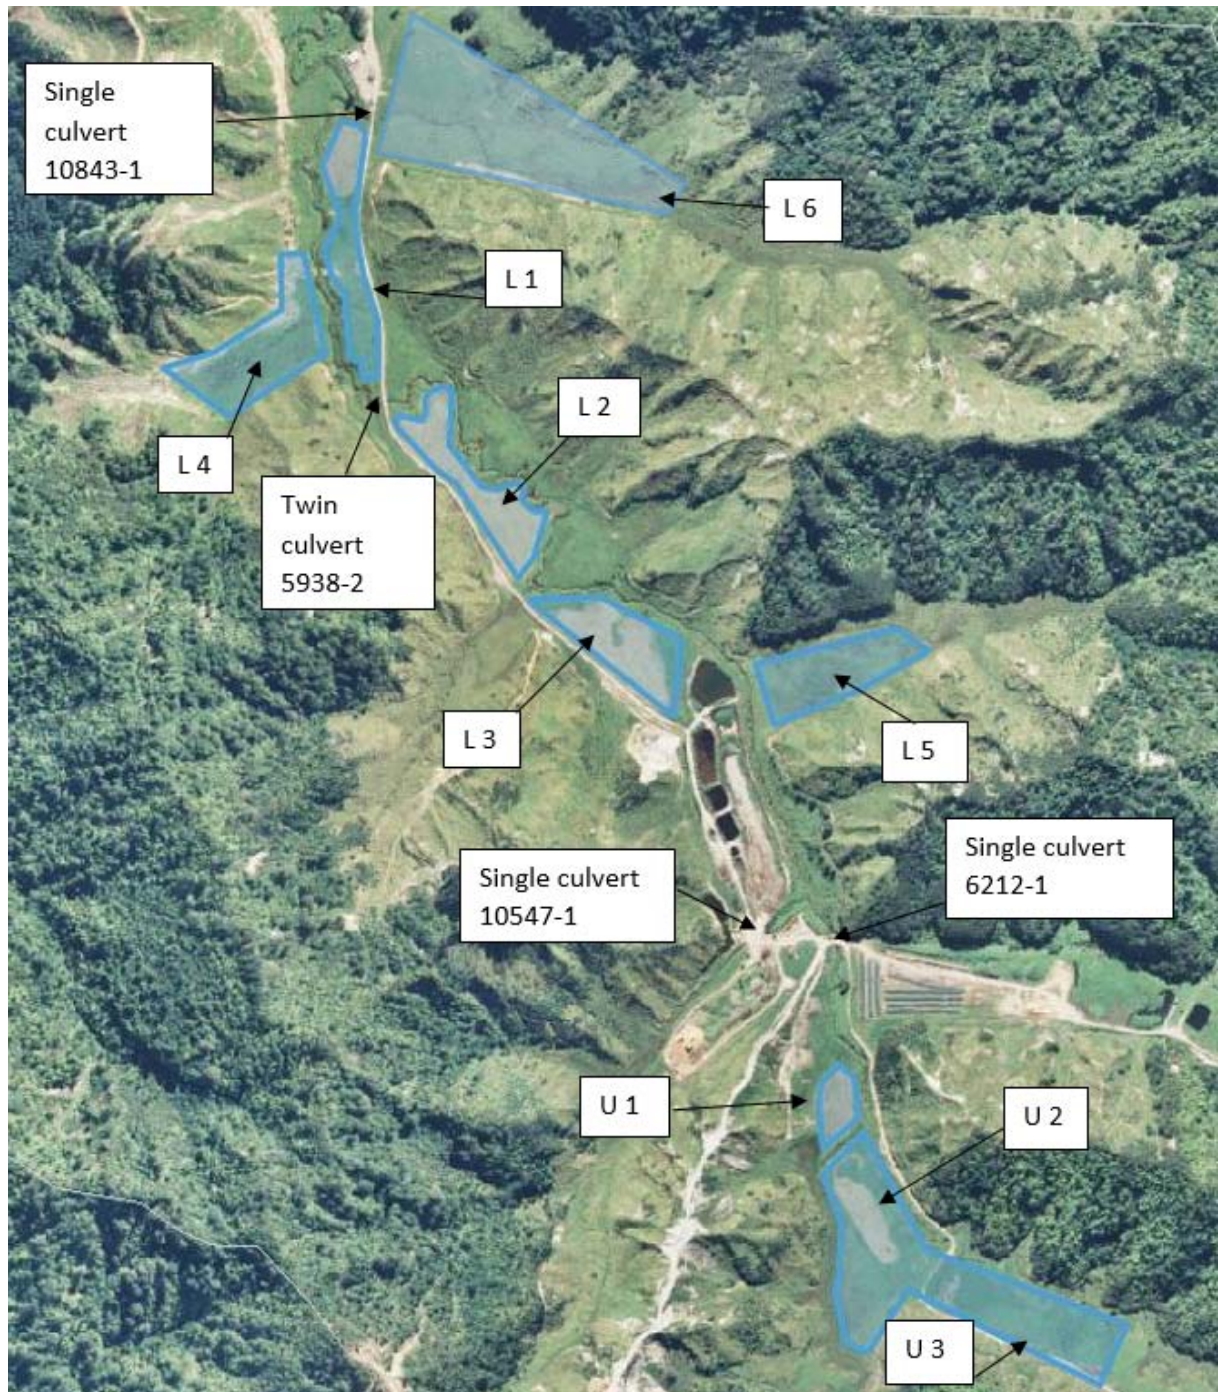
Figure 5 Irrigation areas and culverts RNZ Uruti

The Company provided the Council with irrigation records for the monitoring period. The total volume of fluid irrigated to land (Figure 5) was calculated at 17,775 m³. The Company switched to low rate application irrigation pods in January 2021. This reduced the pump flow rate from 30 m³ per hour, to 20 m³ per hour.

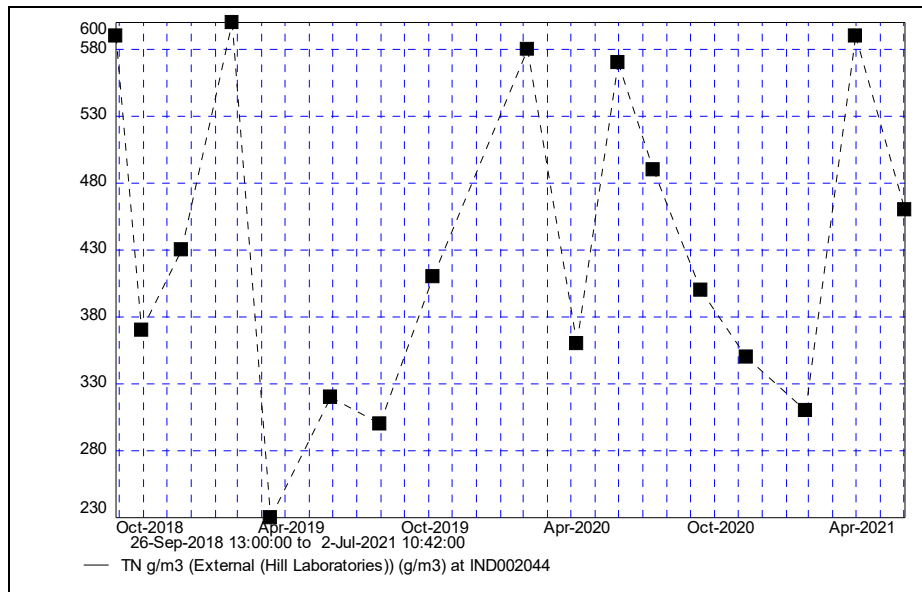
Figure 7 Total nitrogen monitoring IND002044 September 2018 - September 2021

Nitrogen put to land was estimated utilising the average concentration of total nitrogen (TN) from the irrigation pond, in this monitoring period. The average concentration was found to be 433 g/m³. The long term analysis of TN since 2018 is provided in Figure 7.

It was estimated that in the 2020-2021 monitoring period 7,696 kg nitrogen was discharged to land via spray irrigation. This equates to a hypothetical loading rate of 584 kg N per ha across the Company's 13.18 ha irrigation areas. However, the irrigation areas were not evenly utilised this monitoring period (Figure 8).

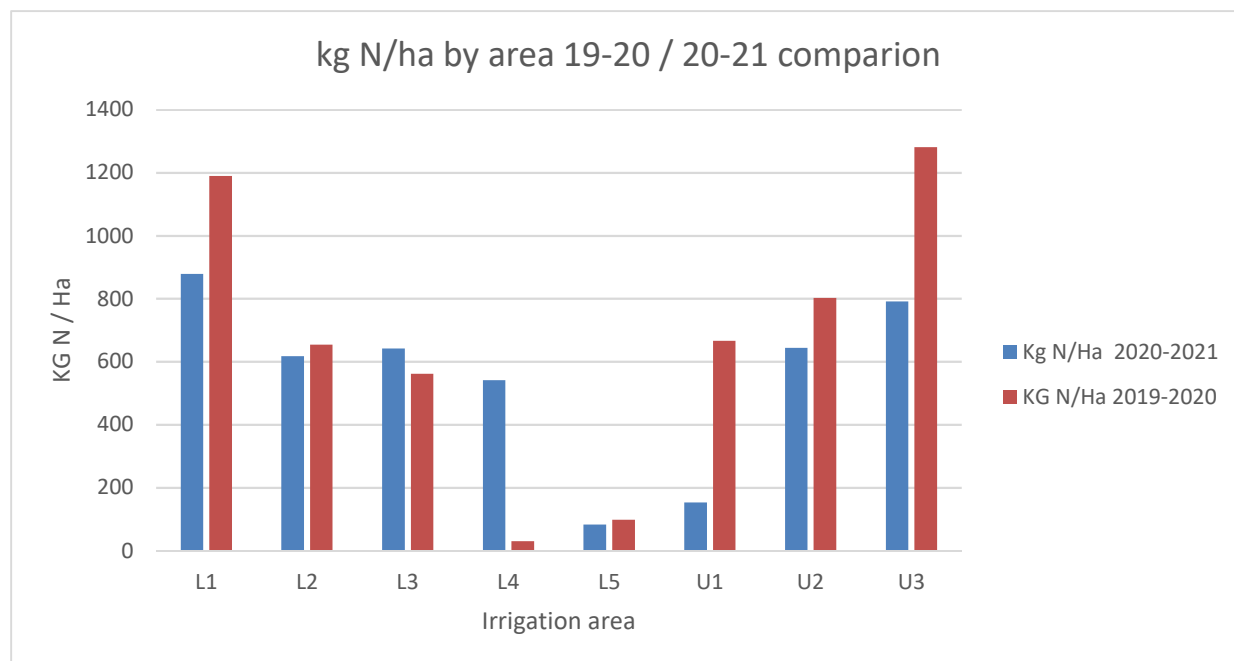
Figure 9 Nitrogen to land 2019-2020 compared to 2020-2021

Other industries have set nitrogen caps, which limit the total amount of nitrogen which can be put to land in a monitoring year. In some cases these caps are set between 250-400 kg N/ha, with the higher end of the

loading allowed for cut and carry operations. This is a means of removing excess nitrogen from the system. The strict loading rates are undertaken to prevent elevated nitrogen from affecting the groundwater and or surface water, which has been observed in some parts of the region. Noting the council is required to give effect to the National Policy Statement for Freshwater Management, balancing the applications to land with what can be sustainable sequestered will be vital for the Company moving forward.

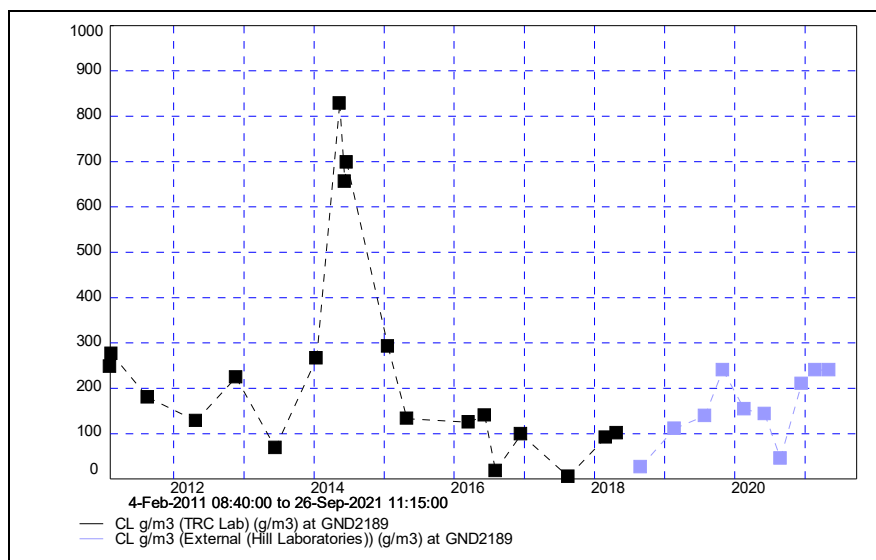
Figure 13 Long-term chloride monitoring GND2189 2011-2021

- Chloride also increased during the monitoring period rising from 45- 240 g/m³, (Figure 13). However, chloride concentrations remained below the elevation observed during the 2014-2015 monitoring period.

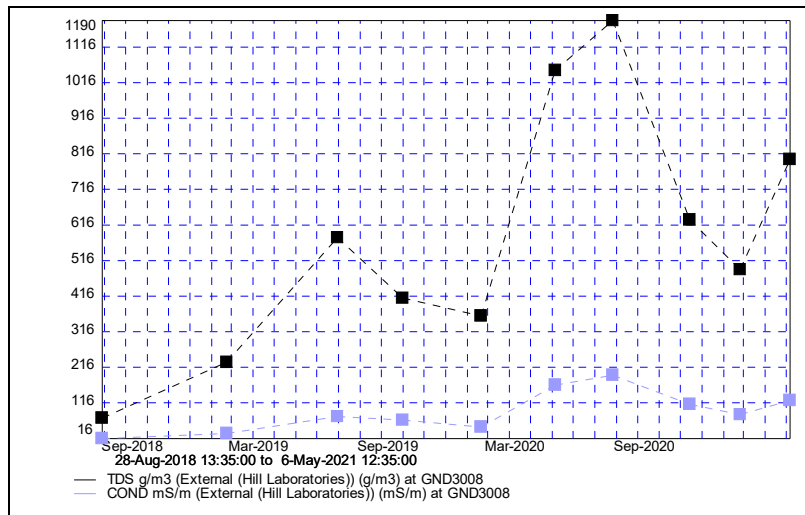
Figure 15 Electrical conductivity and TDS monitoring GND3009 August 2018 - May 2021

- TDS demonstrated a decreasing concentration through the summer months, prior to increasing in the May 2021 sample round. The long term record indicates that this analyte is increasing over time (Figure 15).

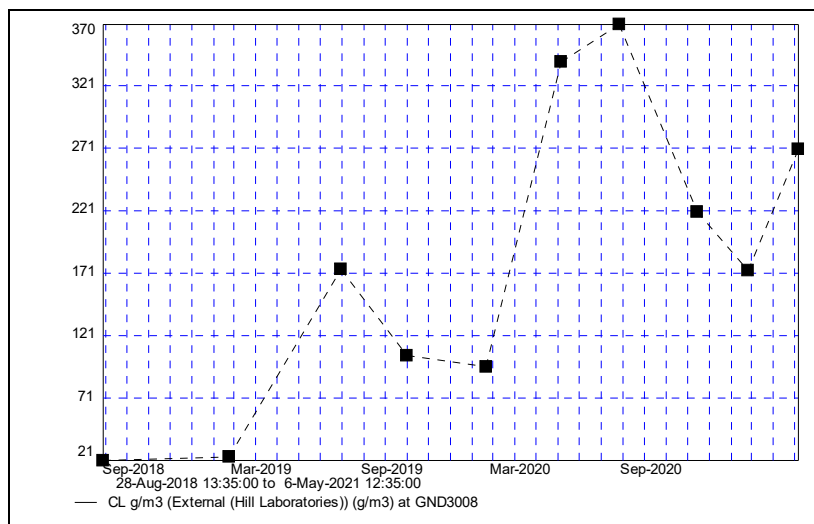
Figure 16 Chloride monitoring GND3008 September 2018- May 2021

- Chloride analysis indicated an overall reduction in concentration throughout the monitoring period. However the long term record (since September 2018) suggests a gradual increase in concentrations over time (Figure 16).

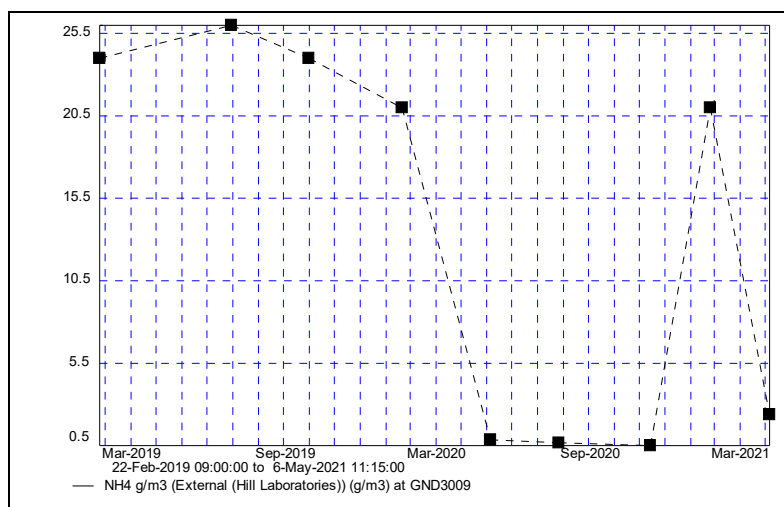
Figure 20 Ammoniacal nitrogen monitoring GND3009 February 2019 - May 2021

- Groundwater level remained relatively stable across the four monitoring events, ranging 1.96-2.12 m bgl.
- pH fluctuated close to neutral across the four monitoring rounds.
- EC monitoring recorded a doubling in concentration in the second half of the monitoring period. However when compared to the longer term record, this monitoring well is exhibiting an overall reduction in EC, (Figure 18).
- TDS monitoring followed a similar trend to the EC, by doubling in the second half of the monitoring period. However, in comparison to the EC, the long term record does not necessarily suggest an overall reduction in this analyte (Figure 19).
- Ammoniacal nitrogen demonstrated a good deal of variation across the four monitoring events, ranging 0.5-21 g/m³. The higher result (21 g/m³, February 2021) is in line with results from the previous monitoring period (Figure 20).
