NPDC Colson Road Landfill  
Monitoring Programme  
Annual Report  
2017-2018

Technical Report 2018-76

Taranaki Regional Council  
Private Bag 713  
STRATFORD  
March 2019

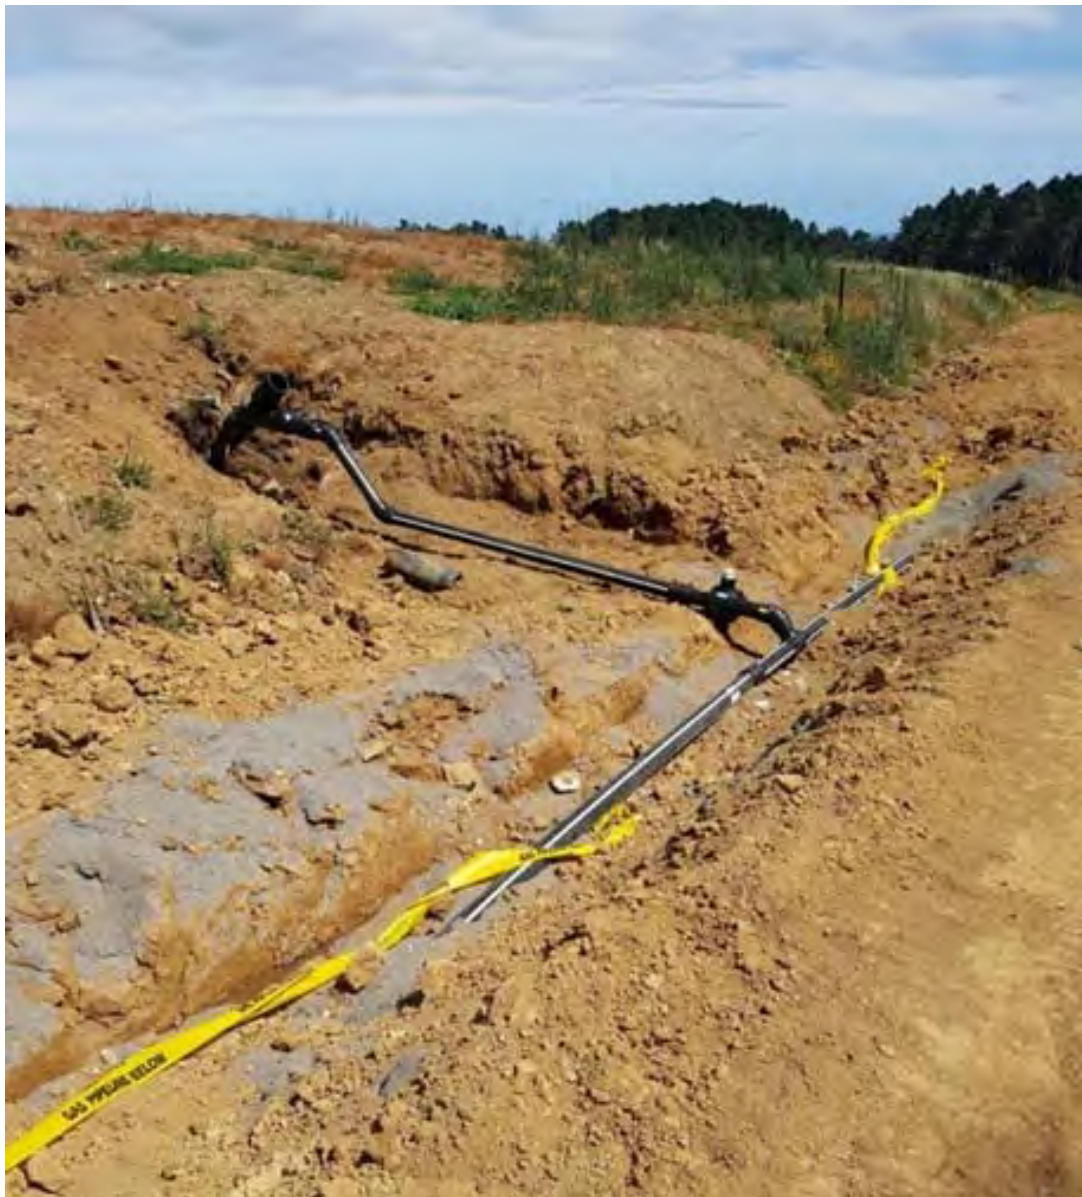
Photo 2 Leachate pipes feeding into the gas collection system

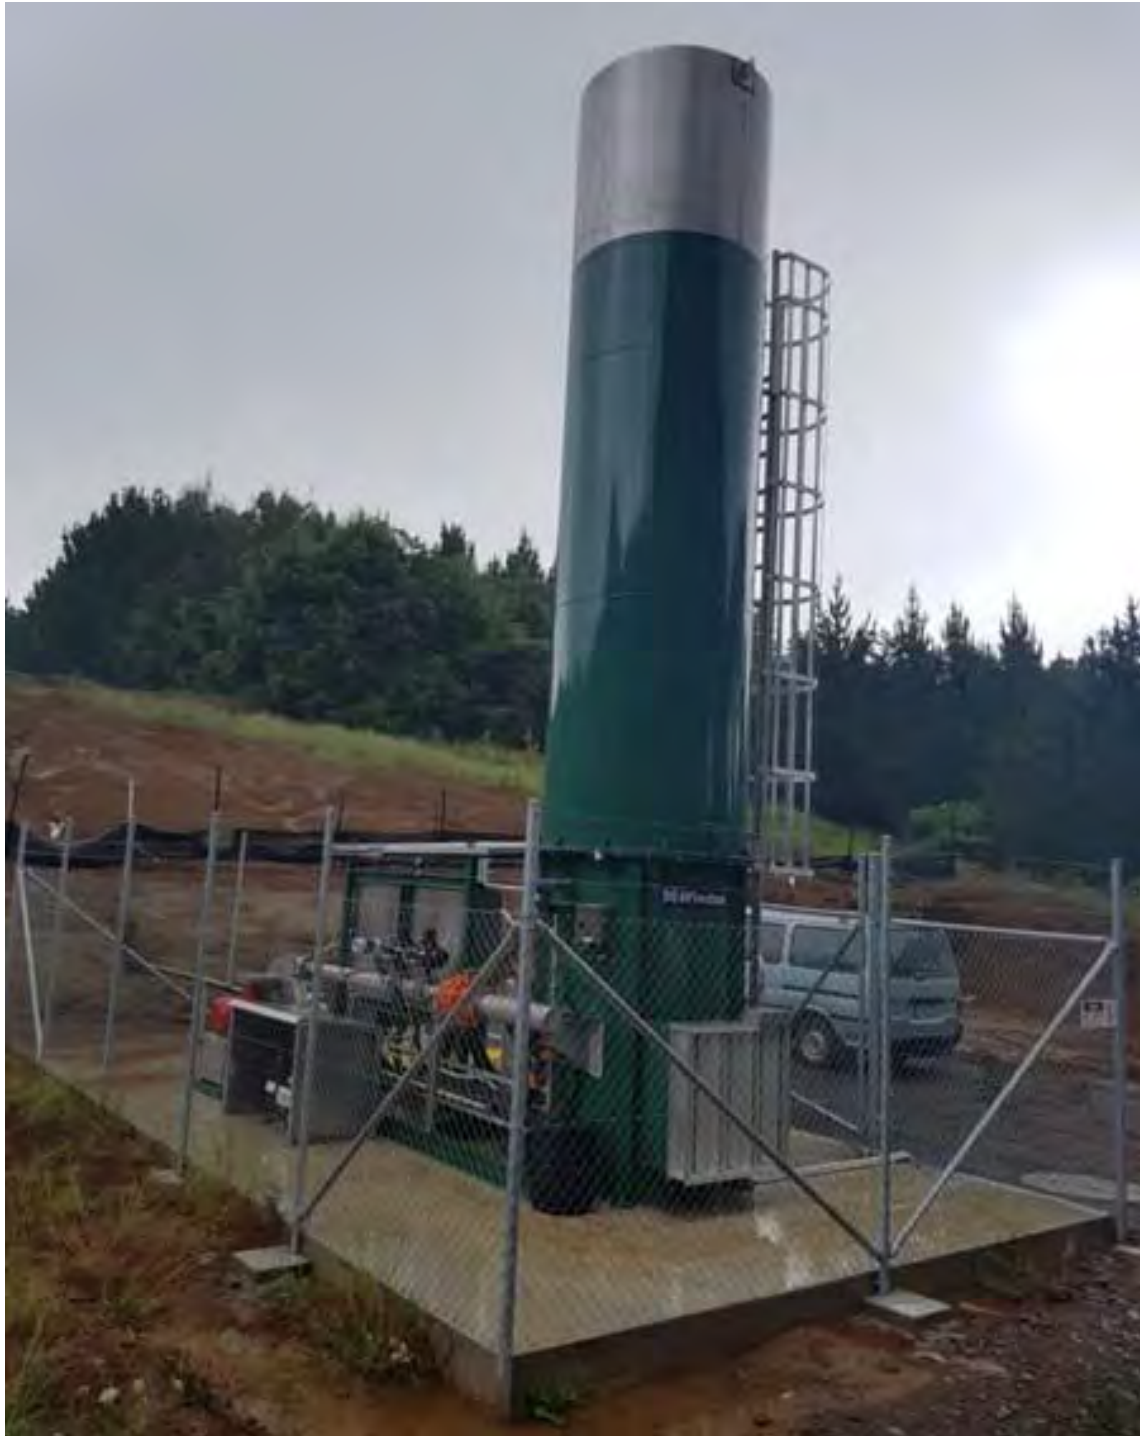
There has been a noticeable reduction in odour around the landfill perimeter since all of the above measures have been initiated and the operation of the flare began. This has resulted in no odour complaints being received in relation to the site since October 2017, and only one unsubstantiated complaint that was received in September 2017, before the flare was installed.

Photo 3 The fully enclosed flare

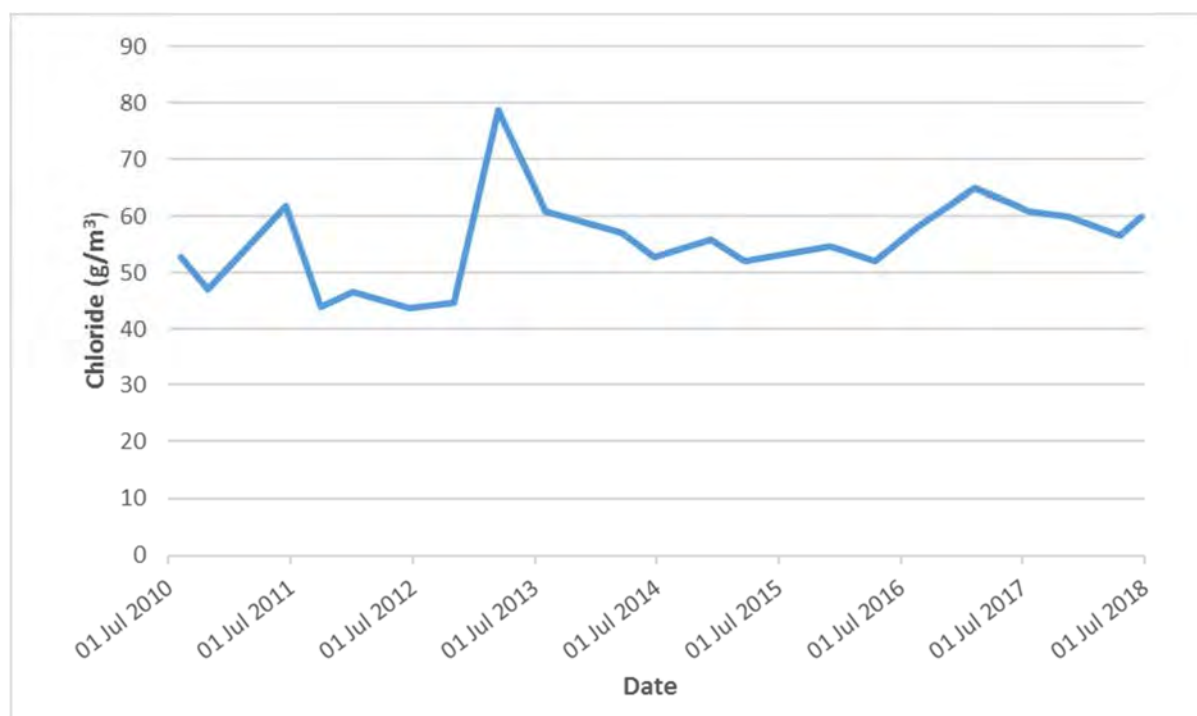
Historically, drainage analysis has shown that little, if any, contamination has been occurring in the groundwater immediately below the liner. Although the level of key indicator species such as zinc and chloride (Figure 5) are relatively stable over the last five years, the results for the year under review indicate that some contaminant concentrations such as ammoniacal nitrogen may have increased (Figure 6).

Figure 5 Chloride concentration in the under liner drainage

The levels are not currently of environmental concern as they remain within normal ranges for Taranaki groundwater. Monitoring of the contaminant concentrations in the under liner drainage will continue.

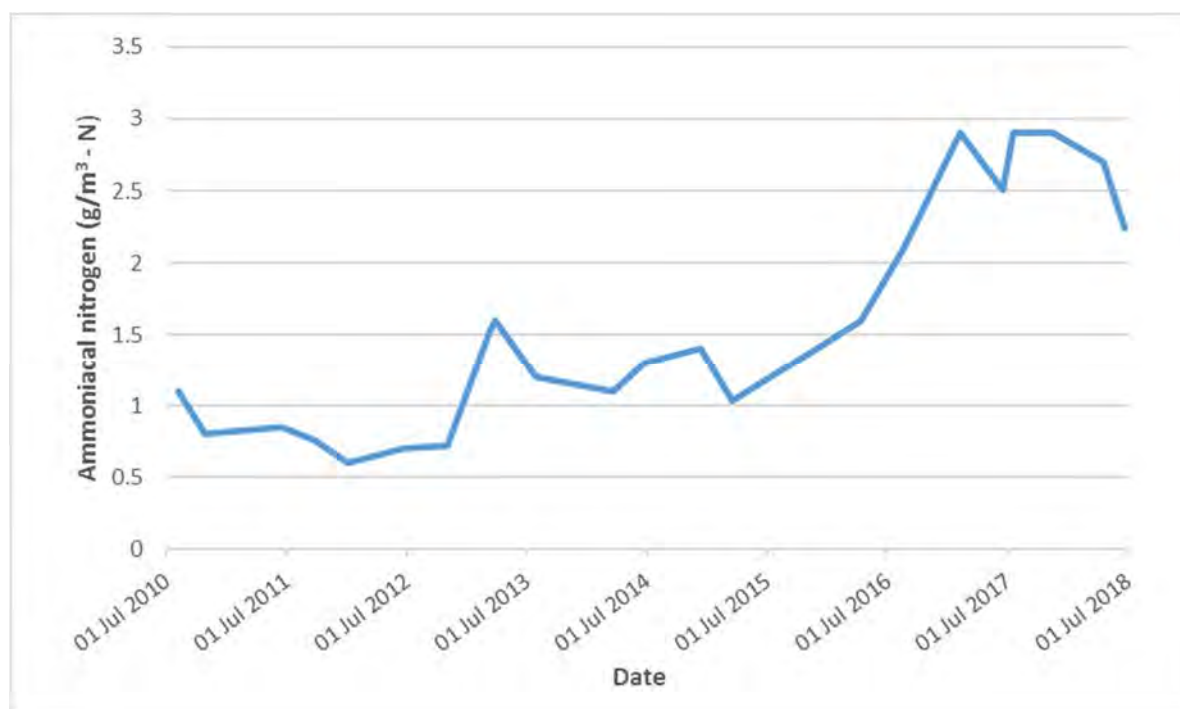
Figure 6 Ammoniacal nitrogen concentration in the under liner drainage

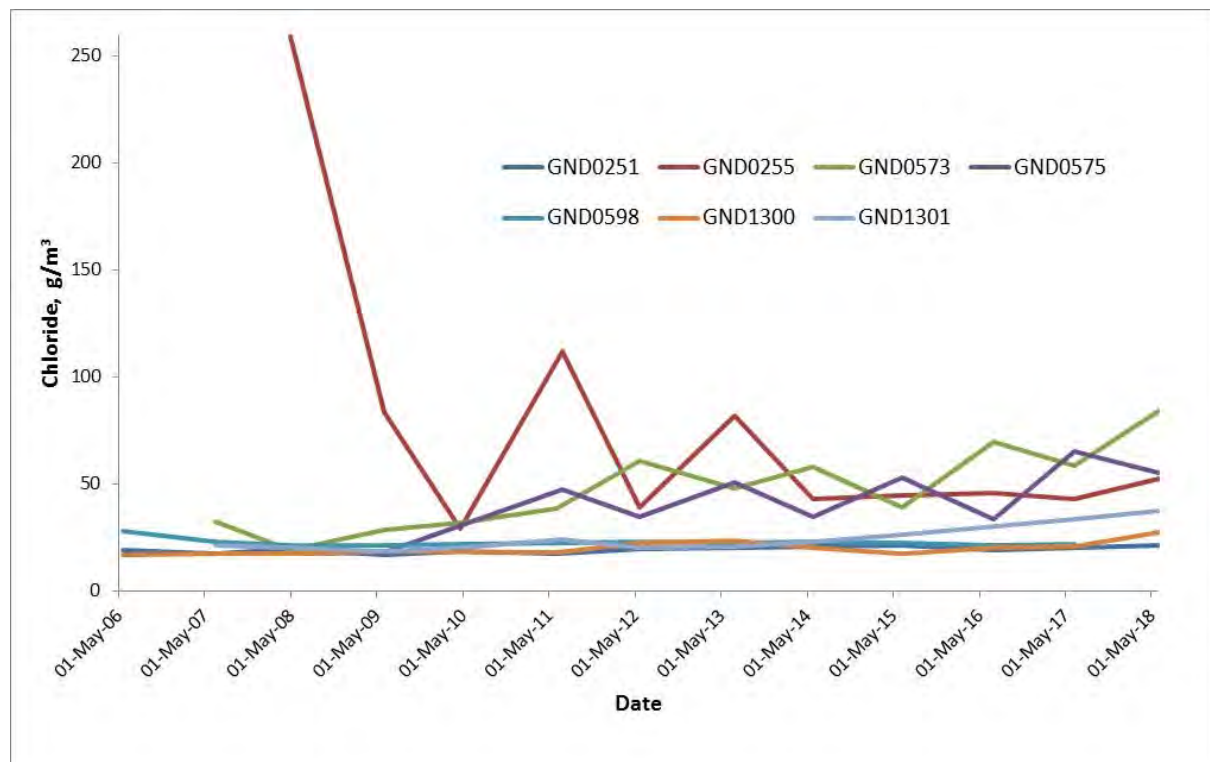
Figure 9 Chloride concentrations in the Colson Road groundwater bores, June 2006 to date

It can be seen that the chloride concentration in bore GND0255 (up gradient of the landfill) have been stabilising at a decreased level since the spike found in April 2008. Conversely, in bores GND0573, GND0575 (and to a lesser extent GND1301), although the changes are relatively small, it does appear that there may be an emerging trend of increasing chloride concentrations. These bores are down gradient of landfill stages two and three, and may be indicative of some minor leachate contamination.

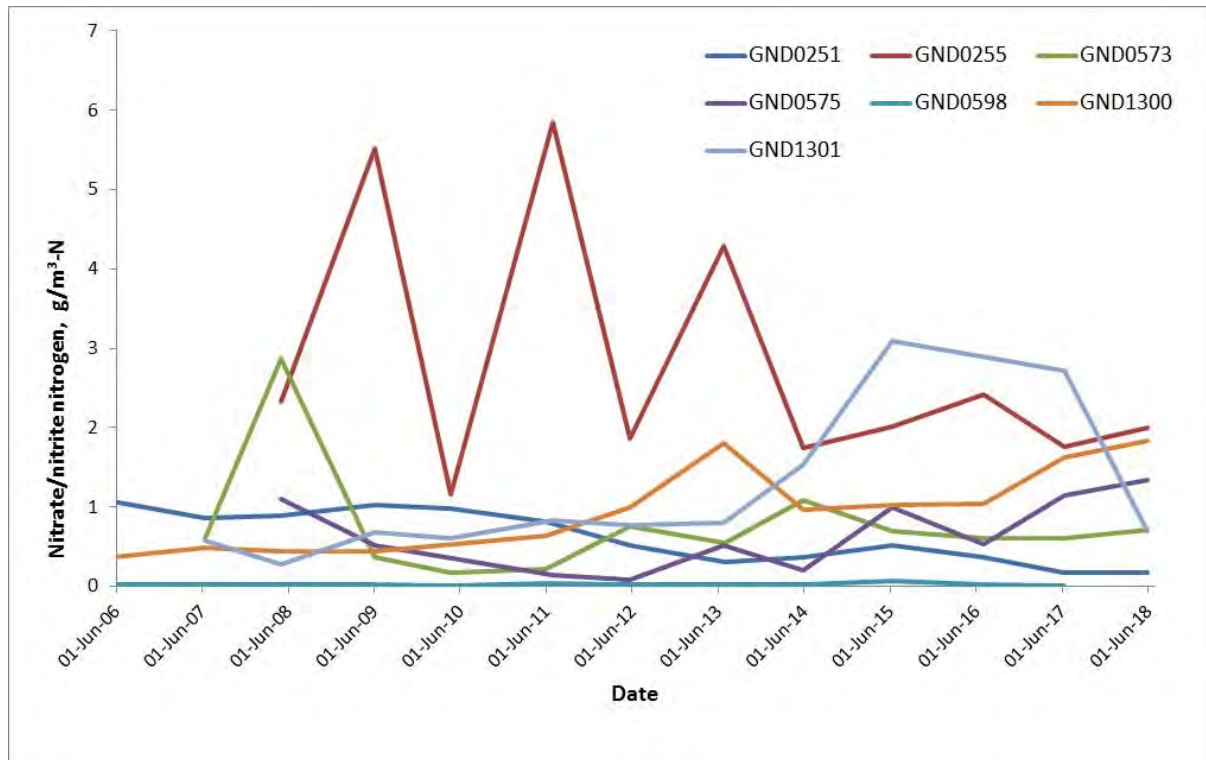
Figure 8 shows that there may also be an emerging trend of increasing nitrate/nitrite nitrogen concentrations in some of these bores, that is, GND0575 (north east of the landfill) and GND1300 (north

east of the composting area and east of the southern end of the landfill). This finding is consistent with the potential emerging trend of increasing nitrate/nitrite nitrogen in the under liner drainage results provided by NPDC (2.2.2, Figure 6). In contrast, it is noted that the nitrate/nitrite nitrogen results obtained at GND1301 (further east of the landfill than GND0575) during the year under review had reduced by about one third, following the higher results obtained in the 2014-2015, 2015-2016 and 2016-2017 years.

Figure 10 Nitrate/nitrite nitrogen concentrations in the Colson Road groundwater bores, June 2006 to date

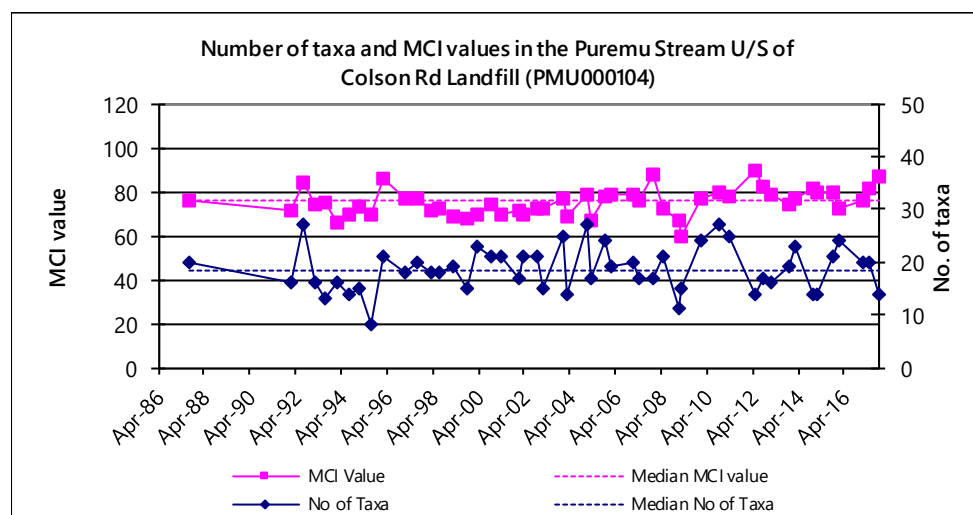
A total taxa richness of 14 taxa was recorded at site 1 (Table 5 and Figure 2). This result was five taxa less than the historical median and six taxa less than the previous survey result of 20 taxa.

Figure 2 Number of macroinvertebrate taxa and MCI values recorded at site 1 in the Puremu Stream, upstream of Colson Road Landfill since April 1987

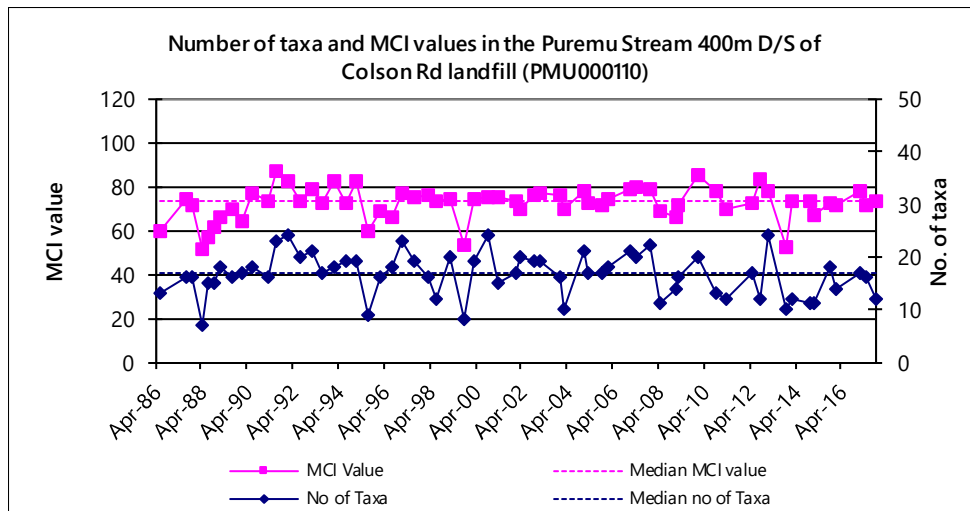
A total taxa richness of 12 taxa was recorded at this site, which was five taxa less than the median recorded by previous surveys at this site, and four taxa less than the richness recorded by the previous survey (Table 5 and Figure 3). The macroinvertebrate community was characterised by two 'tolerant' taxa [snails (*Potamopyrgus*) and midge larvae (*Polypedilum*)] (Table 6).

A slightly higher proportion of 'tolerant' taxa recorded at this site (58%) resulted in the MCI score of 73 units, which indicated 'poor' biological health. This MCI score was equal to the historical median for the site and two units more than score recorded in the preceding survey (Table 5, Figure 3). The SQMCI<sub>s</sub> score of 3.4 units was above the historical median for the site and equal to the score recorded in the preceding survey (Table 5).

Figure 3 Taxa numbers and MCI values recorded at site 2, 400 m downstream of Colson Rd Landfill

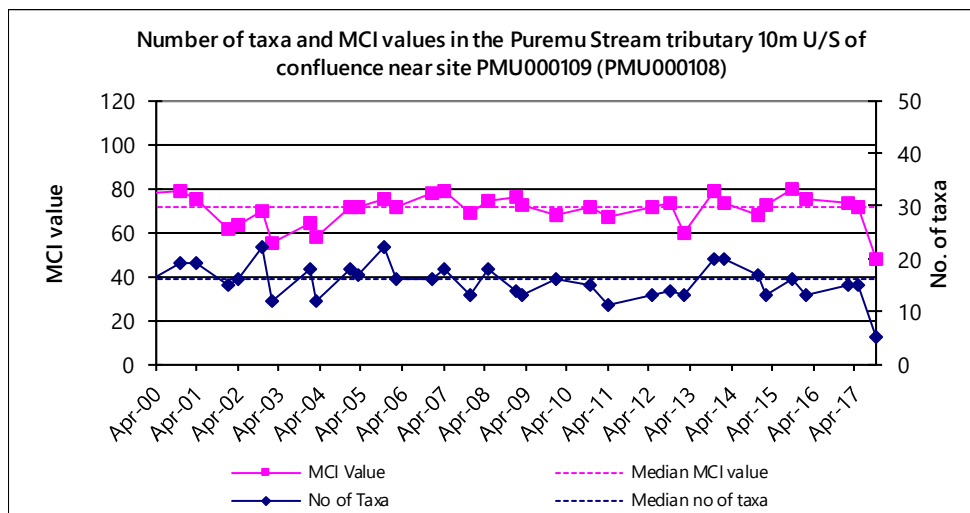
A total of five taxa was recorded at site PT1 in the unnamed tributary of the Puremu Stream, which was 11 taxa less than the historical median for the site and ten taxa less than that recorded in the preceding survey. It was also the lowest richness recorded at this site to date by six taxa, and was a substantial nine taxa less than that recorded at the 'control' site 1 (Table 5 and Table 6).

Figure 4 Numbers of taxa and MCI values recorded to date at site PT1, downstream of Colson Road Landfill

A higher proportion of 'tolerant' (80%) taxa in the macroinvertebrate community was reflected by the MCI score of 48 units, which indicated 'very poor' biological health. This MCI score was a significant (Stark 1998) 24 units lower than the median MCI score for the site, and 23 units lower than the score recorded in the preceding survey (Table 5, Figure 4). This was also the lowest MCI score recorded at this site to date (Table 5, Figure 4).

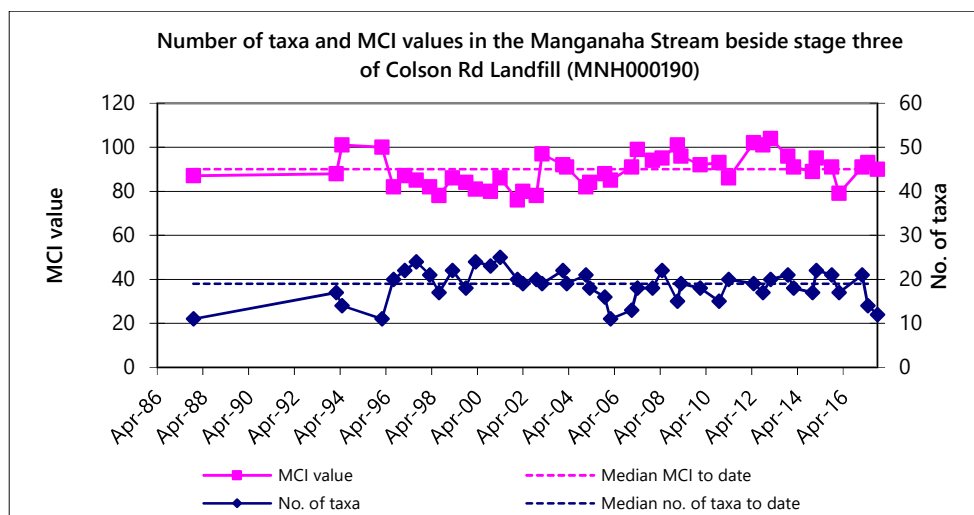
A total of 12 taxa was recorded at site M4 in this survey which was seven taxa less than the historical median for the site and two taxa less than was recorded in the preceding survey (Table 5 and Figure 5). The community at this site was characterised by two 'moderately sensitive' taxa [amphipods (*Paracalliope*) and mayfly (*Austroclima*)] and one 'tolerant' taxon [snail (*Potamopyrgus*)] (Table 7), which was indicative of reasonable preceding water quality.

A higher proportion of 'sensitive' taxa in the macroinvertebrate community resulted in the 'fair' MCI score of 90 units, which was equal to the historical median and an insignificant (Stark 1998) 3 units lower than the previous survey results for this site (Table 5 and Figure 5).

Figure 5 Taxa numbers and MCI values recorded at site M4, in the Manganaha Stream adjacent to Colson Road landfill

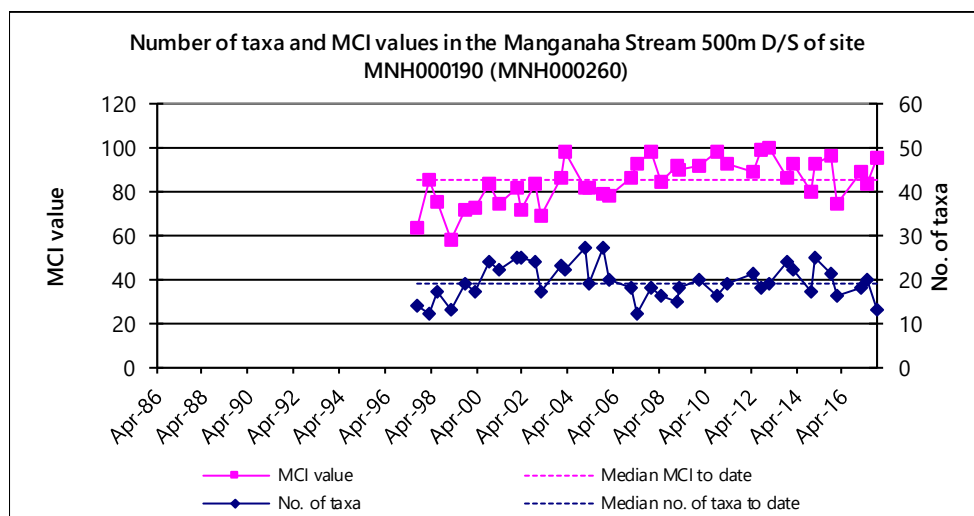
A total of 13 taxa was recorded at site M6, six taxa less than the median for the site and seven taxa less than that recorded in the preceding survey (Table 5 and Figure 6). The community at this site was characterised by one 'moderately sensitive' taxon [mayfly (*Austroclima*)] and two 'tolerant' taxa [snail (*Potamopyrgus*) and sandfly larvae (*Austrosimulium*)] (Table 7).

Figure 6 Taxa numbers and MCI values recorded at site M6, in the Manganaha Stream downstream of Colson Road landfill

The high proportion (75%) of 'sensitive' taxa in the macroinvertebrate community resulted in the 'fair' MCI score of 95 units, which was an insignificant (Stark, 1998) 10 units lower than the historical median MCI, and a significant (Stark 1998) 12 units higher than the score recorded in the preceding survey (Table 5 and Figure 6).

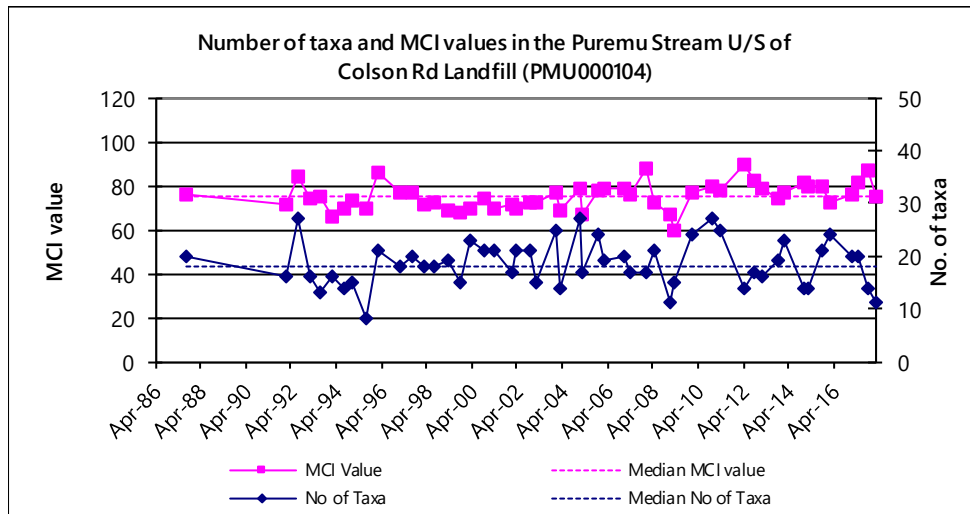
A total taxa richness of 11 taxa was recorded at site 1 (Table 5 and Figure 2). This result was eight taxa less than the historical median and three taxa less than the previous survey result of 14 taxa.

Figure 2 Number of macroinvertebrate taxa and MCI values recorded at site 1 in the Puremu Stream, upstream of Colson Road Landfill since April 1987

In this survey a slightly higher proportion of 'tolerant' taxa (64%) were recorded in the macroinvertebrate community which resulted in the MCI score of 75 units, a significant (Stark 1998) 12 units less than the preceding survey and one unit less than the median score recorded at this site previously (Table 5 and Figure 2). This MCI score indicated 'poor' biological health. The numerical dominance by one 'sensitive' taxon and one 'tolerant' taxon resulted in the SQMCI<sub>s</sub> score of 3.9 units (Table 6). This score was slightly lower than that recorded by the previous survey (by 0.4 unit), and was 0.1 units more than the median score recorded by previous surveys for the site (Table 5).

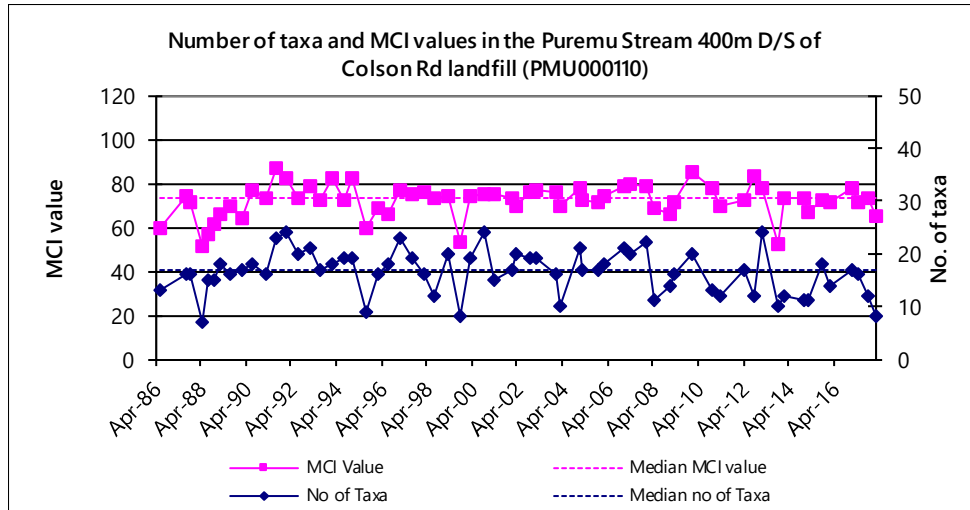
A total taxa richness of eight taxa was recorded at this site, which was nine taxa less than the median recorded by previous surveys at this site, and four taxa less than the richness recorded by the previous survey (Table 5 and Figure 3).

A slightly higher proportion of 'tolerant' taxa recorded at this site (75%) resulted in the MCI score of 65 units, which indicated 'poor' biological health. This MCI score was eight units less than score recorded in the preceding survey and the historical median for the site (Table 5, Figure 3). The SQMCI<sub>s</sub> score of 3.6 units was above the historical median for the site (by 0.6 unit) and 0.2 unit higher than the score recorded in the preceding survey (Table 5).

Figure 3 Taxa numbers and MCI values recorded at site 2, 400 m downstream of Colson Rd Landfill

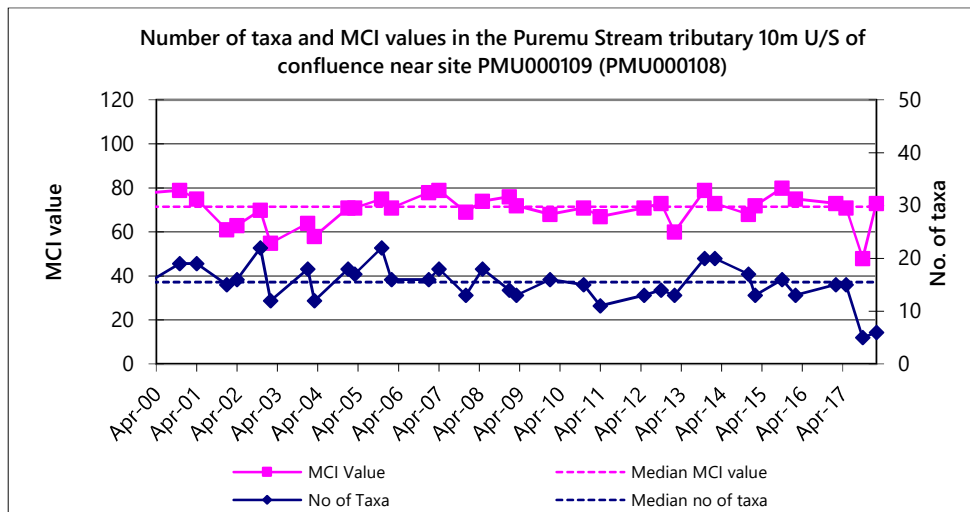
Figure 4 Numbers of taxa and MCI values recorded to date at site PT1, downstream of Colson Road Landfill

A total of six taxa was recorded at site PT1 in the unnamed tributary of the Puremu Stream, which was ten taxa less than the historical median for the site and one taxon more than that recorded in the preceding survey. It was also the second lowest richness recorded at this site to date (Table 5 and Table 6).

The community at site PT1 was characterised by one 'tolerant' taxon [seed shrimps (*Ostracoda*)] (Table 6).

A higher proportion of 'tolerant' (67%) taxa in the macroinvertebrate community was reflected by the MCI score of 73 units, which indicated 'poor' biological health. This MCI score was 2 units higher than the median MCI score for the site, and a significant (Stark 1998) 25 units higher than the score recorded in the preceding survey (Table 5, Figure 4). This showed a significant improvement from the lowest MCI score recorded at this site to date in the preceding survey (Table 5, Figure 4).

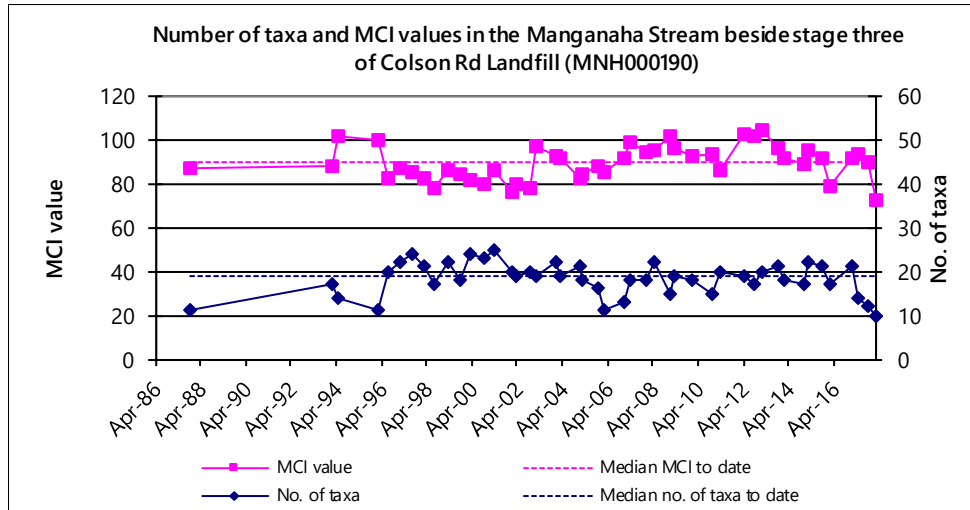
Figure 5 Taxa numbers and MCI values recorded at site M4, in the Manganaha Stream adjacent to Colson Road landfill

A total of ten taxa was recorded at site M4 in this survey which was nine taxa less than the historical median for the site and two taxa less than was recorded in the preceding survey (Table 5 and Figure 5). This was the lowest richness recorded at this site to date, by only one taxon (Table 5). The community at this site was characterised by two 'moderately sensitive' taxa [amphipods (*Paracalliope*) and caddisfly (*Triplectides*)] and two 'tolerant' taxa [oligochaete worms and snail (*Potamopyrgus*)] (Table 7).

A slightly higher proportion of 'tolerant' taxa (60%) in the macroinvertebrate community resulted in the 'poor' MCI score of 72 units, which was a significant (Stark 1998) 18 units lower than the previous survey results and the historical median for this site (Table 5 and Figure 5).

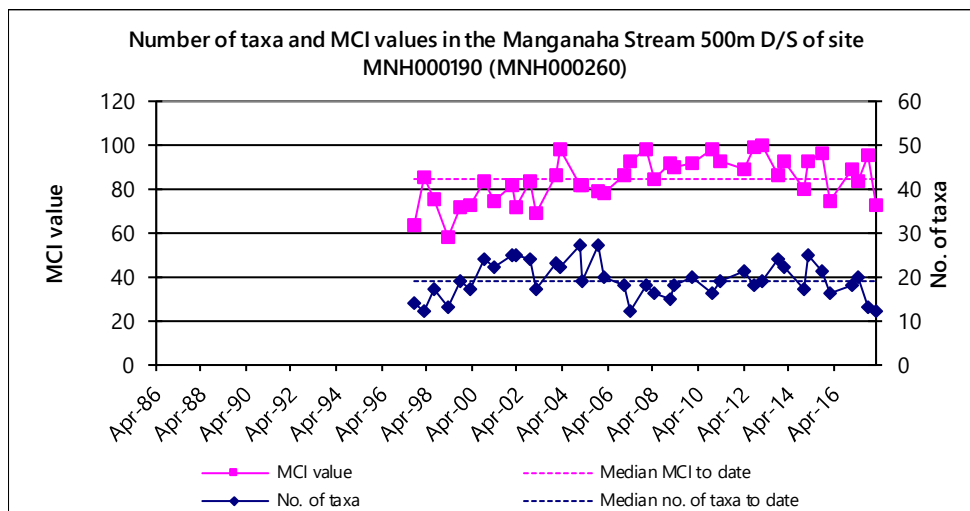
Figure 6 Taxa numbers and MCI values recorded at site M6, in the Manganaha Stream downstream of Colson Road landfill

A total of 12 taxa was recorded at site M6, seven taxa less than the median for the site and one taxon less than that recorded in the preceding survey (Table 5 and Figure 6). This was equal to the lowest taxa richness recorded at this site to date (Table 5). The community at this site was characterised by two 'moderately sensitive' taxa [amphipod (*Paracalliope*) and caddisfly (*Triplectides*)] and three 'tolerant' taxa [oligochaete worms, mud snail (*Potamopyrgus*) and seed shrimp (Ostracoda)] (Table 7).

The high proportion (67%) of 'sensitive' taxa in the macroinvertebrate community resulted in the 'poor' MCI score of 72 units, which was a significant (Stark, 1998) 13 units lower than the historical median MCI, and 23 units lower than the score recorded in the preceding survey (Table 5 and Figure 6).
