Rockvale Deer Stud Ltd
and AJ Cowley Ltd
Combined Monitoring Programme
Biennial Report
2005-2007

Technical Report 2006-76

July 2007

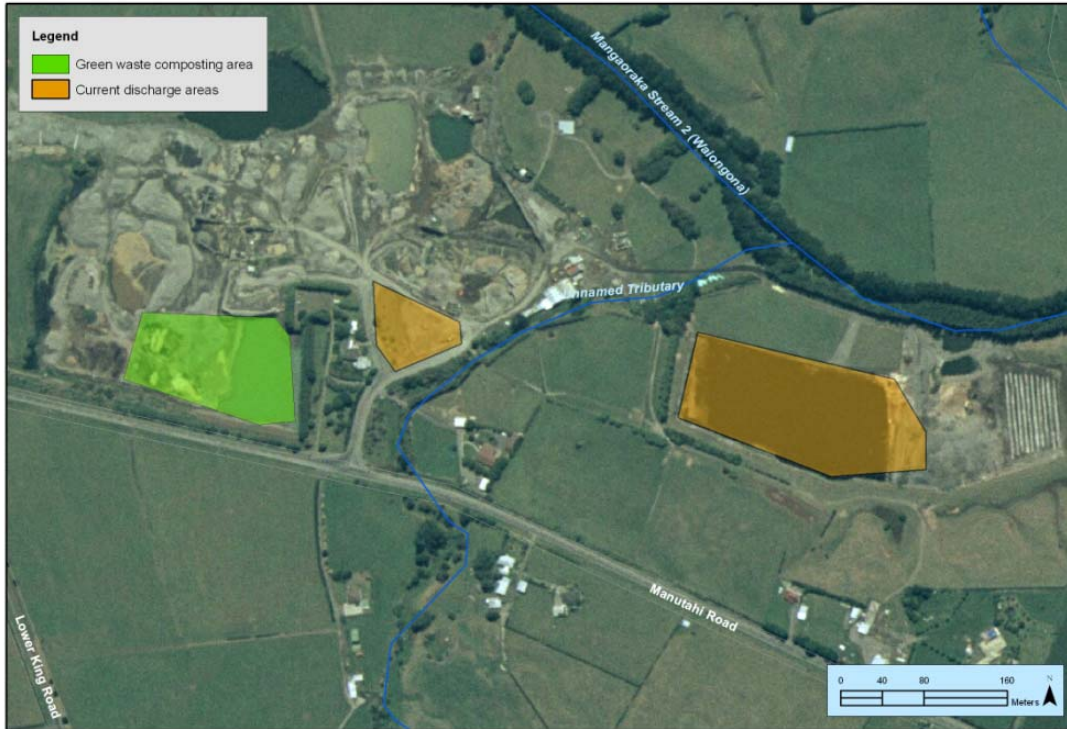
Figure 1 Rockvale Deer Stud Limited & AJ Cowley Limited cleanfill, and AJ Cowley Limited composting area at Manutahi Road, Bell Block
