TAG Oil (NZ) Limited  
Sidewinder Wellsite (Exploration)  
Monitoring Programme Report  
Technical Report 2010–105

July 2011

TAG Oil (NZ) Limited established a hydrocarbon exploration site located on Upper Durham Road, Inglewood, in the Waitara catchment. The site is called Sidewinder (ex Broadside). This operation took place from September 2010 - June 2011.

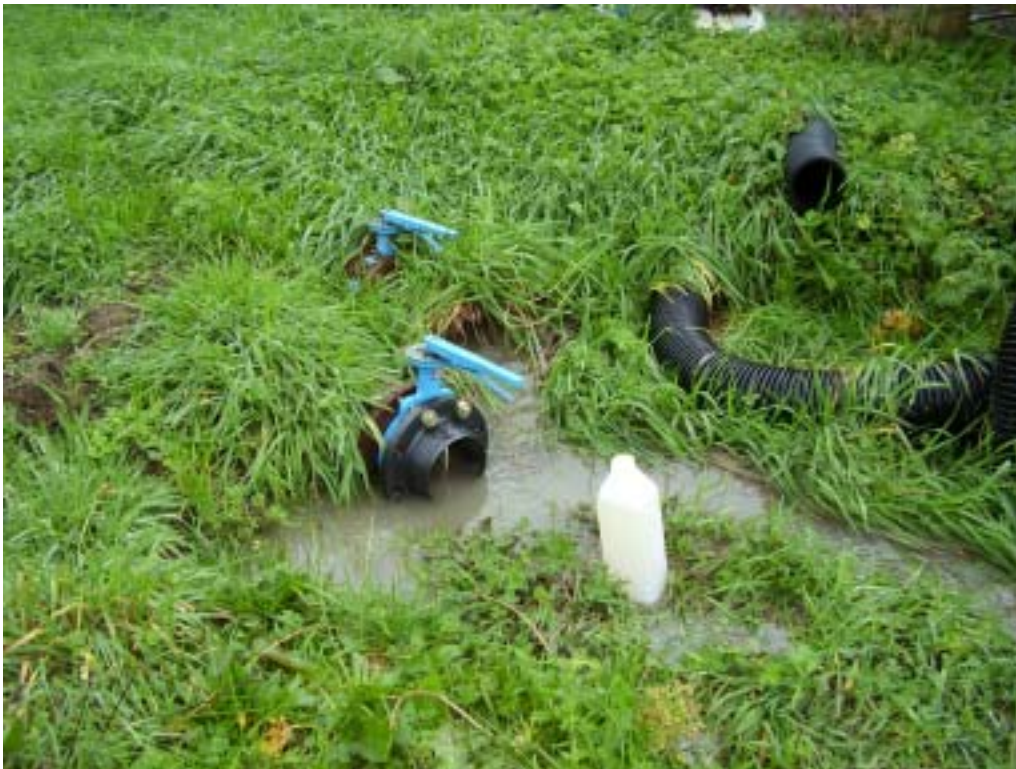
**Photo 1** Water sample collected at the discharge point from the skimmer pits

stormwater/contaminant discharged onto land from the second skimmer pit and flowed in a southerly direction towards and into the Piakau Stream. A water sample was taken at the point where stormwater discharges to land from the second skimmer pit, in order to confirm whether condition 8 of consent 7595-1 was being complied with.

The results also show that the level of chloride and suspended solids in the water sample was higher than the concentrations permitted by condition 8 of consent 7595-1. Actions arising from this incident are discussed in Section 2.5.

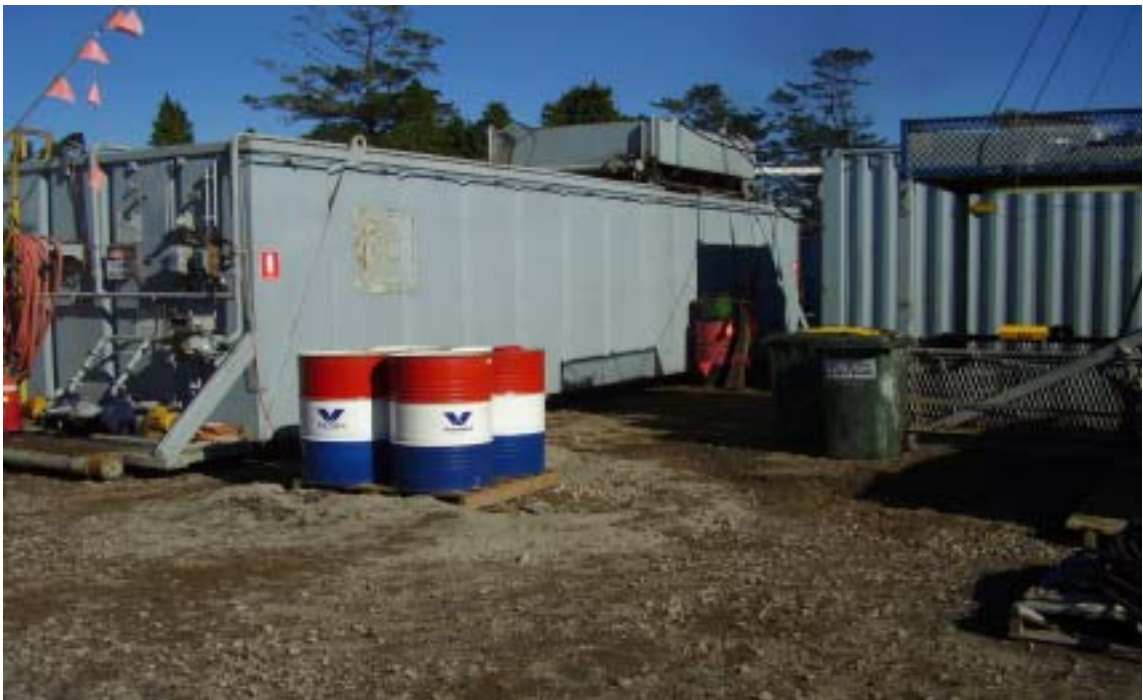
**Photo 2** The bulk fuel, water tank and smaller fuel tank above the water tank

A self notification was received on 9 March 2011 from staff on the Sidewinder wellsite regarding spilt diesel. The incident happened whilst transferring diesel from a bulk storage fuel tank to a smaller tank that sits above both the bulk fuel and water tanks. It was reported that a lack of attention caused the spill.

A compliance monitoring inspection on 15 April 2011 found further diesel was discharging from the area around the bulk fuel tank to the ring drain. It was determined that diesel had entered the open top water tank (which sits below the small diesel tank) during the 9 March 2011 incident. The water tank had overflowed spilling the diesel to ground. Once again all steps were taken to clean up the diesel and ensure it did not discharge off site.

The spill was contained on site and in accordance with special condition 1 of consent 7595-1 and section 2 of the Resource Management Act, all practicable steps were taken to prevent and minimise any adverse effect on the environment. This was achieved through cleaning up the spilt diesel, monitoring the ring drains and skimmer pits for hydrocarbons.

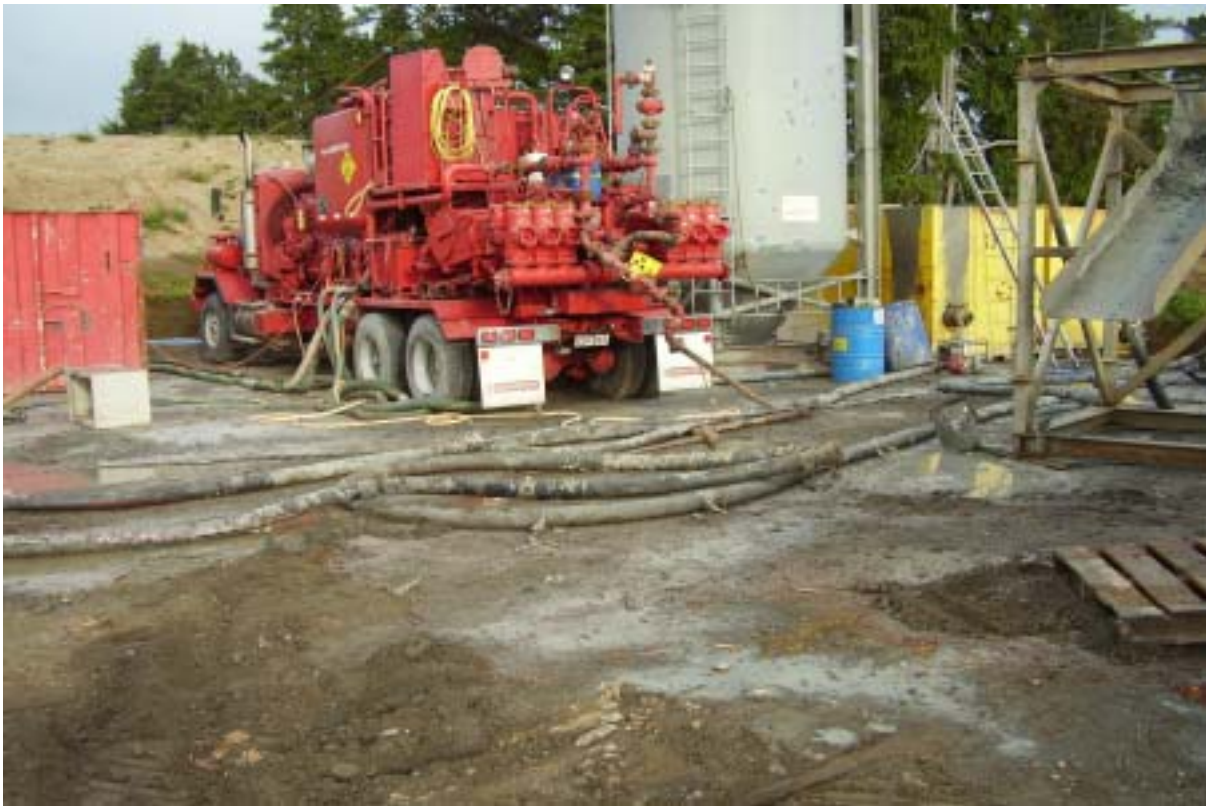
**Photo 3** Location of Halliburton truck and surrounding area with cement on the ground

Another incident involved cement from the Halliburton cement truck discharging to ground and into the ring drain. An investigation found that at the completion of

cementing a well the truck was washed down and all pipes/tanks flushed. As a result of this process a small volume of cement remaining within the pipes was discharged to ground.

However, unfortunately the Halliburton cement truck and associated equipment was overlooked as a potential source of contaminant. The discharge of cement to the ring drain on 15 April 2011 was a direct result of bunding/sumps not being in place as required by condition 7. Following this incident on site procedures were discussed with TAG Oil and Halliburton staff in order ascertain how the spill occurred and how it could be prevented in the future.

The spill was contained on site and in accordance with special condition 1 of consent 7595-1 and section 2 of the Resource Management Act, all practicable steps were taken to prevent and minimise any adverse effect on the environment. This was achieved through applying sawdust to the spilt cement and removing as much as practicable and removing cement from the ring drains.

Since these discussions a tank/sump has been purchased and will be used to contain cement discharged from the truck during the wash down/flushing process.
