## Uruti Composting Facility Management Plan

Remediation New Zealand

## EXECUTIVE SUMMARY

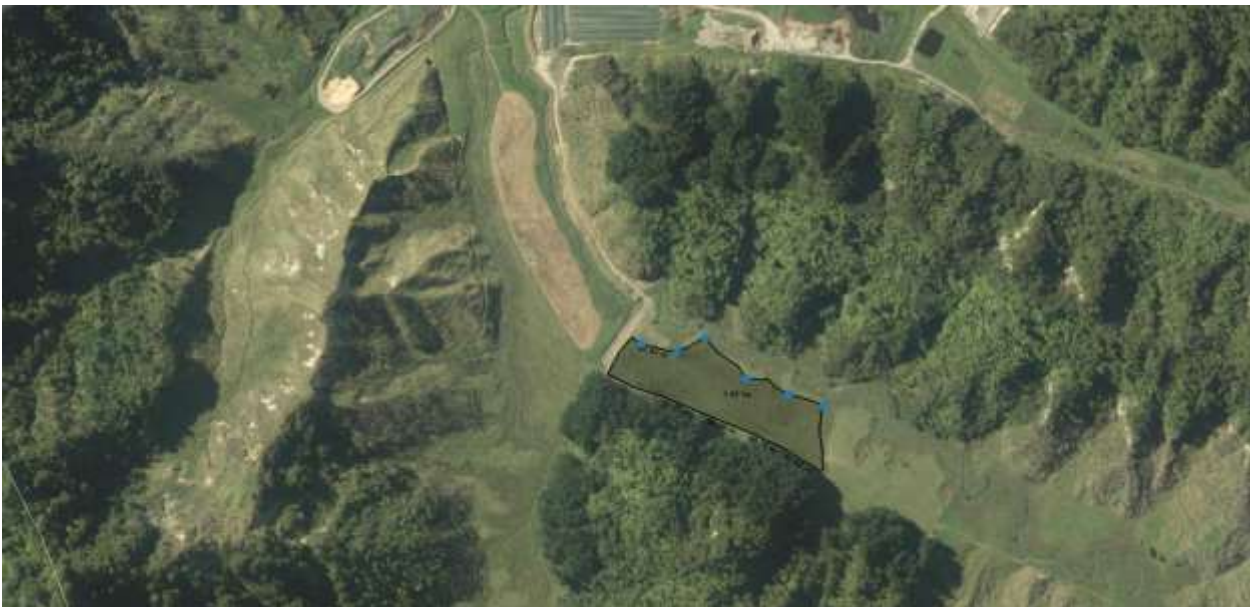
Figure 4.1: Proposed Irrigation Area F

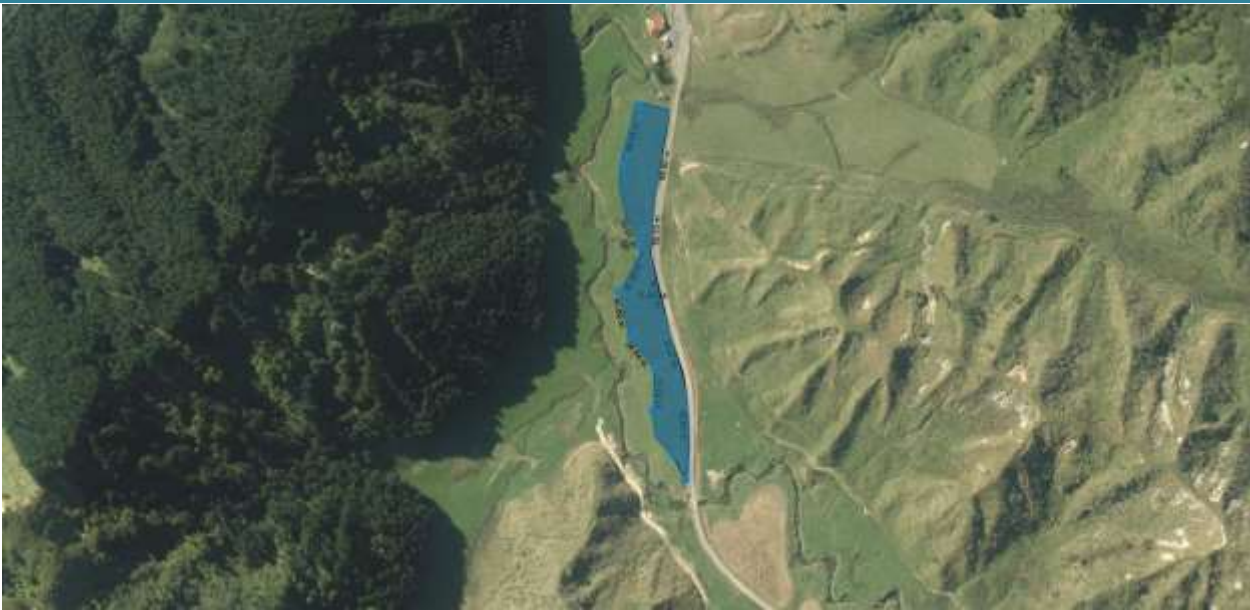
Figure 4.2: Proposed Irrigation Area E

It is envisaged that following the adoption of this site management plan, RNZ will apply for a resource consent variation to developed Phase 1. As part of that application it's highly recommended RNZ develop an irrigation plan which will integrate the new irrigation zones into the decision tree to minimise irrigation zones becoming overloaded (Table 4.1). The proposed Phase 2 irrigation zones will be incorporated into the irrigation plan over the next two years and be closely monitored by RNZ (See figure 4.2 and 4.3 for the proposed new irrigation areas).
