**Remediation New Zealand Ltd**  
**Waitara Road Facility**  
Monitoring Programme  
Annual Report  
2021-2022

Technical Report 2022-25

Monitoring Programme

Annual Report

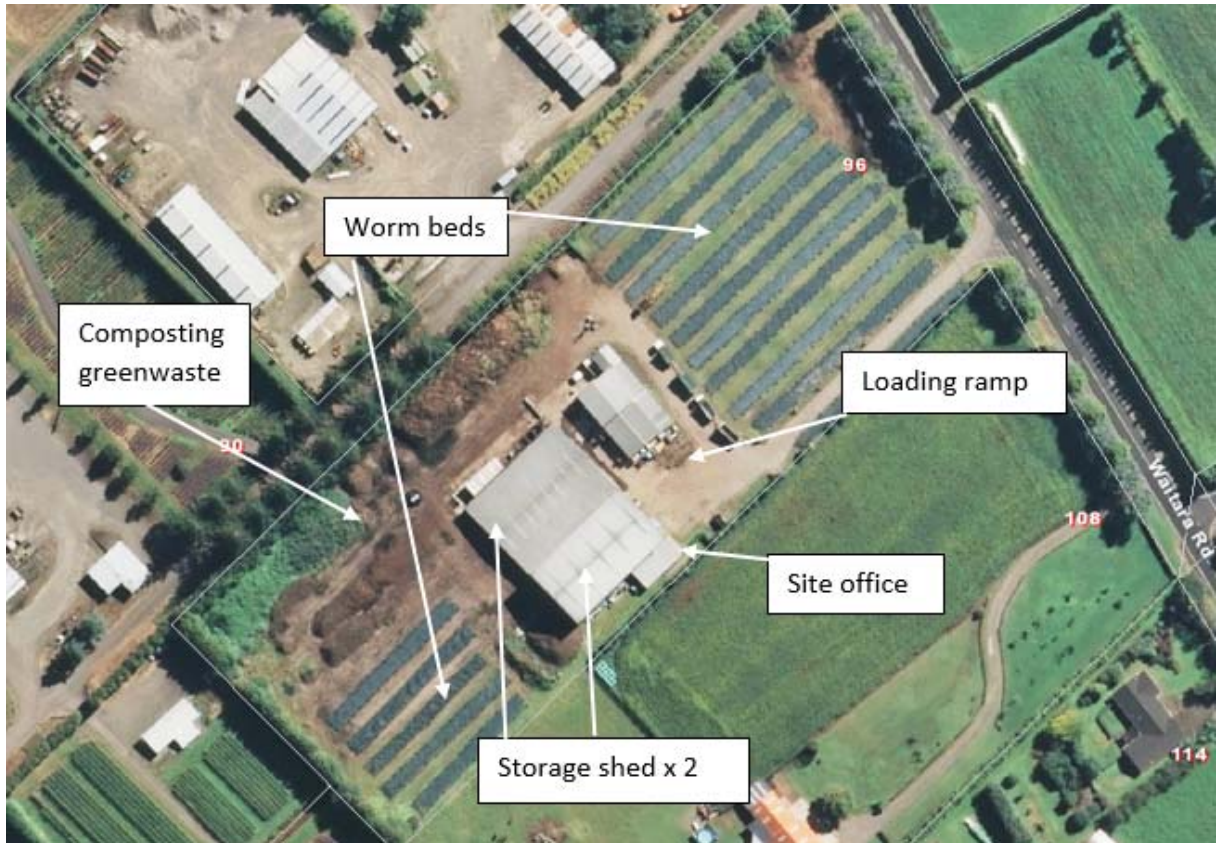
Figure 1 RNZ Waitara Road Facility map

The Company currently operates an existing vermiculture business from the Waitara Road facility. The site also has a processing facility which blends and refines the finished products.

The blended compost is loaded out via covered trucks. A loading ramp is situated to the northeast of the large storage shed. A vehicle washdown facility is provided between the storage sheds.

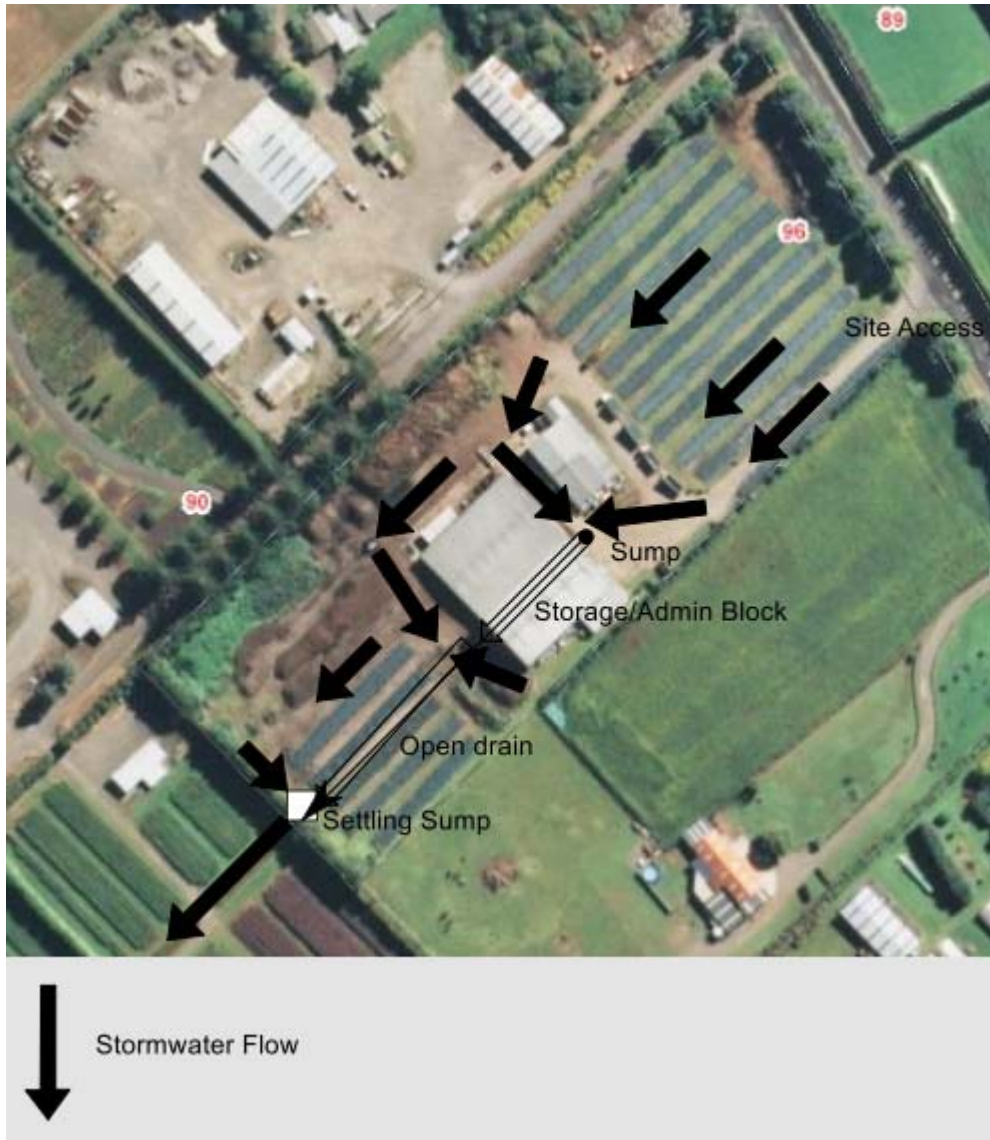
Figure 2 Consent 5892-2 stormwater flow direction

To date, any surface stormwater from the windrows has been directed to open grassed drains along the property boundary. Stormwater from the concrete mixing pad is directed to a sump and holding tank and subsequently pumped back onto the windrows. Stormwater from roofed catchments is directed to holding tanks, also for pumping back onto windrows. Stormwater from the concrete apron in front of the lime, rock and phosphate shed is directed via pipe to an open drain.

Any offsite discharges are via the open drain which runs through the neighbouring property before discharging into an unnamed tributary of the Waiongana Stream, approximately 2.5 km from the subject site.
