Taranaki Galvanizers
Monitoring Programme
Annual Report
2012-2013
Technical Report 2013-57

February 2014

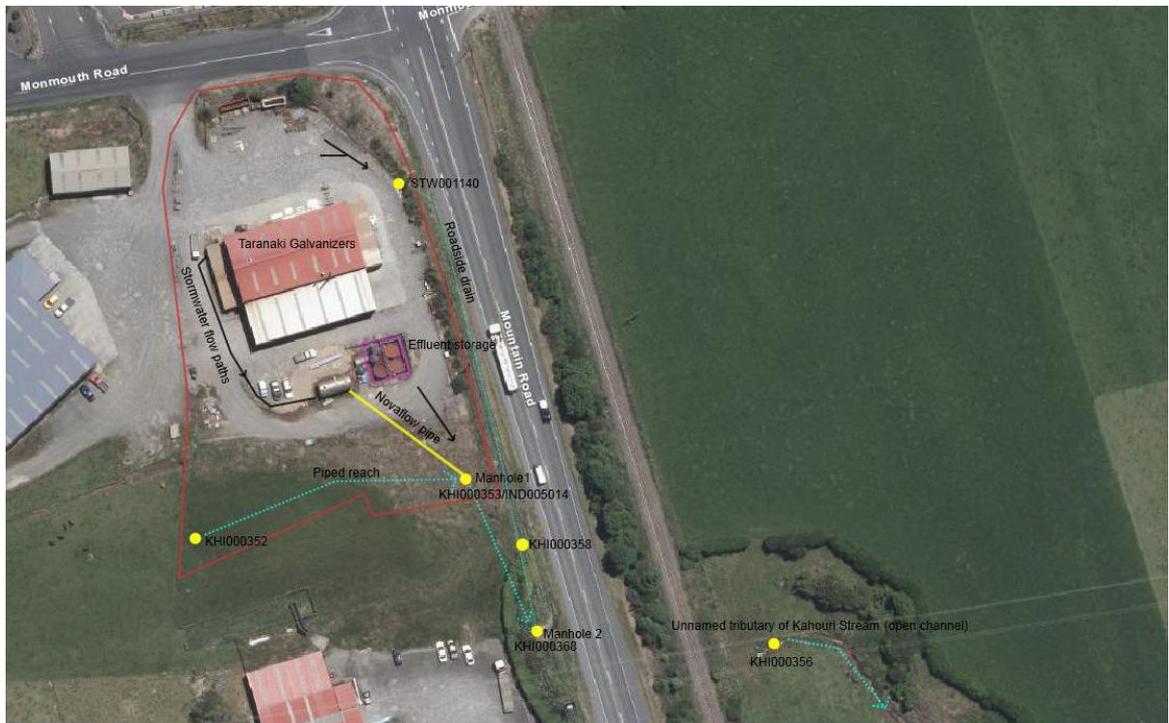
Figure 1 Taranaki Galvanizers site layout

The galvanising plant owned and operated by Taranaki Galvanizers is situated at the corner of State Highway 3 and Monmouth Road, approximately 1 km north of Stratford (Figure 1). Road access to the site is via Monmouth Road.

The galvanising plant is positioned in the central part of the site and houses a series of treatment tanks involved in the galvanising process (Figure 1). Two exhaust fans, one positioned at either end of the main building, are used to extract fumes from the building during galvanising operations. Large doors positioned on the northern and eastern sides of the main building provide access for the receipt and dispatching of materials at the site.

Stormwater from the southern side of the site either flows overland to a grated manhole (manhole 1 in Figure 1) on the southeastern corner of the site or via a yellow novaflow pipe that then discharges into this same manhole. The yellow novaflow pipe conveys both site stormwater and some groundwater seepage from the southern end of the site and is therefore referred to as an industrial discharge as opposed to only a stormwater discharge. The piped unnamed tributary enters manhole 1 immediately above the point of discharge from the yellow novaflow pipe (Photo 1).

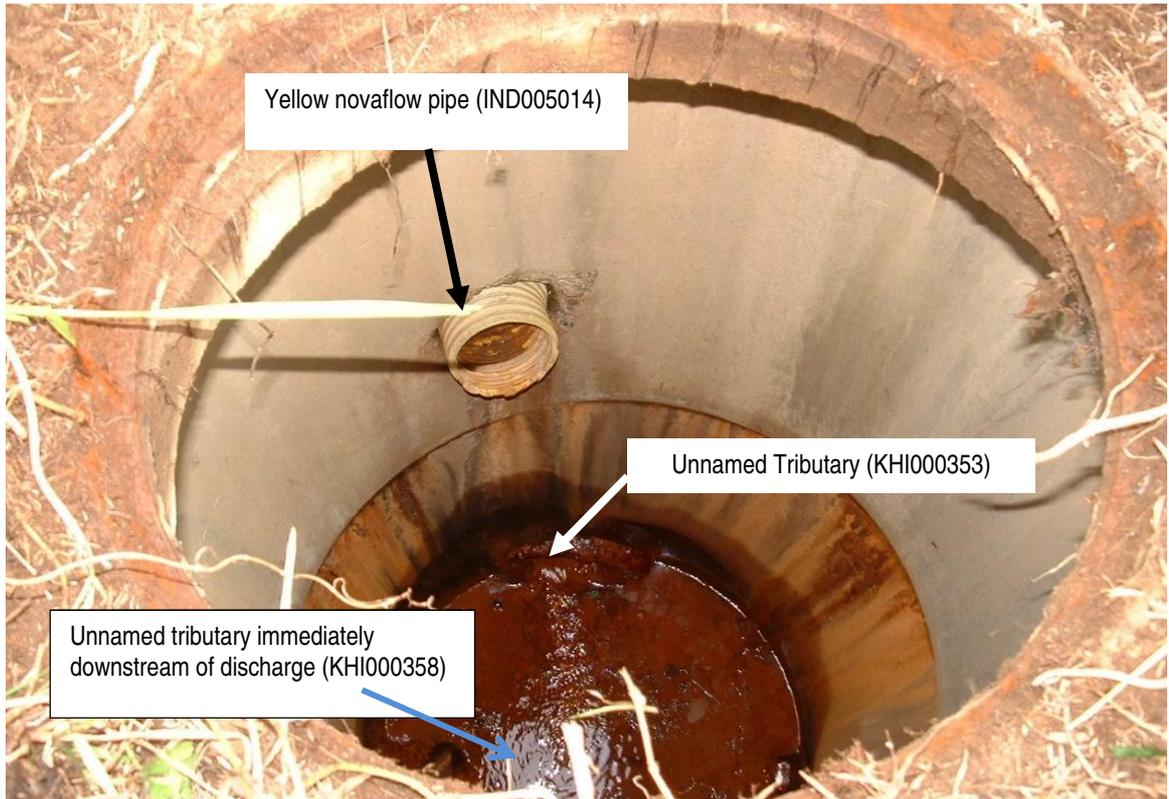
Photo 1 The view down manhole 1 including outlet of the unnamed tributary, the yellow novaflow pipe from the Taranaki Galvanizers site (IND005014) and the tributary immediately downstream of the discharge (KHI000358)

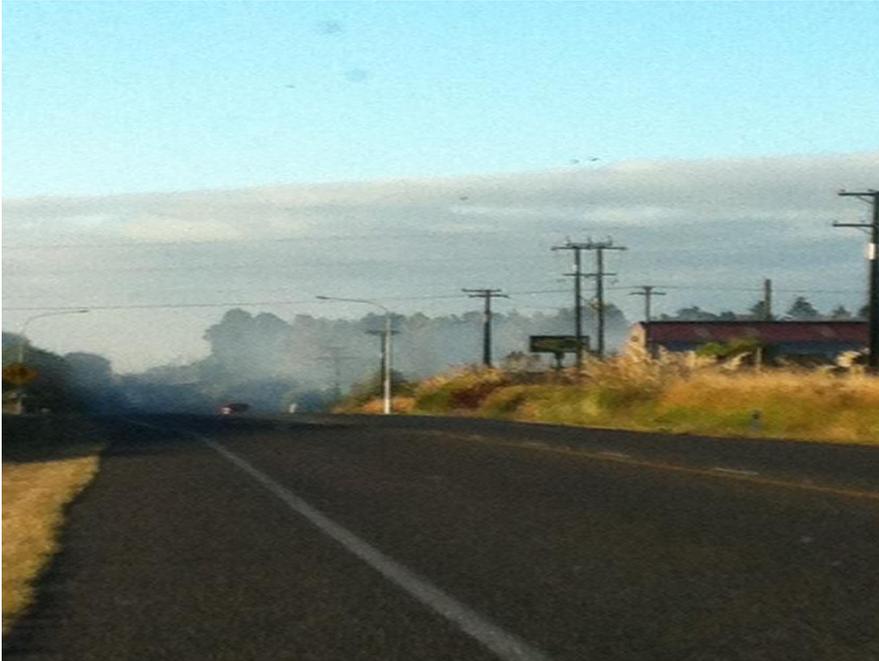
On 6 March 2013, at around 8am, a visible discharge to air was observed extending outside of the Taranaki Galvanizers boundary (Photo 2). Such emissions are known to be predominantly water vapour, ammonia and occasionally smoke, released during the galvanizing process. Smoke can be produced when an item has not been completely cleaned before being immersed into the hot, (>400 °C) bath of molten zinc. On this occasion, no boundary investigation was undertaken and as such, it wasn't determined whether or not this discharge was potentially offensive or objectionable. However, no complaints were received in relation to this or any similar discharge during the year.

Photo 2 Visible discharge to air from Taranaki Galvanizers (6 March 2013)
