# Concrete Batching Plants Monitoring Programme Annual Report 2015-2016

Technical Report 2016–78

August 2016

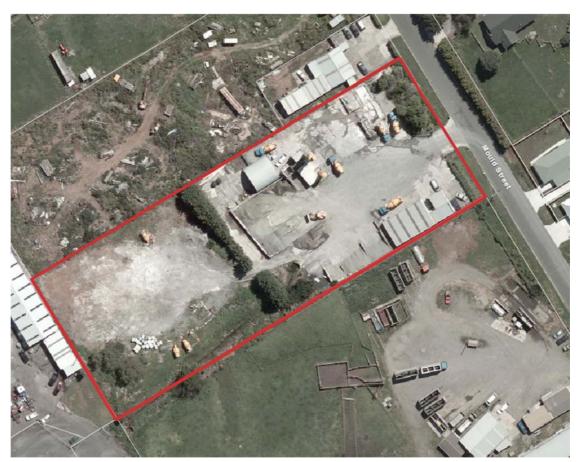
Figure 1 Location of Allied Concrete site, Mould Street, Waitara

Wastewater on the site consists of potentially contaminated stormwater from around the concrete batching plant and aggregate storage areas, and water from washing the concrete trucks. Therefore, the discharges typically contain some cement deposits and other sediments. The wastewater is treated in a four pond settling system, with water recycled from the fourth pond for use in truck washing and in the concrete making process.

Sludge from the settling ponds is removed periodically and stored on site to dry. Excess concrete from the returning trucks is also off loaded at the site, where it is then made into large blocks that are sold to farmers and local contractors.

Allied Concrete have recently made a number of improvements to their stormwater and wastewater management system. In the instances when the pond system overflows, a silt trap and a rock lined basin have been installed to further treat the discharge. This will optimise treatment efficiency prior to the flow reaching the wetland (referred to as the soakage basin in the Allied Concrete's water management plan). A dish channel has been cut near the main entrance to redirect all stormwater from the front yard into the wetland. It has been confirmed by Council that there is an obstructed outlet in this wetland that connects to the New Plymouth District Council reticulated stormwater system and enters a tributary of the Waitara River adjacent to 86 Mould Street.

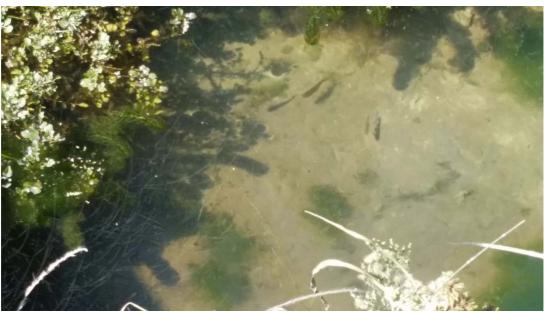
There were no significant environmental effects found that were associated with Allied Concrete's operations. Despite the noticeable deposition of concrete fines on the bed of the tributary at the culvert inlet, unidentified Galaxiid, thought possibly to be Banded Kokopu were found at this location during site visit on 11 March 2015 (Photo 1). The presence of these fish is indicative of the stream's life supporting capacity. Fish were again noted to be present in this area at an inspection during the year under review.

Photo 1 Unidentified Galaxiids found in the tributary at the culvert inlet on the Allied Concrete Waitara site

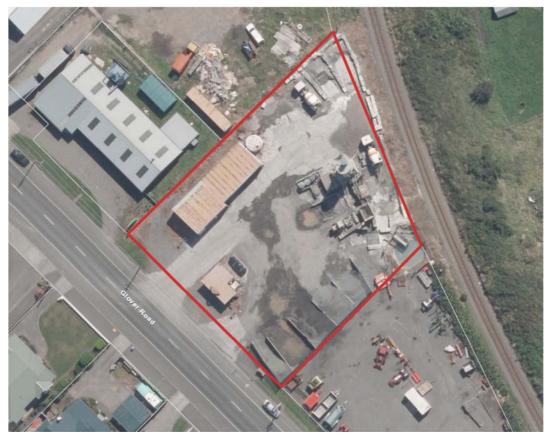
Figure 2 Location of Firth Industries site, Glover Road, Hawera

Wastewater on the site consists of stormwater from around the concrete batching plant and aggregate storage areas, as well as water from washing the concrete trucks. Therefore, the wastewater typically contains some cement deposits and other sediments. Wastewater is treated in a three pond settling system, with water recycled from the third pond for truck washing and use in the concrete making process.

Sludge from the settling ponds is removed periodically and stored on site to dry. Excess concrete from the returning trucks is also off loaded at the site, and is then made into large blocks that are sold to farmers and local contractors.

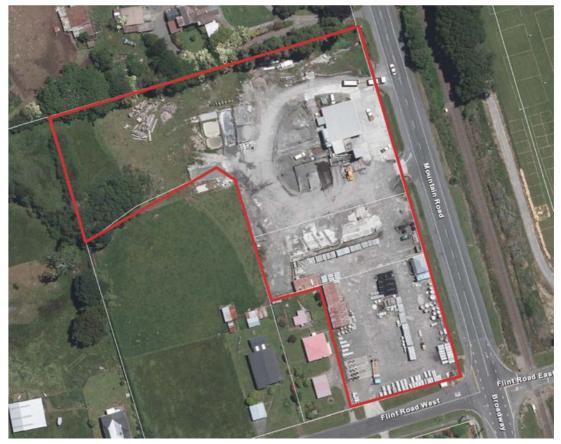
Figure 3 Fletcher Concrete site (Firth Industries and Humes Pipeline Systems), Stratford

- Additional wastewater from the Humes pre-cast pipe manufacturing plant is to be directed to the concrete batching plant wastewater pond and settling system;
- The provision for recycling of truck wash, batching plant and pipe manufacturing wastewater, including two new wastewater holding tanks with the combined capacity of 45,000 litres; and

Two new sludge drying bins and a concrete mould area. These are to be fully contained, with wastewater being directed to the truck wash out wastewater settling area.
