Ballance Agri-Nutrients (Kapuni) Ltd  
Monitoring Programme  
Annual Report  
2017-2018

Technical Report 2018–47

Taranaki Regional Council  
Private Bag 713  
STRATFORD  
March 2019

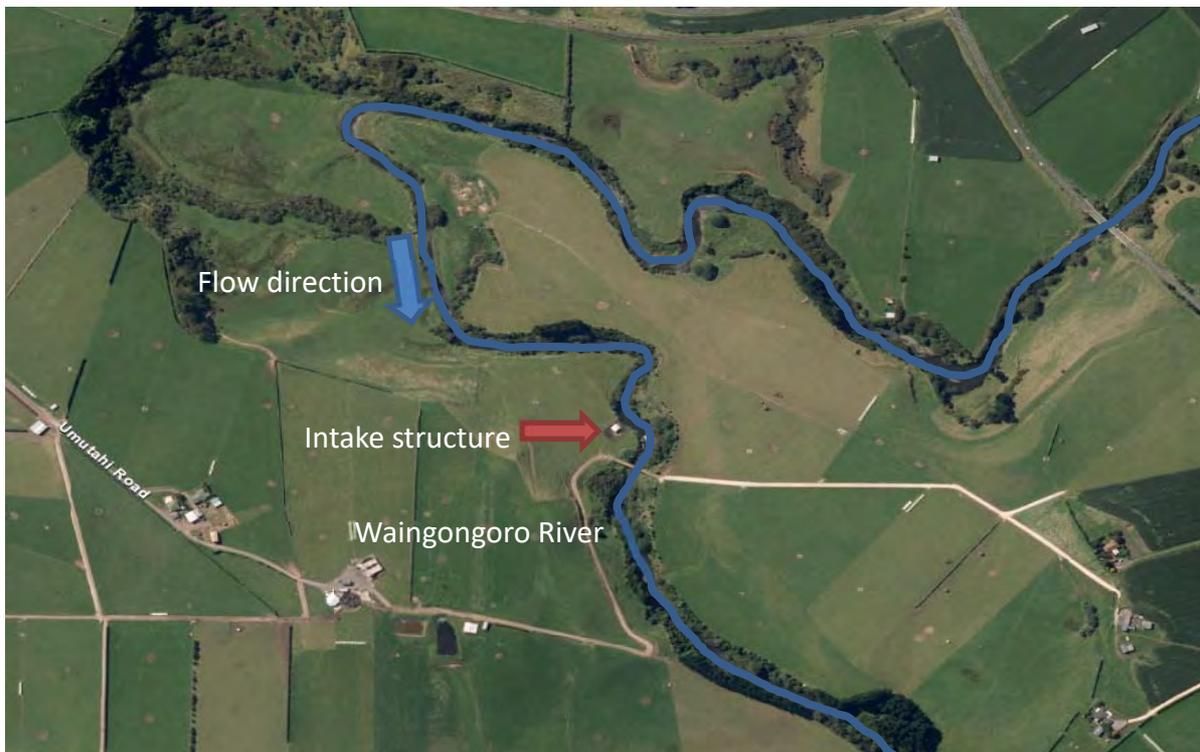
Figure 1 Map showing water intake structure adjacent to the Waingongoro River

Process and operation water for the site is pumped from the Waingongoro River, which is located 7.2 km east from the Company site (Figure 1). Water is pumped at a rate of approximately 140 m<sup>3</sup>/h (3,360 m<sup>3</sup>/d or 39 L/s). The consented daily volume limit, of 3,456 m<sup>3</sup> at a maximum rate of 100 L/s, was increased by 15% to 4,000 m<sup>3</sup>, without an instantaneous limit, under replacement consent 0596-3 in August 2012.

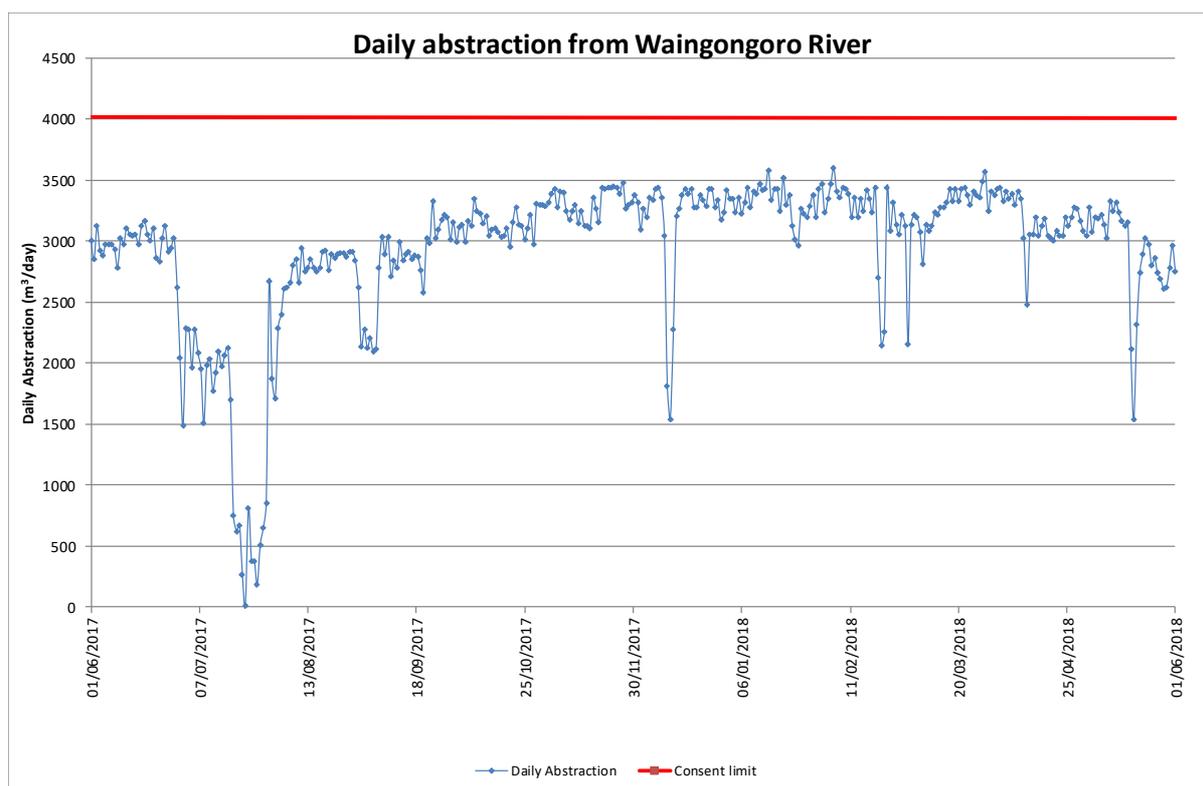
Figure 2 Daily water abstraction by the Company, July 2017 – June 2018

The daily abstraction record for 2017-2018 is presented in Figure 2.

The record shows that the consent limit of 4,000 m<sup>3</sup>/d on maximum abstraction volume was complied with throughout the 2017-2018 review period. The minimum daily recorded volume was 0 m<sup>3</sup>/d and the maximum recorded daily volume was 3,600 m<sup>3</sup>, or 90% of the limit. The median volume was 3120 m<sup>3</sup>/d. The recorded total volume abstracted in the 2017-2018 reporting period was 1,074,667 m<sup>3</sup>, a decrease from the previous year (1,094,167 m<sup>3</sup>) of 2%.

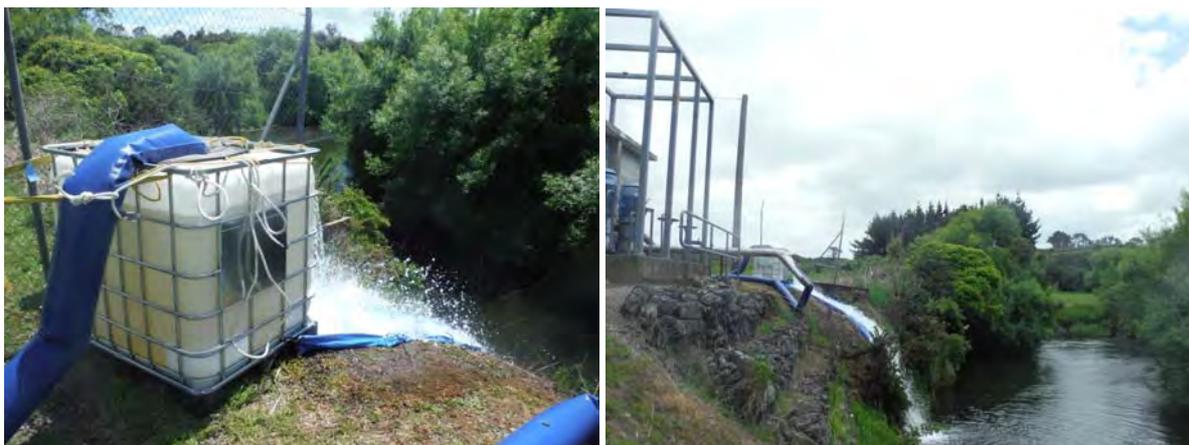
Photo 2 Intake fish entrainment trial, 27 November 2014

Following the October 2014 consultation, a procedure was developed for the monitoring of any fish entrainment at the Company intake. The procedure involves the placement of a trap on the flow that is returned to the river via the "spillback" pipe (Photo 2). The trap comprises a fine mesh (2 mm by 1.5 mm) net in a perforated industrial bulk container (IBC). A large proportion of the water that is abstracted from the river under normal plant operation is diverted through the trap. Any animals caught are identified, counted and recorded. The trap can be operated at any time, to monitor for diurnal or seasonal variation in fish entrainment.

The first sampling run was conducted successfully on 27 November 2014 between 1120 and 1300 NZDT during a recession in river flow ( $1.2 \text{ m}^3/\text{s}$  at Eltham Road hydrometric station, 13 km upstream, exceeded 66% of the time). Flow through the trap was raised gradually to  $78 \text{ m}^3/\text{h}$ , or  $22 \text{ L/s}$ , and held for over an hour, with a total volume sampled of about  $97 \text{ m}^3$ . The animals and detritus that were trapped are shown in Photo 3. No fish were caught. Eleven invertebrates were caught, including a stonefly, an adult dipteran and nine caddisfly, of which three were alive. Obtaining such small whole live specimens demonstrated that fish are not likely to be macerated by the pumps, and that fish larvae are not likely to escape through the net.

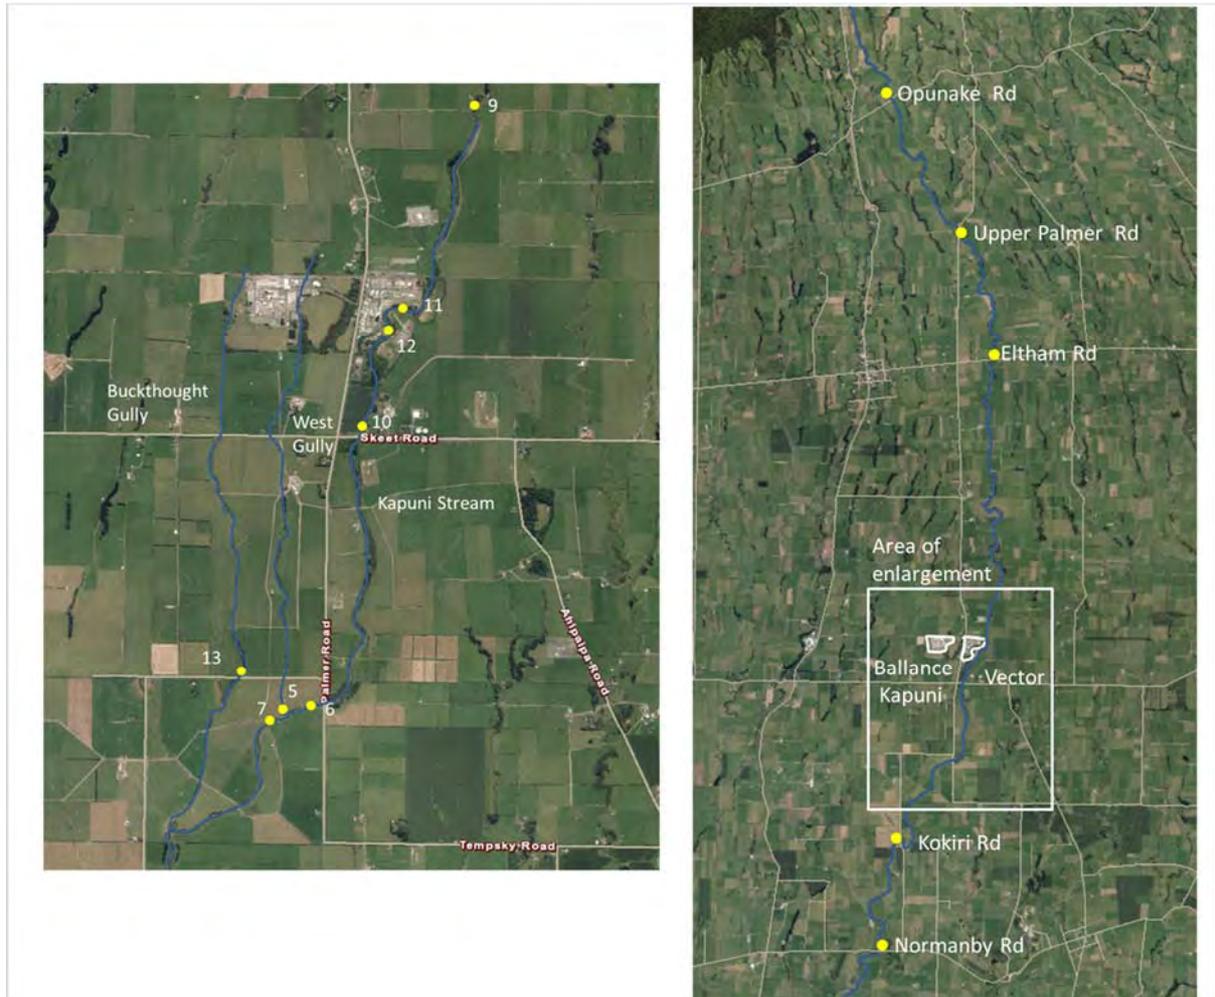
Figure 3 Biomonitoring sites in the Kapuni Catchment

The programme involved assessment of changes in the abundance and diversity of the macroinvertebrates and fish communities. Up to nine sites in the Kapuni catchment, seven on the main stream and two in gullies that run through the irrigation area were monitored quarterly for benthic macroinvertebrates and biannually for fish by electric fishing (Figure 3). Monitoring results and their interpretation are forwarded to the Council quarterly.

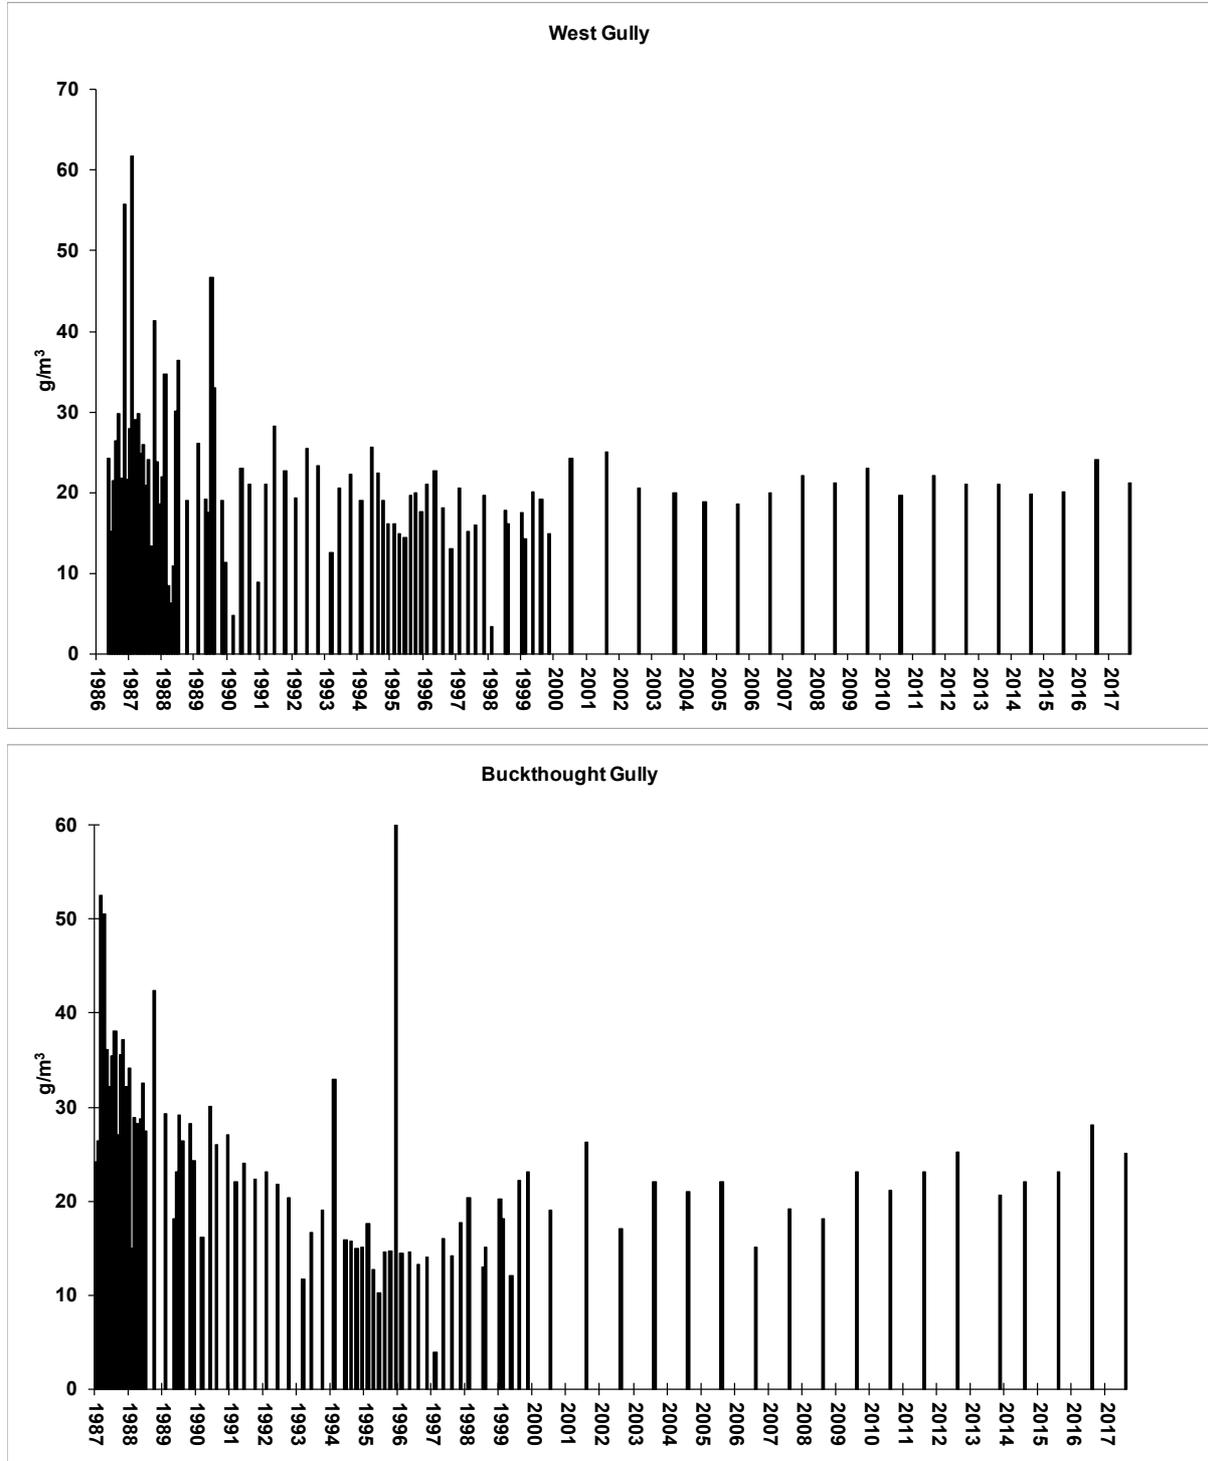
Figure 4 Total nitrogen concentration for West and Buckthought Gully (unnamed tributaries of the Kapuni Stream)

The surface tributaries of the Kapuni Stream which pass alongside, or under, the plant and irrigation areas have also been monitored regularly for nitrogen, which is found almost entirely as nitrate-nitrogen. Results for East Gully have remained generally below 10 g/m<sup>3</sup>N, whilst the water in West Gully is generally in the range 15-25 g/m<sup>3</sup>N (Figure 4).

The concentrations of total nitrogen recorded in Buckthought Gully have shown a decrease from the peaks of the late 1980s and, since the late 1990s, total N has fluctuated in the range 18-26 g/m<sup>3</sup>N. The value of 25.1 g/m<sup>3</sup>N recorded during the current monitoring period (August 2017) represents a slightly higher than average result since results stabilised after 1990, but an improvement on the previous year of 28.1, which was the highest value recorded since December 1995.

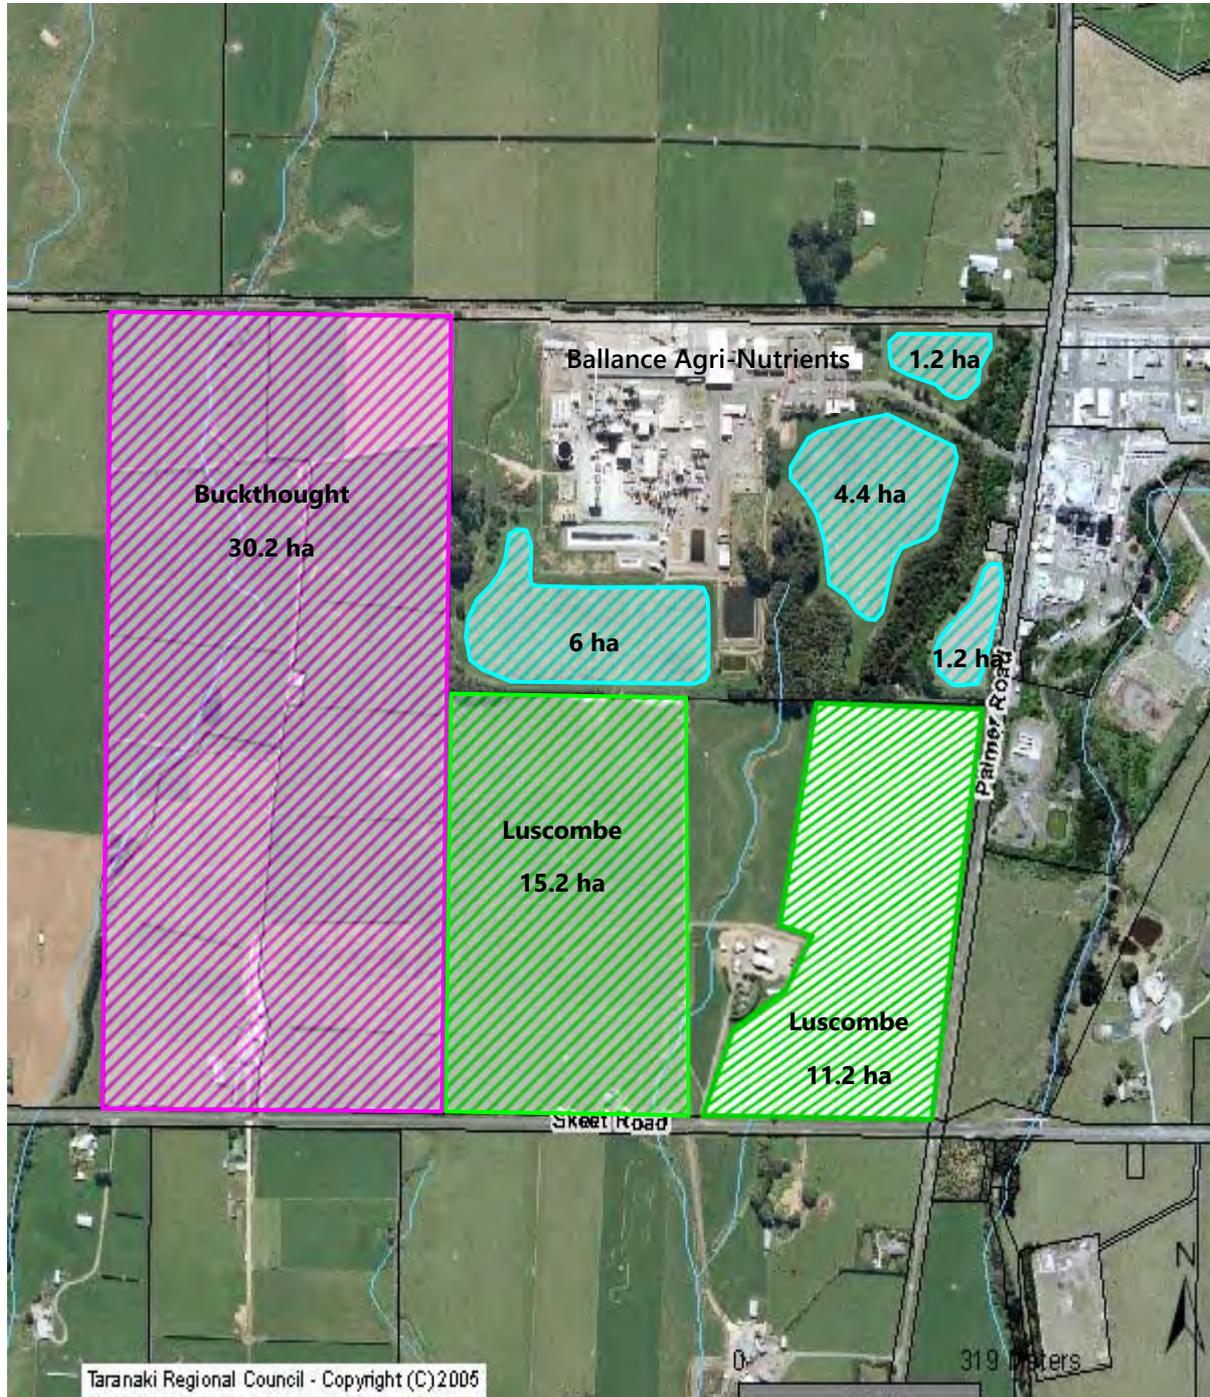
Figure 5 Irrigation areas for the 2017-2018 year

The Company site was inspected on four occasions in the year under review. On each occasion site management was found to be good and the effluent management system, irrigation areas, and stormwater systems found to be working well.

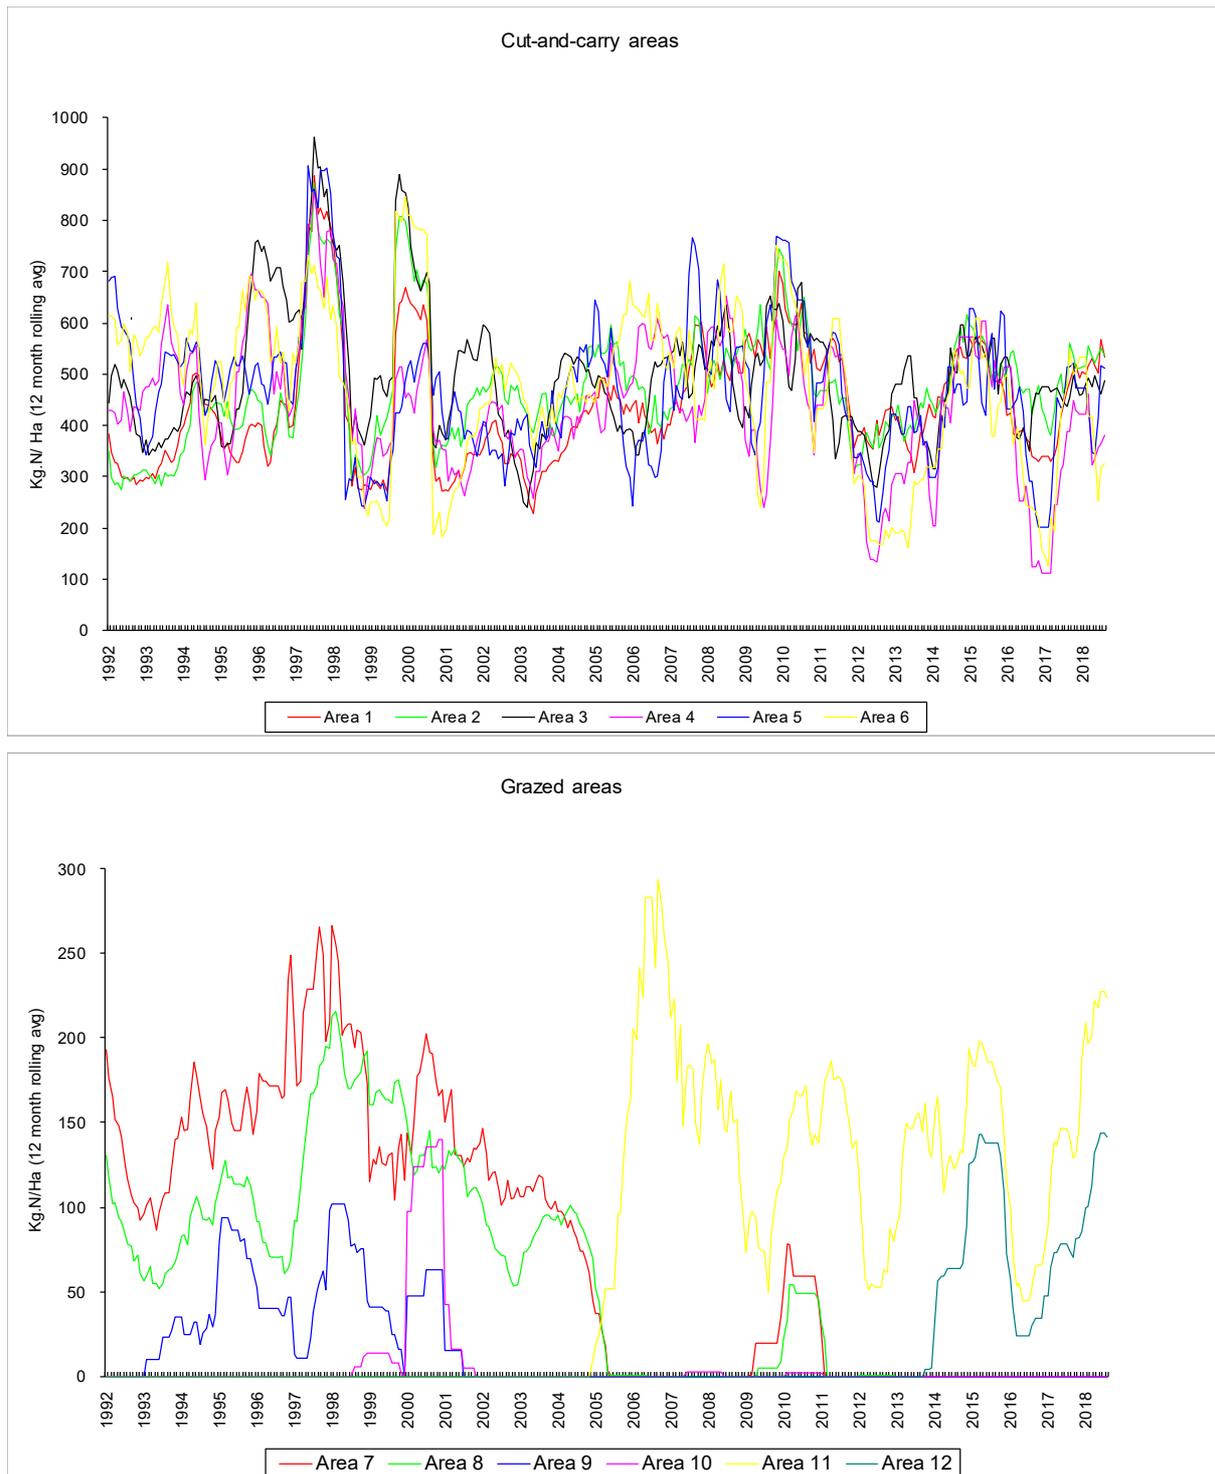
Figure 6 Nitrogen application rates on spray irrigation areas, January 1992 to June 2018

The Company complied with the maximum application rate of 300 kgN/ha/y as specified in the resource consent conditions for the grazed areas at all times during the 2017-2018 monitoring period. The average application on the grazed areas amounted to 192 kgN/ha/y.

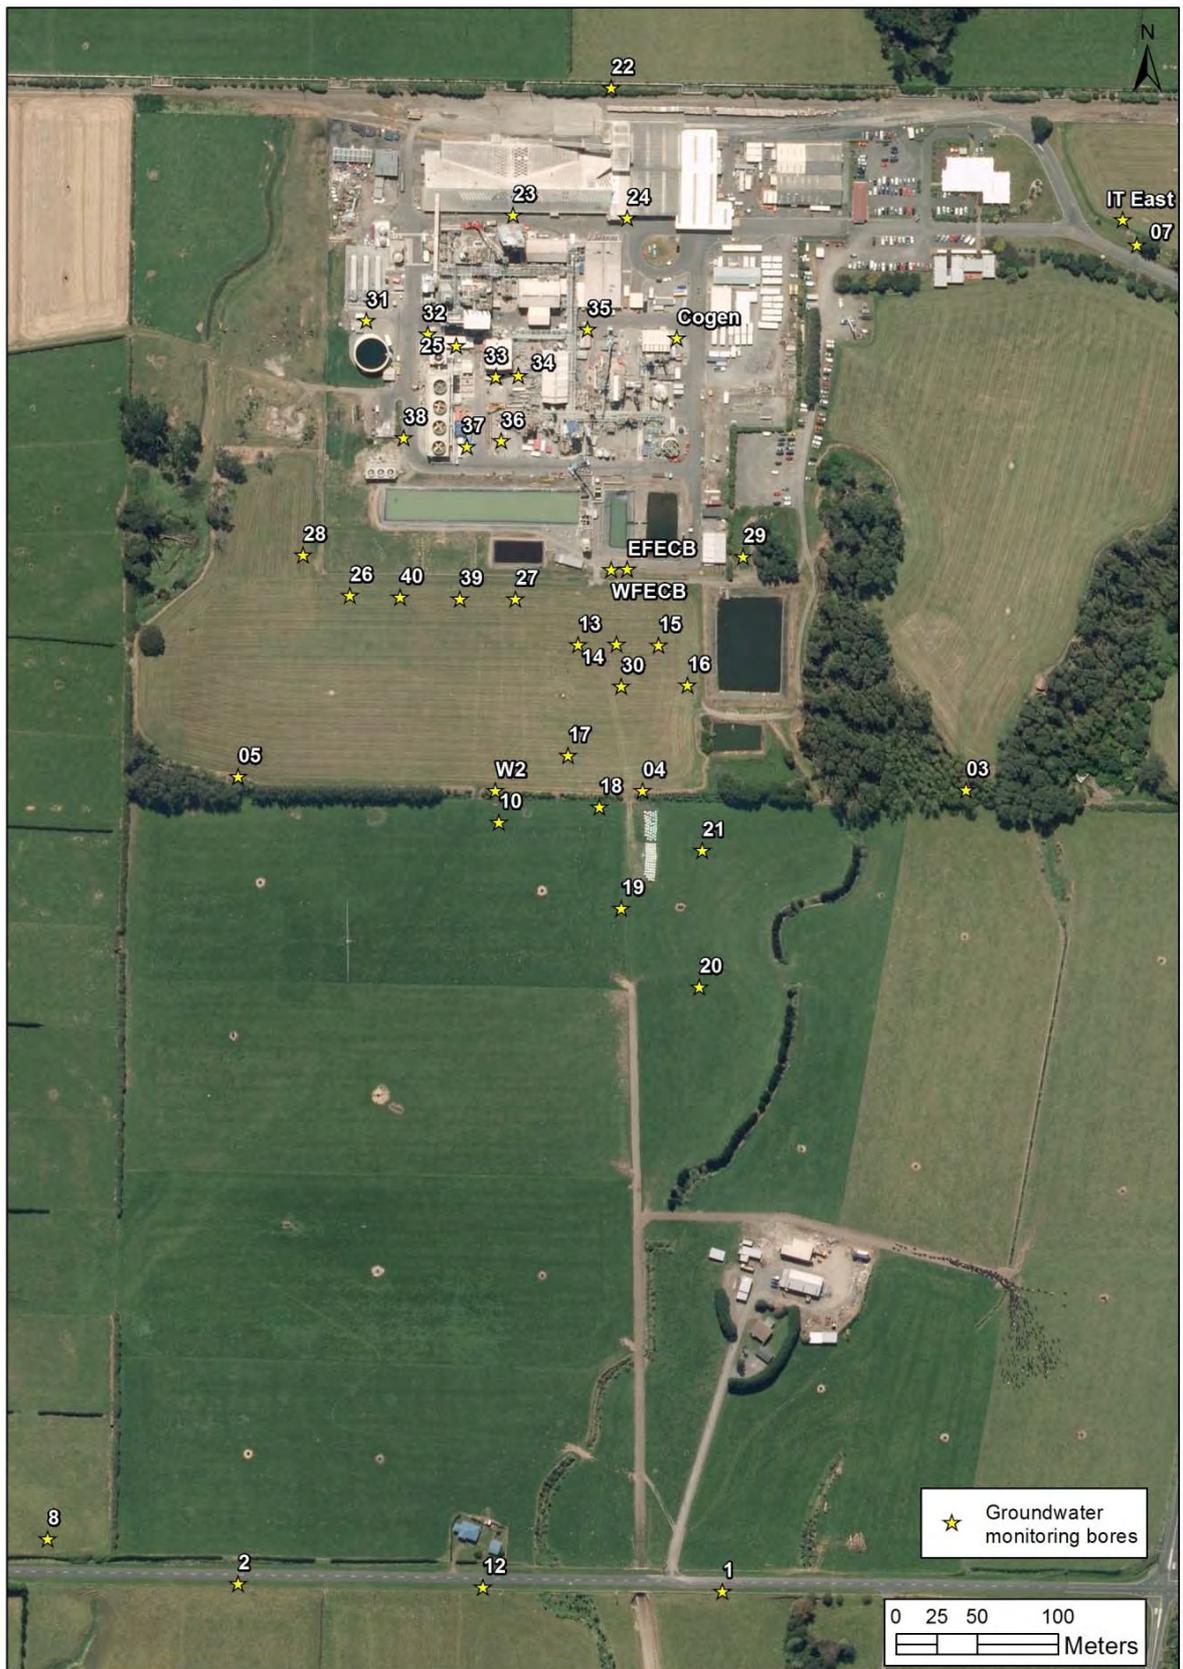
Figure 7 Locations of groundwater monitoring bores

Site	Monitoring bore	Approximate Total N Concentrations (g/m <sup>3</sup> )
Control site	22	3-13
Irrigation areas	3, 4, 5, 7, 10-1, 10-2, 10-3, 10-4, 10-5, W, W1, W2	100 (Bore 10-5 unaffected)
Skeet Road	1, 2, 8, 12-1, 12-2, 12-3	<3-30
FECB plume	East and West bores, 4, 13 to 21, 30	60-100
Plant site	23 to 29, 31 to 40	300-15,100

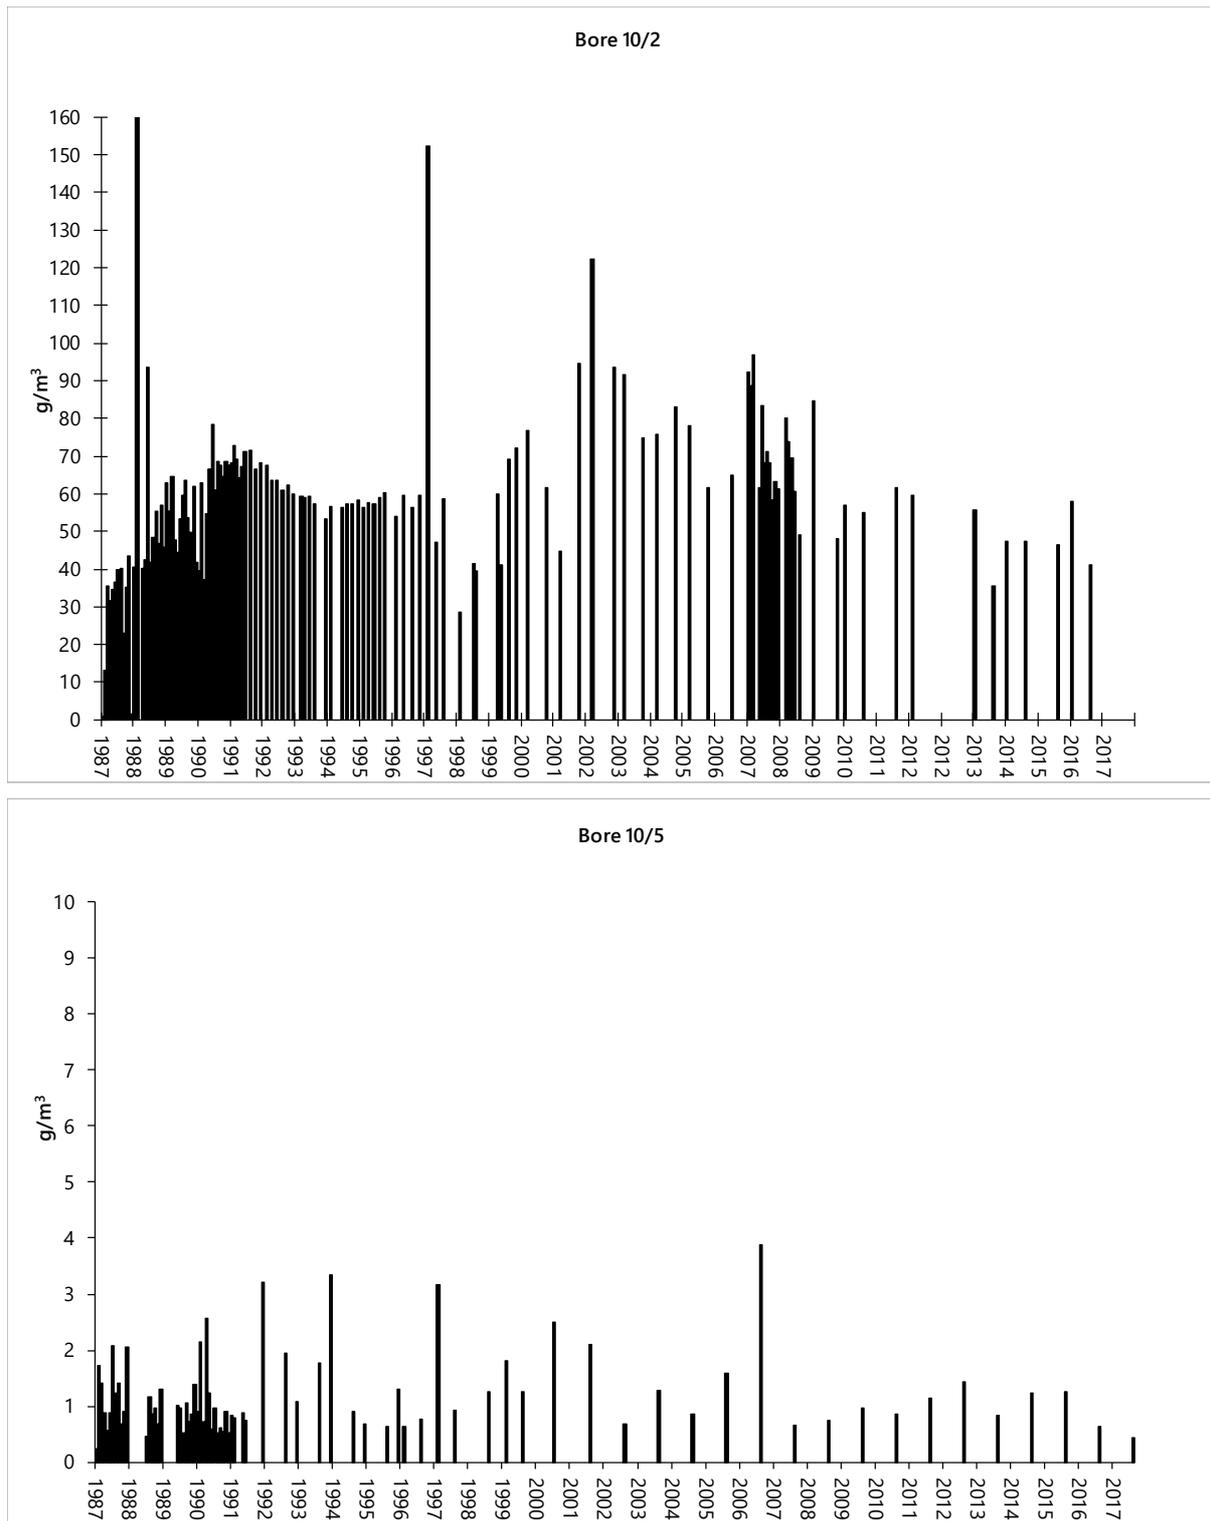
Figure 8 Total nitrogen concentrations in groundwater beneath spray irrigation areas (bores 10-2 and W1, and bore 10/5)

Three of the monitoring bores (Bore 10, Bore W and Bore 12) are multi-piezometric (that is, a cluster of standpipes screened to allow the monitoring and collection of groundwater samples at various depths). These monitoring bores provide the most valuable information as they generate data on the depth of the effects of the irrigated effluent. Bore 10 was drilled at the downslope boundary of the cut-and-carry irrigation area in January 1987; Bore 12 was sunk 500 m further downslope, at Skeet Road, in July 1989. The three shallower piezometers in Bore 10 (10-1, 10-2 and 10-3) were replaced with three piezometers (W, W1 and W2) set at slightly different depth intervals in November 2005, as the seals between some sampling intervals appeared to be failing.

Monitoring results for Bore 10 over the past 31 years have indicated that groundwater is affected by effluent irrigation at a depth of 6.0 to 7.0 m (Bore 10-2), but not at 11.0 to 13.0 m depth (Bore 10-4). Total nitrogen concentrations for Bore 10-2 and Bore W1 are presented in Figure 8, together with values for Bore 10-5 (18.0 to 19.5 m) for comparison.

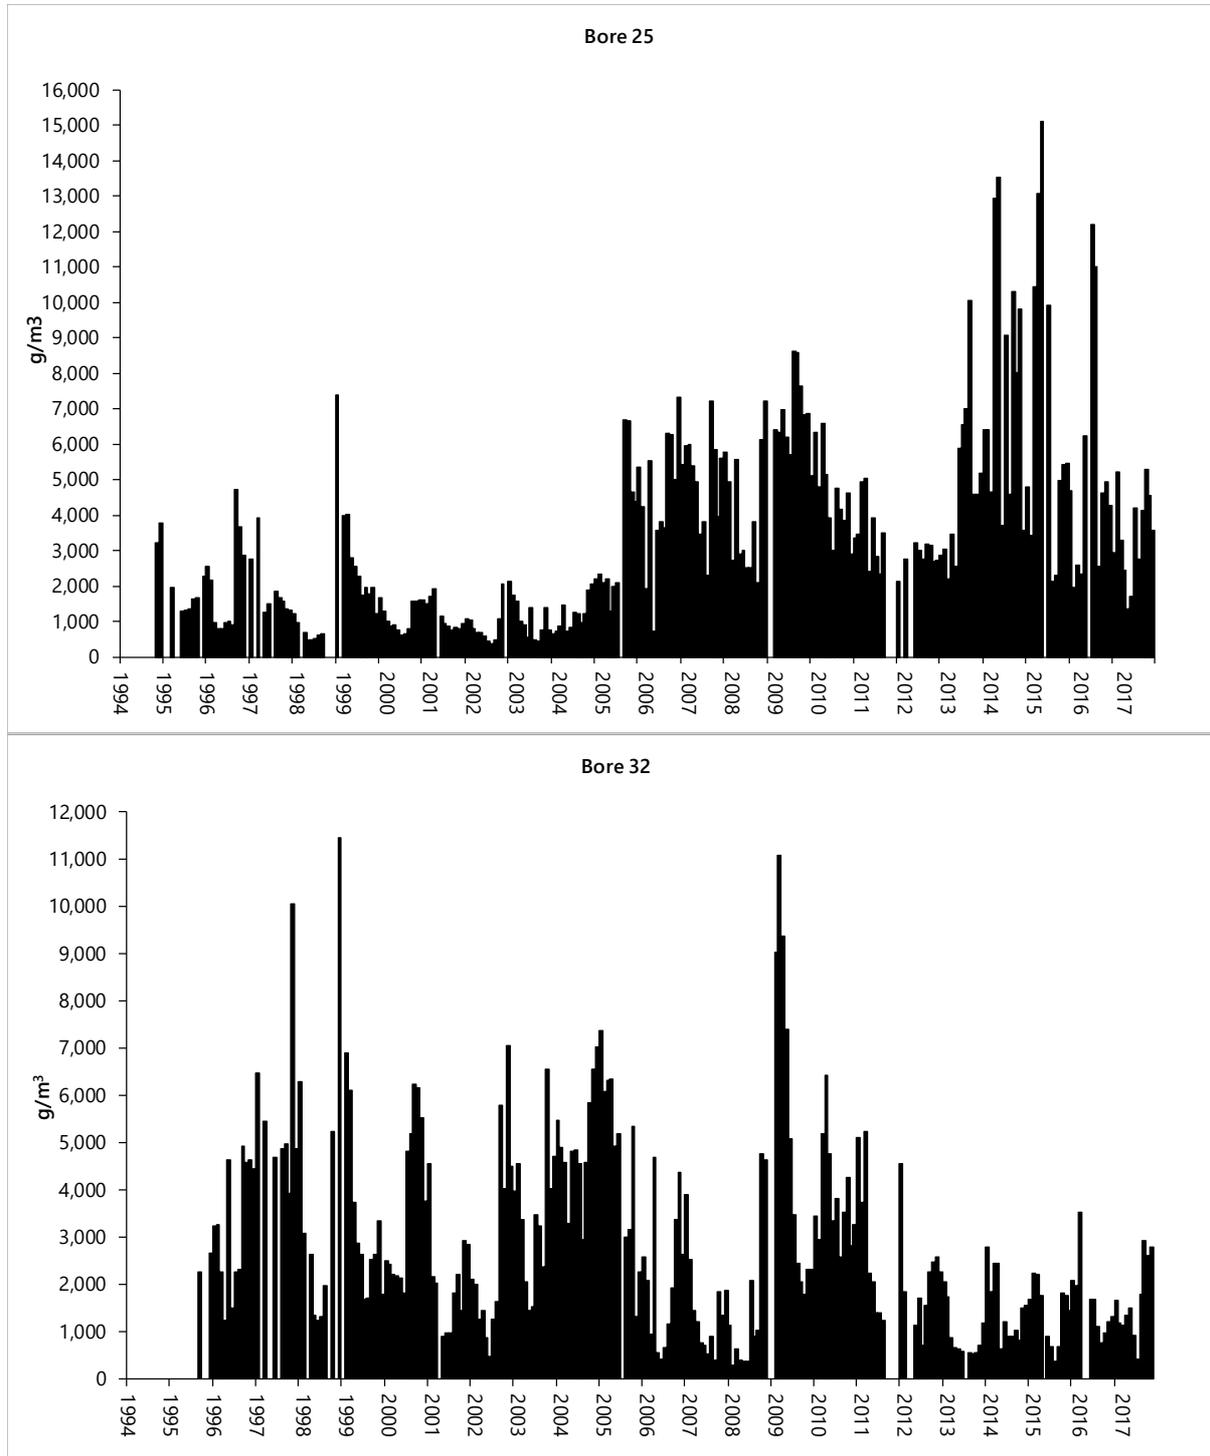
Figure 11 Total nitrogen concentration in groundwater in the vicinity of urea processing (bores 25 and 32) areas

larger proportion recorded as nitrate. Continued annual monitoring is recommended to identify significant trends (if any) in this area. The granulator plume is situated in the middle of the plant site and poses no short-term threat to freshwater ecosystems.

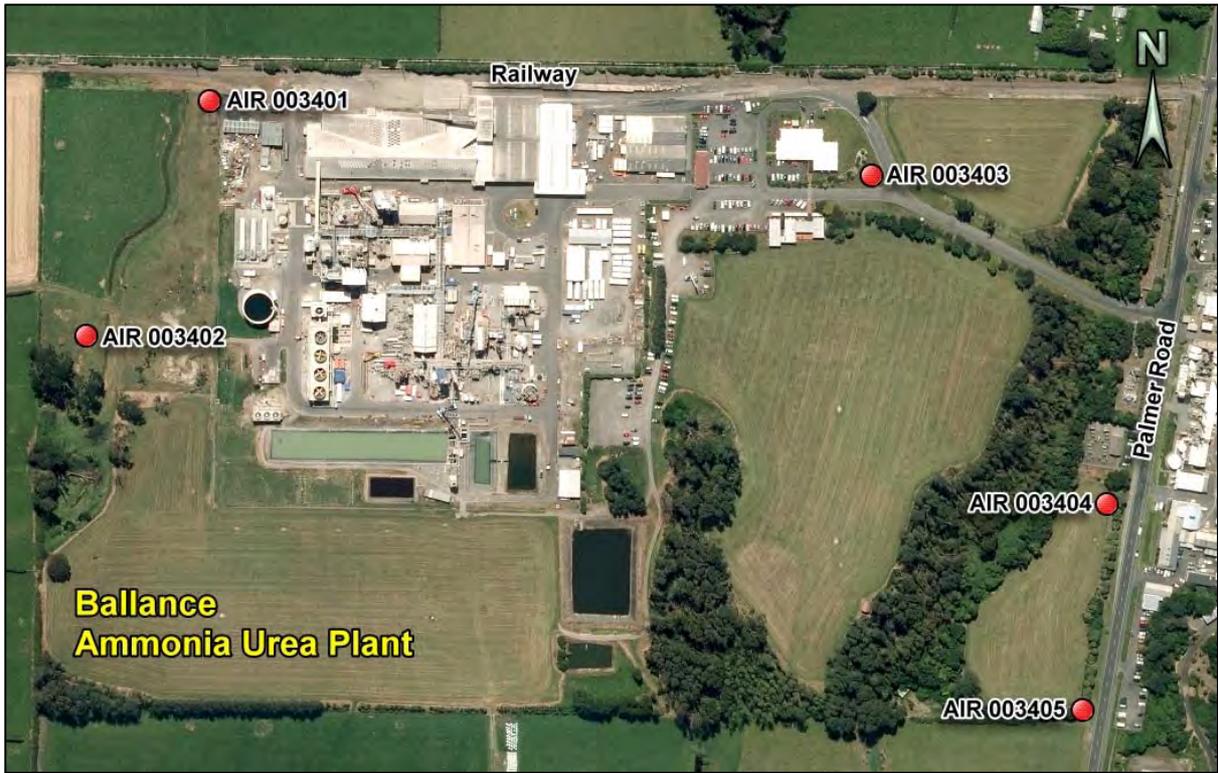
Figure 14 Location of deposition gauge sites 2017-2018

There was a moderate level of rainfall over the 14-day winter 2017 monitoring period, with 34 mm of rain falling at the Council's station on Lower Glenn Road. There was significant wind (at Hawera AWS) from the north and west for the deployment. The results (year 2017-2018) are presented in Table 7. The wind rose for the monitoring period is presented Figure 15.

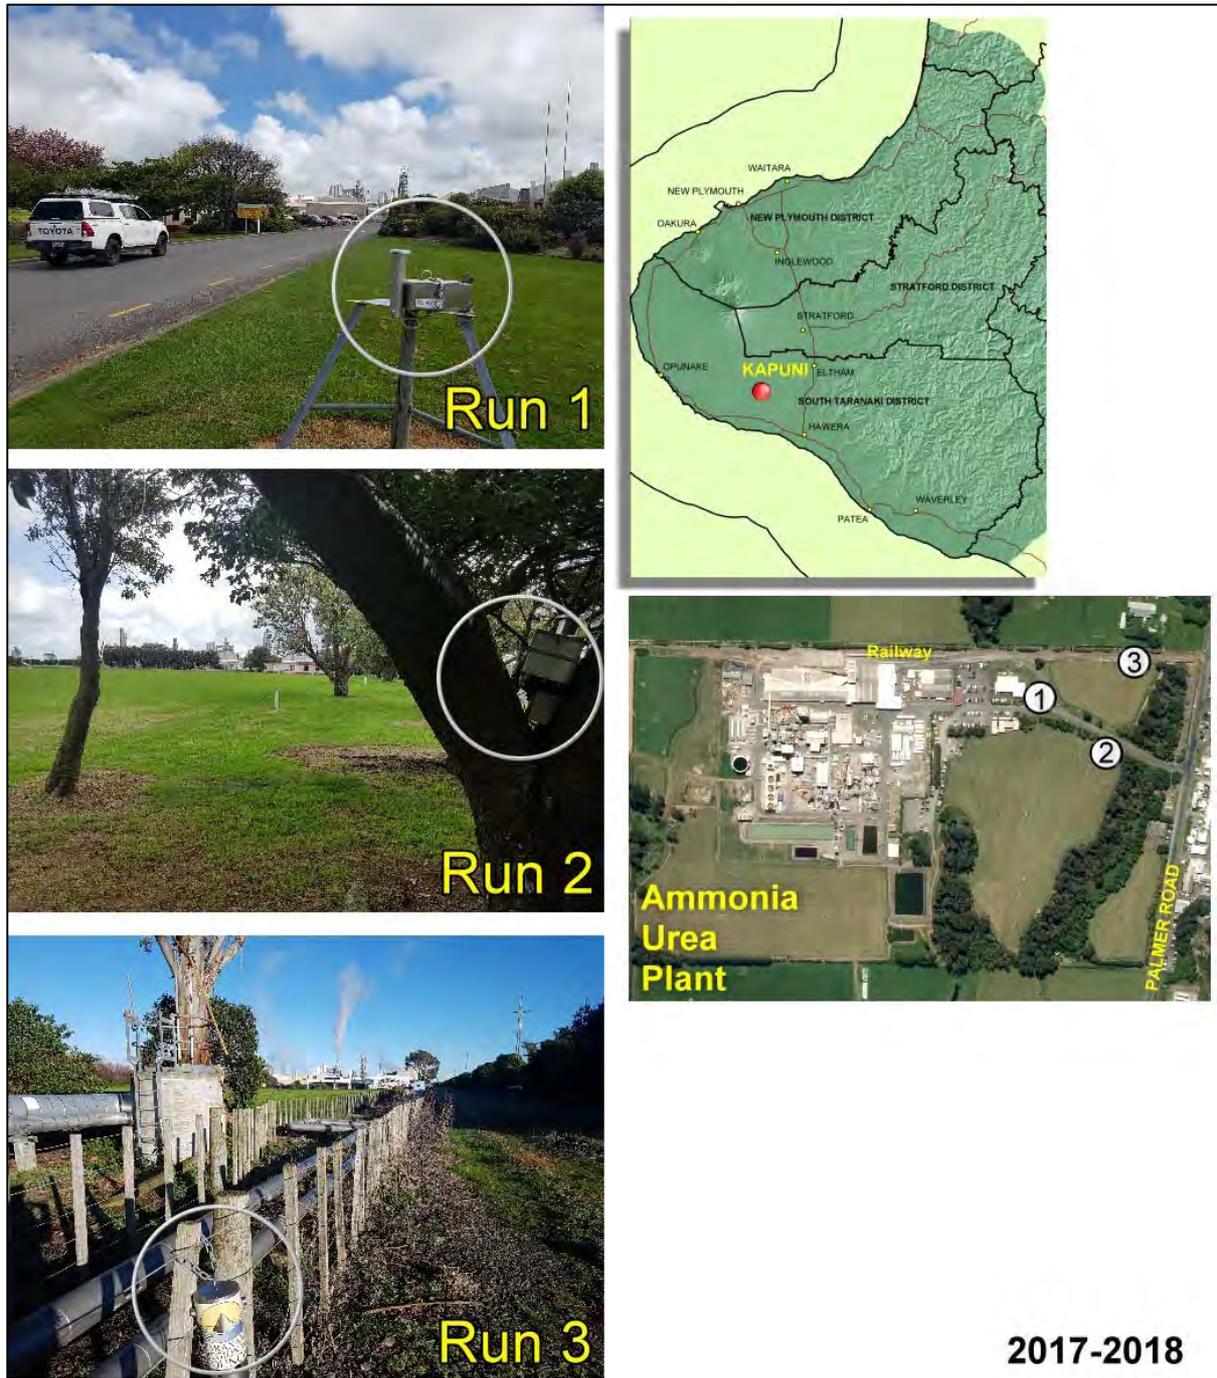
Figure 16 Sampling sites for ambient gas monitoring at ammonia urea plant (2017-2018)

During the monitoring period, a multi-gas detector was deployed on three occasions in the vicinity of the plant. Each survey lasted approximately 48 hours, with the instrument placed in a down-wind position at the start of each deployment. Monitoring consisted of continual measurements of gas concentrations for the gases of interest (ammonia, carbon monoxide, and combustible gases). The location of the multi-gas meter for each sampling run is shown in Figure 16.

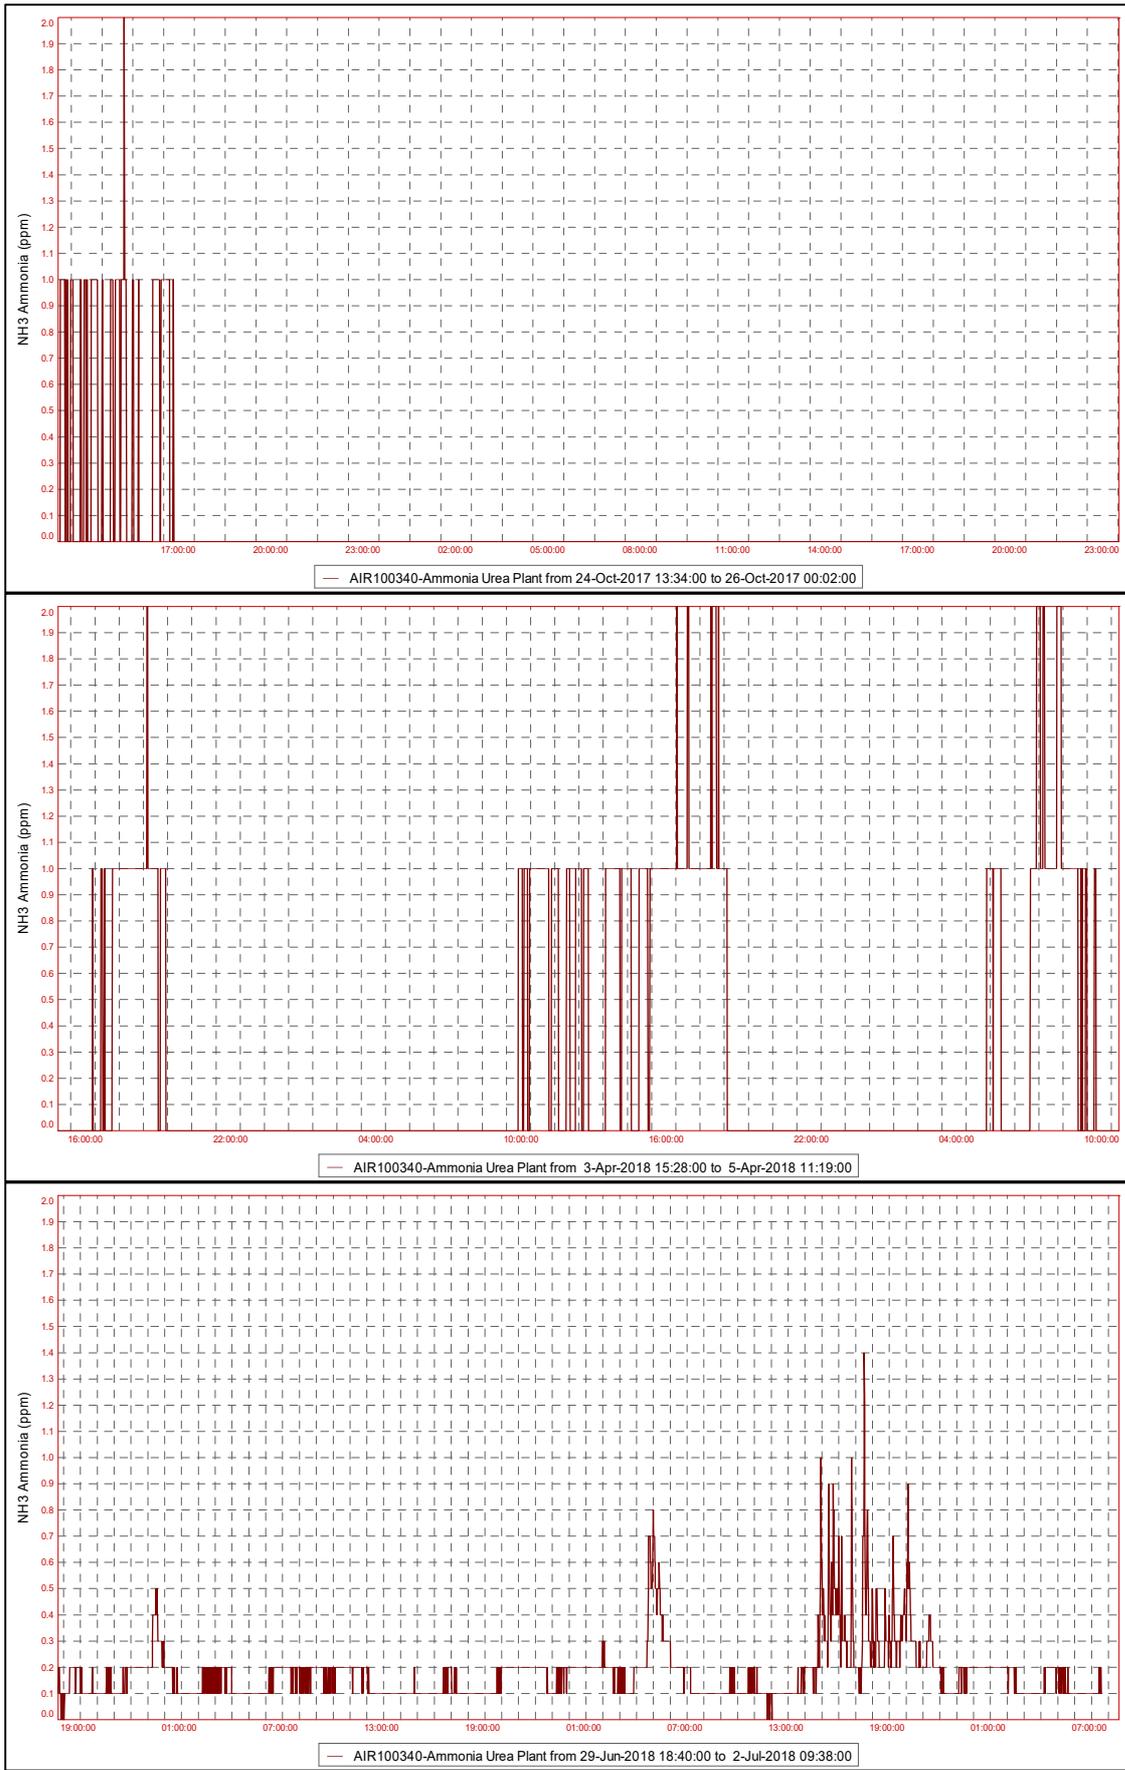
Figure 17 Graphs of ambient ammonia gas levels in the vicinity of ammonia urea plant (2017-2018)

Run		1	2	3	Average
Period (from/to)		24/10/2017 13:34 26/10/2017 00:02	03/04/2018 25:28 05/04/2018 11:19	29/06/2018 18:40 02/07/2018 08:38	
Max	NH <sub>3</sub> (ppm)	2.00	2.00	1.00	1.67
	CO (ppm)	1.00	8.00	1.40	3.47
	LEL (%)	0.00	0.00	0.00	0.00
Mean	NH <sub>3</sub>	0.10	0.30	0.10	0.17
	CO (ppm)	0.10	0.10	0.20	0.13
	LEL (%)	0.00	0.00	0.00	0.00
Min	NH <sub>3</sub>	0.00	0.00	0.00	0.00
	CO (ppm)	0.00	0.00	0.00	0.00
	LEL (%)	0.00	0.00	0.00	0.00
