Ballance Agri-Nutrients (Kapuni) Ltd  
Monitoring Programme  
Annual Report  
2017-2018

Technical Report 2018–47

Taranaki Regional Council  
Private Bag 713  
STRATFORD  
March 2019

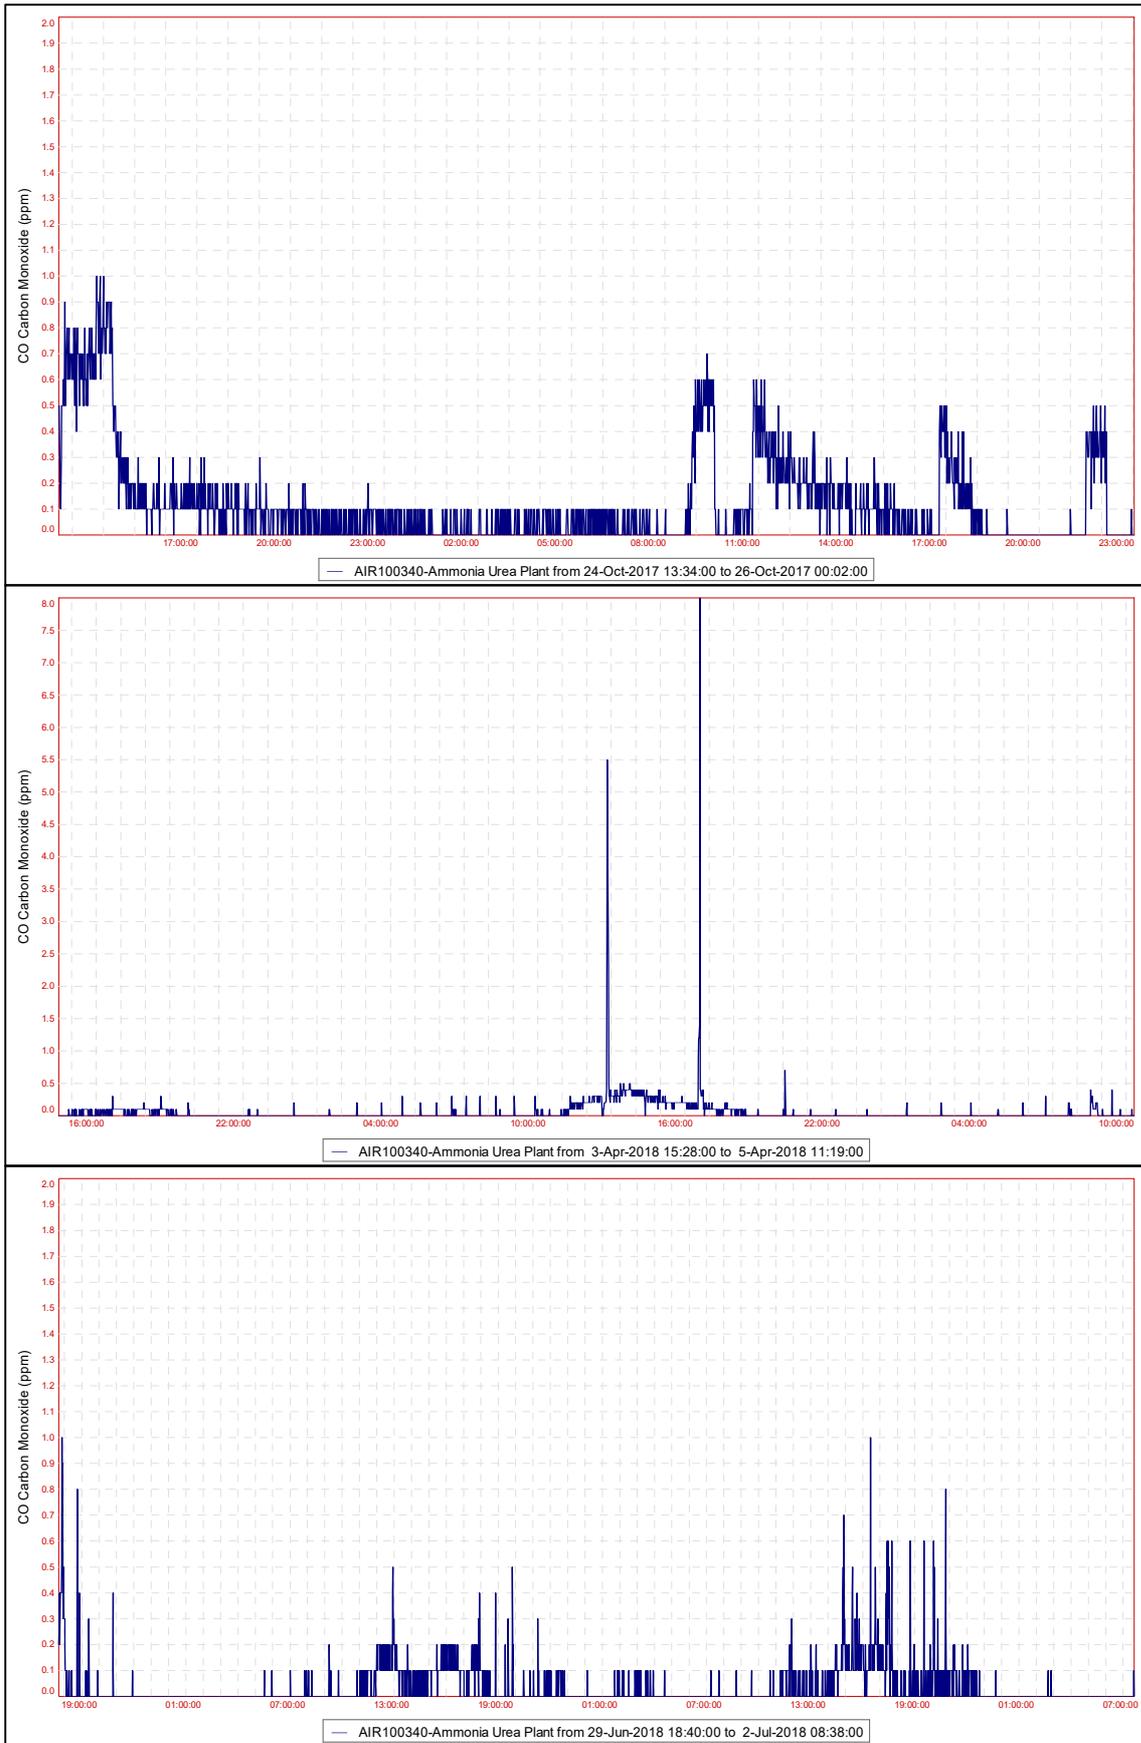
Figure 18 Graphs of ambient carbon monoxide levels in the vicinity of the ammonia urea plant (2017-2018)

Run		1	2	3	Average
Period (from/to)		24/10/2017 13:34 26/10/2017 00:02	03/04/2018 25:28 05/04/2018 11:19	29/06/2018 18:40 02/07/2018 08:38	
Max	NH <sub>3</sub> (ppm)	2.00	2.00	1.00	1.67
	CO (ppm)	1.00	8.00	1.40	3.47
	LEL (%)	0.00	0.00	0.00	0.00
Mean	NH <sub>3</sub>	0.10	0.30	0.10	0.17
	CO (ppm)	0.10	0.10	0.20	0.13
	LEL (%)	0.00	0.00	0.00	0.00
Min	NH <sub>3</sub>	0.00	0.00	0.00	0.00
	CO (ppm)	0.00	0.00	0.00	0.00
	LEL (%)	0.00	0.00	0.00	0.00

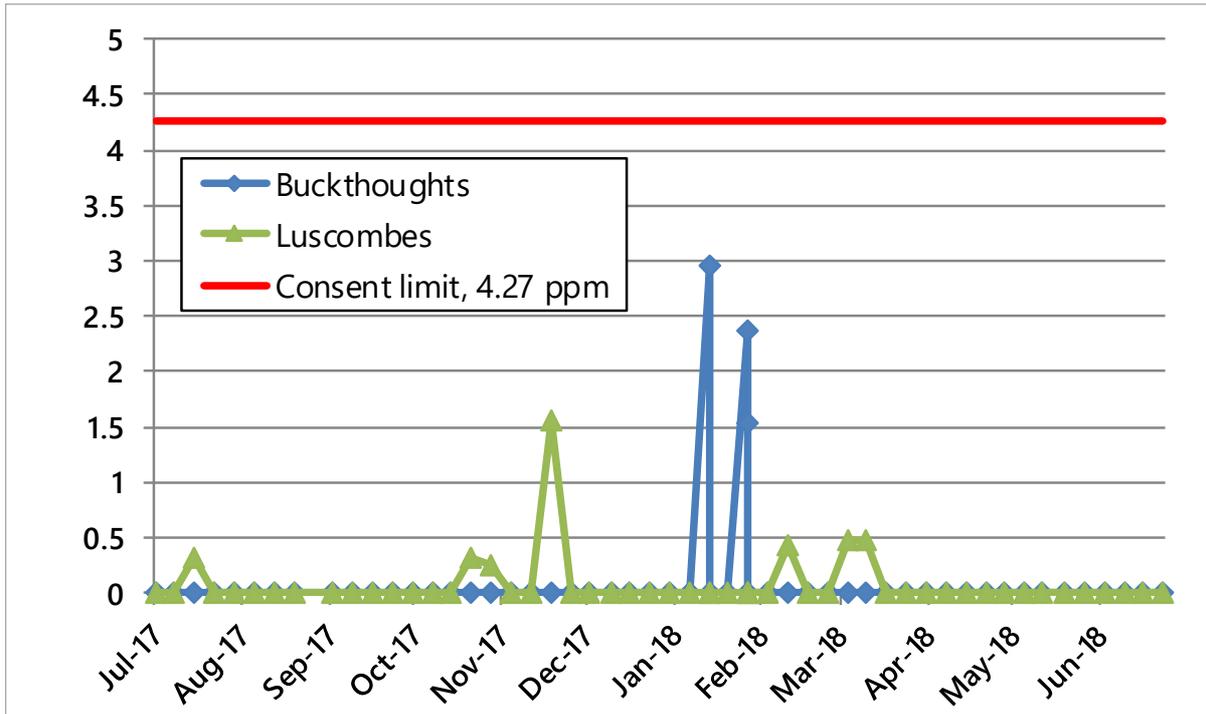
Figure 19 Atmospheric ammonia concentration at ground level on site boundary, ppm (v/v) (2017-2018)

In September 2012, two static monitoring stations for measurement of atmospheric ammonia concentration were established on the western and southern boundaries of the cut-and-carry irrigation area, in consultation with the owners of the adjacent properties, who had requested such monitoring at pre-hearing meetings on the consent application, to determine any long-term trends. The start of the weekly three-hour sampling window was changed from 7.00 am to 1.00 pm, with the approval of Council, to fit better with the Company laboratory workload. Ammonia concentration was measured using a Draeger CMS instrument. Usually, one measurement is taken, over a period of about 10 minutes. The results of ambient ammonia monitoring for the period 1 July 2017 to 30 June 2018 are presented in Figure 19.

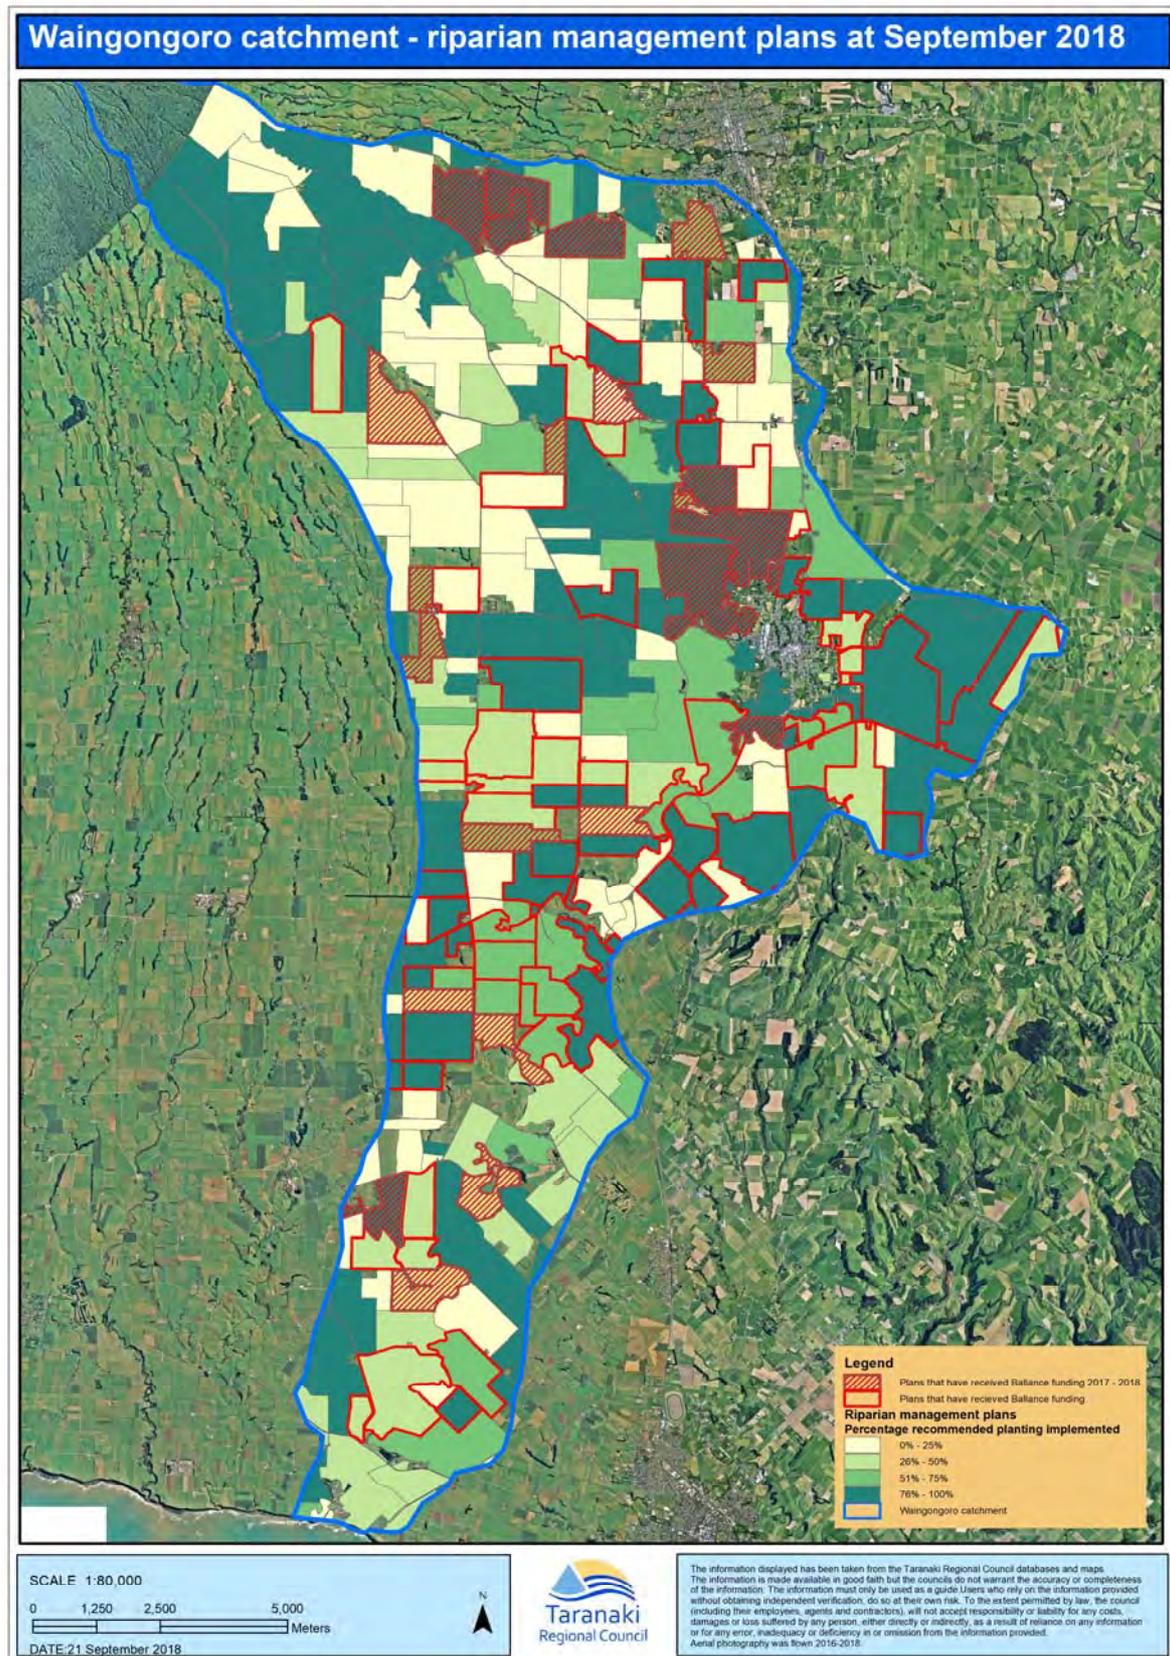
Figure 20 Riparian management plans in Waingongoro catchment with Company funding

in Figure 20. The proportion of recommended planting that has been implemented is indicated for each property.

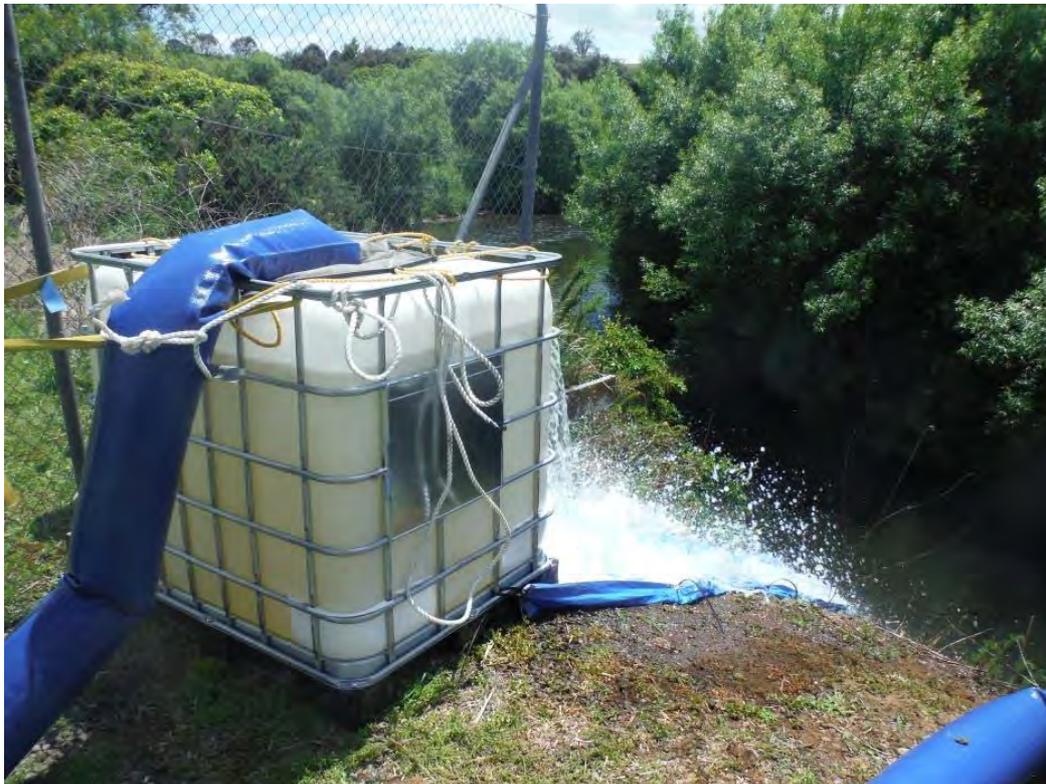
Figure 2. Sampling in operation at full velocity (75 m<sup>3</sup>/h)

The sampling procedure required diverting a proportion of the abstraction to a net suspended in a large plastic container via a large flexible hose (Figure 2-5). The net used had an aperture size of 1.5 mm by 2 mm. River flow at the time of the survey and the volume sampled are presented in Table 2. Approximately 80-100 cubic metres of water was sampled each time for the five surveys over approximately 1.2-1.5 hrs with a minimum of one hour of peak pump velocity (75 m<sup>3</sup>/h). This equates to approximately 55% of the total pump flow.

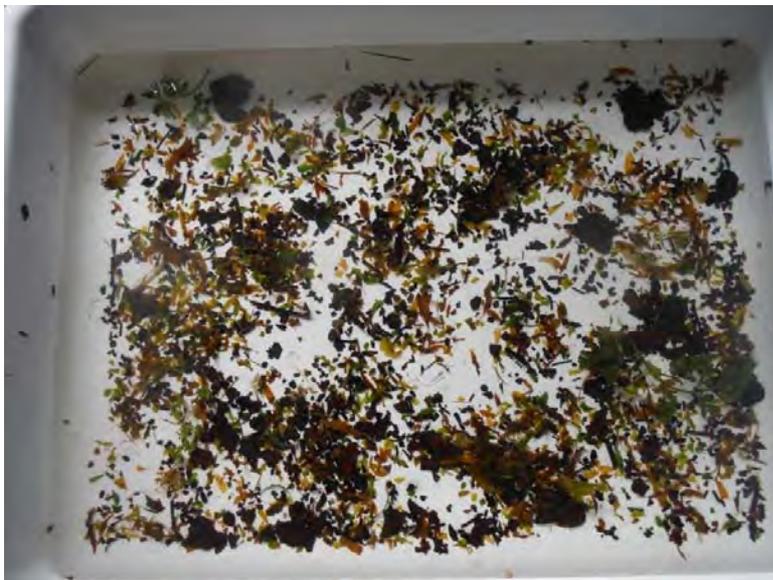
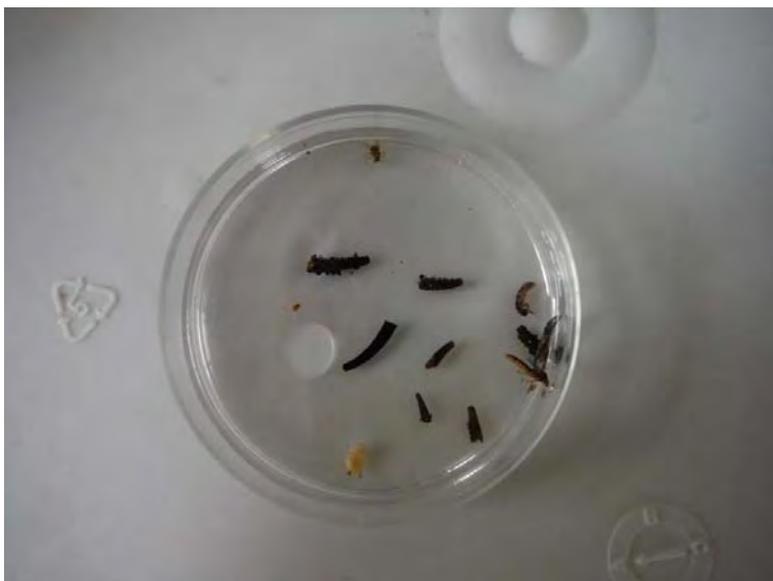
- No fish were caught
- Animals found
  - 1 stonefly
  - 1 adult Diptera (true fly)
  - 9 caddisfly, of which 3 were alive

Figure 6. Tray showing the contents collected from sampling on 27/11/14

Figure 7. Petri dish showing invertebrates collected from the sampling on 27/11/14

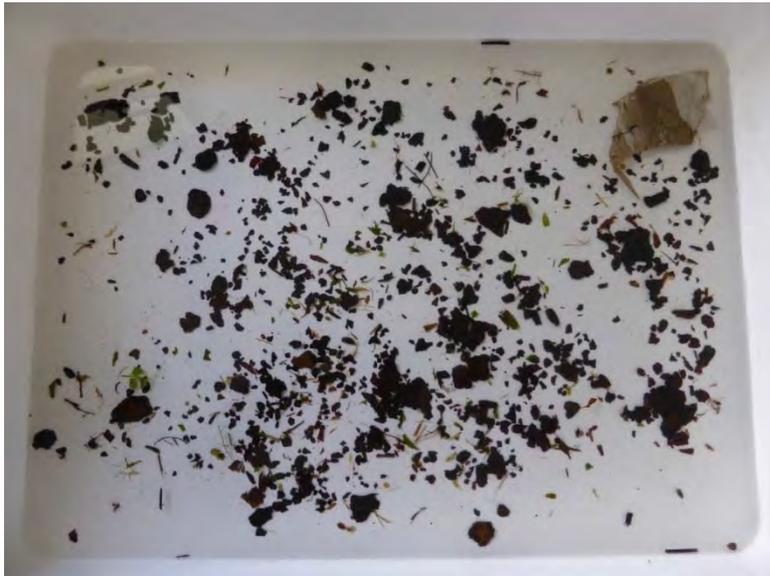
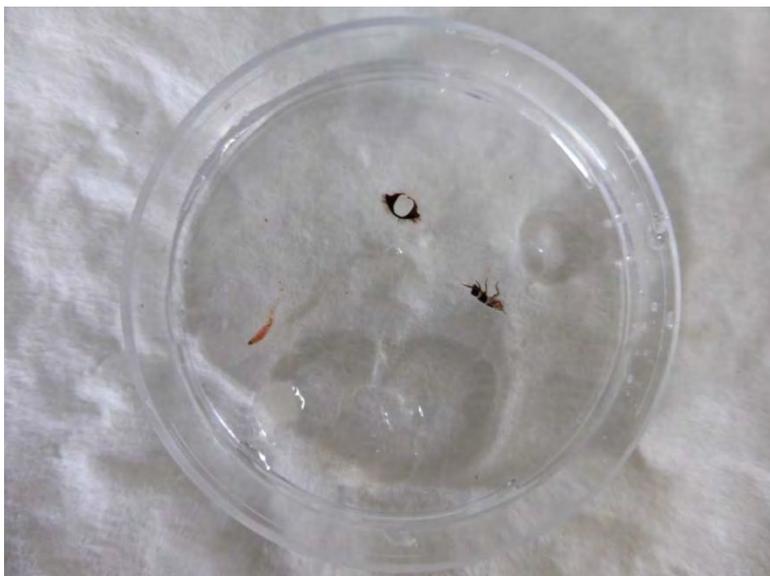
- No fish were caught
- Animals found
  - 2 caddisfly and one chironomid (parts)

Figure 8. Tray showing the contents collected from sampling on 5/02/15

Figure 9. Dish showing parts of two caddisfly and one chironomid found in the 5/02/15 sample

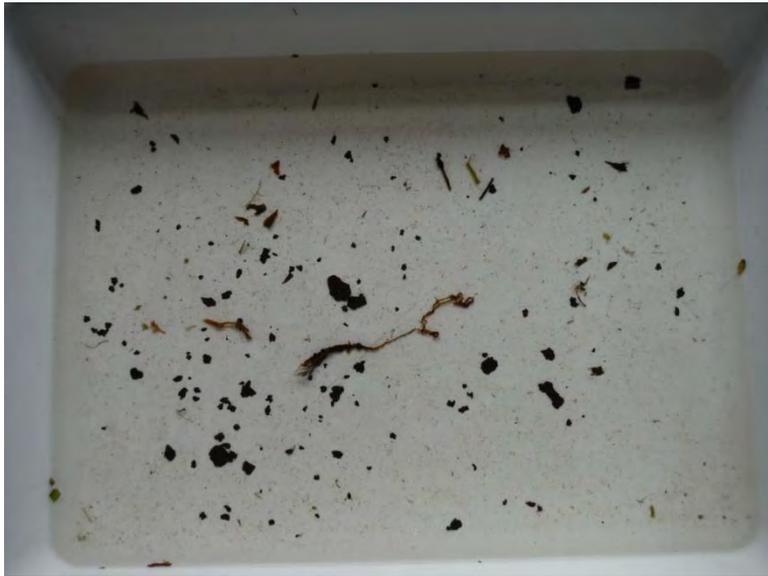
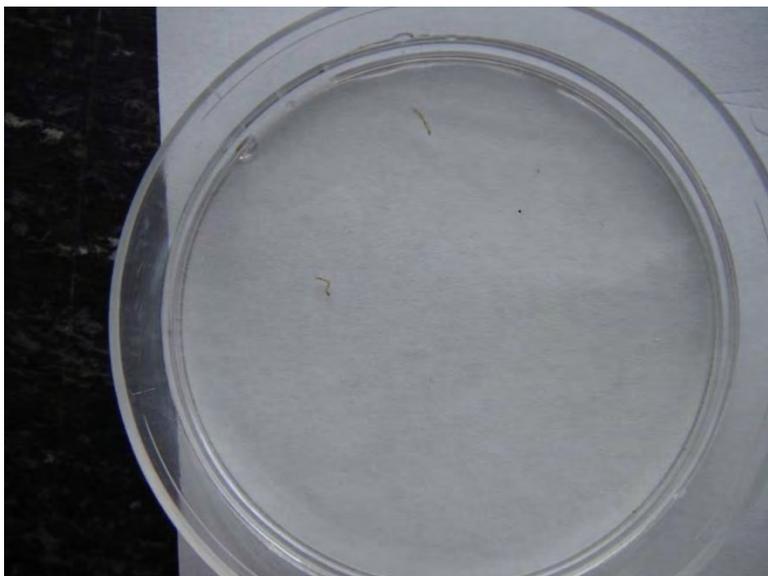
- No fish were caught
- Animals found
  - 2 chironomids. One chironomid was still alive

Figure 10. Tray showing the contents collected from sampling on 24/02/15

Figure 11. Dish showing two chironomids found on the 24/02/15 sample

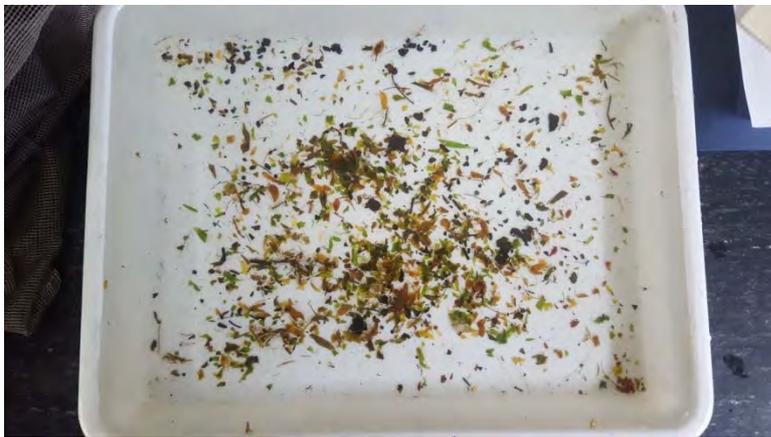
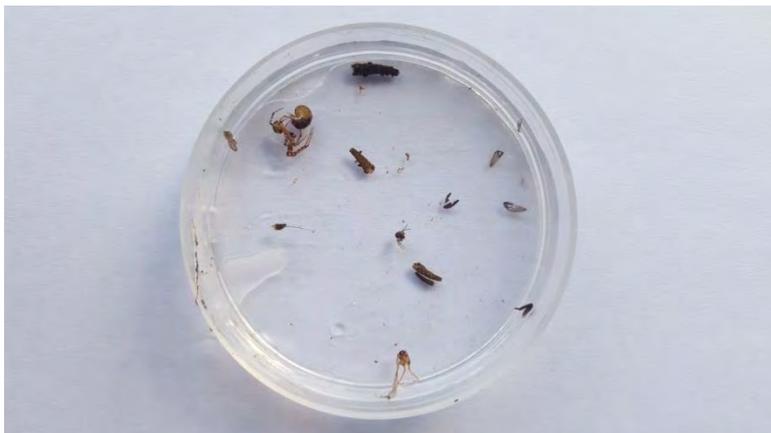
- No fish were caught
- Animals found
  - 2 cased caddisfly one alive
  - 2 empty cased caddisfly cases
  - 1 live caseless caddisfly
  - 2 terrestrial spiders, one dead one alive
  - 1 terrestrial fly
  - A few body parts including 2 wings, 1 abdomen, 1 mouthpart, 1 leg

Figure 12. Tray showing the contents collected from sampling on 20/10/16

Figure 13. Dish showing animals found on the 20/10/16 sample

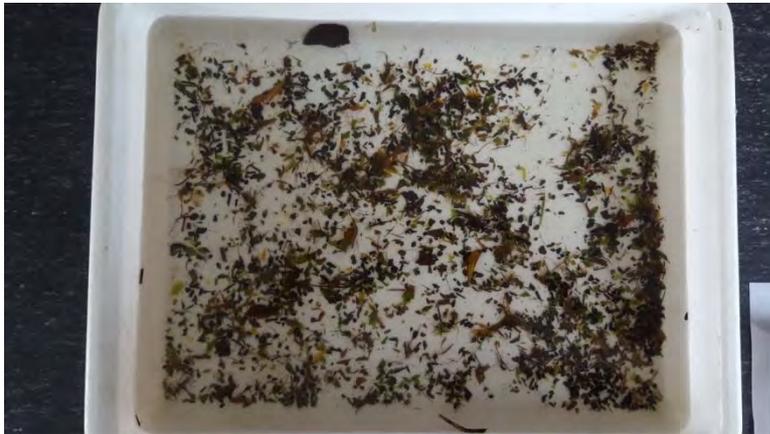
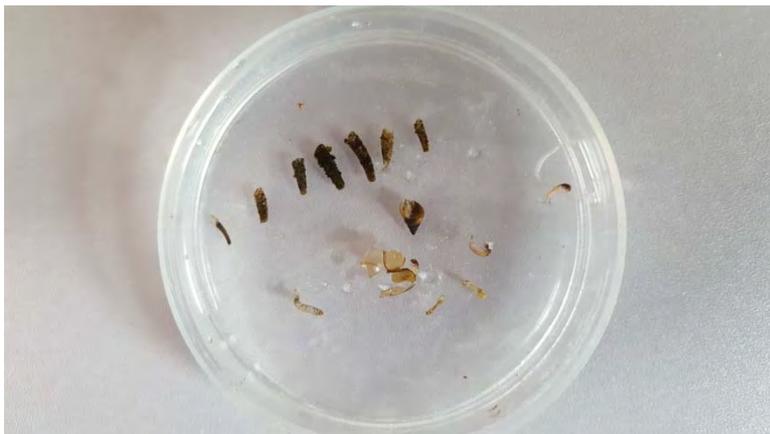
- No fish were caught
- Animals found
  - 7 empty cases from cased caddisfly
  - 3 caddisfly (2 might be from the empty cases)
  - 2 sandfly larvae
  - 1 snail
  - 1 chironomid midge
  - 1 crane fly larvae
  - Assorted insect parts

Figure 14. Tray showing the contents collected from sampling on 23/11/16

Figure 15. Dish showing animals found on the 23/11/16 sample
