South Taranaki District Council
**Closed Landfills (Eltham, Hawera, Kaponga,
Manaia, Patea, Opunake and Otakeho)**

Monitoring Programme

Annual Report

Technical Report 2021-67

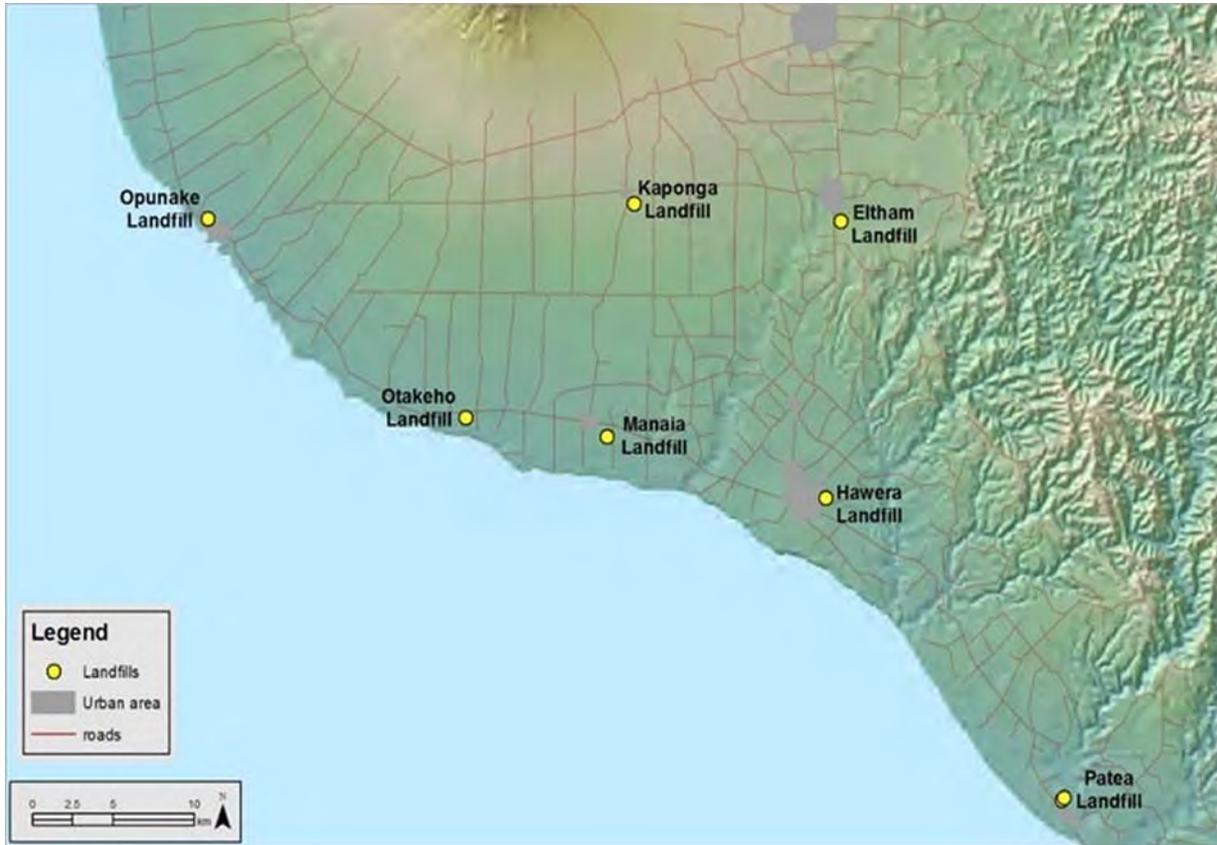
Figure 1 Regional map of STDC closed landfills

STDC maintained seven closed municipal landfills in the South Taranaki District during the 2020-2021 period (Figure 1). All these sites have a long history of waste disposal and, as older facilities, do not have engineered liners. Landfills of this nature are designated as Class B landfills in the MfE publication Module 2: Hazardous Waste Guidelines, Landfill Waste Acceptance Criteria and Landfill Classification (2004). The

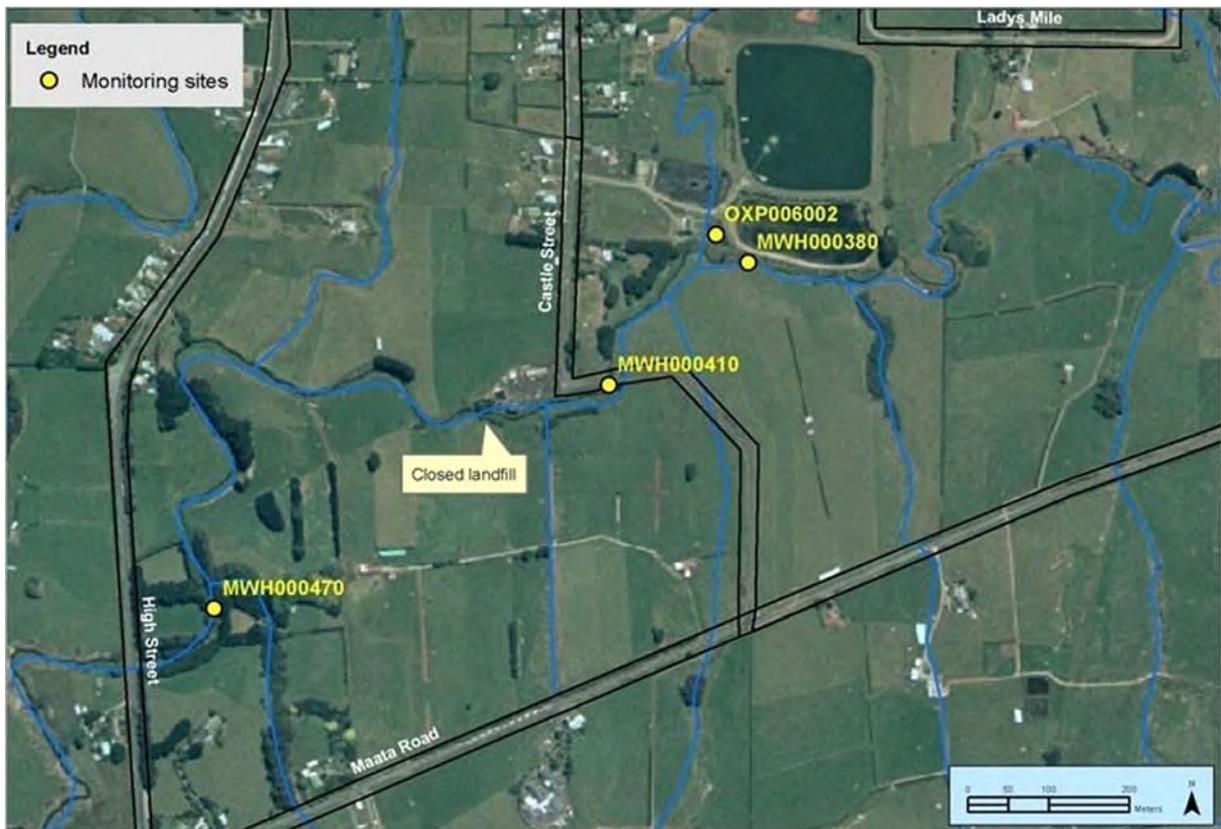
Figure 2 Eltham landfill and sampling sites (not currently monitored)

Inspections of the closed landfill were undertaken on 15 October 2020 and 9 February 2021. There was good pasture growth over the landfill cap and no slumping or leachate discharge was observed. No adverse environmental effects from the closed landfill were noted.

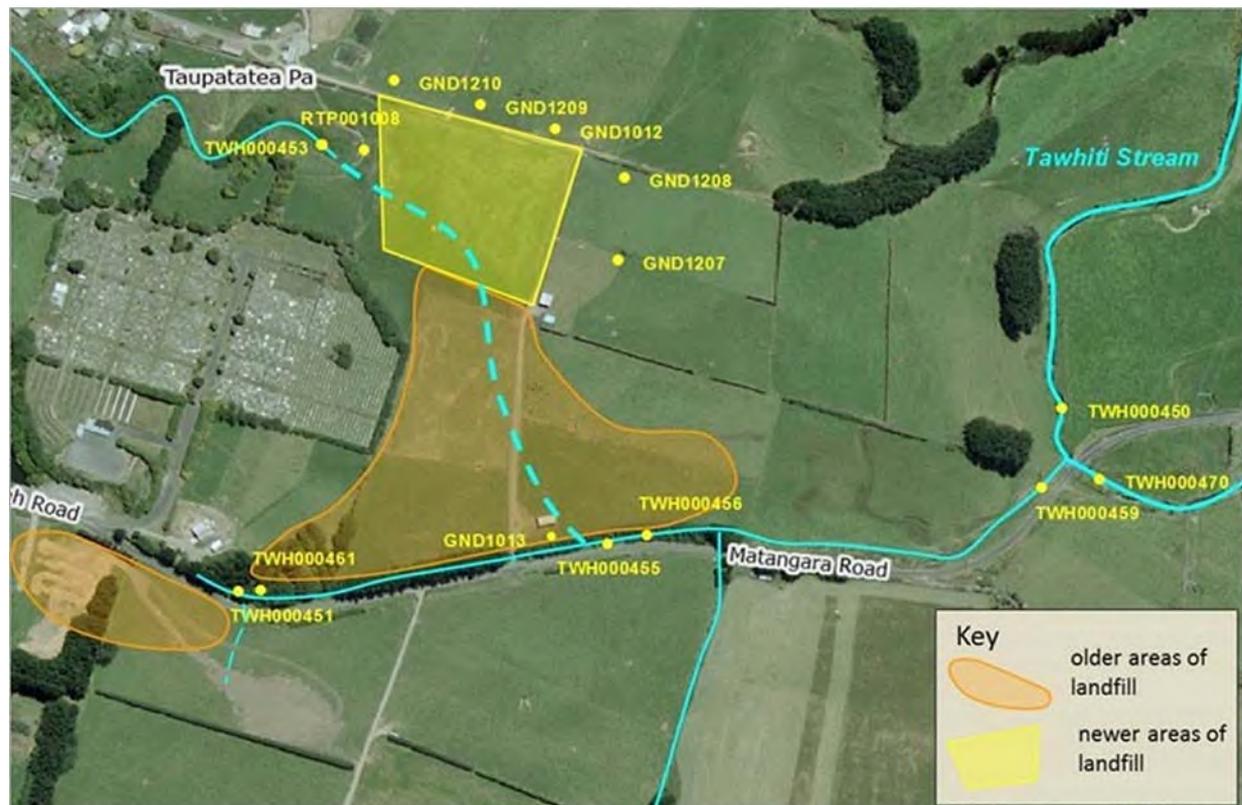
Figure 3 Aerial view of Hawera landfill and sampling sites

The cap was intact and well-grassed, with no sign of ponding. No slumping, cracking or erosion was noted. The batters were tidy and well-maintained. There was no evidence of recent grazing. The stormwater drains were clear and dry. The leachate system was tidy and operational with no sign of spills or overflows. No odour or dust issues were noted. Methane was not detected during the inspection. The site was unoccupied and fully secure with permanent fencing.

The roadside tributary shows moderate levels of contamination, mostly in the form of BOD, iron and ammoniacal nitrogen. Historically, the uppermost monitoring site in the roadside tributary has been found to contain similar levels of contaminants to the landfill tributary at the culvert outlet, which is unsurprising given the extent of historical filling in the area as shown in Figure 3.

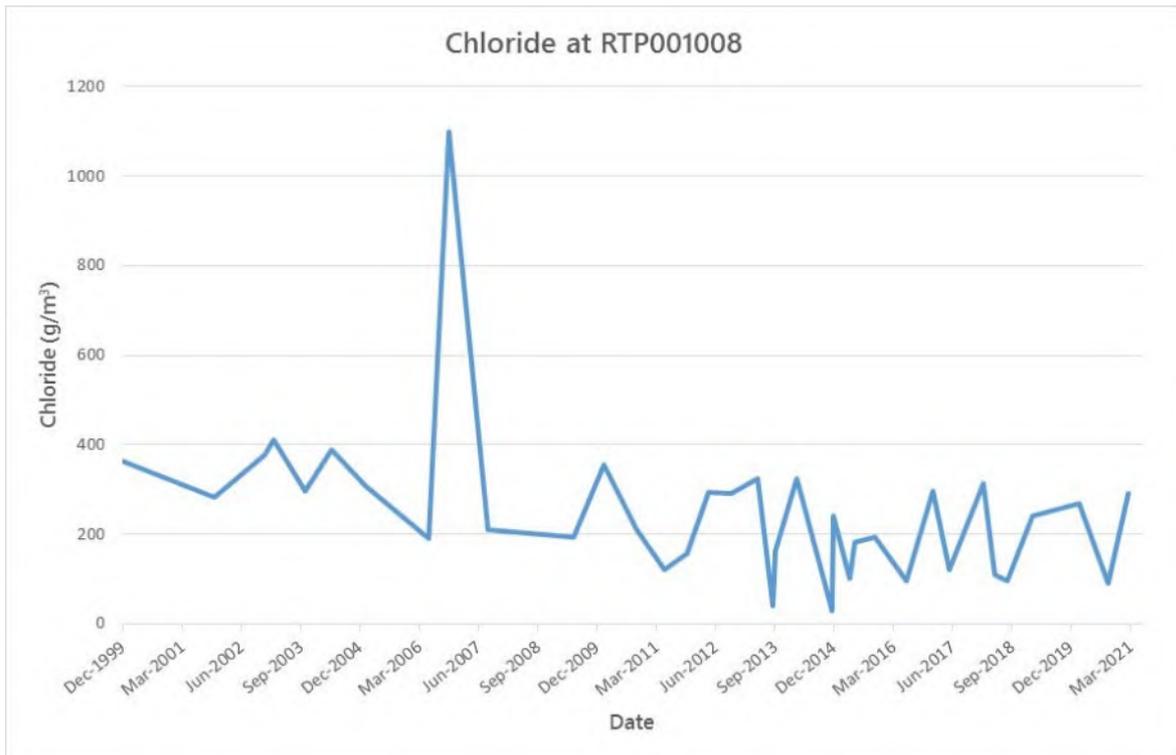
Figure 4 Hawera landfill leachate chloride concentration; 1999-2021

Results indicate that waste in the landfill is still actively degrading and releasing contaminants. The high alkalinity, chloride, chemical oxygen demand and ammoniacal nitrogen concentrations are typical values for landfill leachate and, as expected, these contaminants are gradually trending down over time (Figure 4, Figure 5, and Figure 6). All of the results obtained during the year under review were below the maximum values previously recorded, although a number were above the historical medians.

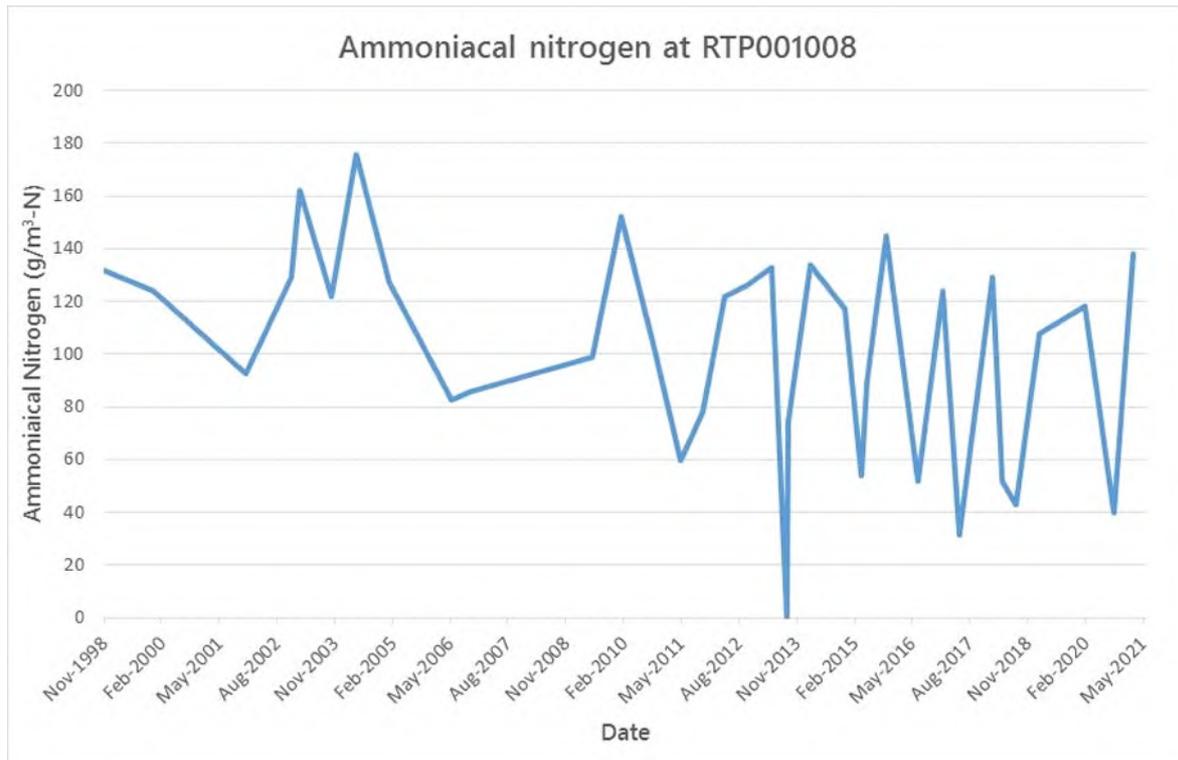
Figure 6 Hawera landfill leachate ammoniacal nitrogen, 1998-2021

As most of this leachate is pumped to the Hawera wastewater treatment plant, the majority of the contaminants found in these samples have no direct effect on surface waters near the site. However, they do give an indication of the contaminant concentrations present in the subsurface flows that have the potential to enter groundwater at this site, due to the lack of an engineered liner. It is noted that most of the contaminants show a distinct seasonal variation.

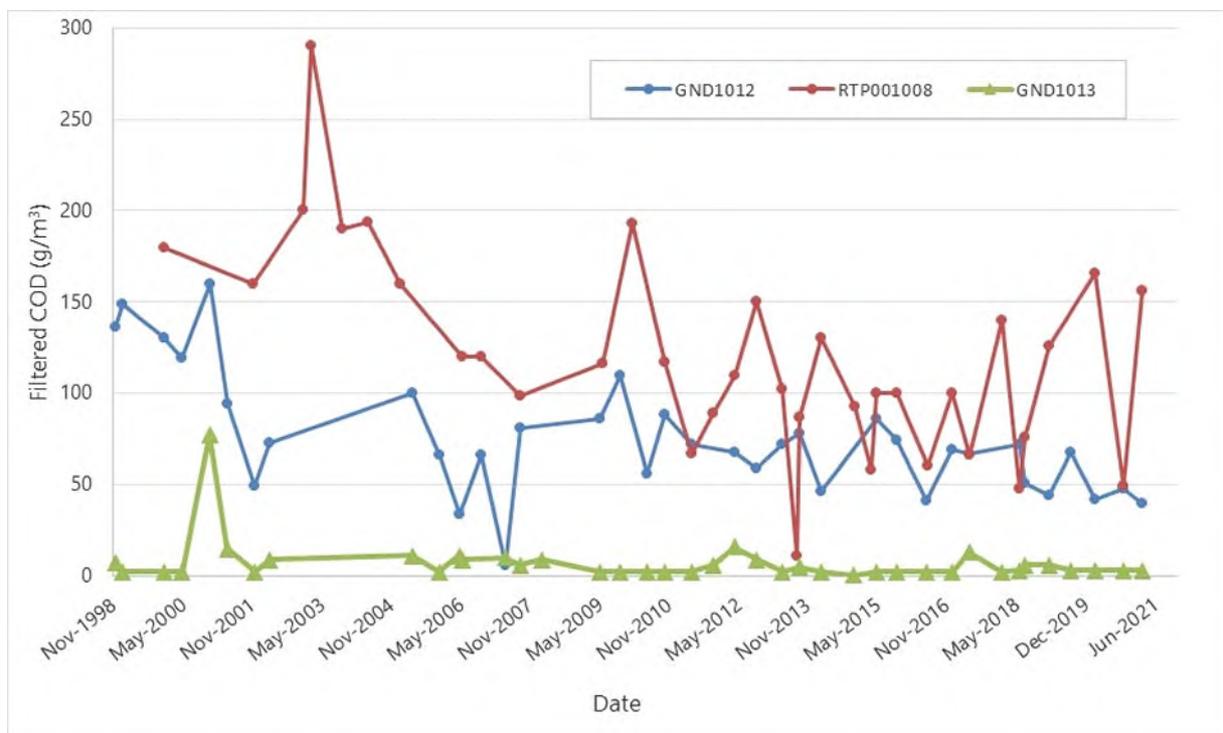
Figure 7 Comparison of filtered chemical oxygen demand between GND1012, GND1013 and RTP001008

As with previous monitoring periods, bore GND1012 exhibits elevated levels of landfill contamination indicators, such as increased chlorides, alkalinity, iron, and ammoniacal nitrogen. This bore is immediately adjacent to, and down gradient of the landfill footprint, and in recent years has contained a similar level of contaminants to the leachate as indicated by the relative alkalinity, conductivity and chemical oxygen demands. It is noted that bore GND1013 is further from the most recently landfilled areas and as a result has far lower levels of these landfill indicator species (Figure 7, Figure 8 and Figure 9).

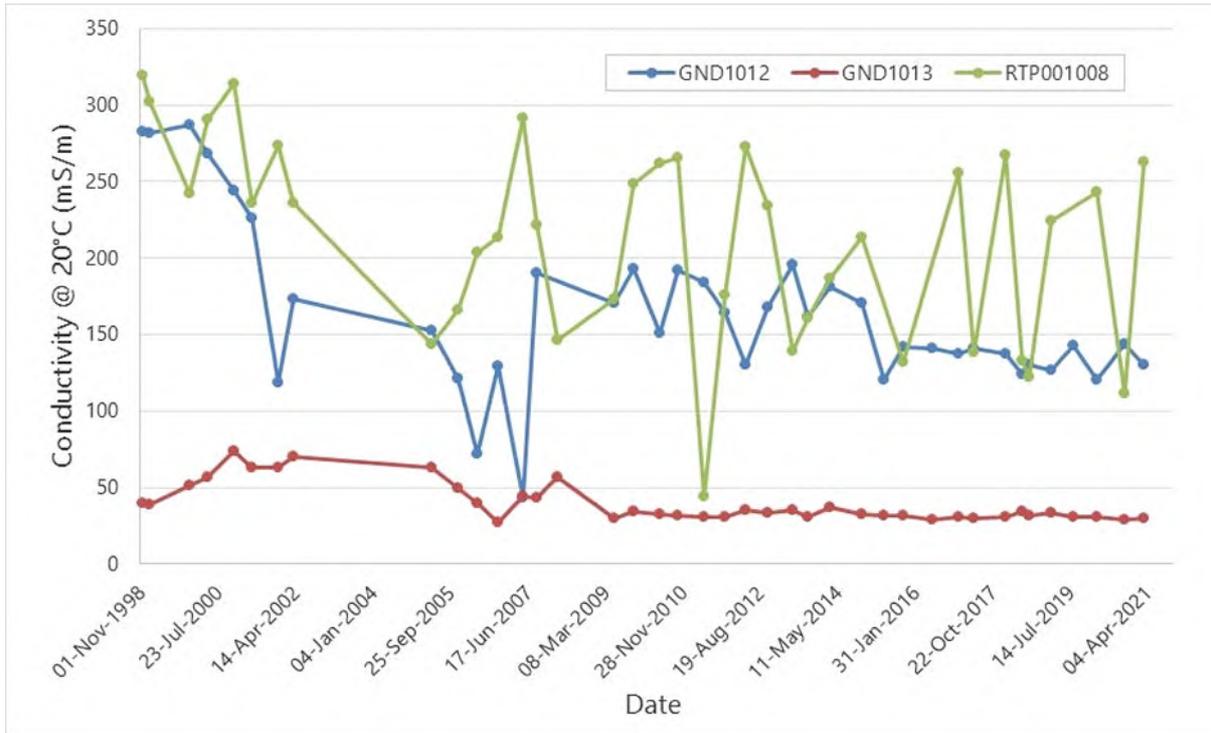
Figure 8 Comparison of conductivity between GND1012, GND1013 and RTP001008

* conductivity is now measured @25°C and results from June 2018 have been converted to 20°C for the graph

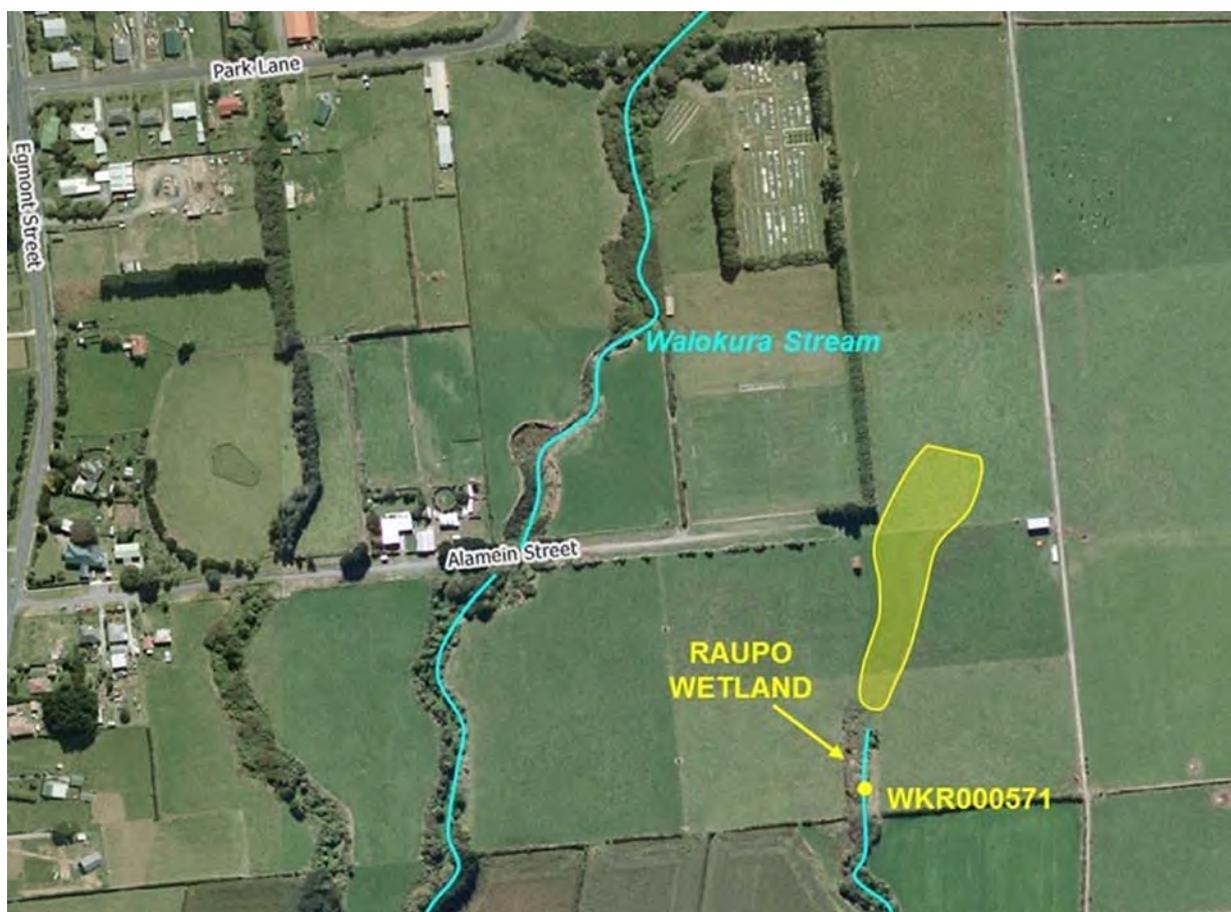
Figure 10 Aerial view of the Kaponga landfill site

STDC (previously as Eltham District Council) operated the Kaponga landfill from the 1970's to 1993. The Kaponga landfill site is located in a gully that also has a wetland fed by a number of springs emanating from within the landfill (Figure 10). This landfill closed in 1993. The cap has been covered by pasture for over a decade and the site is now part of a dairy farm. On closure, the site was sown in suitable pasture grasses to ensure rapid stormwater runoff and minimise percolation through the capping layer. Raupo growth on the lower face of the reinstated surface provides some natural attenuation of leachate and hence gives protection to the Waiokura Stream.

The cap was intact and well-vegetated, with no sign of recent grazing. There was no slumping, cracking, or erosion on either the cap or batters. The batters were tidy and stable, with no exposed refuse noted. The stormwater drains were clear and dry. Abundant iron oxide deposits on the streambed were noticeable at the outlet of the wetland. Site security and fencing was intact, and no odour or dust issues were noted.

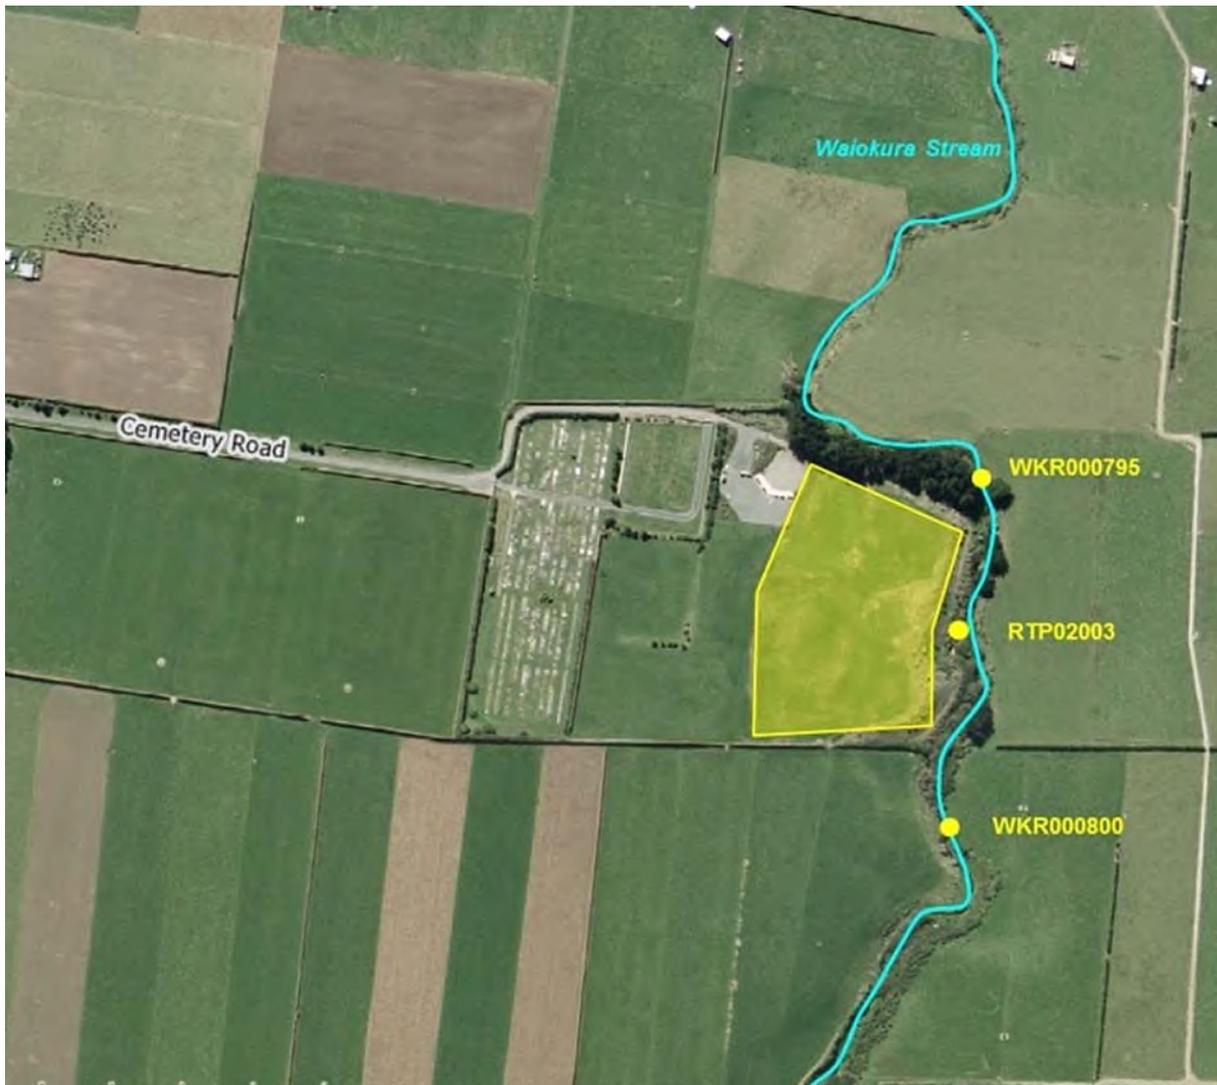
Figure 11 Aerial view of Manaia landfill showing sampling sites and landfill footprint

The Manaia community landfill was in operation from the 1980s and STDC has held consent 3952, which authorises the discharge of both leachate and stormwater from the site, since 1991. The landfill initially serviced the township of Manaia and the surrounding rural areas exclusively. However with the closure of the Matangara landfill (Hawera) in June 1998 and the Opunake landfill in November 1999, the landfill's catchment expanded to service these other areas until it closed in June 2006.

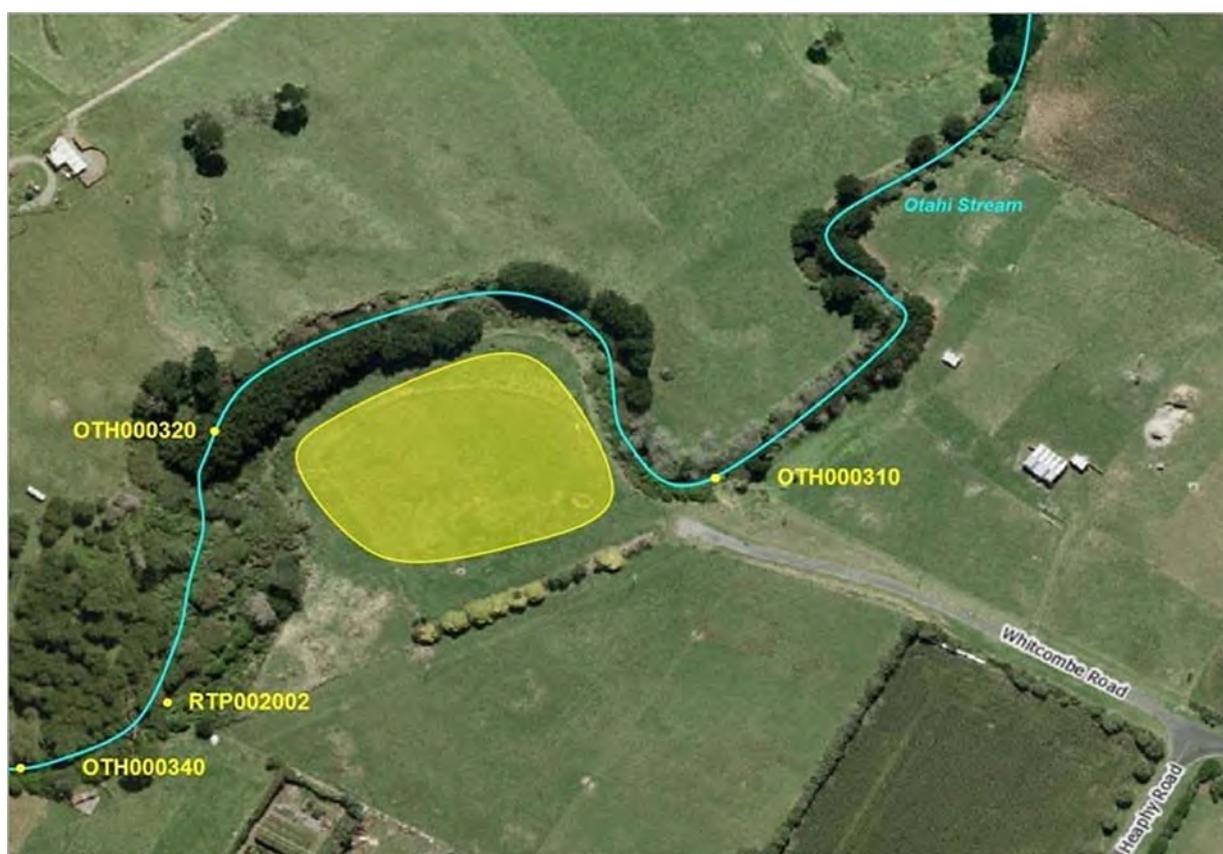
Figure 12 Aerial view of Opunake landfill footprint and sampling sites

The Opunake landfill was operational from 1979, closing in 1999 with the expiry of the 20 year lease of the land. The landfill site is located on Whitcombe Road, and was used to service the township of Opunake and the surrounding rural areas. Waste from Rahotu and Pungarehu was also disposed of at the landfill. The 4.73 ha site was initially operated in an uncontrolled manner for many years with a significant amount of rubbish being burnt. In 1990 a ban on fires was imposed and the site began to operate under restricted hours. In 1999 STDC submitted a landfill closure plan and had the site reinstated.

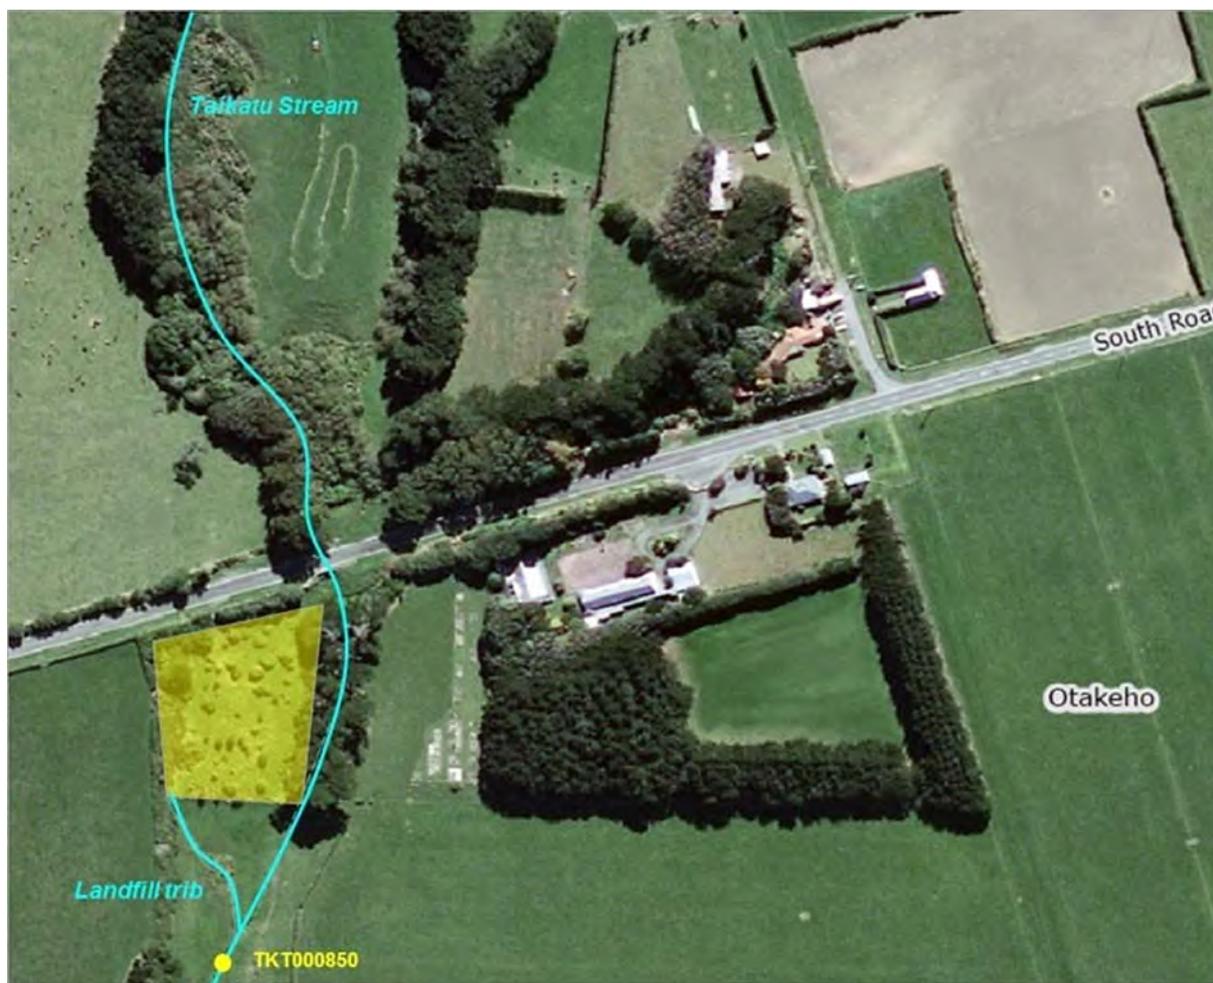
Figure 13 Aerial image of Otakeho landfill and monitoring site in the Taikatu Stream

The Otakeho landfill (Figure 13) was a small uncontrolled landfill that STDC closed in 1991. STDC at the time also applied for a consent to discharge leachate and stormwater into the Taikatu Stream. This consent was renewed in 2000, 2005, and recently in November 2018. Consent 3953-4 allows for discharge of leachate and stormwater onto and into land where it may enter water.

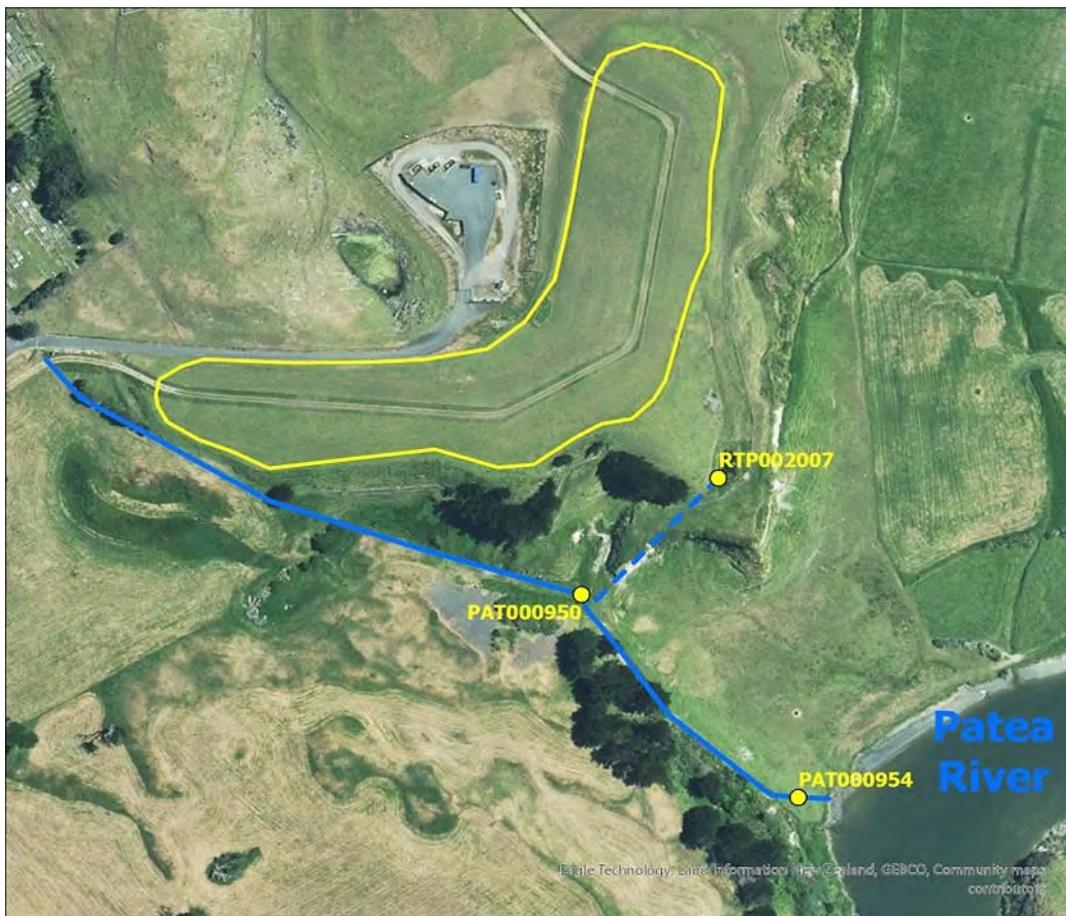
Figure 14 Aerial view of the landfill at Patea showing sampling sites (landfill footprint in yellow)

Prior to 1991, the Patea landfill was a largely uncontrolled landfill servicing the residents of Patea. In 1992 STDC applied for resource consents to continue operating the landfill under the RMA. The landfill continued to operate until December 2007 and was then covered with a light clay cap. Full landfill closure works commenced in August 2008 and were completed in November of the same year.

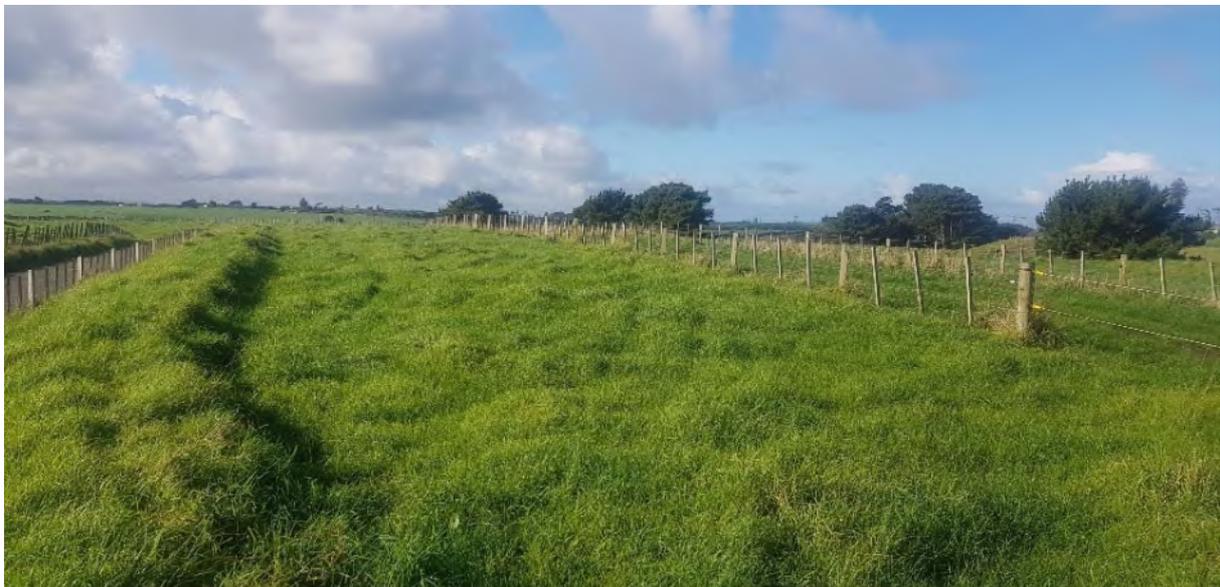
Photo 1 Patea Landfill June 2021

The perimeter stormwater collection drains were clear and damp. The cap and bund wall were intact, with no signs of slumping or ponding. This was well grassed with no stock present at the time of the inspection (Photo 1). The site was unoccupied at the time of inspection. Fencing was intact and permanent and the site was secure.
