Value Timber Ltd
Monitoring Programme
Annual Report
2022-2023

Technical Report 2023-34

Taranaki Regional Council
Private Bag 713
Stratford

ISSN: 1178-1467 (Online)
Document: 3189113 (Word)
Document: 3198442 (Pdf)
March 2024

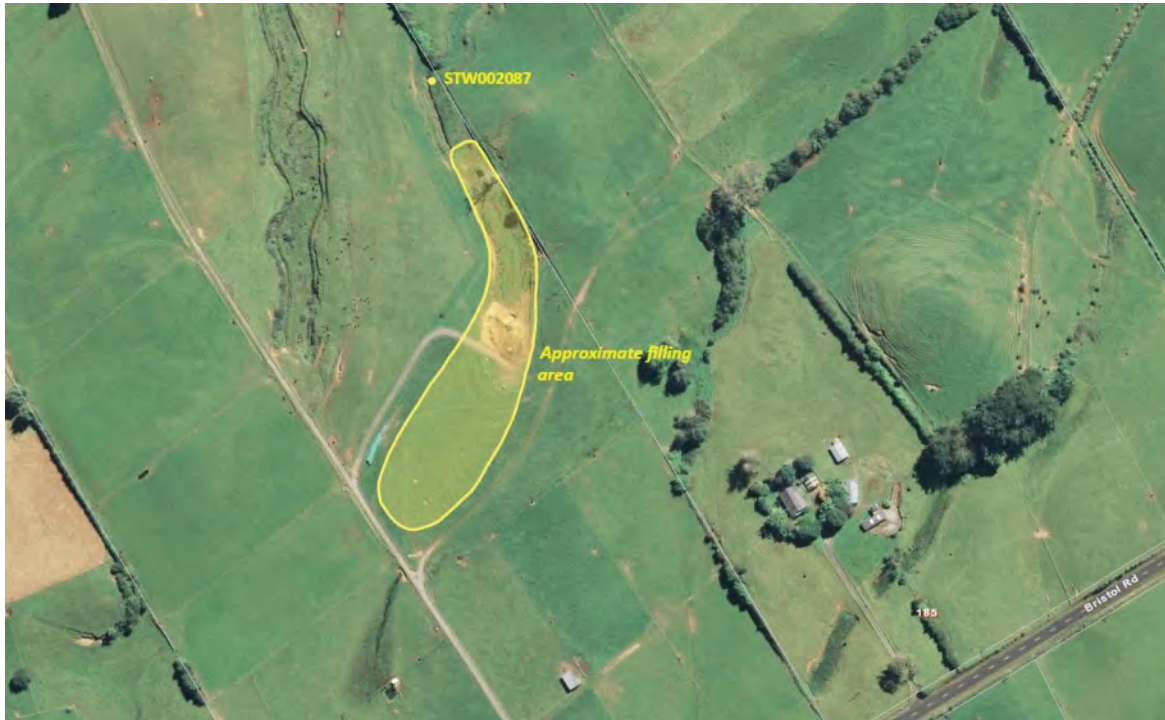
Figure 1 Aerial image of the Bristol Road site and sampling site

The site is located between two unnamed tributaries of the Kurapete Stream system. The site where the wood waste is discharged is a gully that directs stormwater and spring water from the surrounding pastureland to the headwater of the unnamed tributary of the Kurapete Stream. The previous owner of the property was in the process of filling the gully when the property was sold to the current owner. The current operation will continue to fill in the gully with untreated woodchip and sawdust to create more flat pasture land. Stormwater run-off from the land surrounding the fill area is intercepted and diverted by two lateral channels on each side of the fill area. Piping is being progressively laid ahead of the fill to allow groundwater and spring water to drain away without being in contact with the wood waste. The final cap

The samples were taken from site STW002087, which is in the receiving drain downstream of the fill area, just upstream of the property's boundary fence (Figure 1).

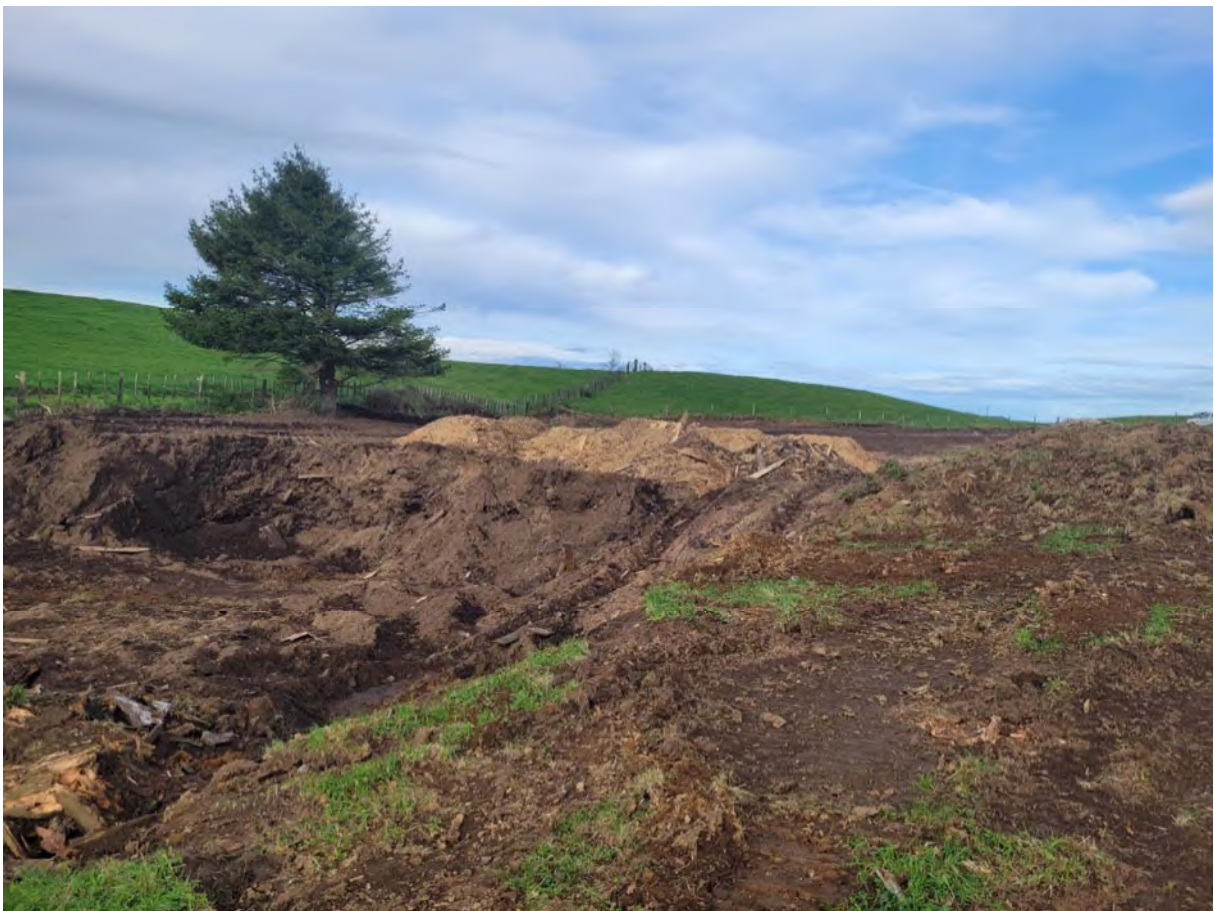
Photo 1 Value Timber Ltd wood waste cap 23 June 2023

will consist of at least 300 mm of compacted clay and 100 mm of topsoil. The capping will be completed progressively as the gully is filled. Photo 1 illustrates the wood waste cap as of June 2023.

The completed fill area was well vegetated and remained stable with no cracking slumping or ponding noted.
