Value Timber Supplies Ltd

Monitoring Programme

Annual Report

Technical Report 2024-37

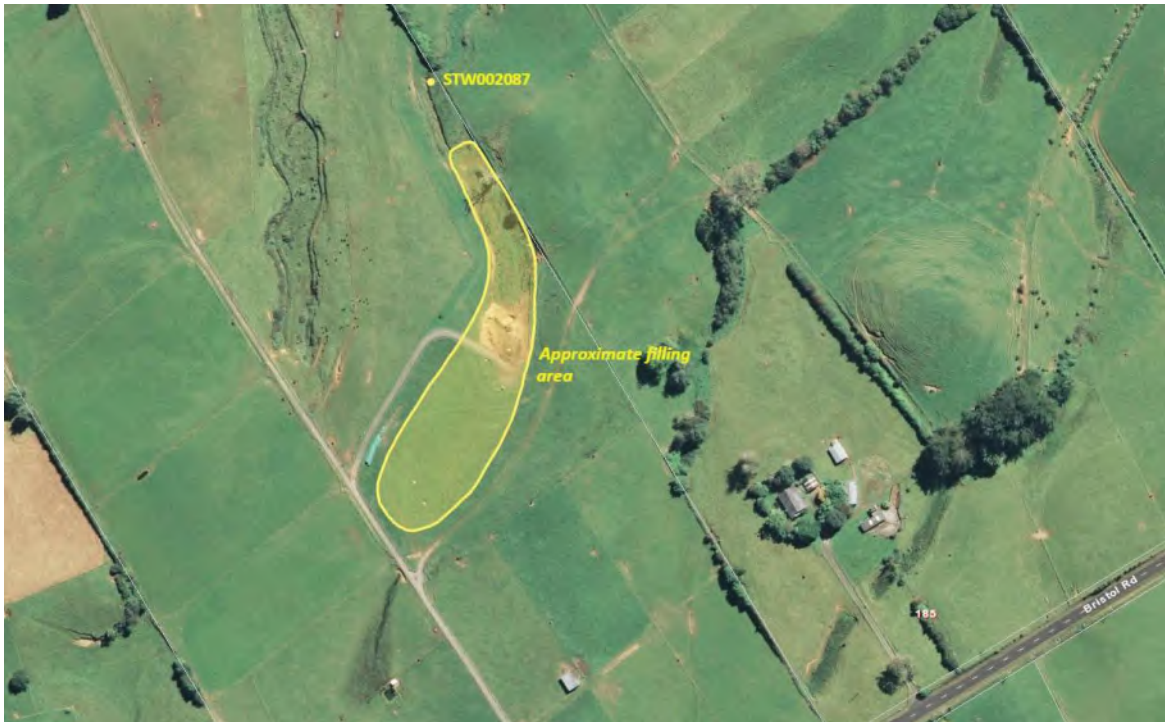
Figure 1 Aerial image of the Bristol Road site and sampling site

The samples were taken from site STW002087, which is in the receiving drain downstream of the fill area, just upstream of the property's boundary fence (Figure 1).

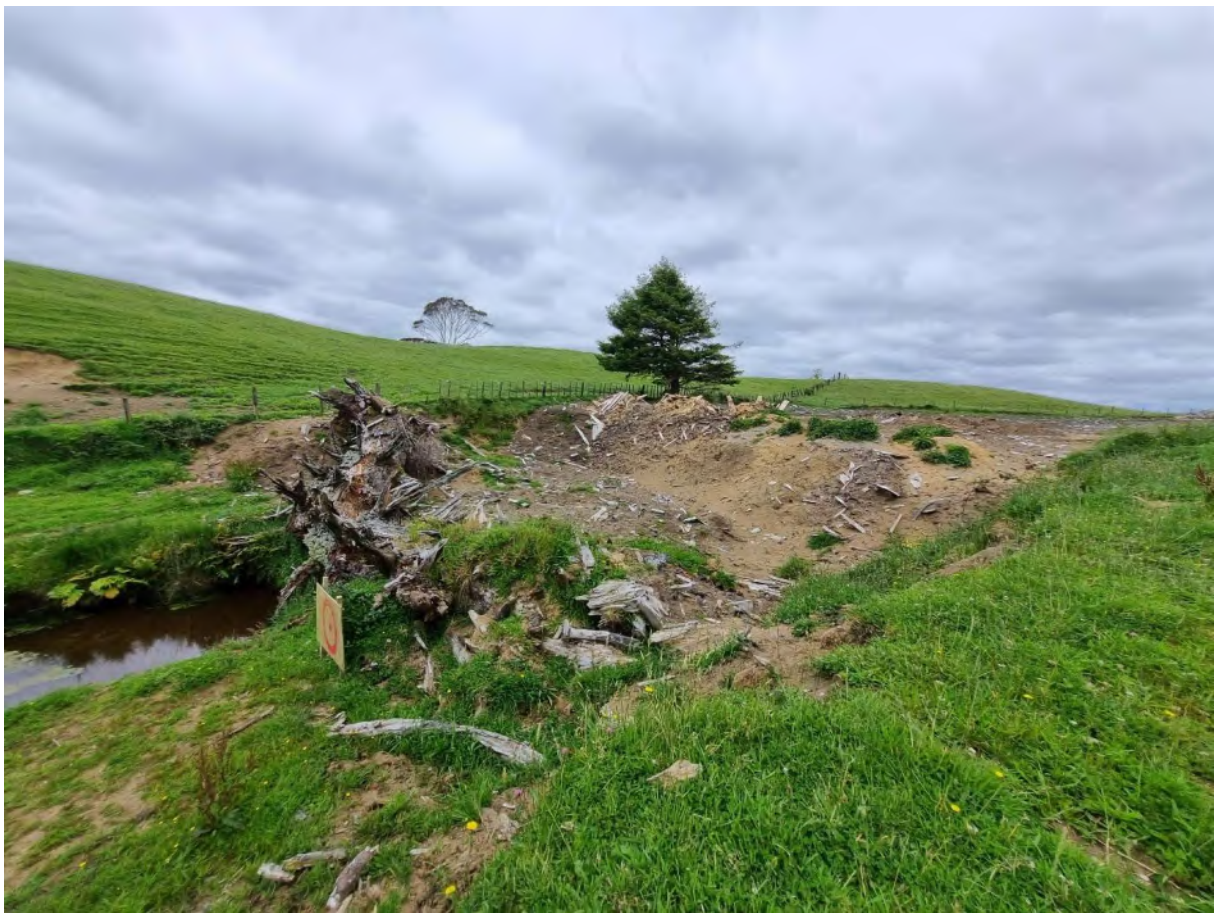
Photo 1 Value Timber Supplies Ltd wood waste cap 15 December 2023

The site is located between two unnamed tributaries of the Kurapete Stream system. The site where the wood waste is discharged is a gully that directs stormwater and spring water from the surrounding pastureland to the headwater of the unnamed tributary of the Kurapete Stream. The previous owner of the property was in the process of filling the gully when the property was sold to the current owner. The current operation will continue to fill in the gully with untreated woodchip and sawdust to create flatter pasture land. Stormwater run-off from the land surrounding the fill area is intercepted and diverted by two lateral channels on each side of the fill area. Piping is being progressively laid ahead of the fill to allow groundwater and spring water to drain away without being in contact with the wood waste. The final cap will consist of at least 300mm of compacted clay and 100mm of topsoil. The capping will be completed progressively as the gully is filled. Photo 1 illustrates the wood waste cap as of June 2023.
