Westown Haulage Cowling Road

Monitoring Programme

Annual Report

Technical Report 2024-74

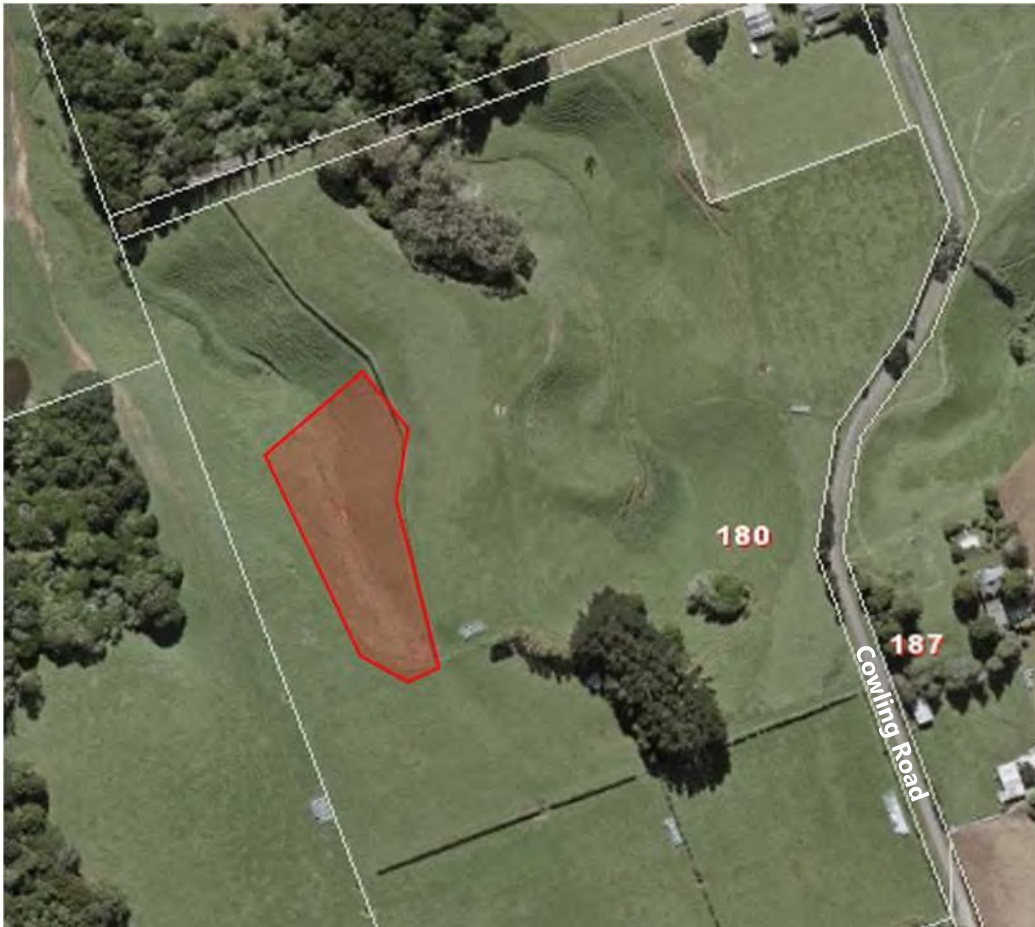
Figure 1 Approximate extent of the Westtown Haulage Ltd cleanfill, 180 Cowling Road, before filling

The cleanfill area is a gully to the north of the area used for their contracting services. This is a new area, specific to this resource consent and is separate to the cleanfill area relating to consent 9854-1.0. The gully is being filled from the south towards the north. The gully starts shallower in the southern portion of the site (Photo 1) and deepens towards the northern boundary. The lower, northern portion of the gully contains a waterbody (Photo 2, Figure 1). Only the upper, southern portion of the gully, which does not contain the water body is proposed to be filled, as shown in Figure 2.

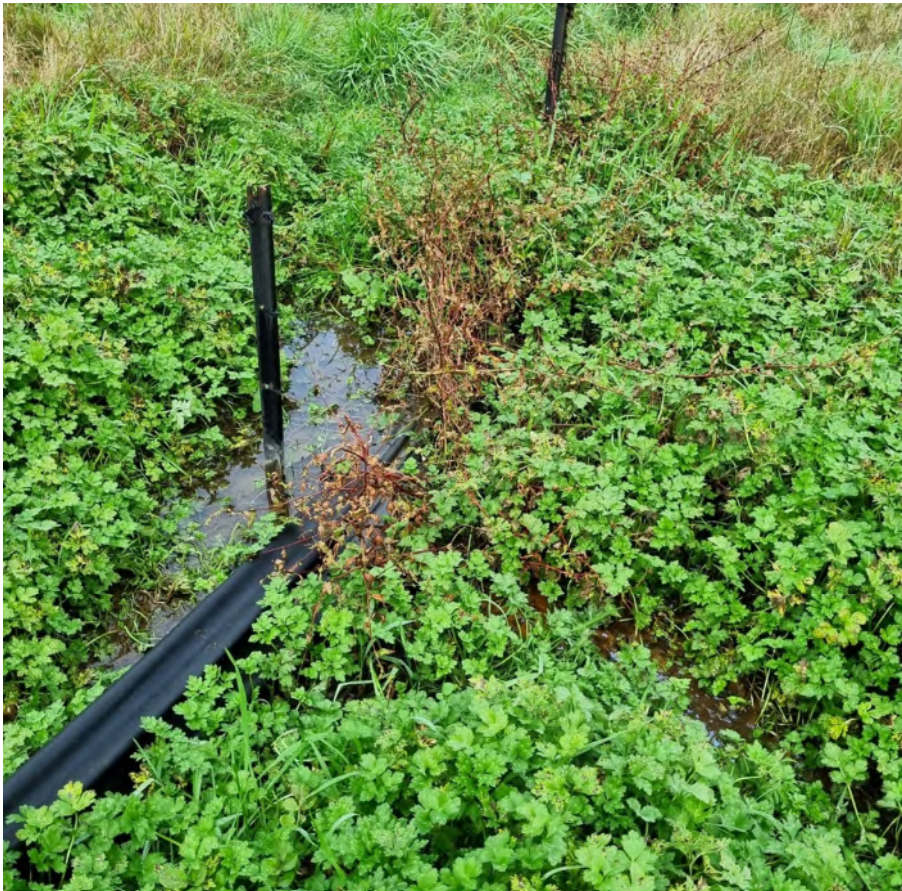
Photo 3 One of the silt fences needing to be reinstated

Three routine compliance monitoring inspections were carried out during the year under review. The inspections were carried out on 5 September 2023, 23 February 2024 and 17 July 2024, during which times the site had been well used and there was no issue with unauthorised material, dust or odour. During the July 2024 inspection, some of the silt fences had fallen down and become ineffective. It was requested that these be reinstated immediately (Photo 3). An oily sheen was noted in the discharge and receiving water sites and samples were taken (Photo 4).

At the time of the first two inspections during the year under review there were good silt control measures in place in the form of silt fencing and a settling pond. Although the site was considered to be compliant with consent conditions at the July inspection, it was noted that urgent minor repairs were needed on the silt fencing.

1. THAT in the first instance, monitoring of consented activities at the cleanfill site in the 2024/25 year continues at the same level as in 2023/24.
2. THAT should there be issues with environmental or administrative performance in 2024/25, monitoring may be adjusted to reflect any additional investigation or intervention as found necessary.
3. THAT an update be provided regarding the erosion and sediment control plan.

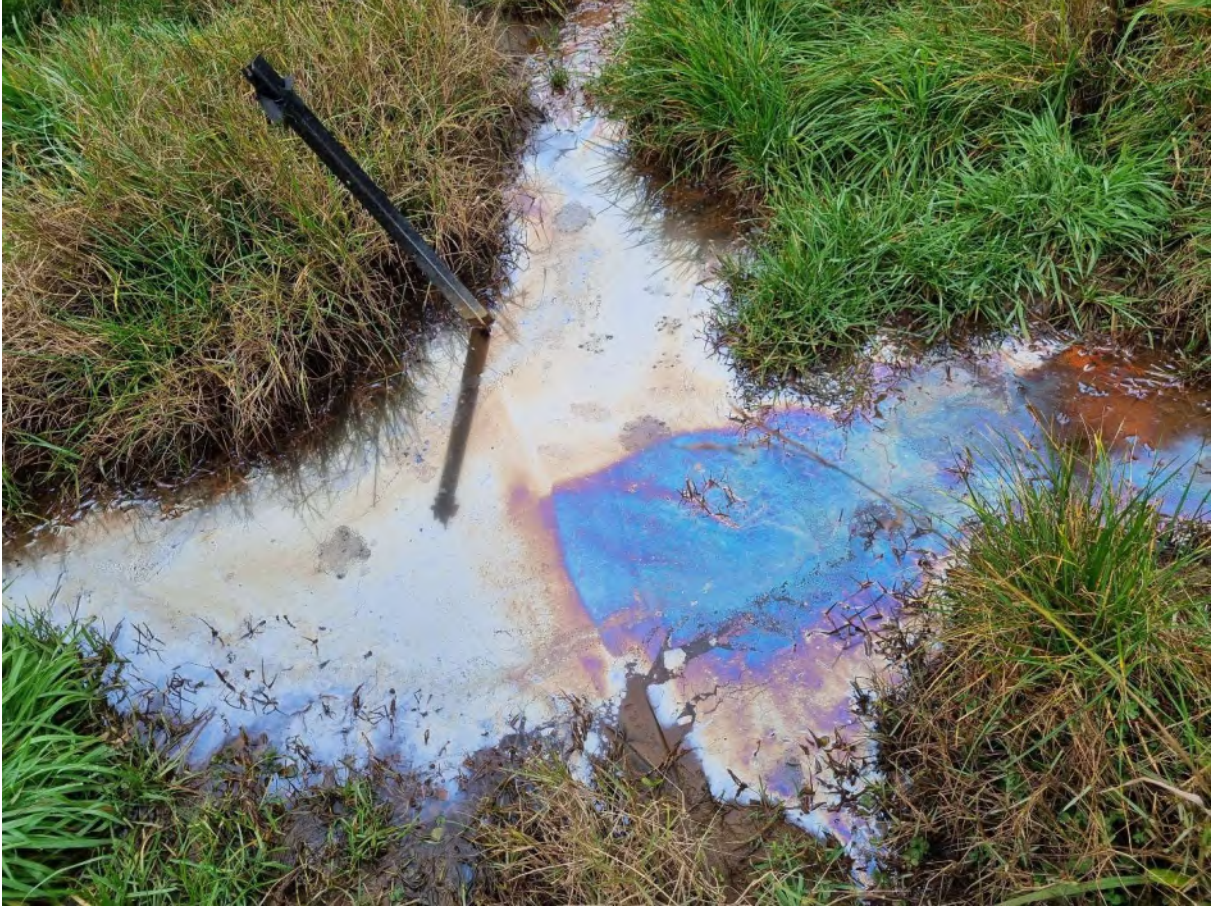
Photo 4 An example of the oily sheen as seen in the discharge next to the silt fences

No visual effects were found in the receiving waters on the three compliance monitoring inspections. Testing of the oily sheen in the discharge and receiving waters at the time of the final inspection failed to detect any hydro-carbon presence, which indicates the sheen was likely from an organic source. We observed high quantities of runoff resembling iron oxide in the ring drain, which supports this conclusion.

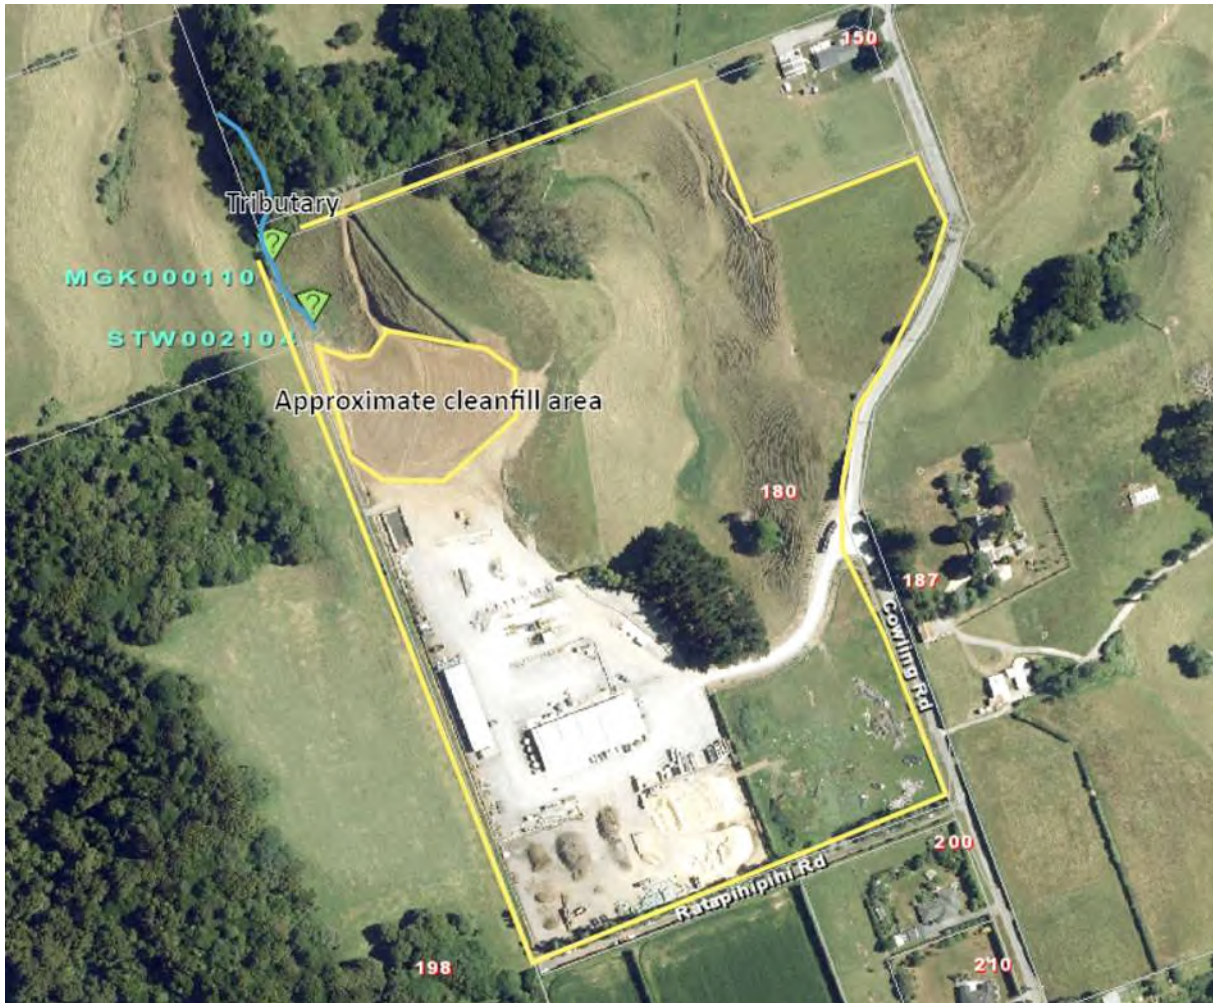
Figure 2 Downstream receiving water (MGK000110) and discharge (STW002104) sampling sites at Westtown Haulage cleanfill
Aerial image from 2021

During the year under review a sample was to be collected of the discharge from the cleanfill site and from the receiving water downstream of the site boundary as described in Table 2 and shown in Figure 3. As there was no discharge at the time of sampling, only the receiving water downstream was sampled. The results are given in Table 3. The results from the sampling of the oily sheen are given in Table 4. The suspended sediment value for the discharge site during the second sampling event was significantly elevated, but this was most likely caused by the disturbance of the deposited sediment that occurred during sampling.

Site description	Site Code	Co-ordinates (NZTM)
Discharge sample	STW002104	E 1690299, N 5671555
Receiving water sample	MGK000110	E 1690276, N 5671590
