Kea Oil and Gas Limited
Puka-1 wellsite Exploration Wellsite
Monitoring Programme Report
2012-2013

Technical Report 2013-97

September 2014

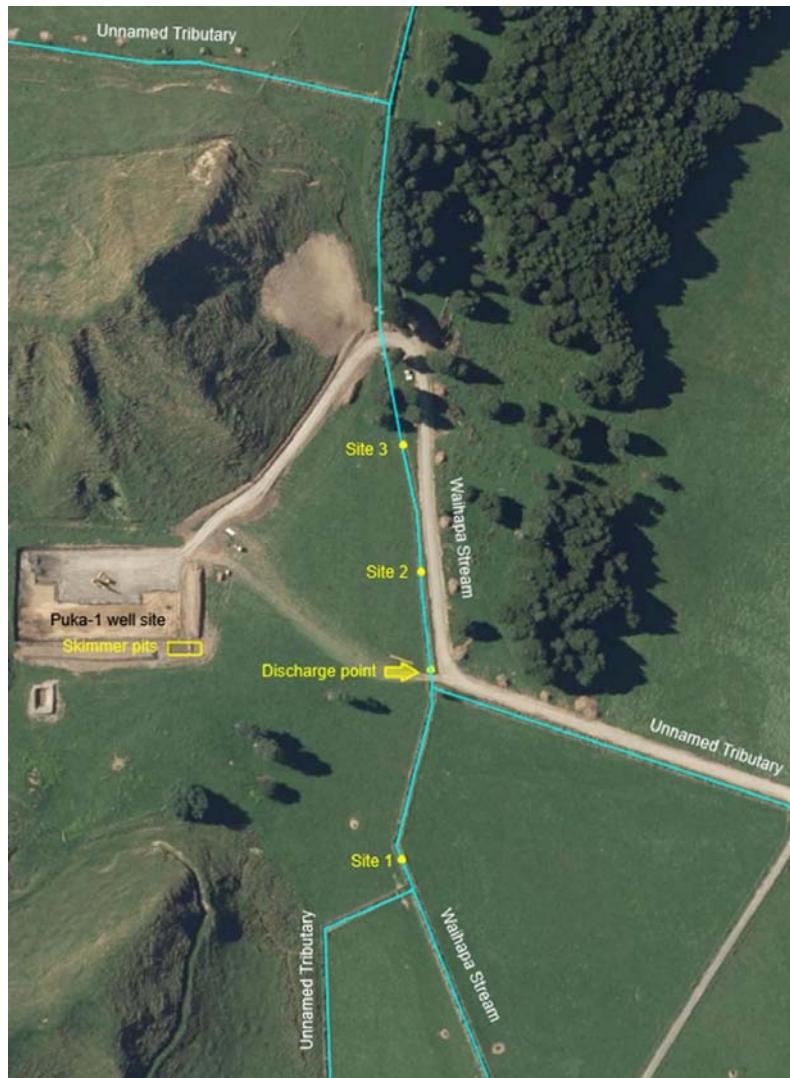
Figure 1 Biomonitoring sites in the Waihapa Stream in relation to the Puka-1 wellsite

Table 1: Biomonitoring sites and sampling methods used in the Waihapa Stream related to the Puka-1 wellsite

Site No.	Site code	Grid reference (NZTM)	Location	Sampling method	Altitude (m above sea level)
1	WHP000182	1720472E-5637639N	100m u/s of Puka-1 wellsite	Kick-sweep	210
2	WHP000183	1720476E-5637793N	25m d/s of discharge from Puka-1 wellsite	Streambed kick	210
3	WHP000185	1720468E-5637855N	80m d/s of discharge	Kick-sweep	210

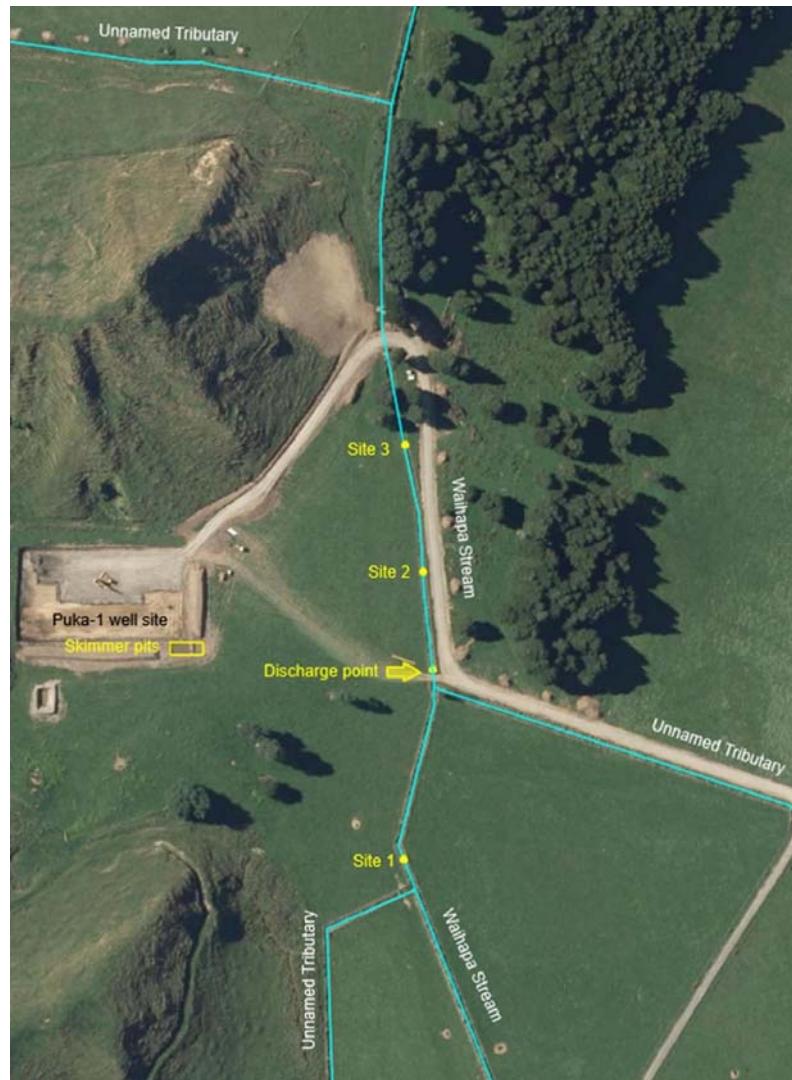
Figure 1 Biomonitoring sites in the Waihapa Stream in relation to the Puka-1 wellsite

Table 1: Biomonitoring sites and sampling methods used in the Waihapa Stream related to the Puka-1 wellsite

Site No.	Site code	Grid reference (NZTM)	Location	Sampling method	Altitude (m asl)
1	WHP000182	1720472E-5637639N	100m u/s of Puka-1 wellsite	Kick-sweep	210
2	WHP000183	1720476E-5637793N	25m d/s of discharge from Puka-1 wellsite	Streambed kick	210
3	WHP000185	1720468E-5637855N	80m d/s of discharge	Kick-sweep	210
