# Civil Quarries Ltd - Everett Road Quarry

Monitoring Programme

Annual Report

Technical Report 2021-96

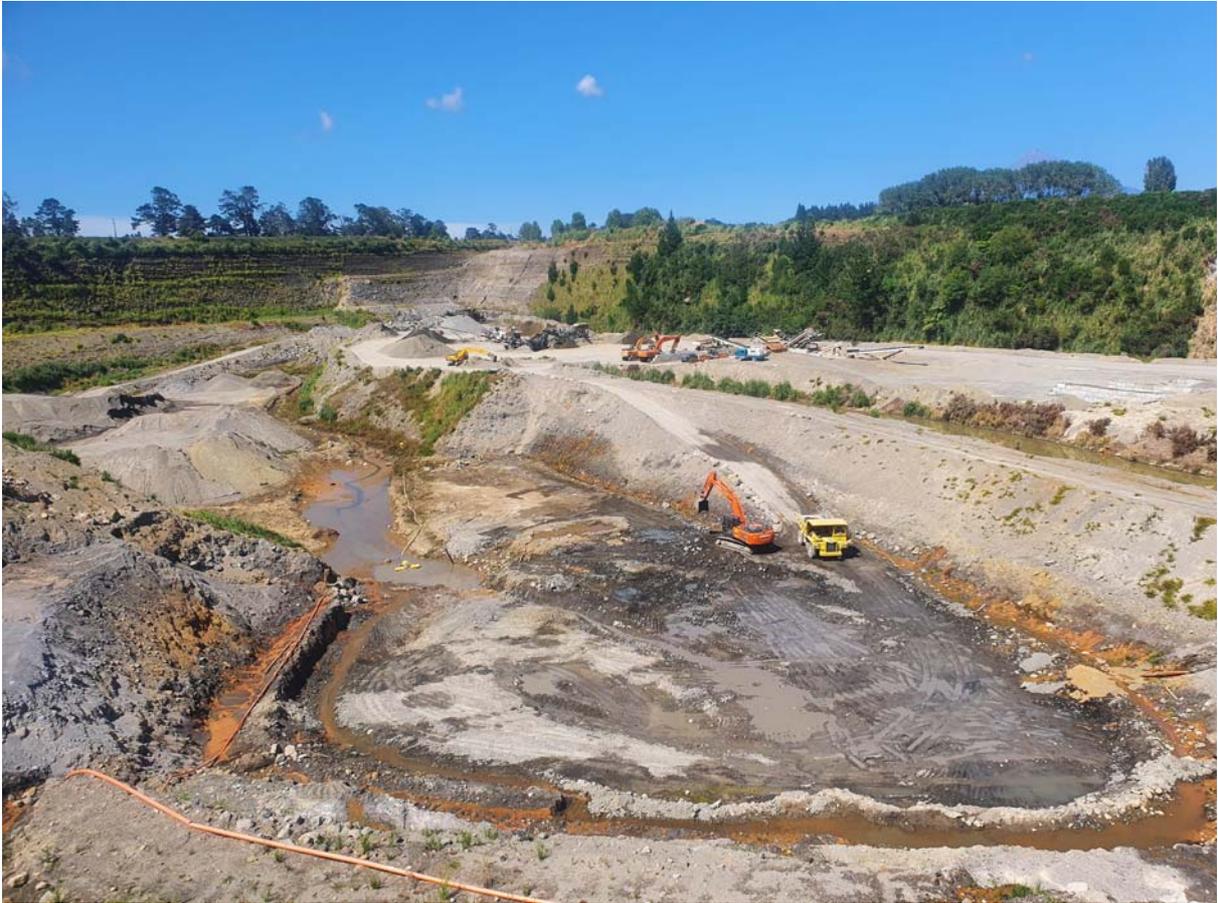
Photo 1 New excavation area west of the washwater ponds, January 2021.

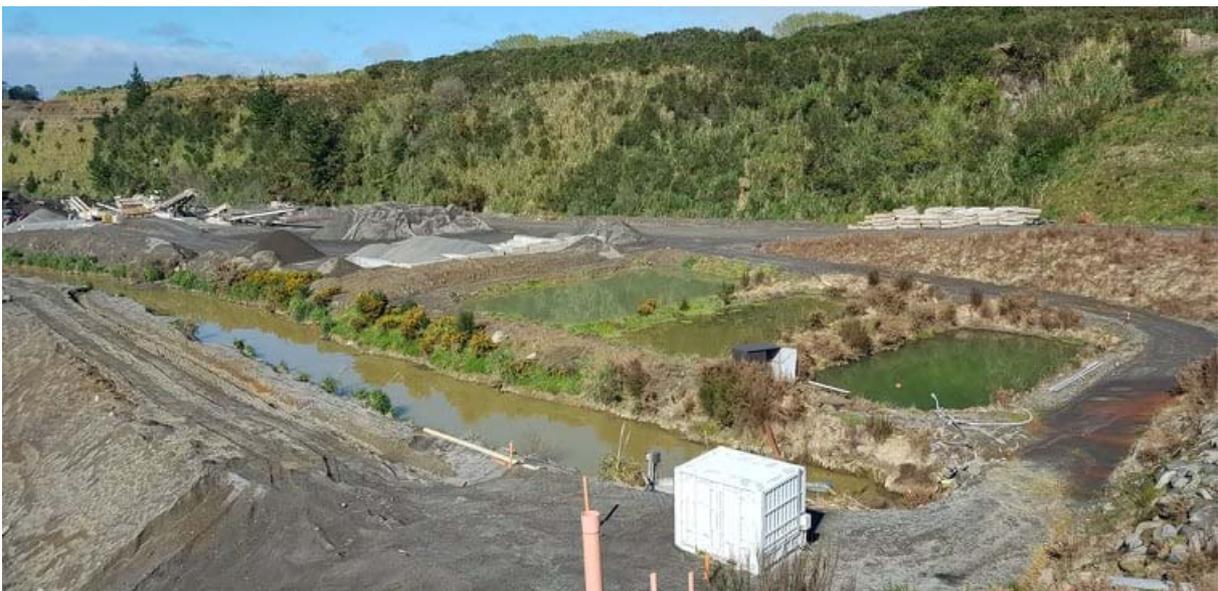
Photo 2 Washwater ponds and stormwater Pond A in the foreground, October 2021.

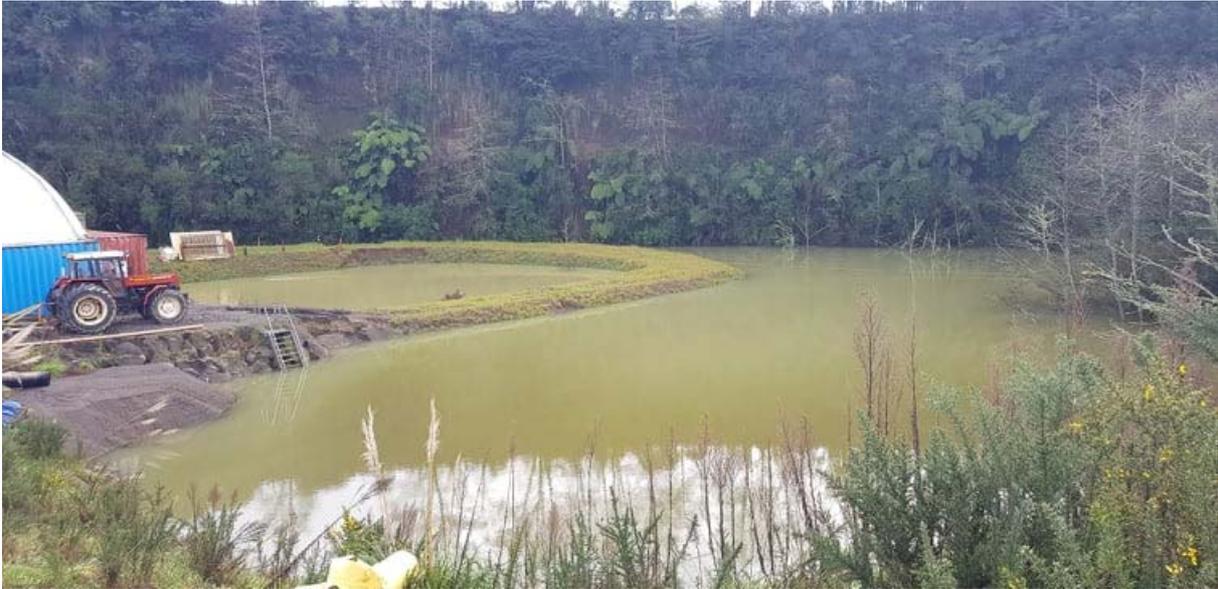
Photo 3 Stormwater Ponds B and C, July 2021.

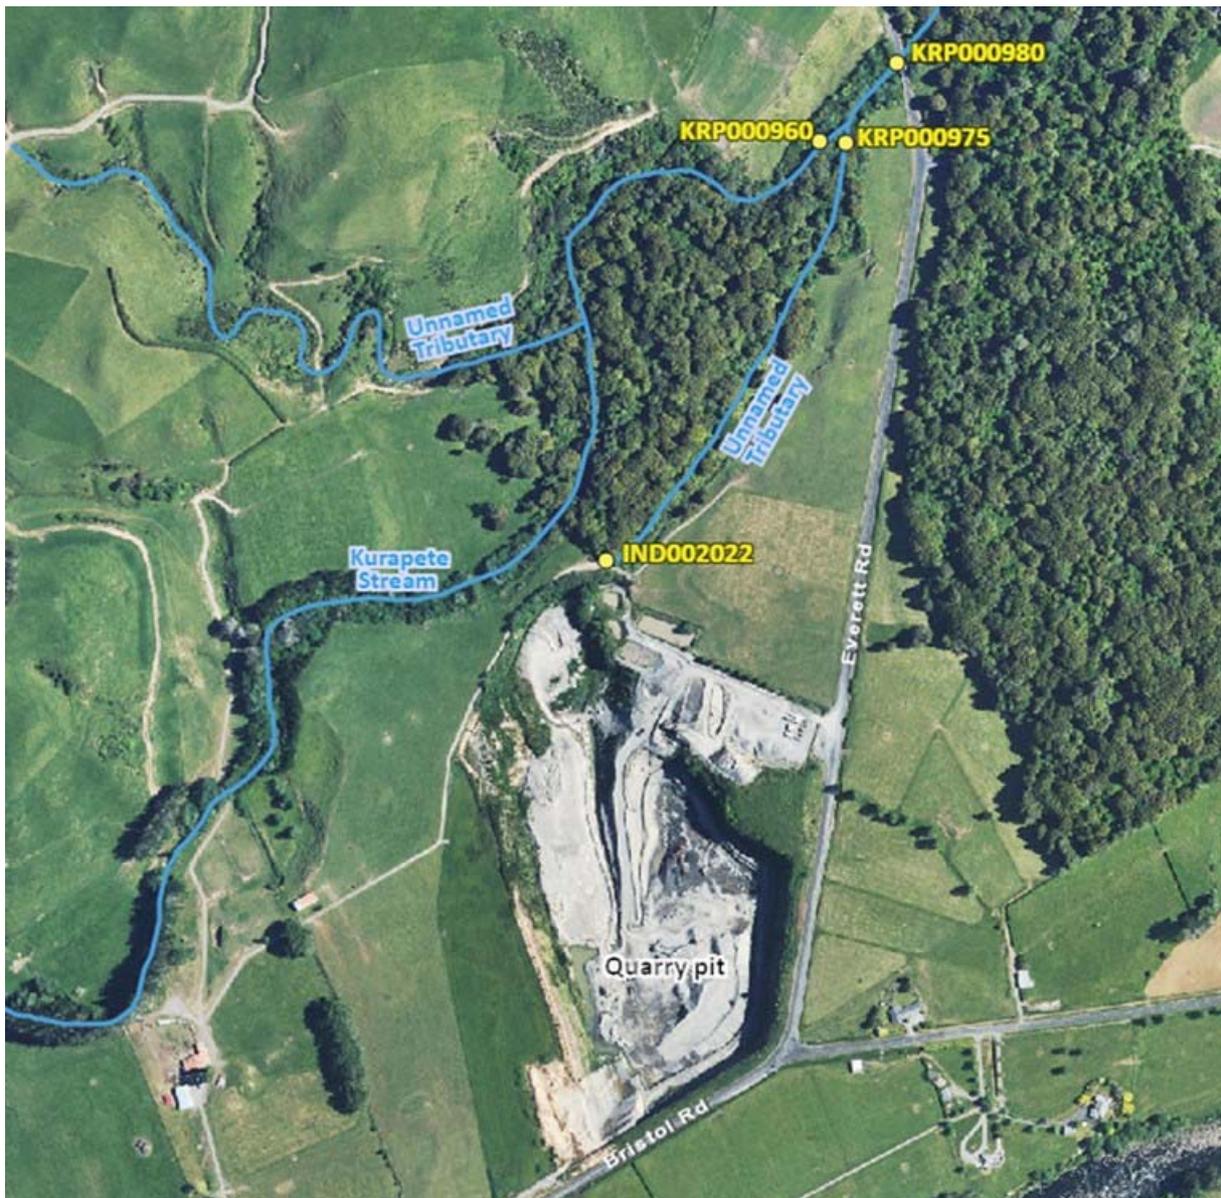
Site	Location	GPS coordinates	Site code
Quarry stormwater	At discharge outlet	1710431E 5668301N	IND002022
Kurapete Stream	100 m upstream of Everett Road bridge (upstream of quarry tributary)	1710640E 5668709N	KRP000960
Unnamed tributary	5 m upstream of the Kurapete Stream confluence (600 m downstream of discharges at quarry)	1710658E 5668713N	KRP000975
Kurapete Stream	At the Everett Road bridge (approximately 100 m downstream of quarry tributary)	1710695E 5668758N	KRP000980

Figure 1 Sampling site locations, Everett Road Quarry

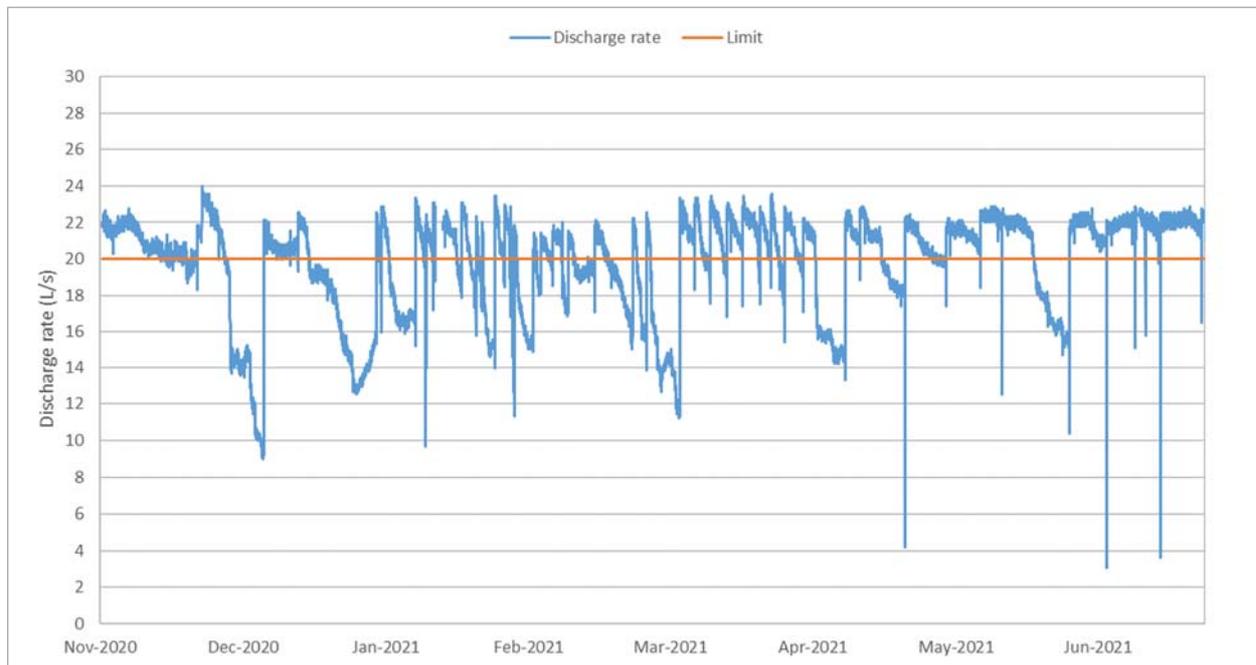
The consent holder is to provide data on groundwater abstraction and water discharge via telemetry. The discharge flowmeter is currently set up between Ponds C and D so whilst it gives some indication of the flow rate through the system, it doesn't accurately show the discharge rate from the site. The data below is from this flowmeter and shows the discharge may well be over the consented limit at times. There is no groundwater take data available as a flow meter has not yet been set up for this. This is to be addressed in the coming year as part of the reconfiguration of the stormwater system.

Figure 2 Stormwater flow rate November 2020 to June 2021

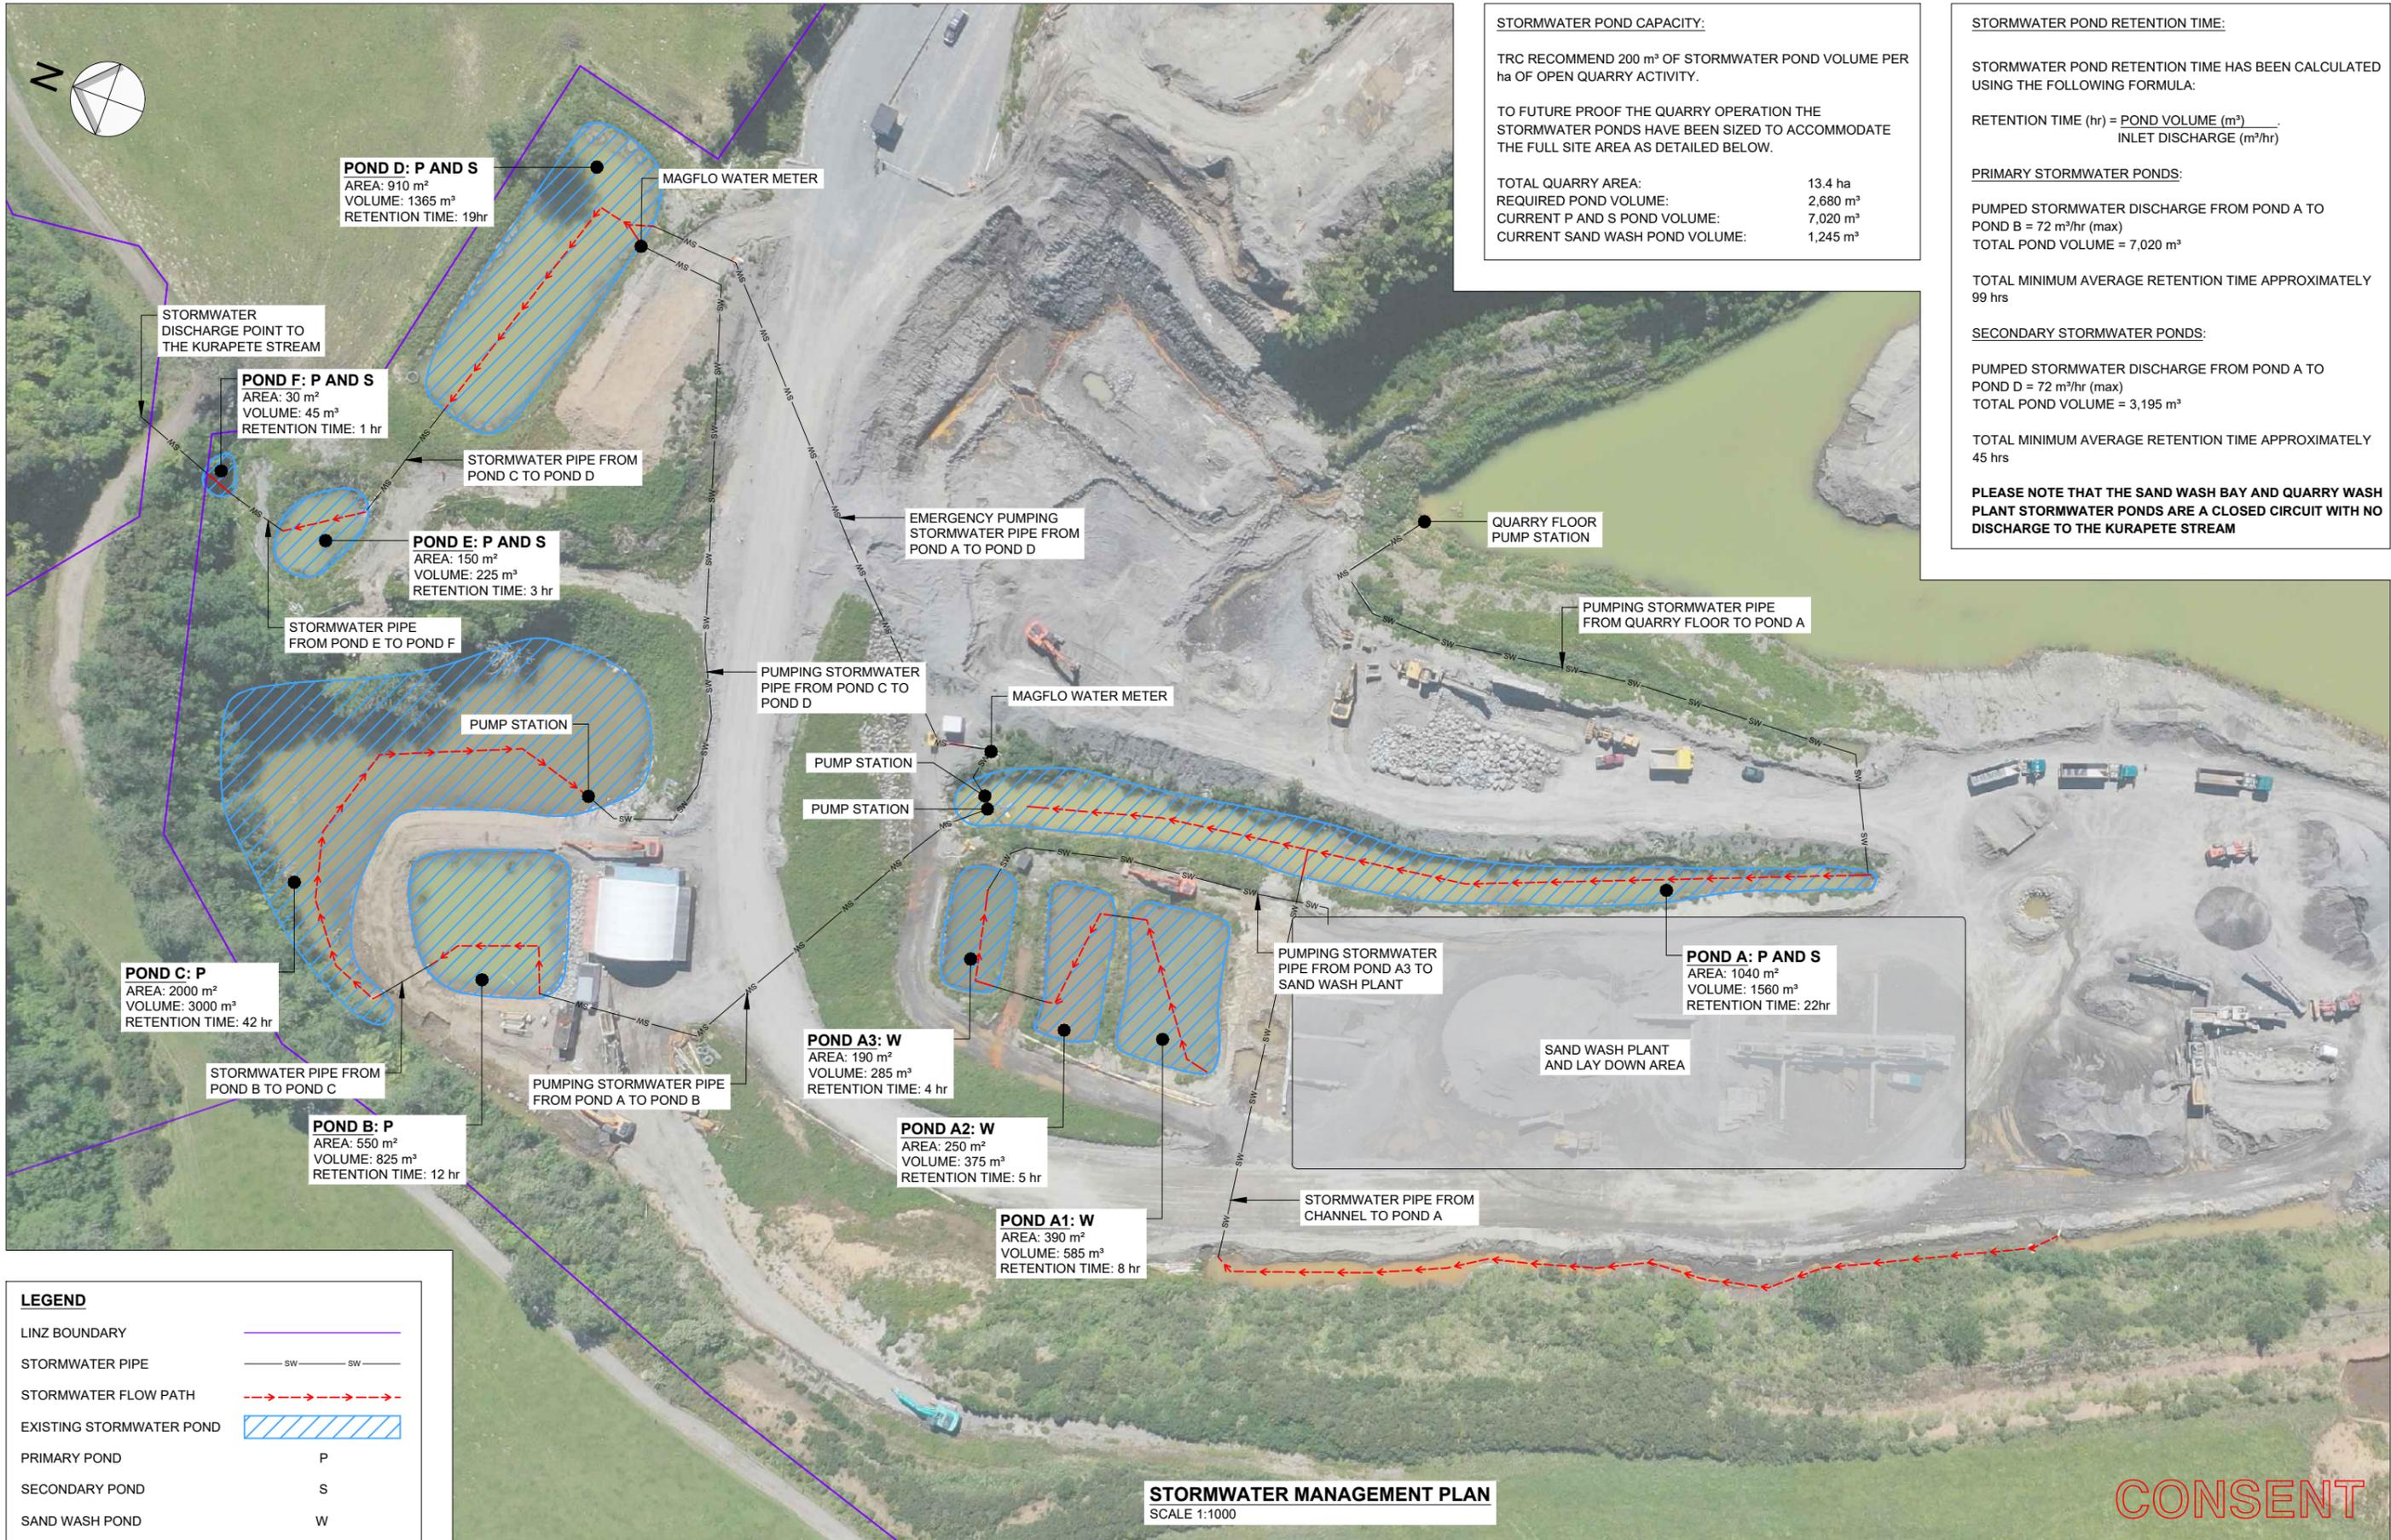
Map of stormwater and washwater  
treatment system December 2020

**STORMWATER POND CAPACITY:**  
 TRC RECOMMEND 200 m³ OF STORMWATER POND VOLUME PER ha OF OPEN QUARRY ACTIVITY.  
 TO FUTURE PROOF THE QUARRY OPERATION THE STORMWATER PONDS HAVE BEEN SIZED TO ACCOMMODATE THE FULL SITE AREA AS DETAILED BELOW.

TOTAL QUARRY AREA:	13.4 ha
REQUIRED POND VOLUME:	2,680 m³
CURRENT P AND S POND VOLUME:	7,020 m³
CURRENT SAND WASH POND VOLUME:	1,245 m³
