Urenui and Onaero Beach Camps  
Monitoring Programme  
Annual Report  
2019-2020

Technical Report 2020-19

Taranaki Regional Council  
Private Bag 713  
STRATFORD  
September 2020

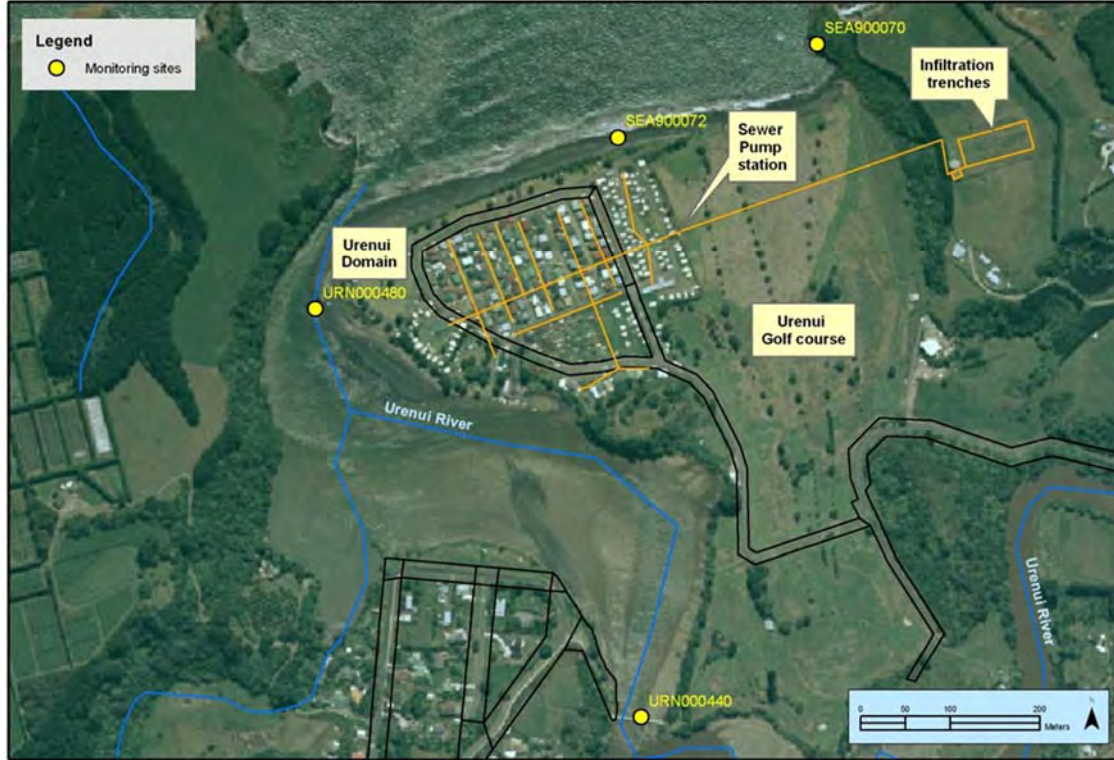
Figure 1 Map of sampling sites, sewage disposal system and other features of interest at Urenui Beach Camp

Site	Location	Site code	GPS coordinates (NZTM)
1	Urenui River SH3 bridge	URN000420	1721404 - 5682968
1a	Urenui River footbridge	URN000440	1720608 - 5682914
2	Urenui River at mouth	URN000480	1720245 - 5683370

Site	Location	Site code	GPS coordinates (NZTM)
3	Sea coast approx. 200 m east of river mouth	SEA900072	1720582 - 5683563
4	Sea coast at east end of beach	SEA900070	1720803 - 5683667

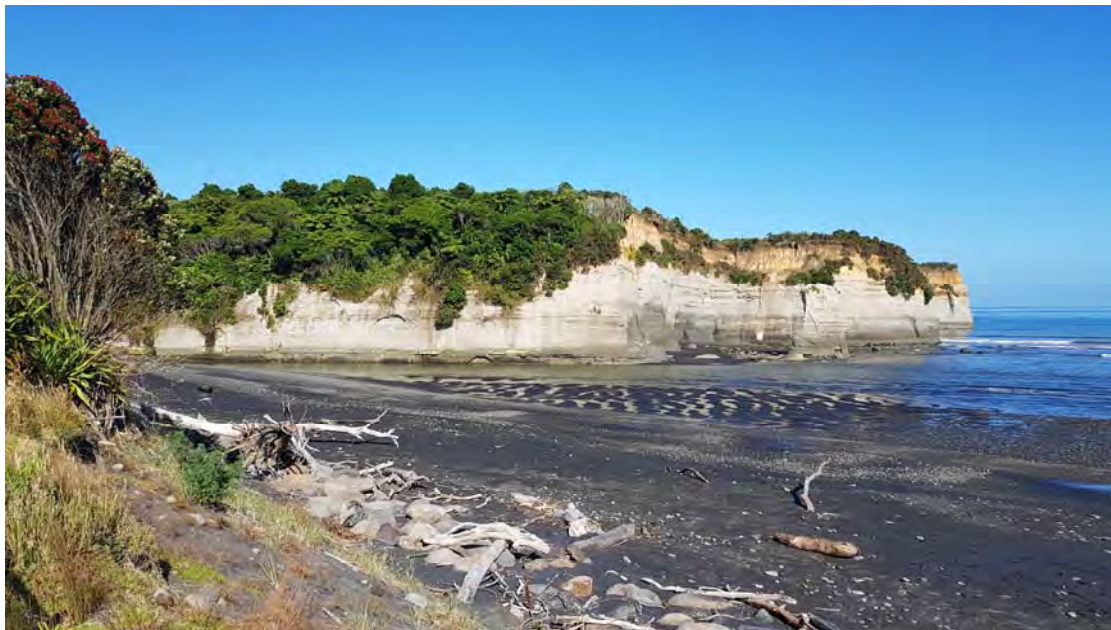
Photo 2 Urenui Beach, December 2017

Samples were collected at four sites in conjunction with the Urenui Beach Camp: two river and two coastal sites (Photo 2). A description of each site is provided in Table 2, and the locations of the four sampling sites are shown in Figure 1. The bridge on State Highway 3 (Site 1) was previously used as the upstream sampling site. An alternative site, 1 km downstream at the footbridge (Site 1a), has been used since 2001 as Site 1 is no longer safe to sample from.

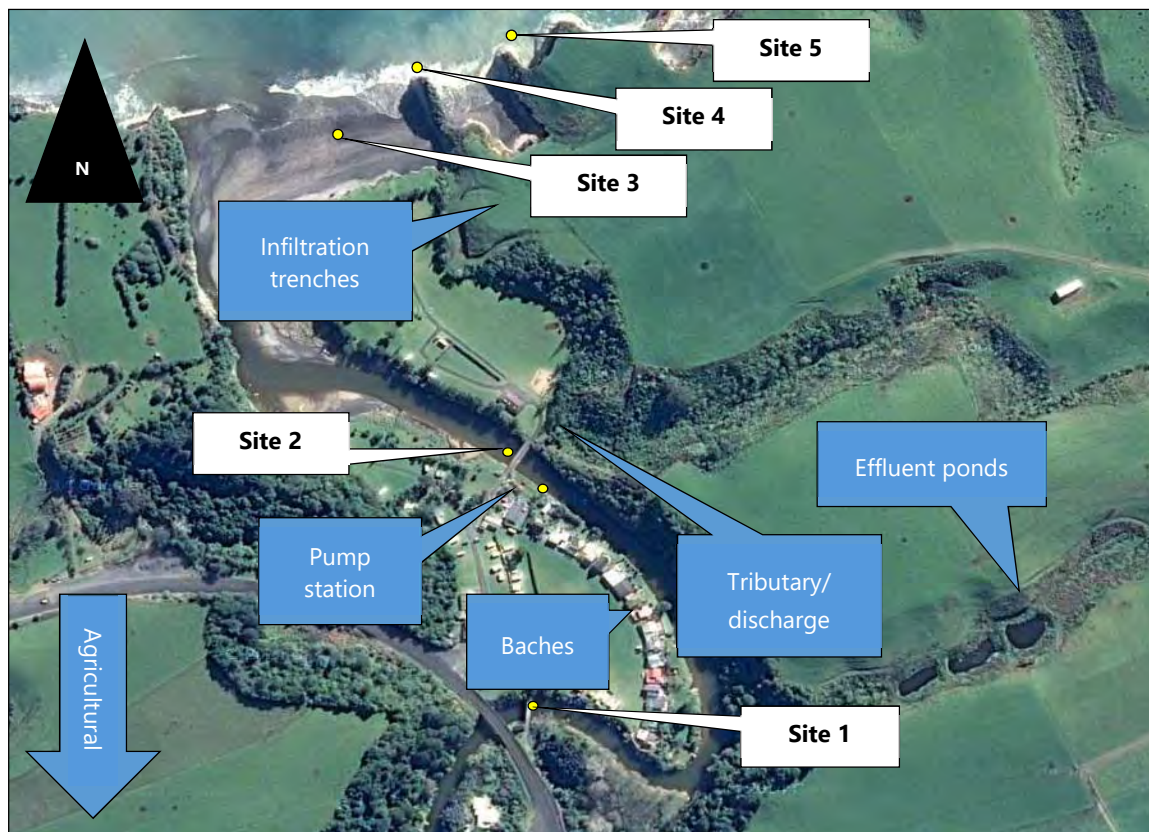
Figure 2 Map of sampling sites, sewage disposal system and other features of interest at Onaero Bay Holiday Park

Site	Location	Site code	GPS coordinates (NZTM)
1	Onaero River SH3 bridge	ONR000450	1718296 - 5682687
2	Onaero River at domain pump station bridge	ONR000470	1718283 - 5682895
3	Sea coast on beach adjacent to surf club	SEA900085	1718158 - 5683163
4	Sea coast beneath sewage infiltration cliff	SEA900083	1718216 - 5683212
5	Sea coast north of sewage infiltration cliff	SEA900081	1718296 - 5683239

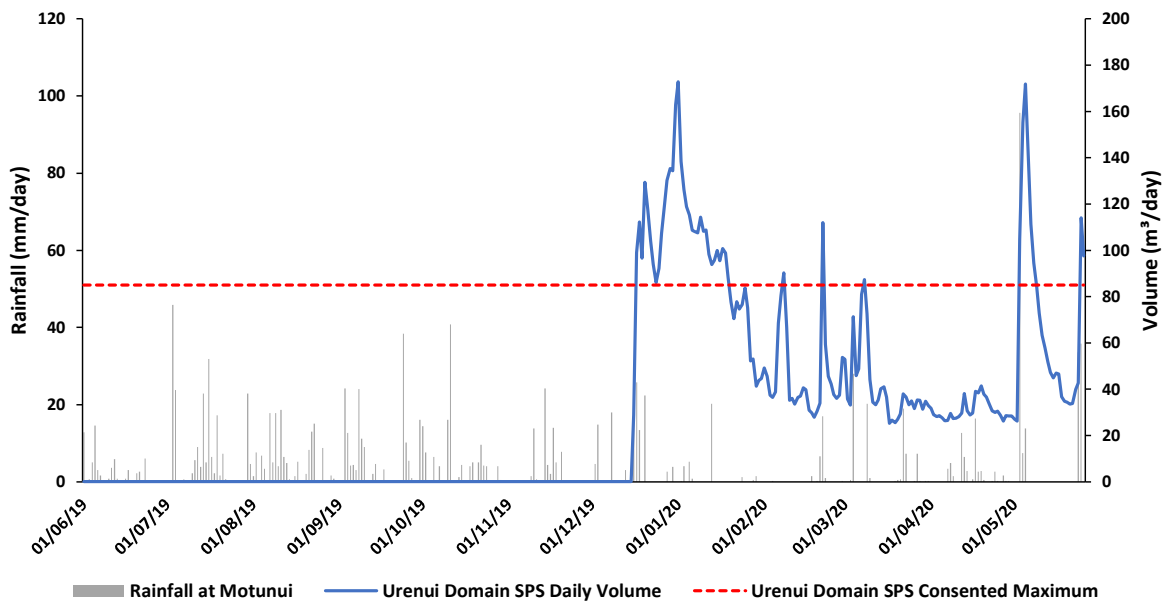
Figure 3 Urenui Domain supplied flow meter data

A flow meter within the wastewater treatment system was installed by NPDC in December 2019 at Urenui Beach Camp, in order to comply with condition 3 of consent 1389-3. NPDC complied with this data request and provided daily records of effluent volumes discharged to the soakage trenches between 17 December 2019 and 31 June 2020. From the period the flow meter was installed, the Urenui Beach Camp exceeded the consent limit of 85 m<sup>3</sup>/day for 28% of the period.

Self-notification data received from flow meters at Urenui and Onaero showed that on multiple occasions, treated septic tank sewage effluent was discharged to groundwater in excess of the consented limits. NPDC has commissioned an Assessment of Environmental Effects and is planning for an improved system with additional measures such as monitoring of the discharges and receiving environments, reduction of inflow and infiltration, monitoring and limiting occupancy of the campgrounds, improvement to system buffering capacity, and investigations into alternative infrastructure for wastewater treatment at both sites. The abatement notices have been extended until 31 December 2020 to enable suitable actions to be scoped and implemented, noting that no adverse environmental effects have been detected as a result of the non-compliances. The Council is continuing to liaise closely with NPDC regarding the situation.

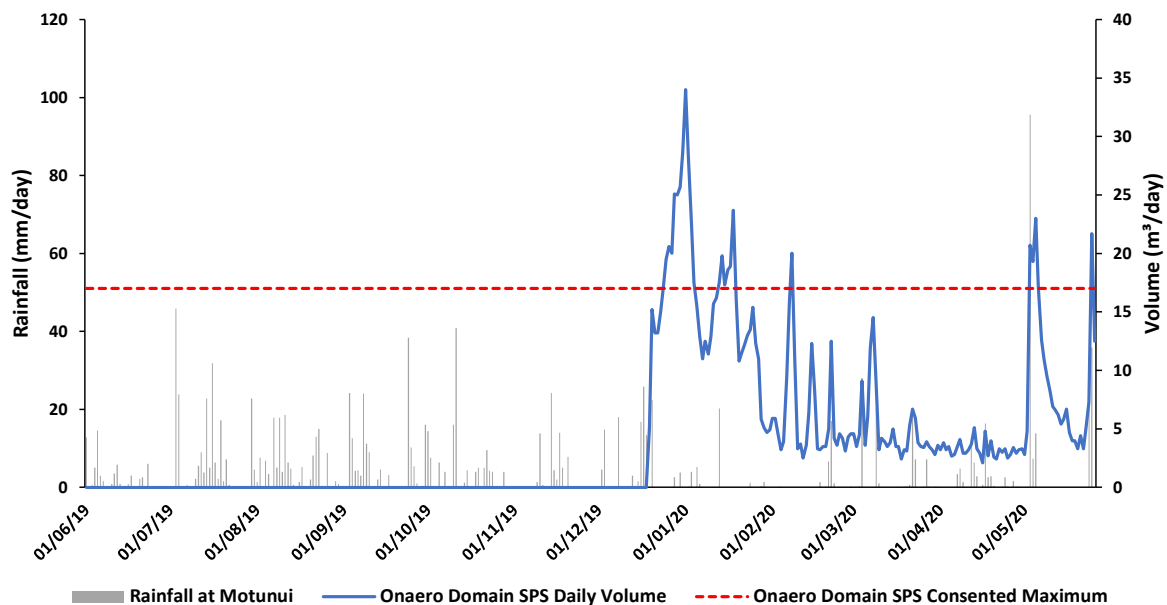
Figure 4 Onaero Domain supplied flow meter data

A flow meter within the wastewater treatment system was installed by NPDC in December 2019 at Onaero Beach Camp, in order to comply with condition 3 of consent 1389-3. NPDC complied with this data request and provided daily records of effluent volumes discharged to the soakage trenches between 20 December 2019 and 31 June 2020. From the period the flow meter was installed, the Onaero Beach Camp exceeded the consent limit of 17 m<sup>3</sup>/day for 12% of the period.
