Wai-iti Beach Retreat
Monitoring Programme
Annual Report
2019-2020

Technical Report 2020-14

Taranaki Regional Council

September 2020

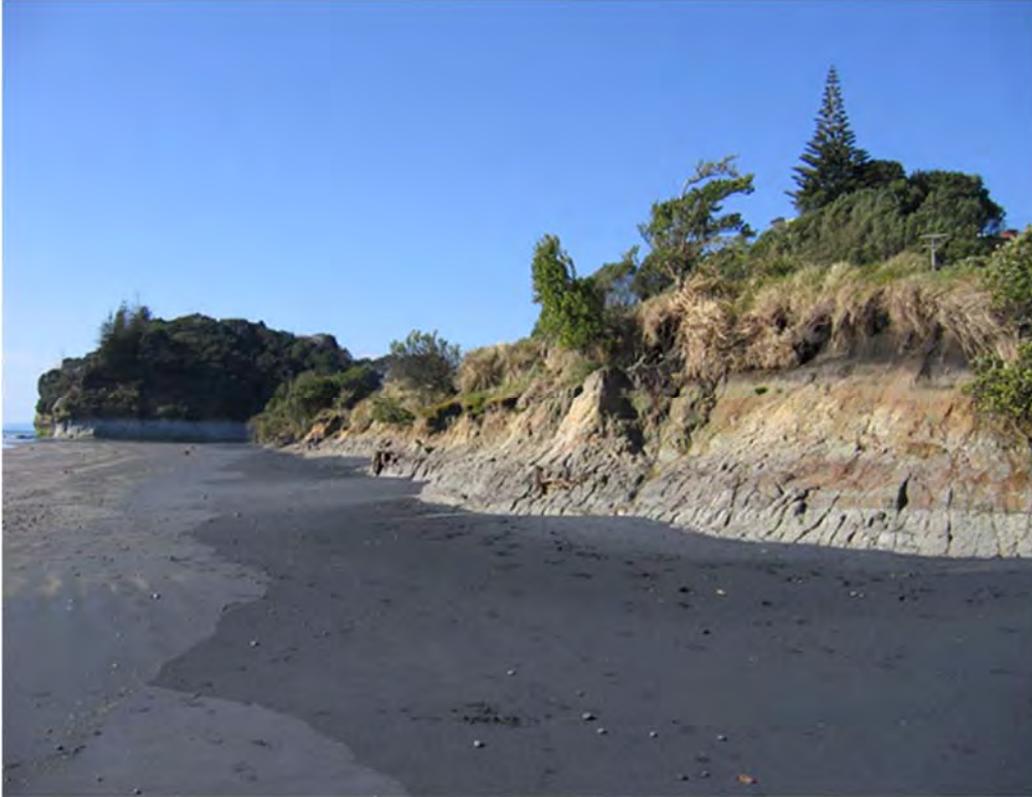
Photo 3 Erosion on Wai-iti foreshore prior to construction of the rock wall

Over the summer and autumn months of 2004, rough seas combined with high tides reached the beach toe of the coastal banks and sand dunes that front the Retreat. Fresh erosion scarps were cut into these banks for nearly the full beach frontage, where no system of protection existed (Photo 3).

In 2005 an application was received for a resource consent to provide boulder rip rap protection, over a total distance of 293 m, from the stream at the south end of Wai-iti Beach to an area of existing large boulder protection in the north. This consent was granted in July 2005. To mitigate any possible end effects, the area between the public entrance and the river was also protected using the boulder rip rap method.

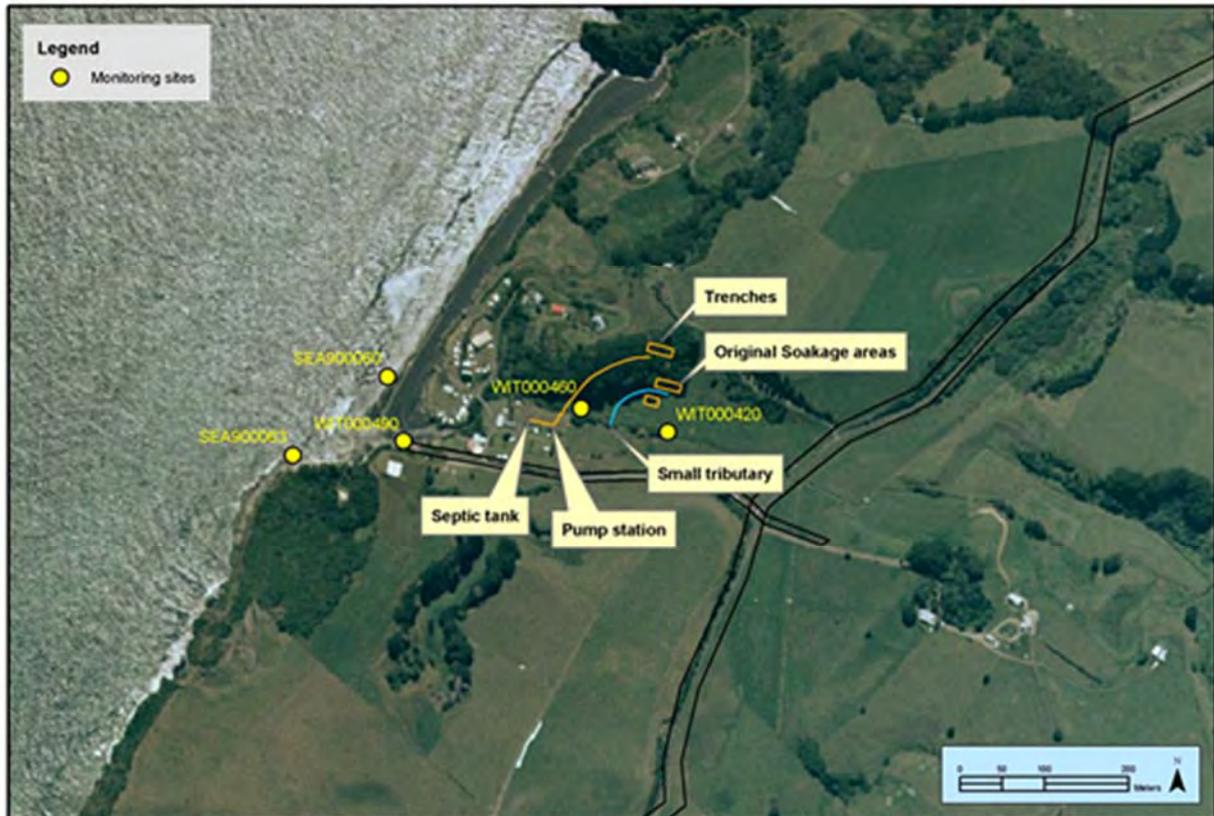
Figure 1 Locations of wastewater treatment system and sampling sites at the Wai-iti Beach Retreat

All wastewaters from the camping ground enter a septic tank of 143 m³ capacity. The effluent is then pumped via a 50 mm alkathene pipe across the Wai-iti Stream and into soakage trenches situated on a wooded hillside approximately 30 m from the stream.
