Wai-iti Beach Retreat

Monitoring Programme

Annual Report

Technical Report 2022-60

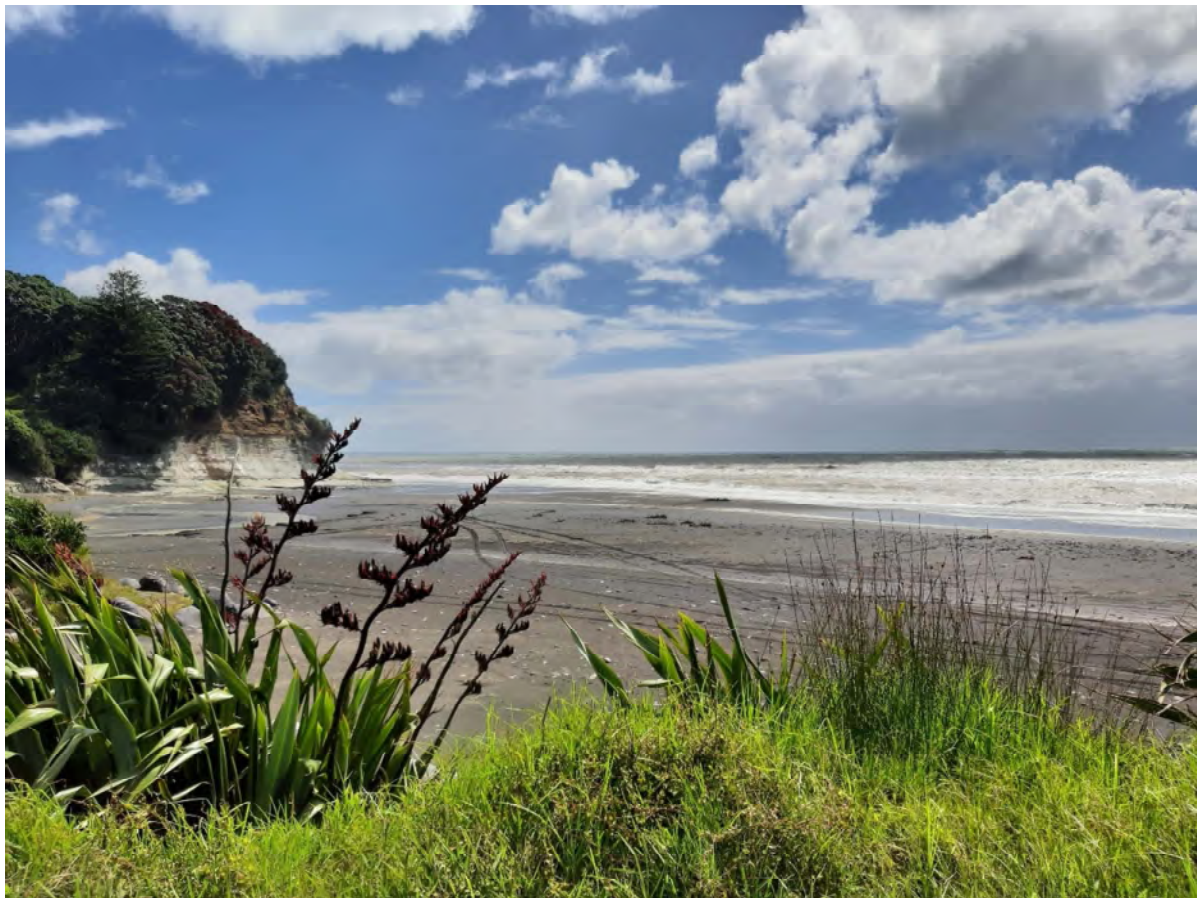
Photo 1 Wai-iti Beach Retreat

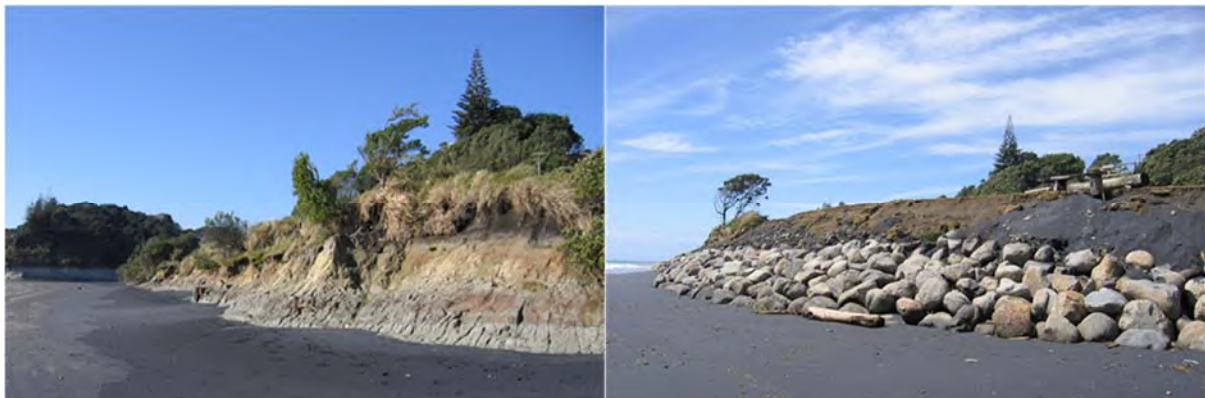
Over the summer and autumn months of 2004, rough seas combined with high tides reached the beach toe of the coastal banks and sand dunes that front the Wai-iti Beach Retreat. Fresh erosion scarps were cut into these banks for nearly the full beach frontage, where no system of protection previously existed (Photo 2).

In 2005 an application was received for a resource consent to provide boulder rip rap protection, over a total distance of 293 m, from the stream at the south end of Wai-iti Beach to an area of existing large boulder protection in the north. This consent was granted in July 2005. To mitigate any possible end effects, the area between the public entrance and the river was also protected using the boulder rip rap method.

Photo 2 Erosion on Wai-iti foreshore prior to construction of the rock wall, and the rock wall facing north from stream (Nov 2005)

The rock wall looked to be in good condition with no scouring noted. Inspections of the rock wall found no notable end effects, and neither the wall nor the land behind it appeared to be suffering from any obvious erosion or degradation.

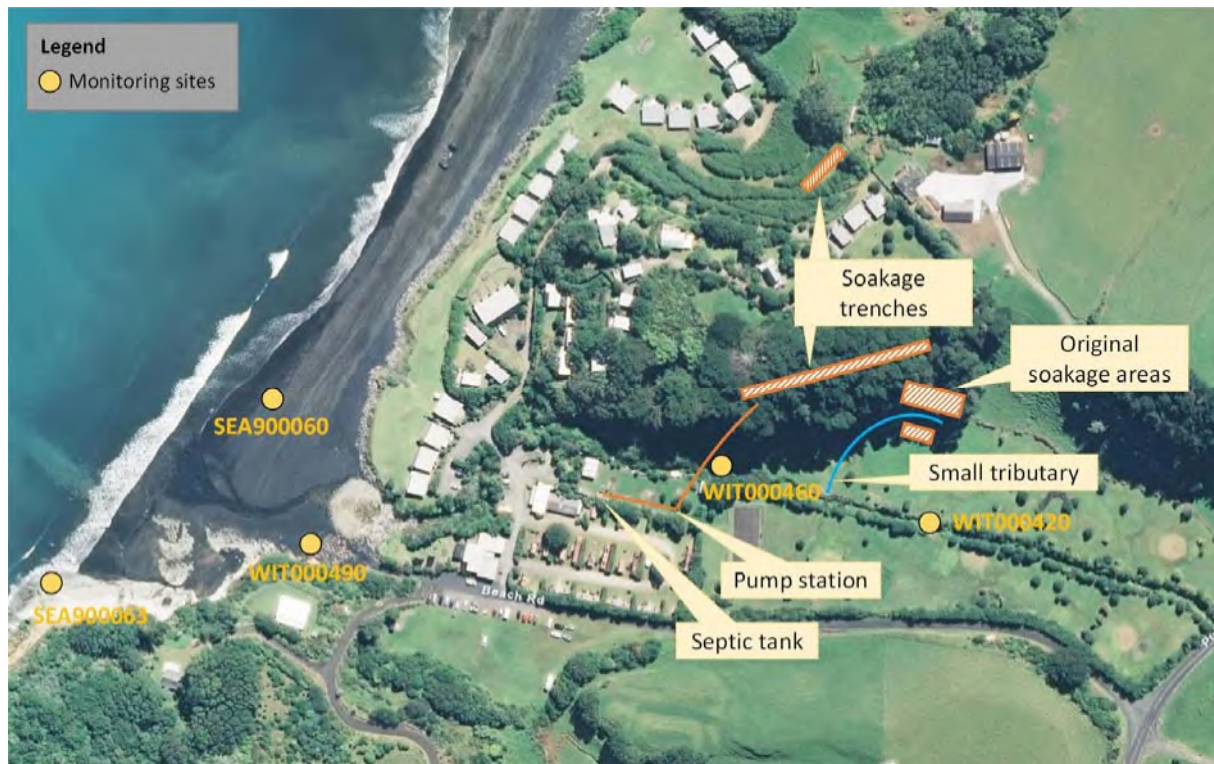
All wastewaters from the camping ground enter a septic tank of 143 m³ capacity. The effluent is then pumped via a 50 mm alkathene pipe across the Wai-iti Stream and into soakage trenches situated on a wooded hillside approximately 30 m from the stream. When previous proprietors took over the property in 1986-1987, the disposal system consisted of a seepage ditch situated near the base of the wooded hillside. Monitoring found that this trench system was an unsuitable means of disposal, resulting in high faecal coliform counts at the mouth of the Wai-iti Stream. This inadequate treatment led to the development of the new multiple soakage trench system on the hillside which was commissioned in 1991. More recently this has been extended, and another soakage field has been created in the Olive Grove on the other side of the hillside to allow the Retreat to spread the load across a wider area.

Samples were collected at five sites during the second site inspection. Three samples were collected from the Wai-iti Stream and two from coastal sites either side of the stream mouth (Table 2, Figure 1, and Photo 3). With the exception of WIT000460, these sampling sites have mostly been monitored since 1994. WIT000460, located approximately 10 m downstream of the tributary, was added to the programme during the 1999-2000 monitoring period to assess the influence of the tributary on water quality in the Wai-iti Stream.

Figure 1 Locations of wastewater treatment system and sampling sites at the Wai-iti Beach Retreat

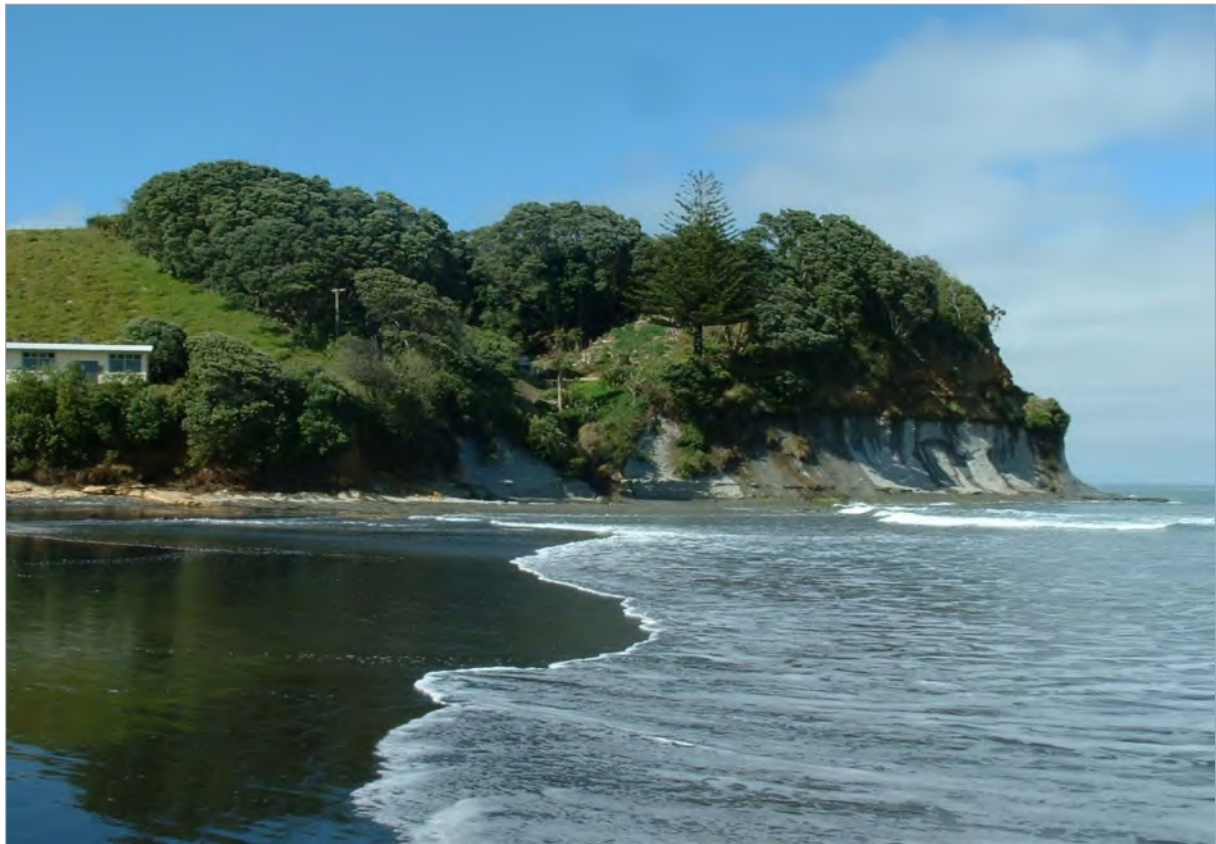
Photo 3 Wai-iti Beach, looking from site SEA900060 towards SEA900063, with the Wai-iti Stream entering from center-left

The results of the routine bacteriological monitoring undertaken during the 2021-2022 summer monitoring period are presented in Table 5. The FIB counts of the samples collected in January 2022 from the three freshwater sites were all at Alert or Action mode under the Marine Recreational Bathing Guidelines (MfE, 2003; Table 3). The *E. coli* count for the upstream site exceeded requirements for Action mode, but decreased further downstream, which suggests this has been caused by influences upstream of the Retreat, and unlikely to be a result of activities at the Retreat itself. Enterococci counts at both coastal sites were low and well under the Alert mode.
