# South Taranaki District Council Eltham WWTP

Monitoring Programme
Annual Report
2022-2023

Technical Report 2023-07

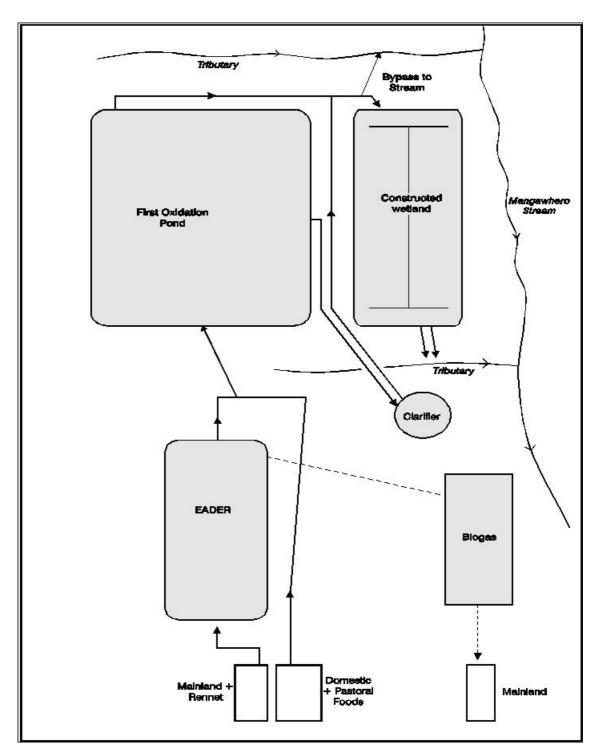
Figure 1 Schematic layout of Eltham WWTP prior to the diversion of wastewater to the Hawera WWTP

The layout of the WWTP as it existed prior to the new pipeline diversion is illustrated in Figure 1.

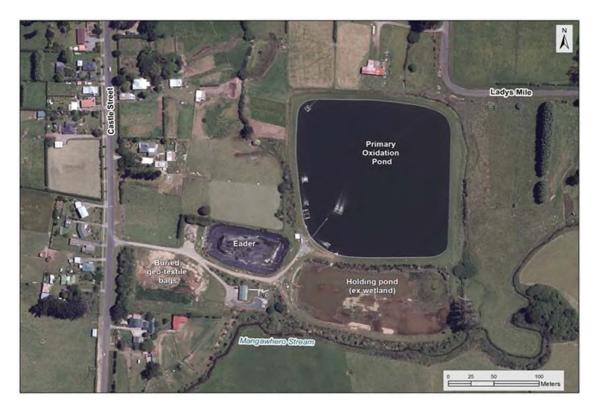
Figure 2 Aerial view of the Eltham WWTP

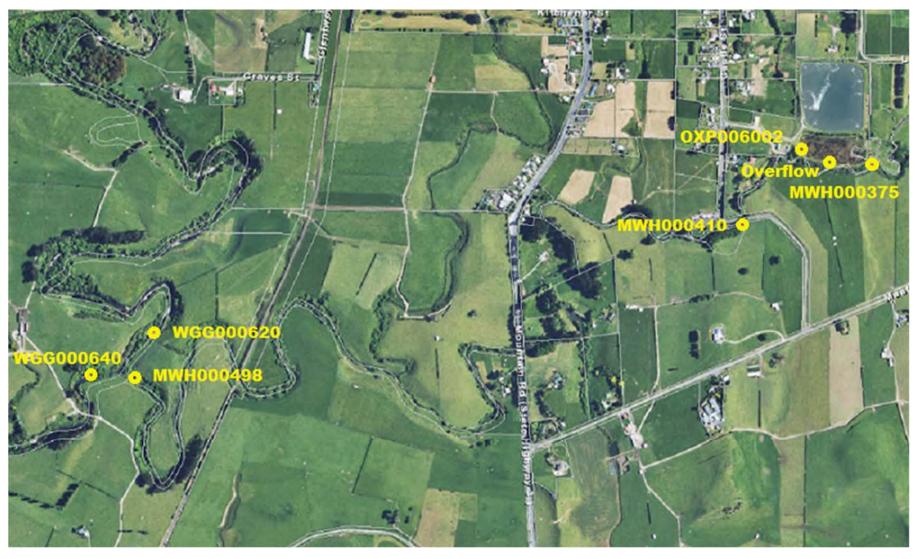
Figure 3 Aerial map showing location of sampling sites

Routine monthly 'State of the Environment Monitoring' (SEM) occurs at three sites downstream of the WWTP. The results of this monitoring are included for comparison purposes and to provide baseline analysis in the event of any discharges from the Eltham WWTP.

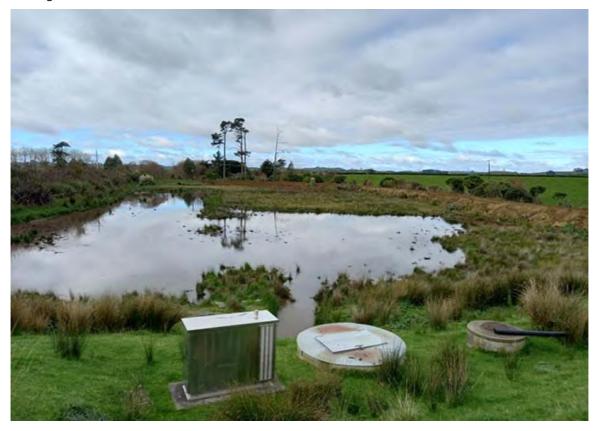
The high levels in the ponds after Cyclone Dovi in February 2022 showed that the level of the outlet pipe was higher than the southern bank of the overflow pond, resulting in overtopping. Following an engineering investigation, the embankment was raised in June 2023 (Photo 1).

Photo 1 Overflow detention pond raised bund (right of photo)

There was a slightly noticeable odour around the inlet and step screen areas, with no odour issues noted around the pond perimeter nor beyond the southern boundary. The WWTP surrounds were found to be tidy. Work to raise the bund around the overflow retention pond was scheduled to commence shortly.
