South Taranaki District Council

Ōpunake WWTP

Monitoring Programme

Technical Report 2023-65

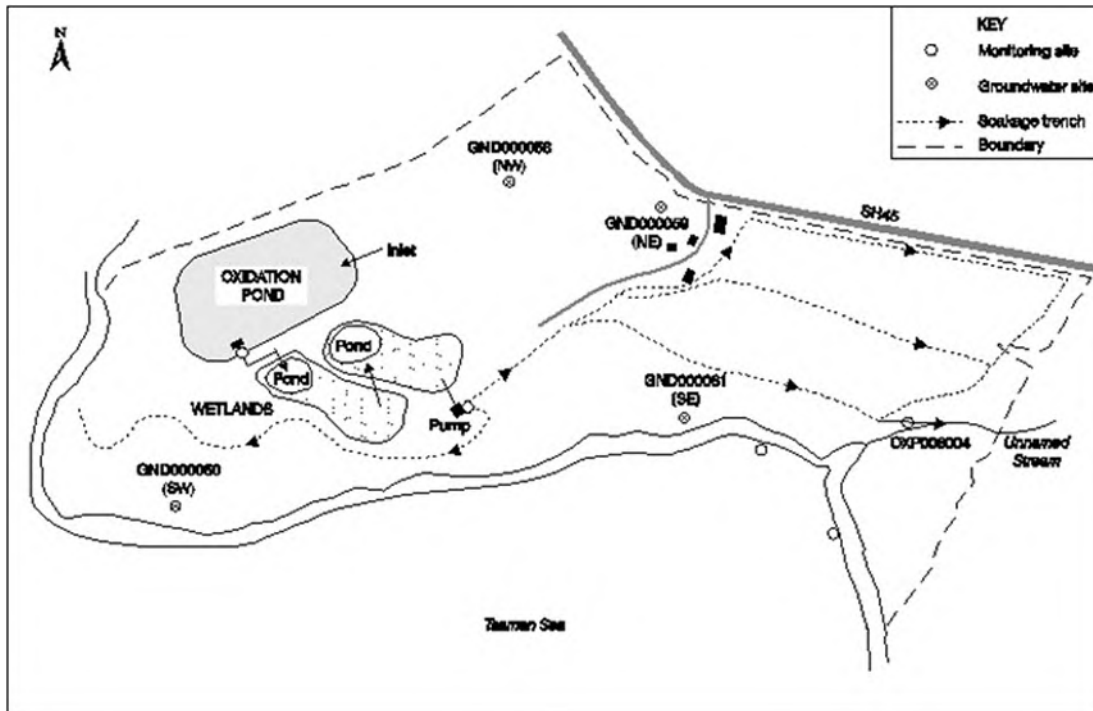
Figure 1 Schematic of Ōpunake WWTP design and layout

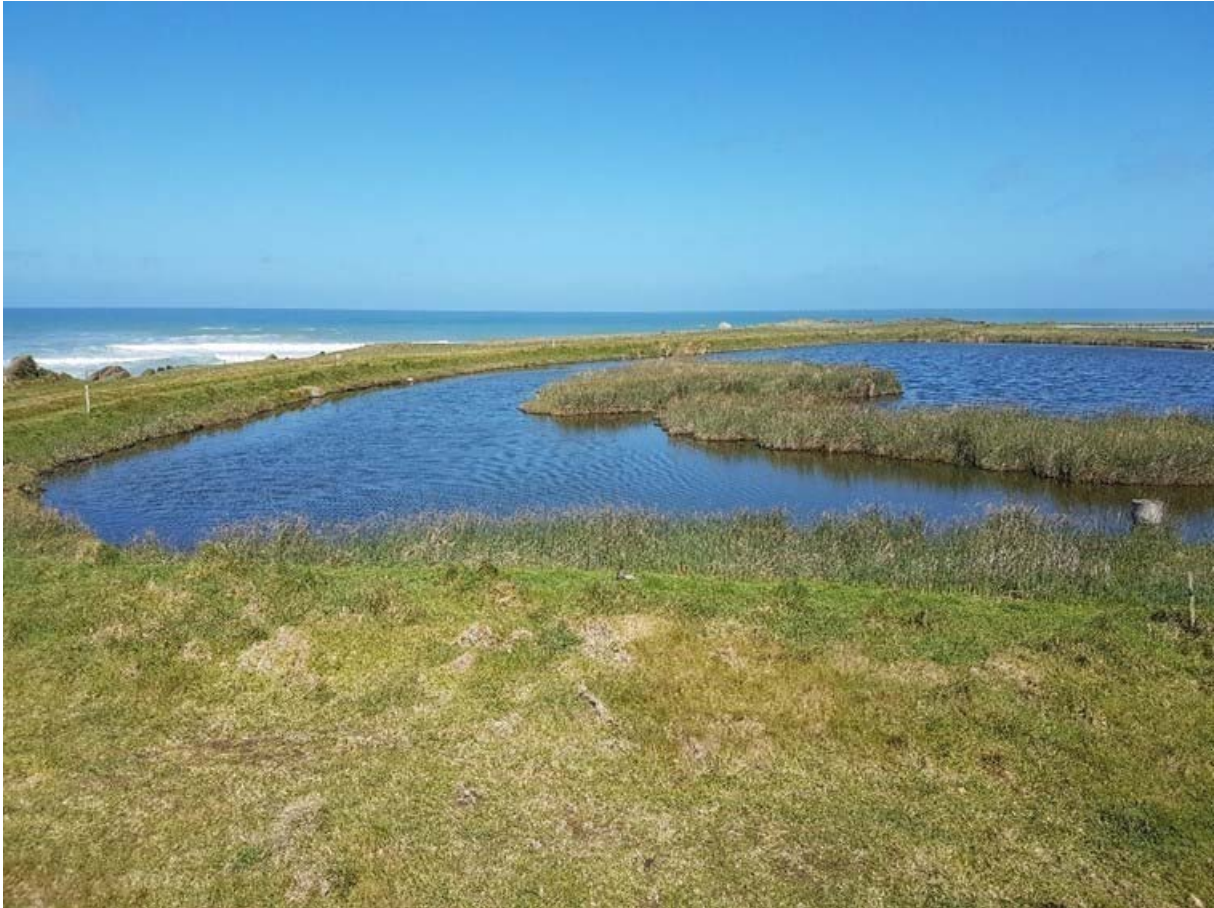
Photo 1 Ōpunake WWTP wetlands

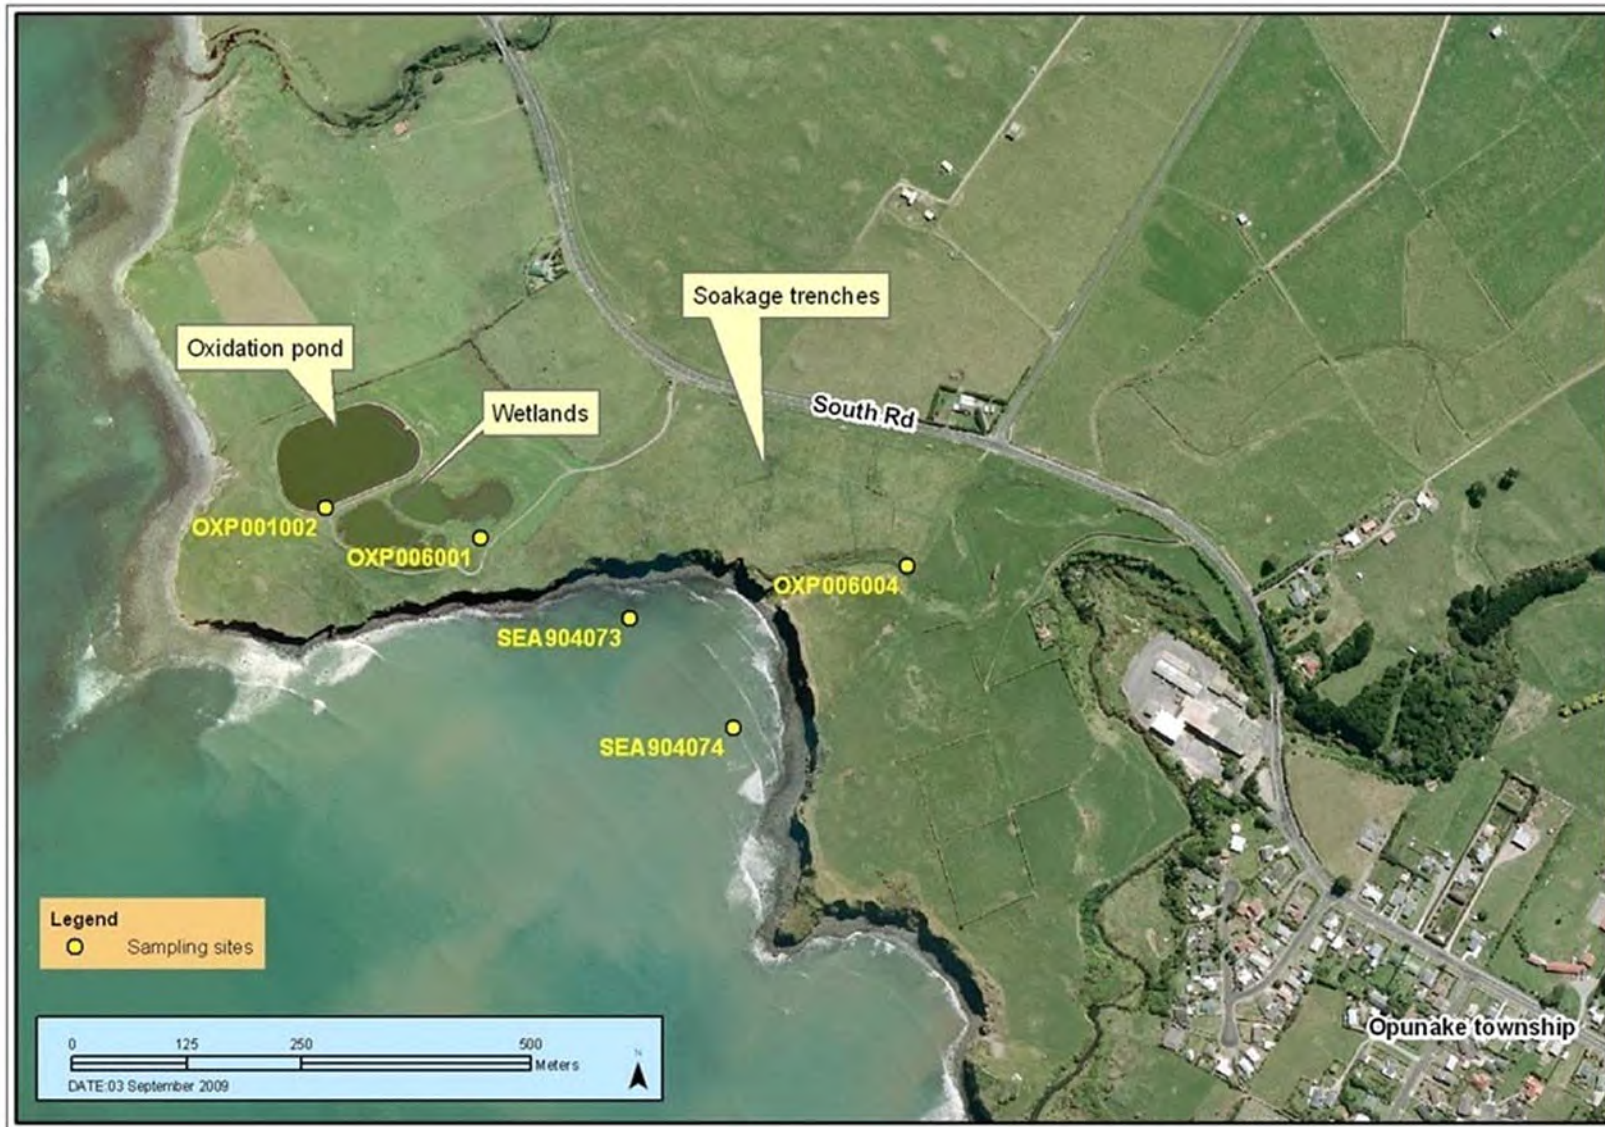
Figure 2 Opunake WWTP and sampling locations (sites SEA904073 and SEA904074 were not sampled during the year due to no access)

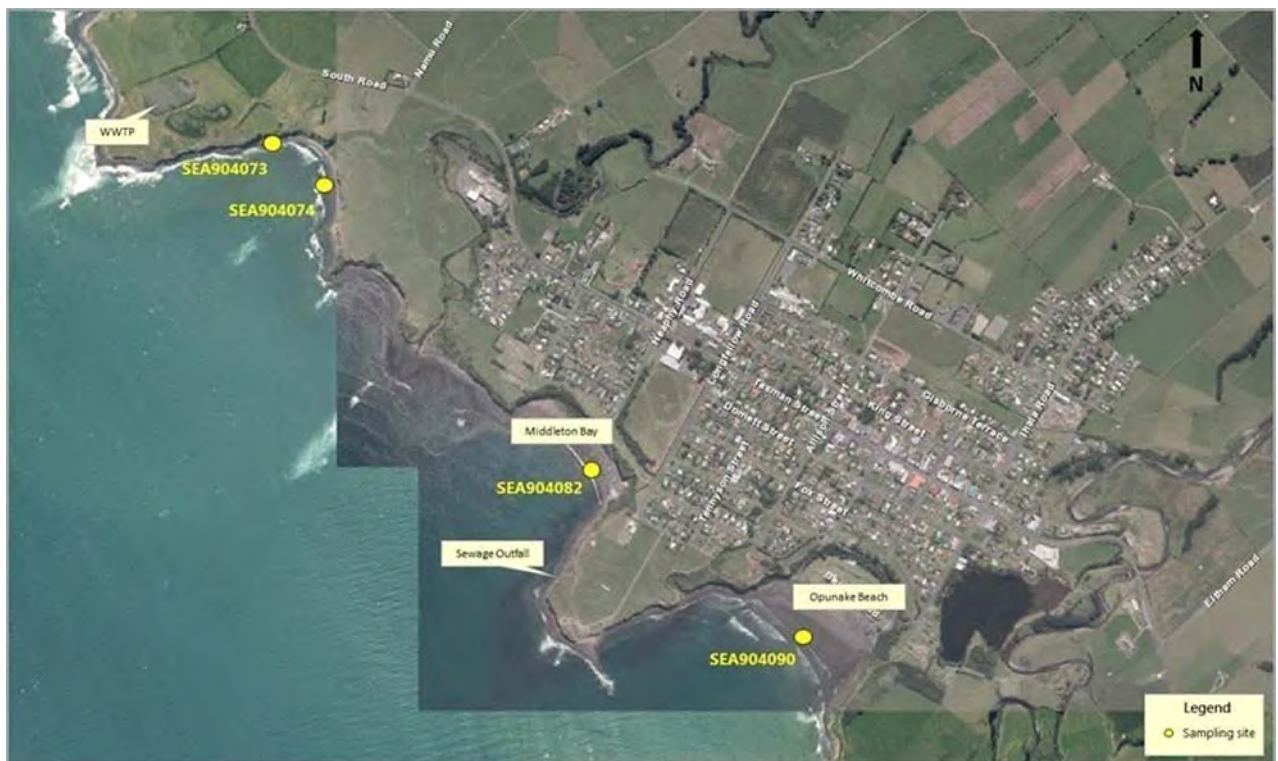
Figure 3 Location of receiving water sampling sites for Ōpunake WWTP

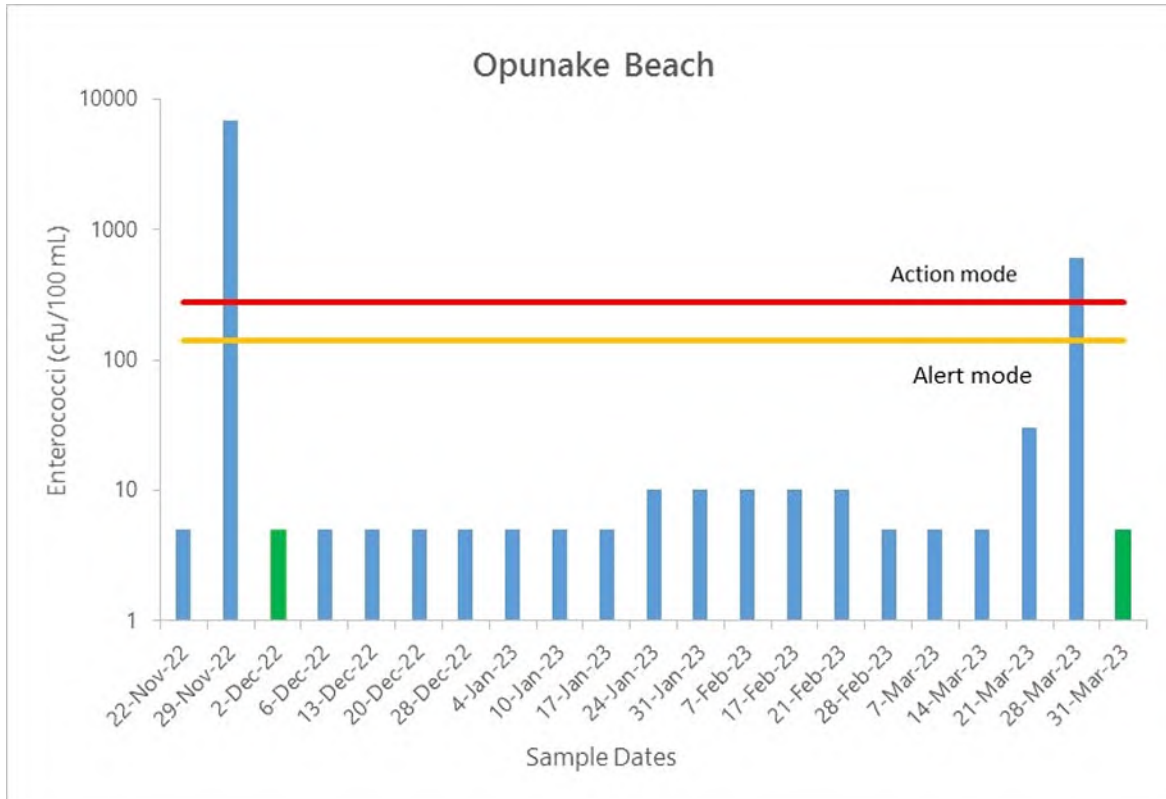
Figure 4 Enterococci results for Ōpunake Beach summer 2022-2023

Blue = routine weekly sample, green = follow up sample, Results of <10 are displayed on the graph as 5

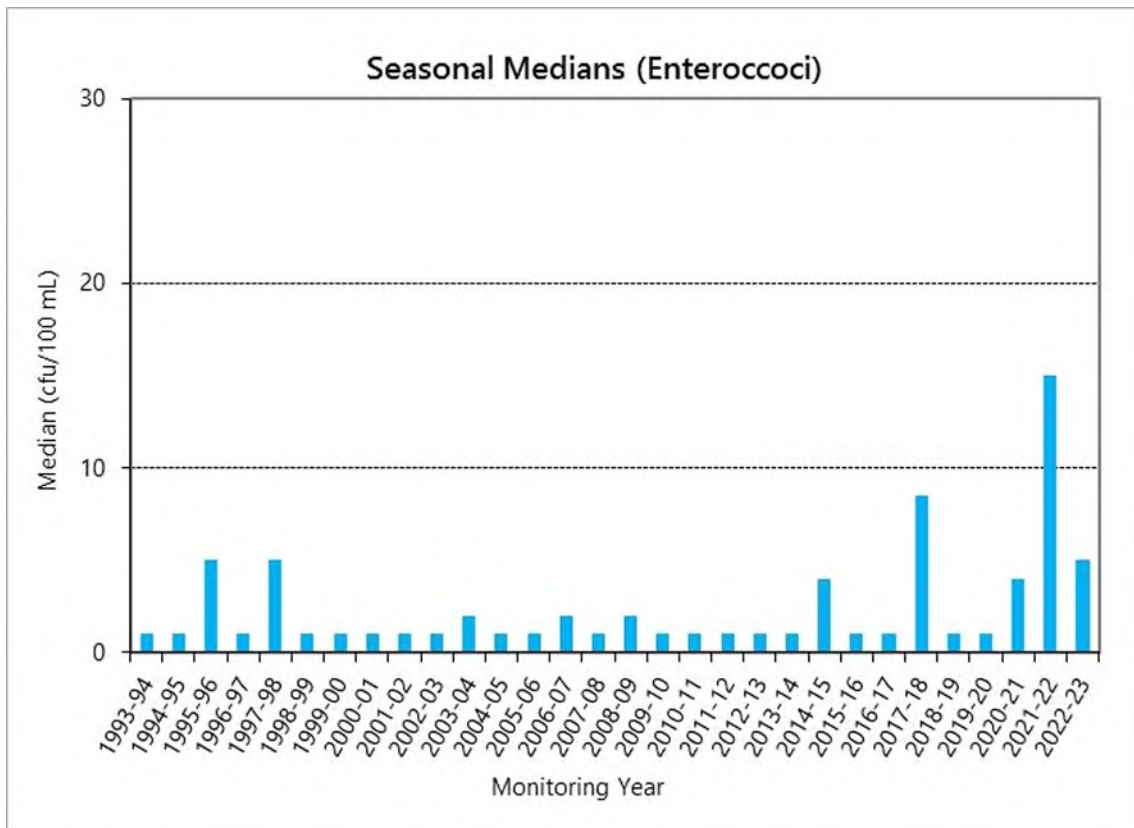
Figure 5 Median bacteriological results at Ōpunake Beach since summer 1993-1994

Figure 5 shows that, in terms of median numbers of enterococci, the contact recreational water quality at this site is generally very good. It is noted that the protocol for sampling has changed in the last couple of years so that samples are collected irrespective of weather or tide, unlike previously where samples were collected around high tide in fine weather only. Prolonged and/or heavy rainfall will often result in high levels of enterococci in the samples as these are washed down flooded streams and rivers from farmland. This can be exacerbated by a low tide where a sea sample collected from a site near a stream mouth may contain a high proportion of freshwater.

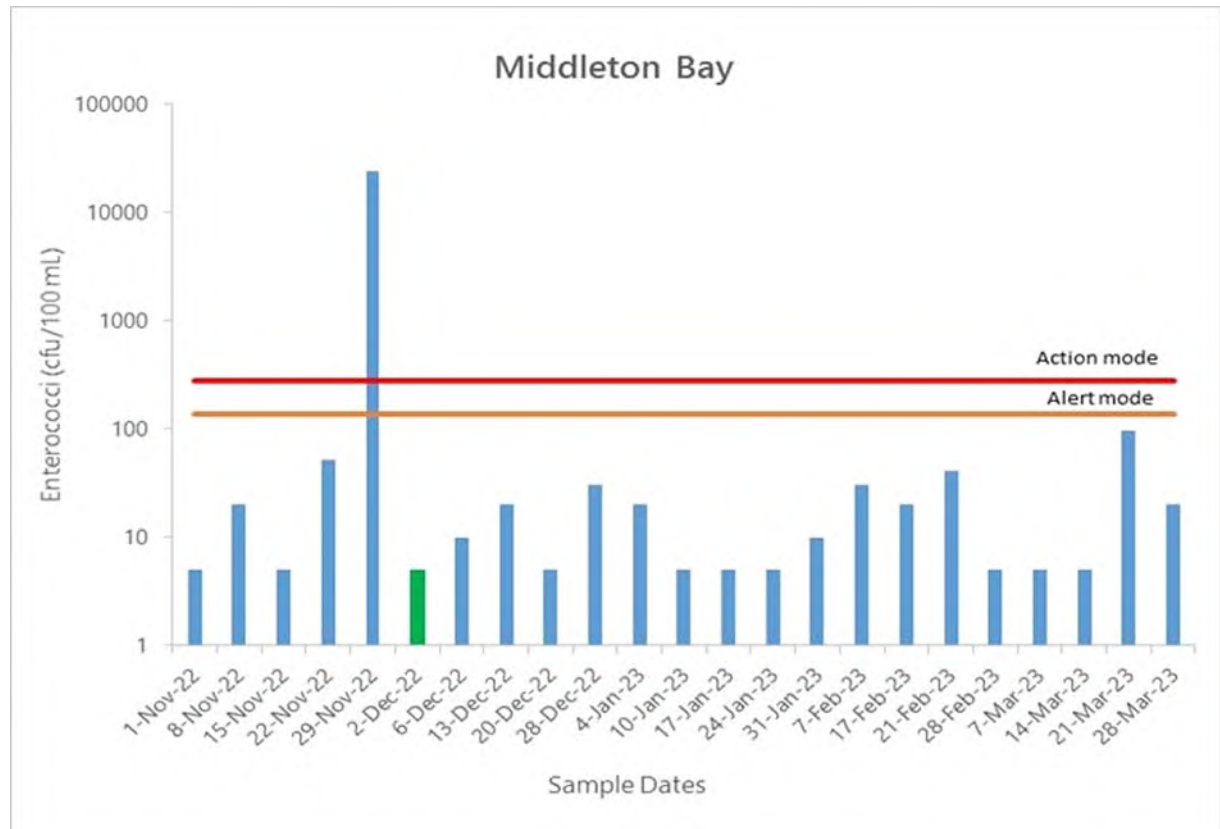
Figure 6 Bacteriological (enterococci) results from Middleton Bay during summer 2022-2023

Blue = routine weekly sample, green = follow up sample, Results of <10 are displayed on the graph as 5

The generally high water quality was emphasised by the seasonal median count of 10 enterococci (cfu/100 ml) for the 23 samples collected during the survey period. The numbers of enterococci were extremely high on one occasion (>24,200 cfu/110 ml), however a follow-up sample found numbers had reduced.

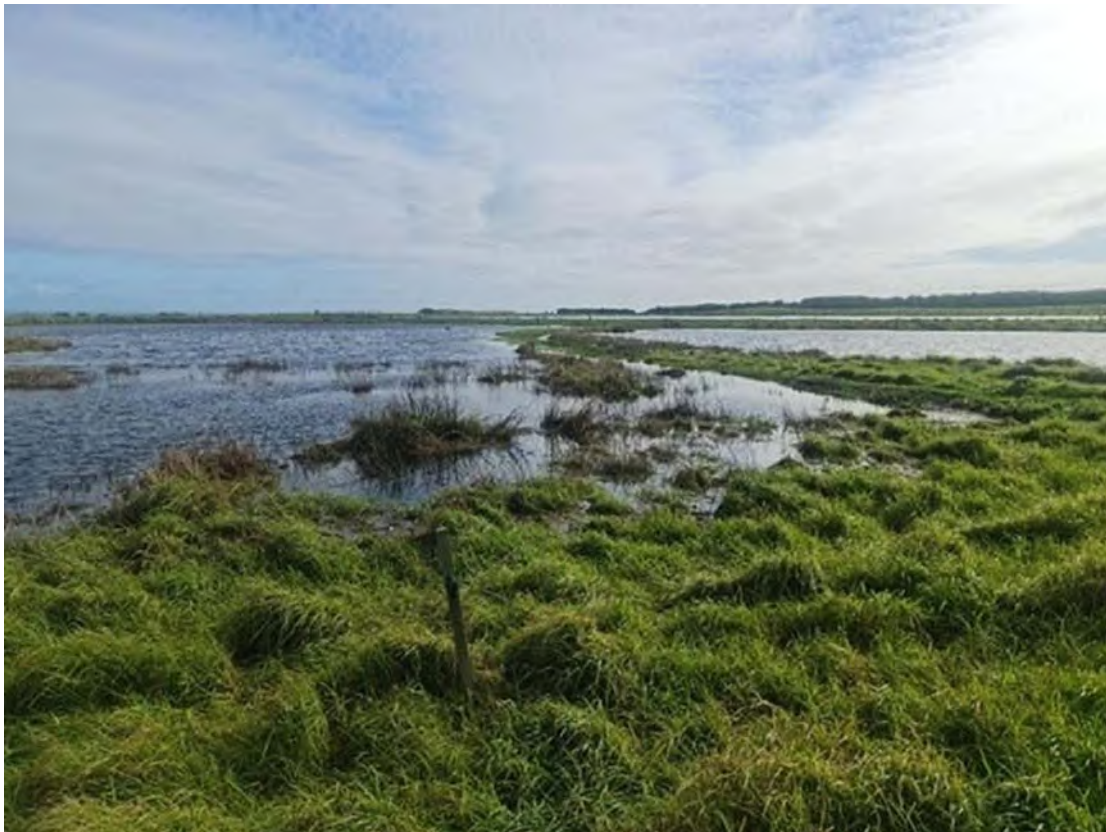
Heavy rainfall between 1 and 12 of August 2022 resulted in high levels in the pond and wetlands (Photo 2) and the overflow pipelines from the wetlands were opened, these pipelines divert some flow to go over the cliff, and not to the normal disposal fields/creek discharge point.

Photo 2 High levels in the pond and wetlands in August 2022

A project has been initiated with a strategy being developed to determine the appropriate technical solution to resolve the issue of poor soakage soil infiltration of wastewater into the wetland and adjacent soakage trenches during winter months. The land becomes saturated due to high rainfall and inflow and infiltration load. The project will investigate minor improvements to the current soakage trenches and produce a
