South Taranaki District Council
Hawera Municipal Oxidation Ponds System
Monitoring Programme
Annual Report
2014-2015
Technical Report 2015–37

October 2015

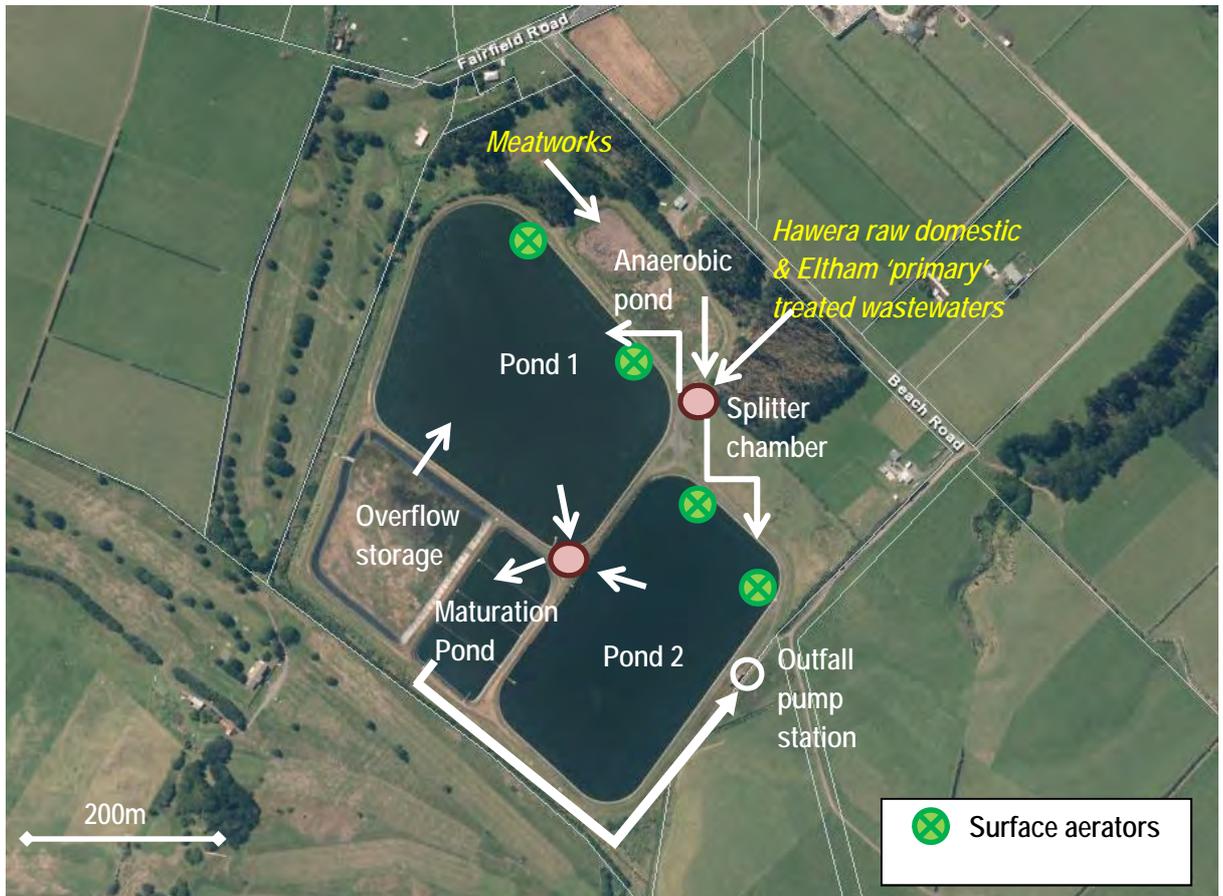
Figure 1 Configuration of the HWWTP (adapted from NIWA 2012)

During high rainfall events, the maturation pond can overflow into the neighbouring emergency overflow/storage detention pond (capacity approximately 65,000 m³, NIWA 2012) with wastewater then being passed back into Pond 1. Consent 7520-1 has been granted to allow overflow from the detention area into the local stream that borders the HWWTP. Since being granted in 2009, this consent has not yet needed to be exercised.

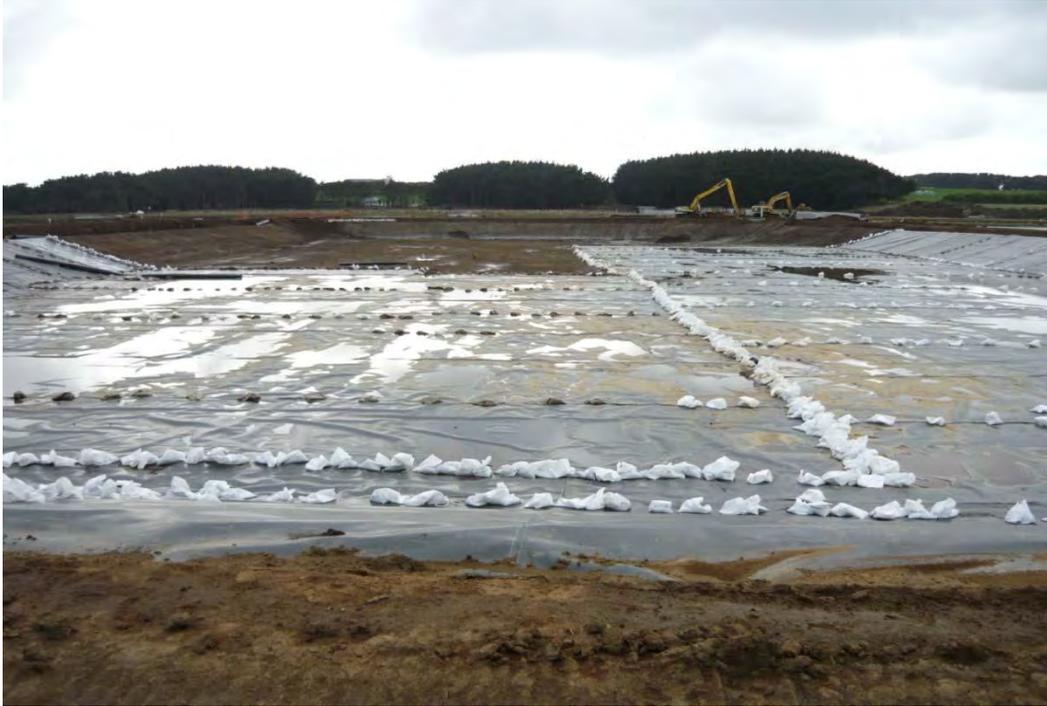
Photo 1 Construction of maturation ponds, July 2009

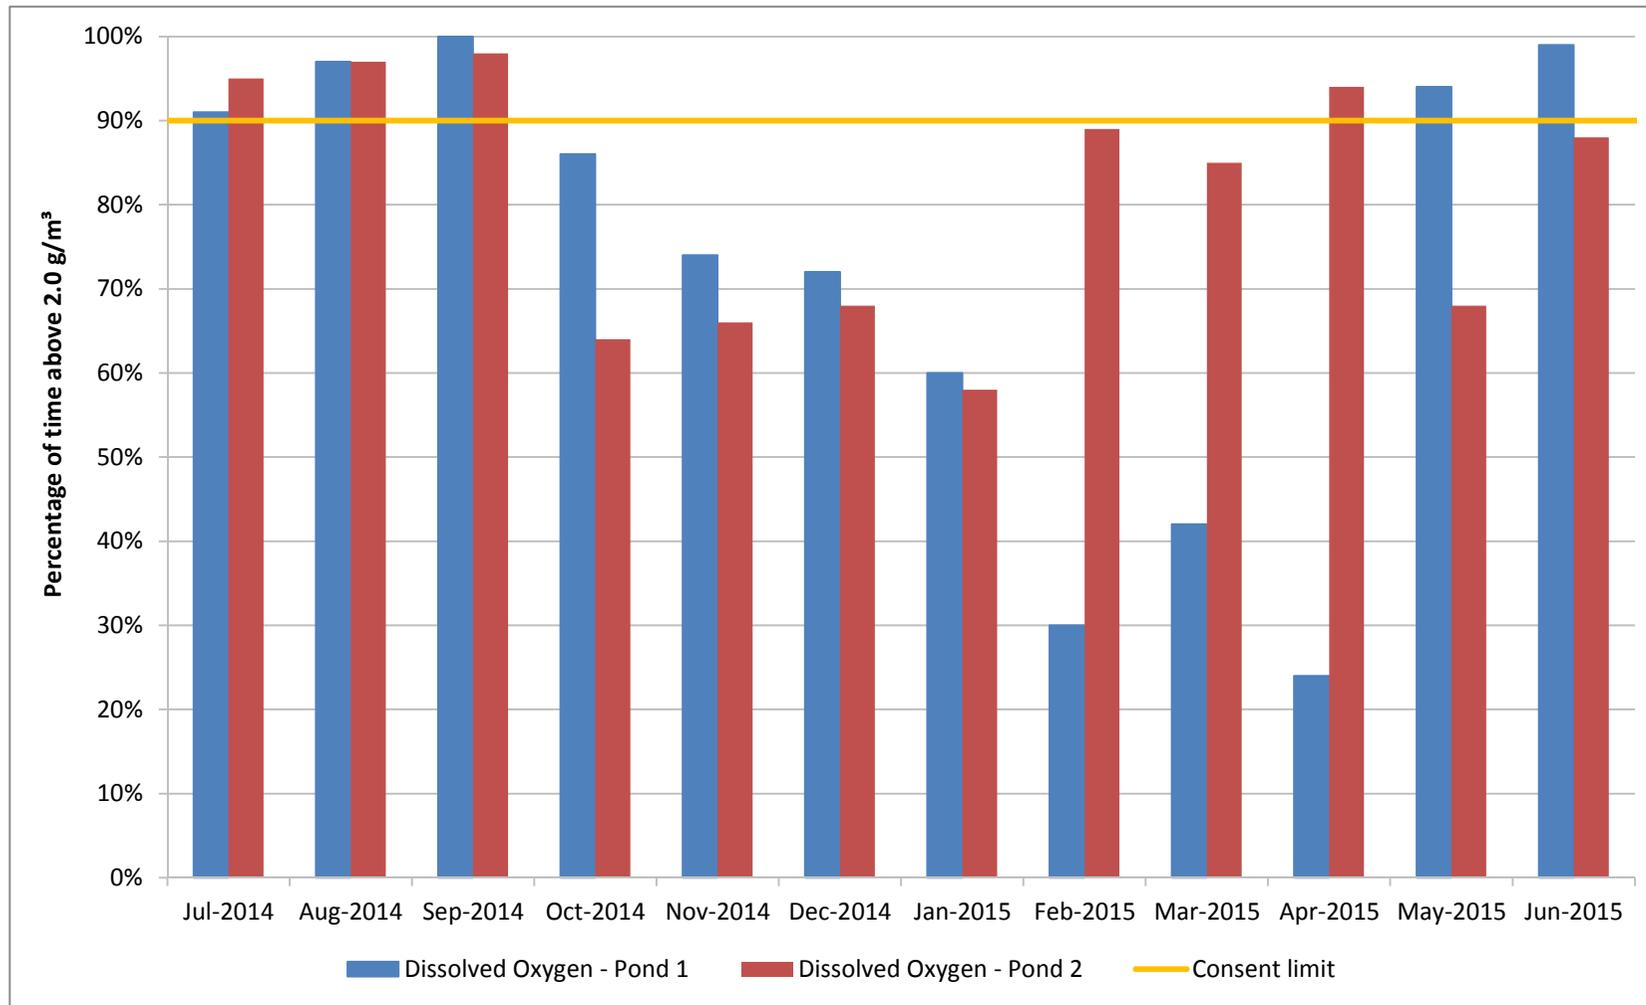
Conditions 1 and 2 of consent 5079-1 require that the ponds are maintained in an aerobic condition, with the DO maintained at a level at, or exceeding, 2 g/m³ for 90% of the time during the hours of 11:00 to 14:00.

Figure 2 Compliance of DO concentration (g/m^3) with consent conditions in the primary and secondary oxidation ponds 2014-2015 (between hours of 1100 – 1400). Data from pond outlet.

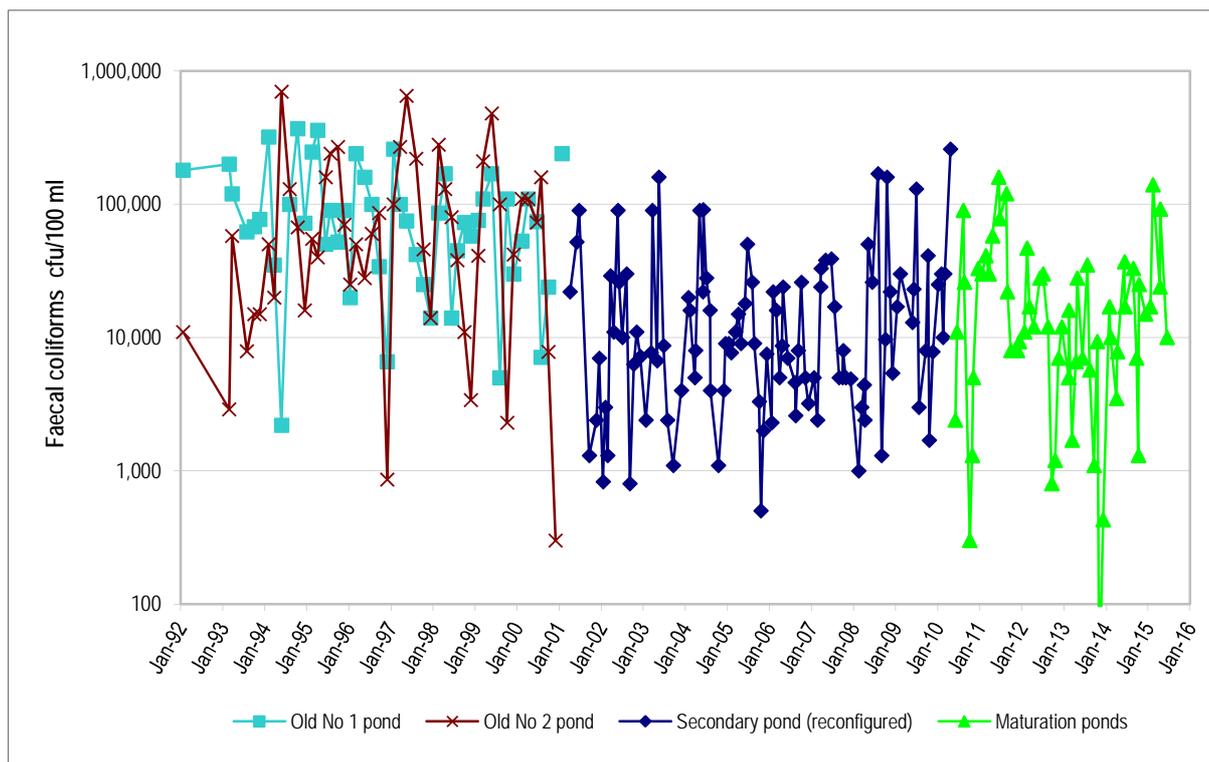
Results presented in Figure 3 indicate that there has been an improvement in the bacteriological quality of the treated wastewater discharged to the Tasman Sea since the reconfiguration of the treatment ponds system in 2001. After the reconfiguration, bacteriological quality initially decreased; this was to be expected as the increased flow reduced the overall retention time and hence bacteriological die-off within the treatment system. During the current monitoring period, faecal coliform numbers were slightly elevated when compared with those from the past three years. However, the results from this year remain within the range of all faecal coliform counts post-2001.

Figure 3 Faecal coliform numbers in the HWWTP effluent, 1992 to 2015

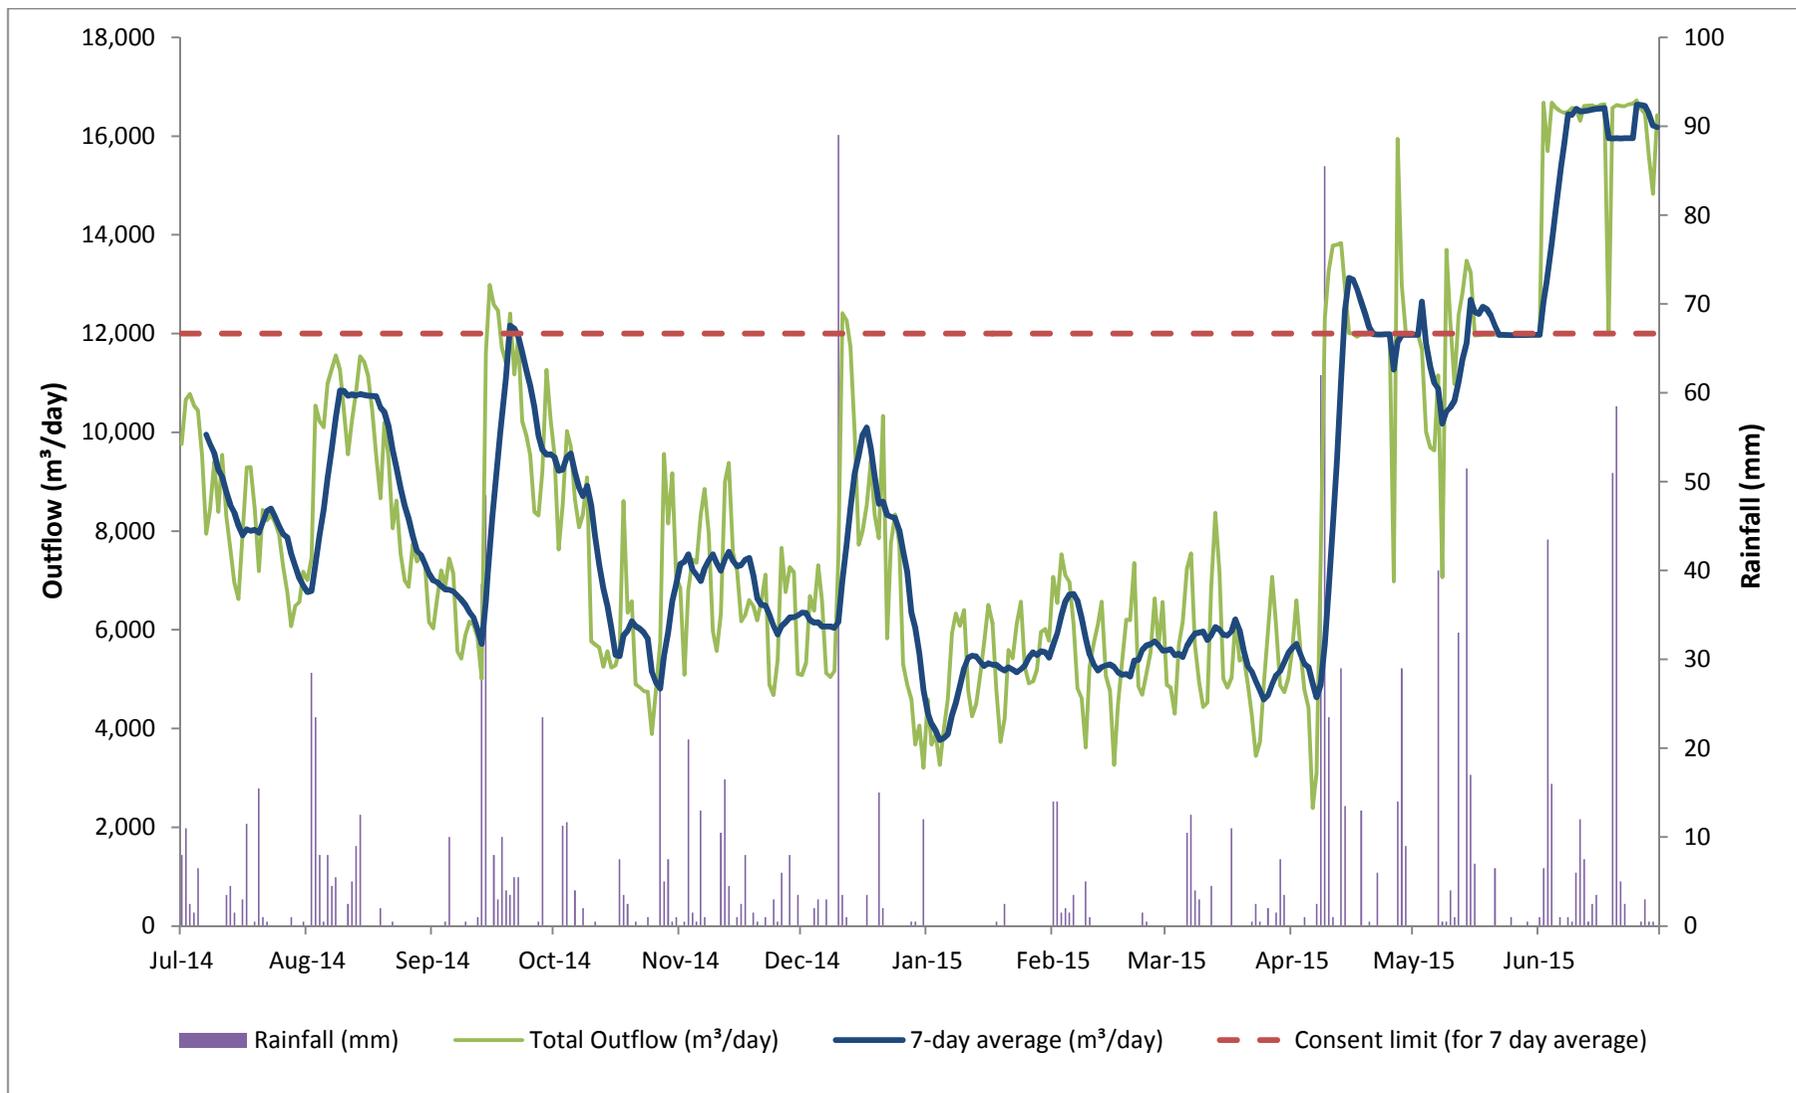
Condition 5 of consent 5079-1 requires STDC to provide records of the discharge volumes to the Outfall. The consent holder supplied records for the period from 1 July 2014 to 30 June 2015 (Figure 4).

The allowable discharge rate of 12,000 m³ (average over seven days) was exceeded five times during the 2014-2015 period. The total number of days where the seven day average was above the consent limit was 46. There was only one day in June where the seven day average was below the consent limit.

Figure 4 Daily discharge volumes (m^3/day) from the HWWTP and daily rainfall data (mm) from a Council rainfall station approximately 5 km east of the site, 1 July 2014 to 30 June 2015

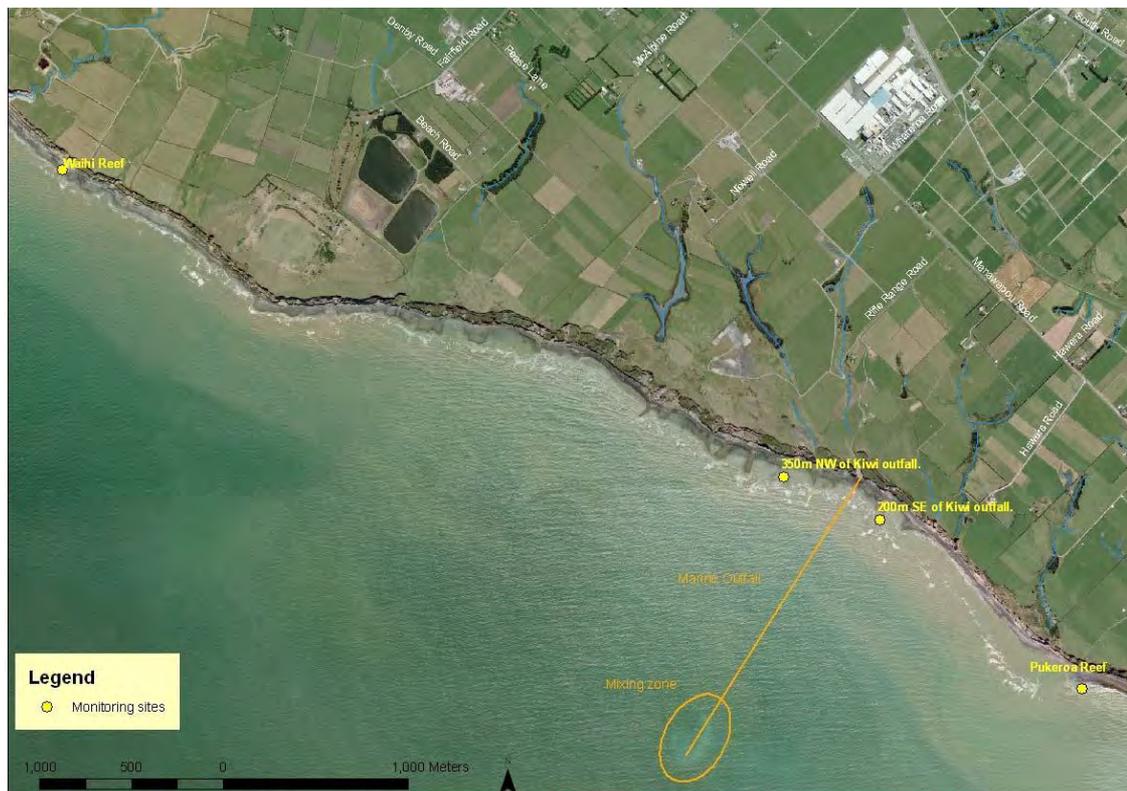
Figure 5 Location of marine ecological monitoring sites

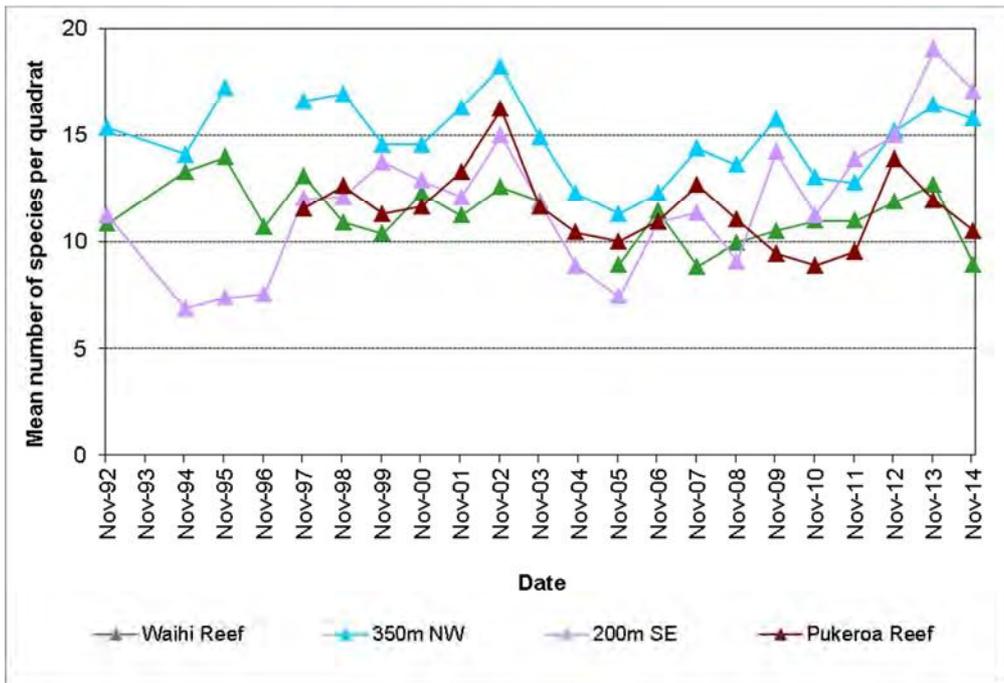
Figure 6 Mean number of species per quadrat: spring surveys 1992-2014

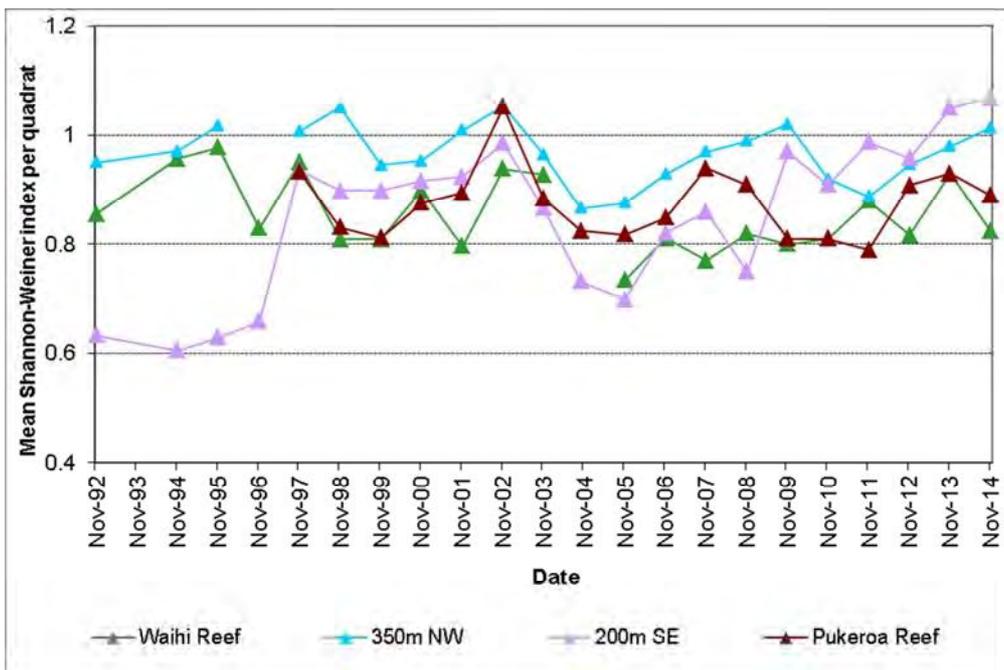
Figure 7 Mean Shannon-Weiner index per quadrat: spring surveys 1992-2014

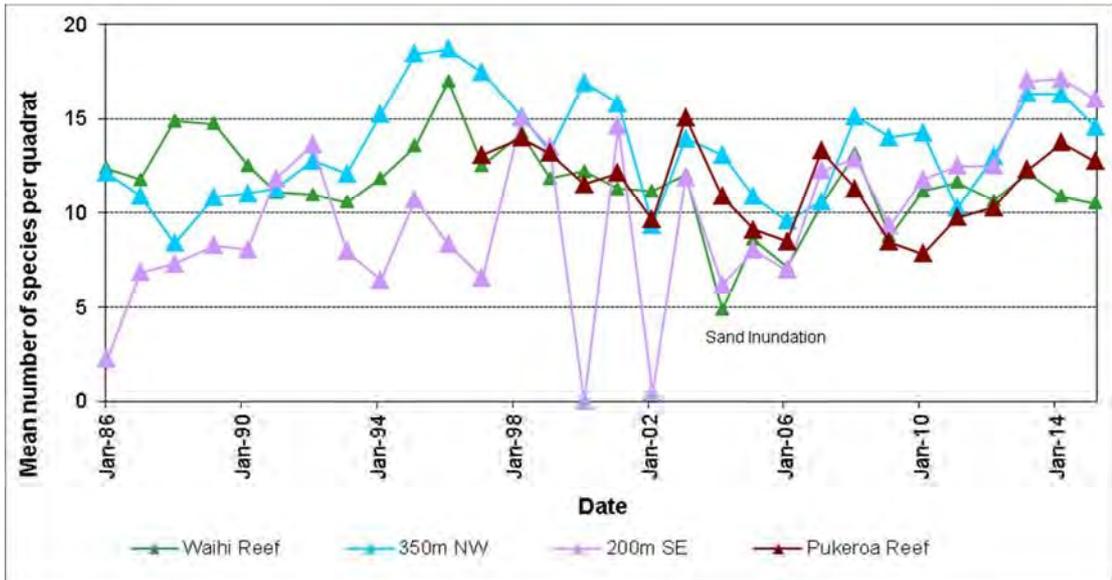
Figure 8 Mean number of species per quadrat: summer surveys 1986-2015

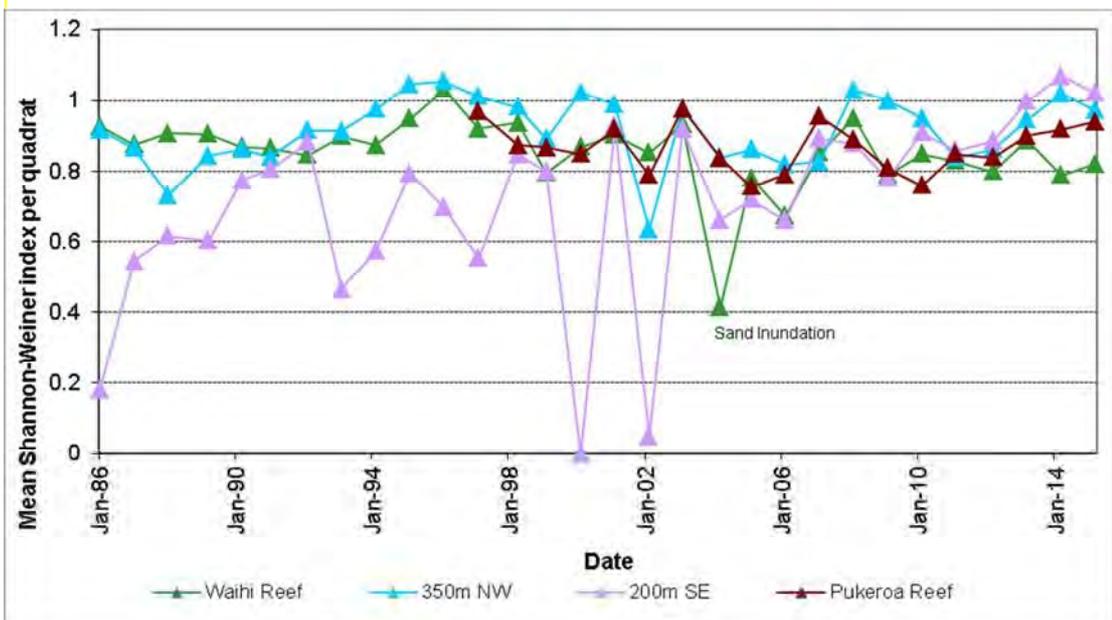
Figure 9 Mean Shannon-Weiner index per quadrat: summer surveys 1986-2015

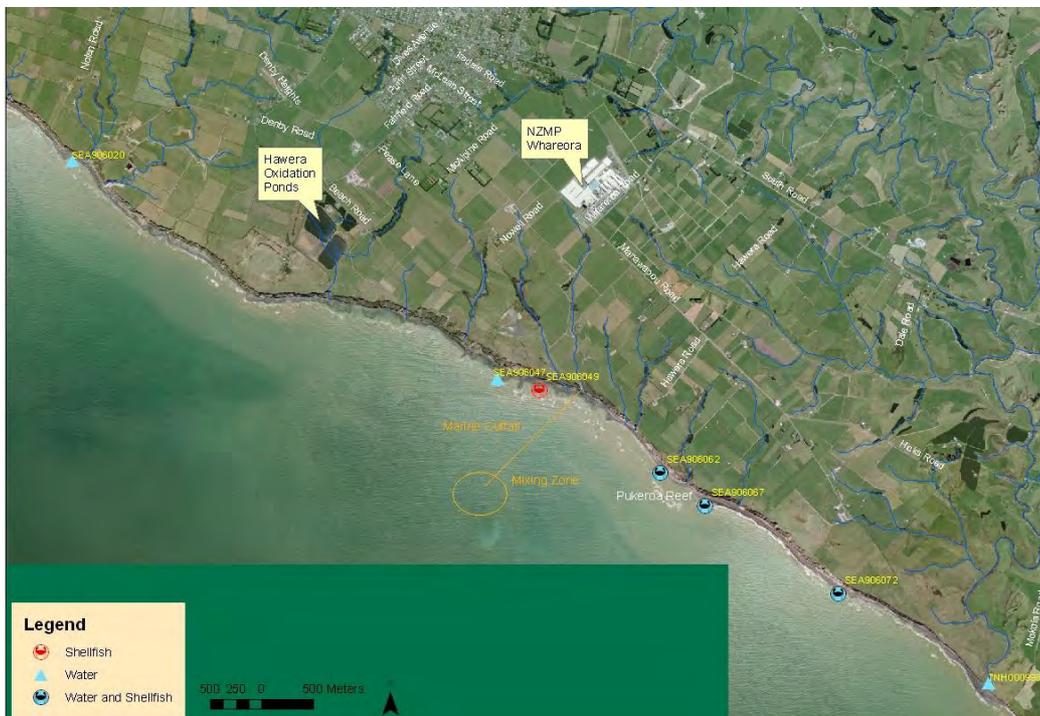
Figure 10 Water and shellfish collection sites

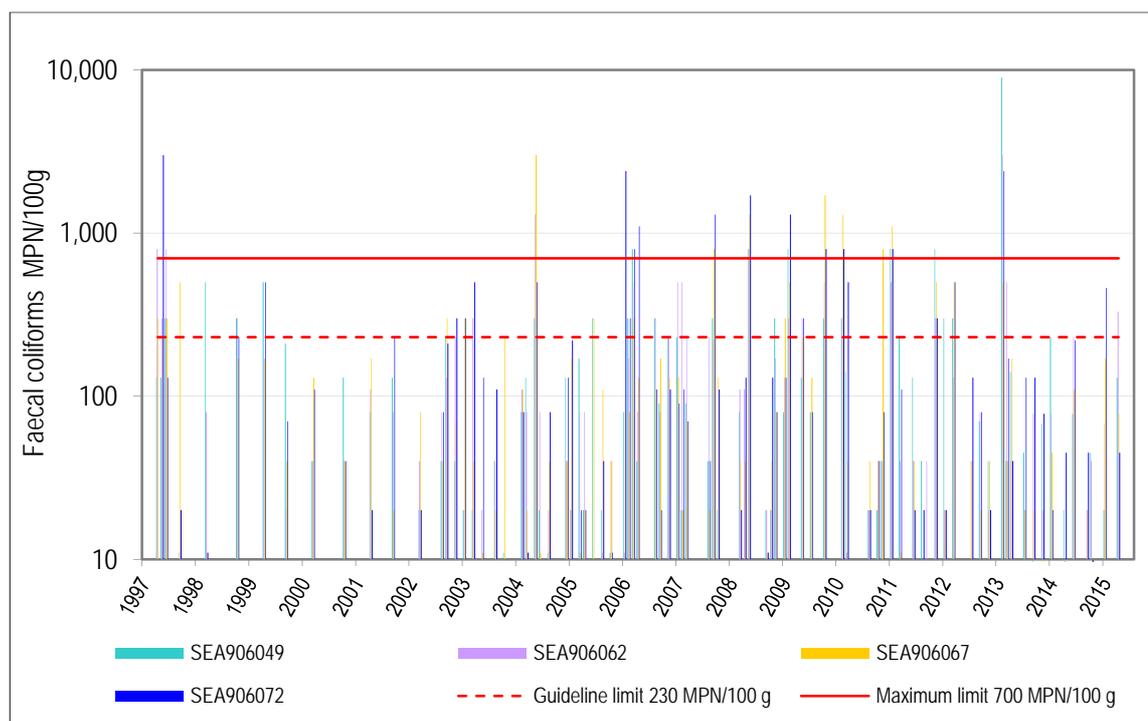
All four sites' median counts have been within the guideline limit (230 MPN/100g) since 2001, however since 2001, six samples exceeded the maximum 700 MPN/100g *E. coli* limit at SEA906049 (8%), three at SEA906062 (4%), seven at SEA906067 (9%), and ten at SEA906072 (14%). Usually these exceedances have followed wet weather when faecal coliform numbers in the coastal seawater have increased due to the run-off from many small coastal streams and the nearby Tangahoe River catchment (see TRC, 2004).

Figure 11 Shellfish (mussel) tissue faecal coliform bacteria numbers (MPN/100g) from surveys of coastal sites (since 1997) adjacent to the Outfall².

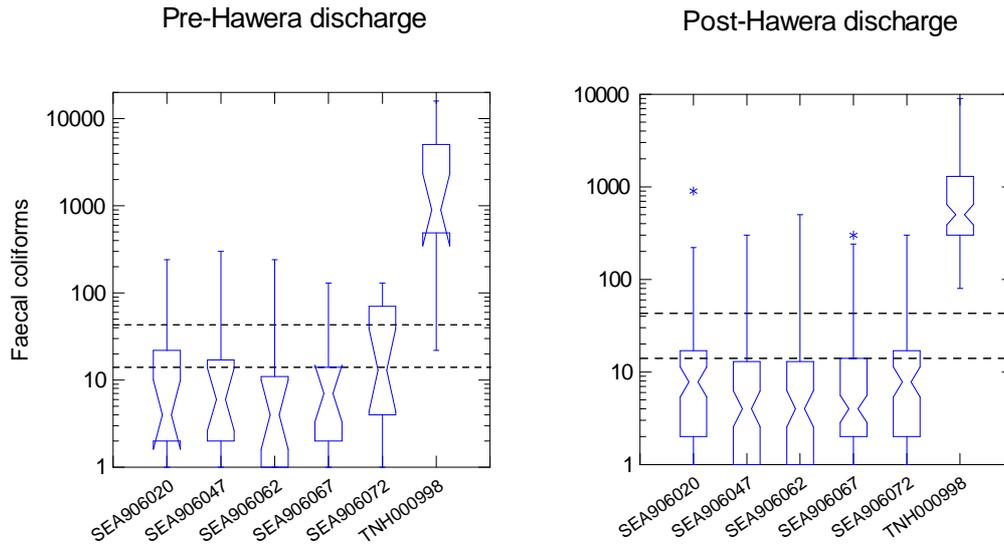
Figure 12 Faecal coliform counts (MPN/100ml) at shoreline sites and in the Tangahoe River before and after connection of the HWWTP discharge to the Outfall

Note: top limit line equals the 90% guideline, bottom limit line equals median guidelines for shellfish-gathering waters

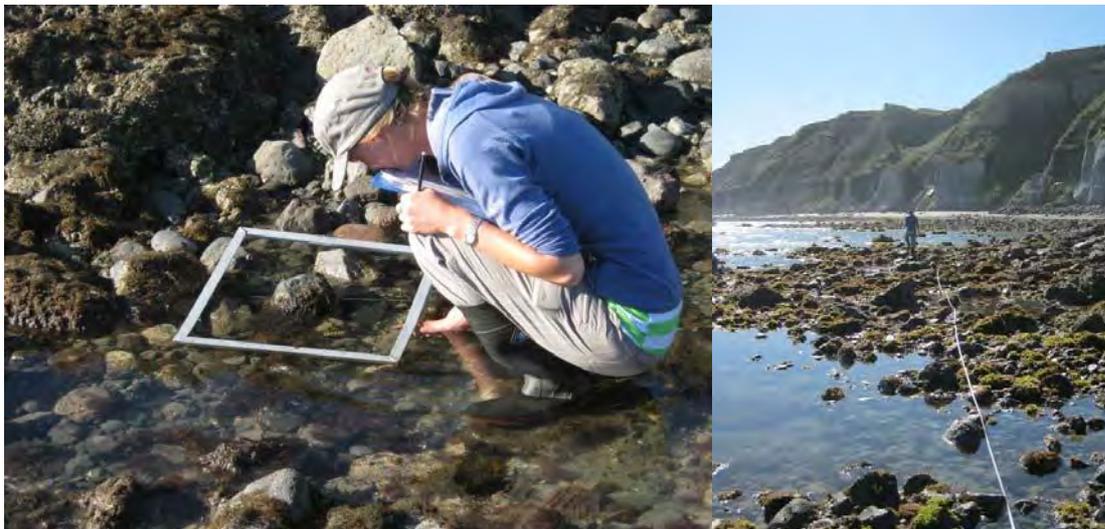
At each site, a 50 m transect was used to establish five 5 m x 3 m blocks. Within each block, five random 0.25 m² quadrats were laid giving a total of 25 random quadrats (Photograph 5). For each quadrat the percentage cover of algae and encrusting animal species was estimated using a grid. For all other animal species, individuals larger than 3 mm were counted. Under boulder biota was counted where rocks and cobbles were easily overturned.

Photograph 5 Survey at 200 m southeast of the outfall showing the quadrat and transect used

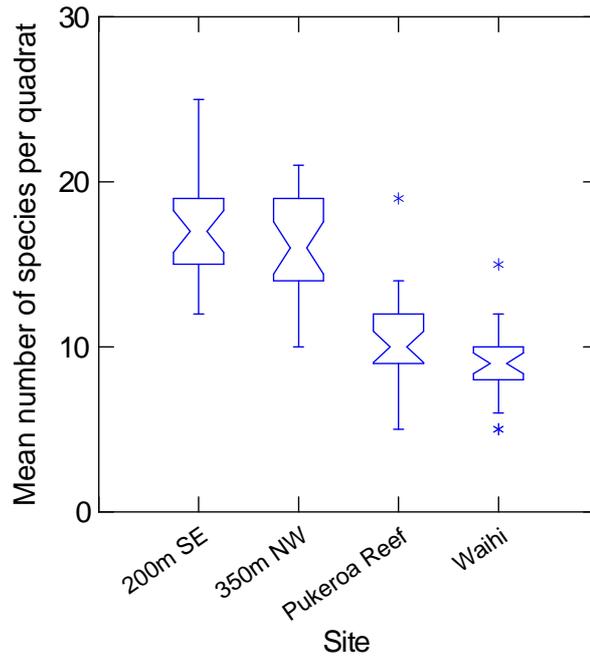
Figure 2 shows the total number of species per quadrat as a box and whisker plot. The notched area of the box represents the median plus and minus a 95% confidence interval for the median. This form of graphical representation allows a quick comparison to be made between sites. Generally, if the notched areas of the boxes for the different sites do not overlap, one would expect to obtain a significantly different result with ANOVA.

Figure 2 Box and whisker plots of mean number of species per quadrat

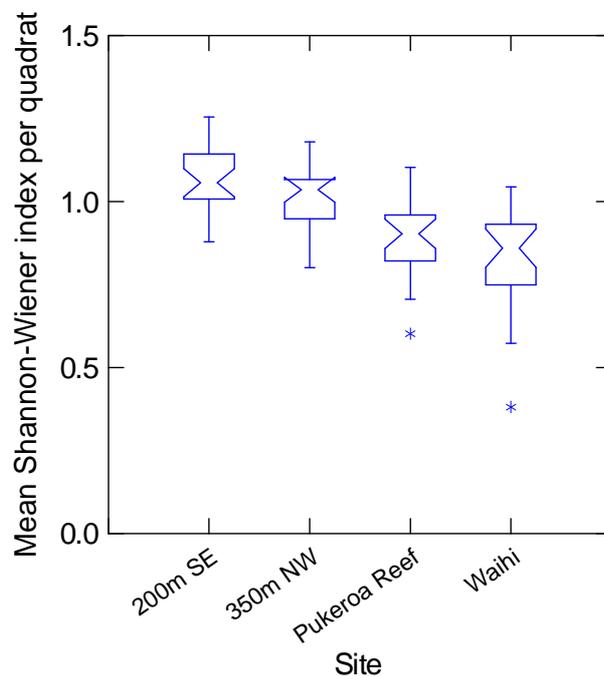
Figure 3 shows the mean Shannon-Weiner index data at each site as a box and whisker plot.

Figure 3 Box and whisker plots of mean Shannon-Weiner indices per quadrat

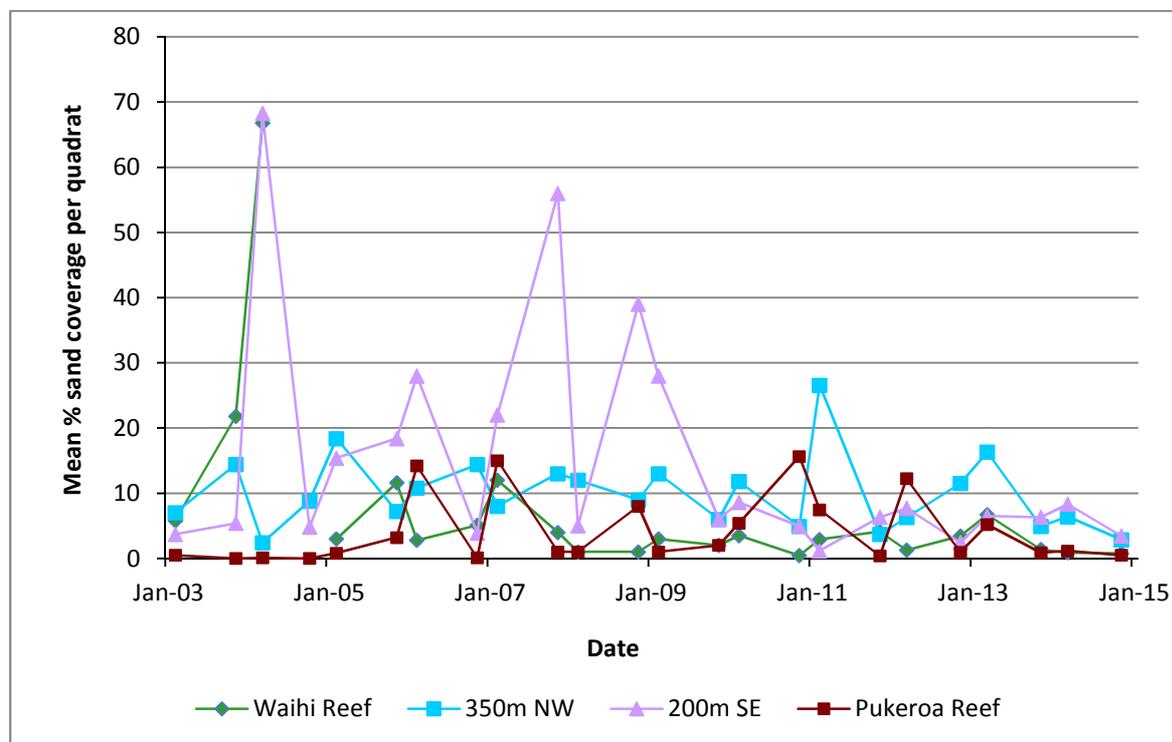
Figure 4 Mean percentage sand cover from summer 2003 to spring 2014

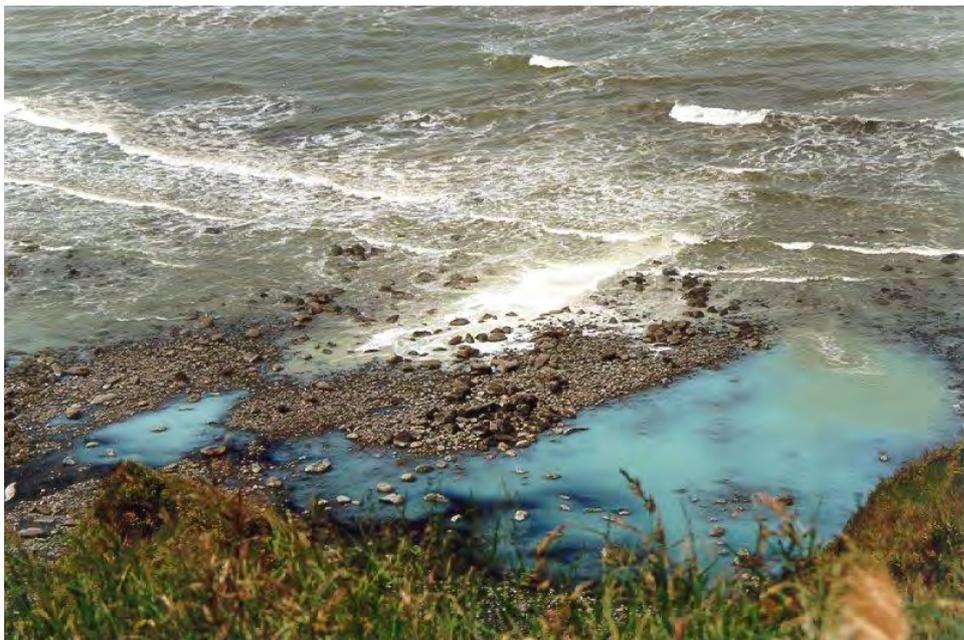
Previous surveys have shown that the dairy factory wastewater discharged through the near-shore outfall prior to 1997 (Photograph 6) was having significant adverse effects on the local intertidal community. The adverse effects recorded included the coating of rocks and tidal pools with fats, significant coverage by filamentous bacterial growths and a significant decrease in ecological diversity. The nature and magnitude of adverse effects varied with distance from the outfall, and were most apparent at the sites 30 m and 200 m southeast of the outfall (note that the former site is no longer surveyed as of 2007). In 1997 the dairy company installed a long outfall to discharge the wastewater nearly 2 km offshore in order to mitigate the adverse effects occurring along the coastline. Numerous spring and summer intertidal surveys have now been undertaken along the Hawera coastline subsequent to installation of the long outfall. Results show a general improvement in the health of intertidal communities following installation of the outfall. In February 2001 the Hawera Oxidation Ponds municipal wastewater was also connected to the long outfall.

Photograph 6 Discharge from the dairy factory near-shore outfall prior to 1997

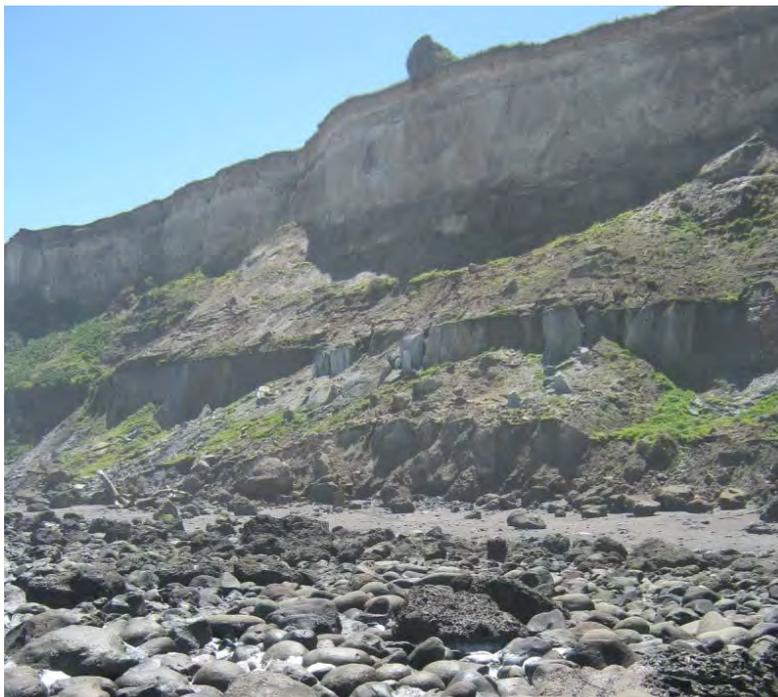
Photograph 8 Erosion of the cliffs close to Waihi Reef site (2014)

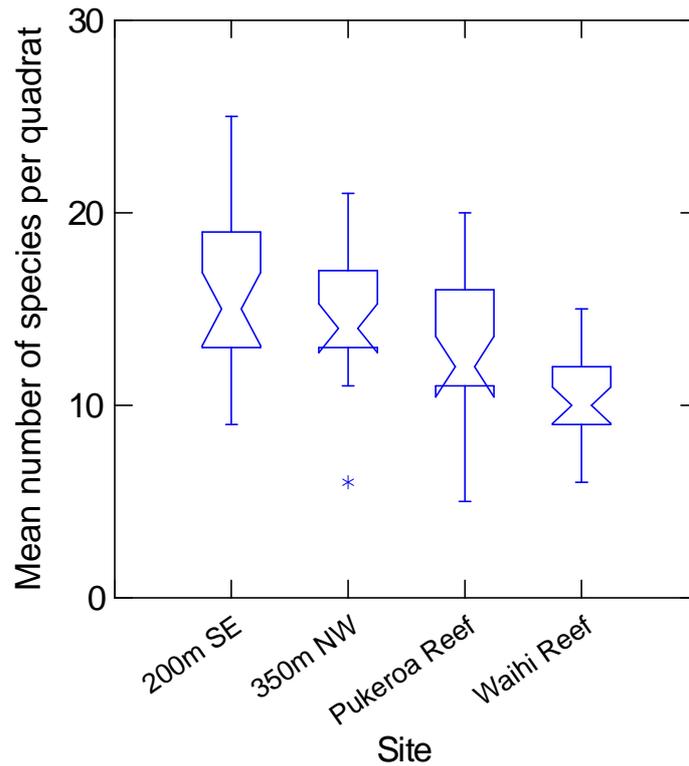
Figure 2 shows the total number of species per quadrat as a box and whisker plot. The notched area of the box represents the median plus and minus a 95% confidence interval for the median. This form of graphical representation allows a quick comparison to be made between sites. Generally, if the notched areas of the boxes for the different sites do not overlap, one would expect to obtain a significantly different result with ANOVA.

Figure 2 Box and whisker plots of mean number of species per quadrat

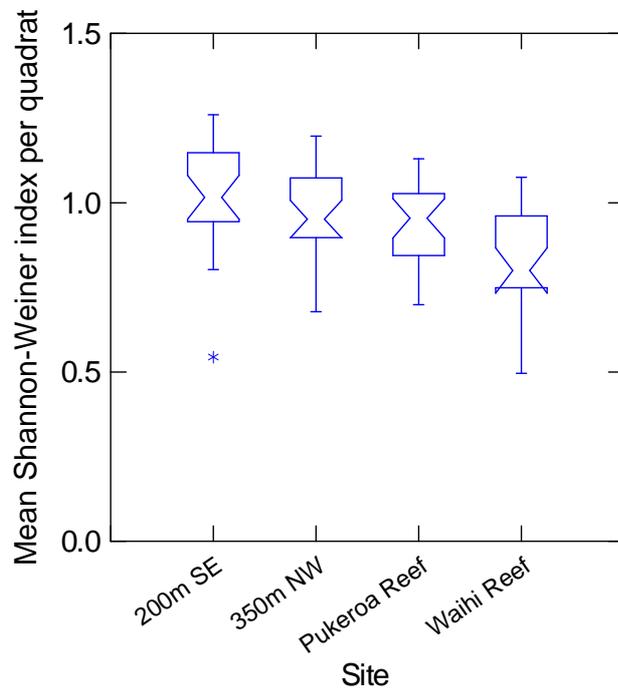
Figure 3 shows the mean Shannon-Weiner index data at each site as a box and whisker plot.

Figure 3 Box and whisker plots of mean Shannon-Weiner indices per quadrat

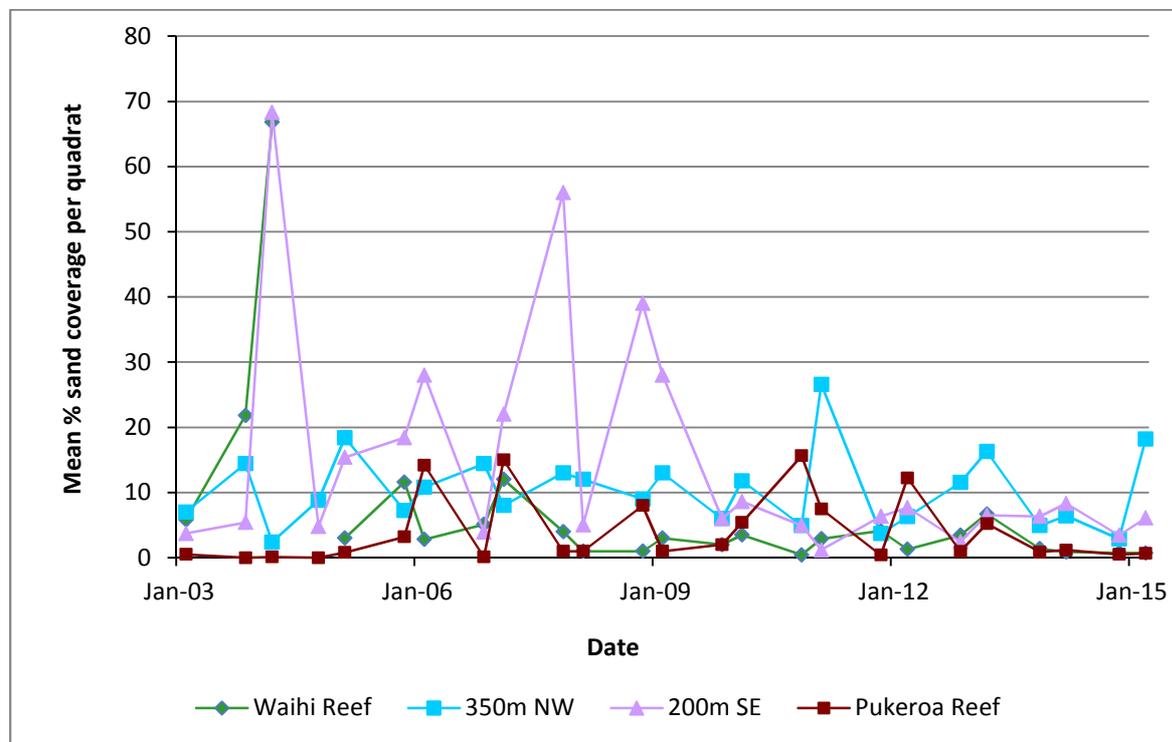
Figure 4 Mean percentage sand cover from summer 2003 to summer 2015

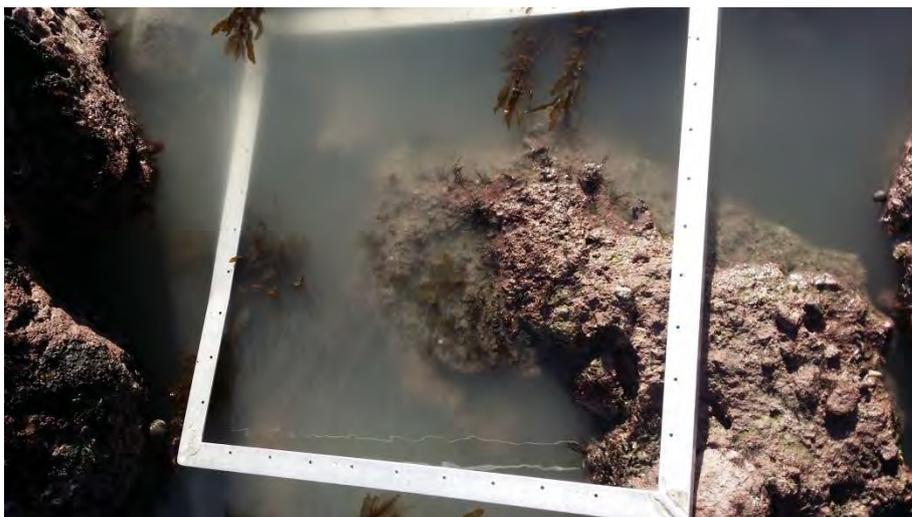
Photograph 7 Turbid intertidal pools 200 m SE of the outfall

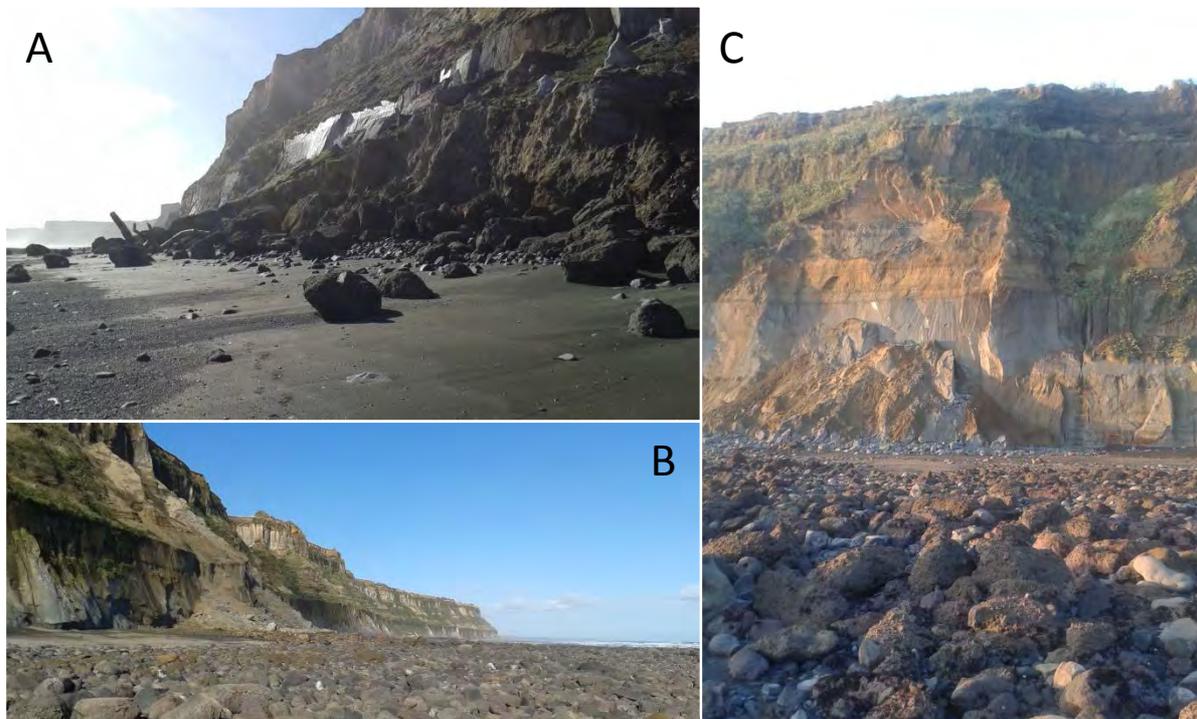
Photograph 9 Erosion of the cliffs close to (A, B) Waihi reef and (C) 200 m SE of the outfall (2015)
