South Taranaki District Council  
Hawera Municipal Oxidation Ponds  
Monitoring Programme  
Annual Report  
2017-2018

Technical Report 2018-58

Taranaki Regional Council  
Private Bag 713  
STRATFORD  
April 2019

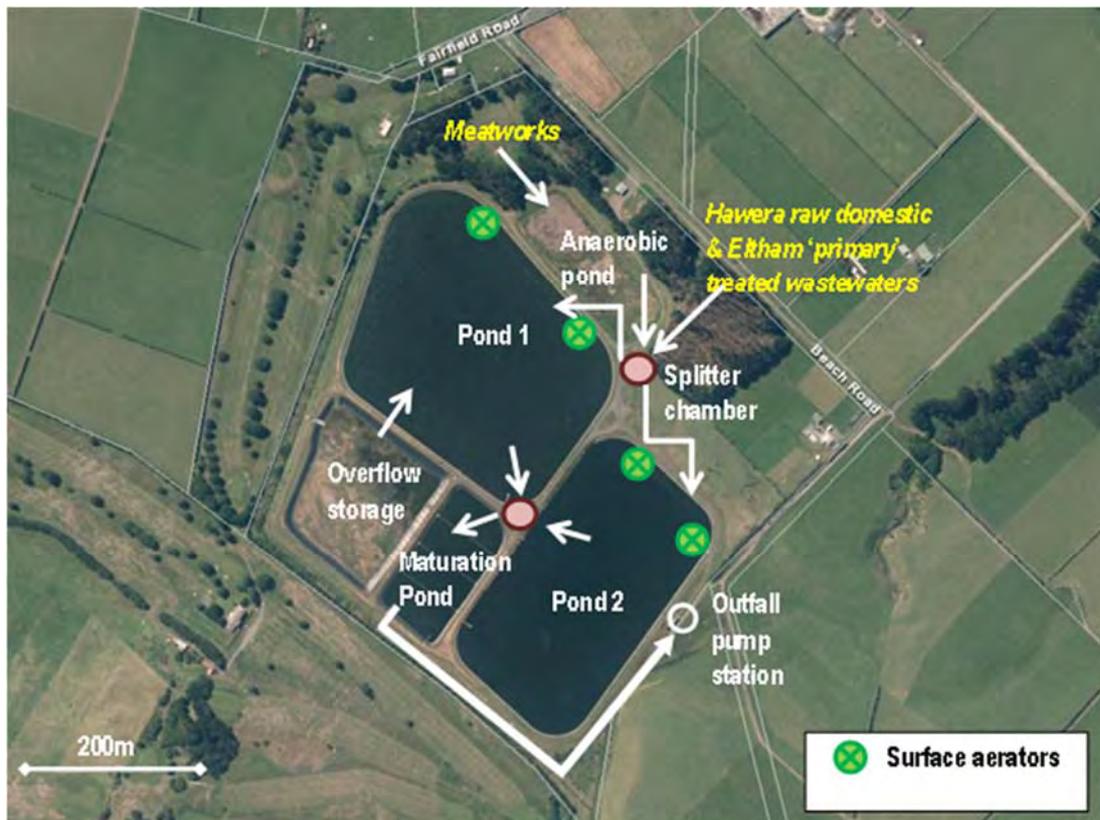
Figure 1 Configuration of the HWWTP (adapted from NIWA, 2012)

During high rainfall events, the maturation pond can overflow into the neighbouring emergency overflow/storage detention pond (capacity approximately 65,000 m<sup>3</sup>, NIWA, 2012) with wastewater then being passed back into Pond 1. Consent 7520-1 has been granted to allow overflow from the detention area into the local stream that borders the HWWTP. Since being granted in 2009, this consent has not yet needed to be exercised.

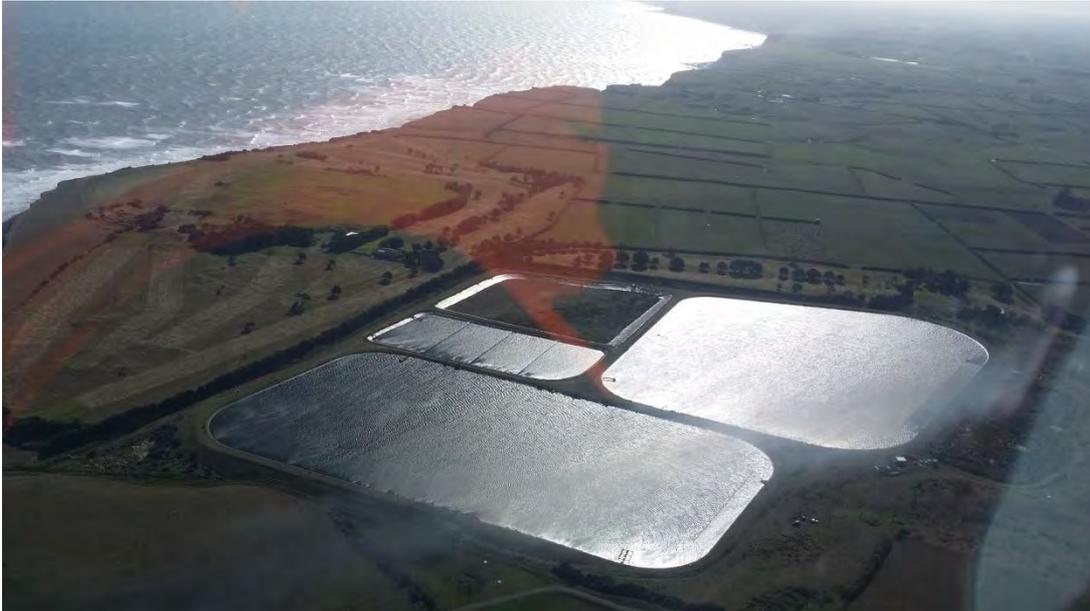
The effluent from both Ponds 1 and 2 combines at the outlet points from each pond and flows through to the new maturation pond, constructed in 2009 (Photo 1). The maturation pond has three baffles dividing the pond into four cells to increase the residence time within the pond. The total HRT for the ponds is estimated to be approximately 60 days (NIWA, 2012). Final treated effluent from the maturation pond is gravity-fed to the pump station, from where it is pumped (preferentially at night) via a 2.8 km pipeline, to the mixing chamber on the cliff top and combines with wastewater from the Whareroa dairy factory for discharge via the 1,845 m long Outfall.

Photo 1 Aerial photograph of the Hawera pond system, 8 March 2016

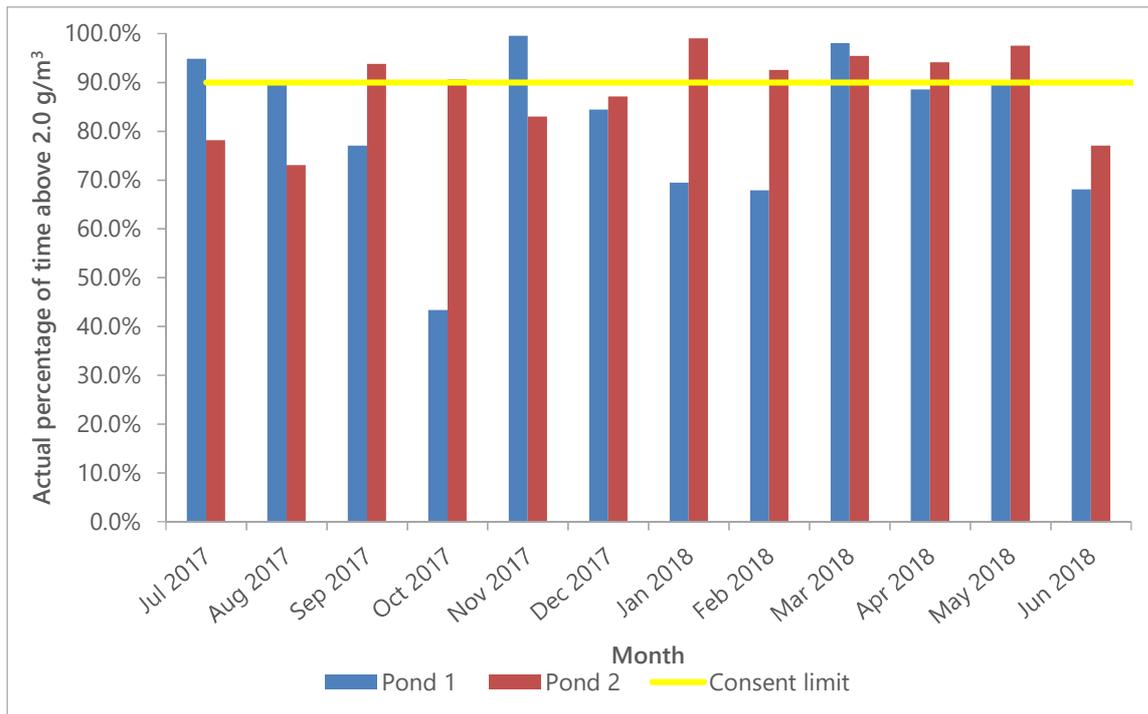
Figure 2 Compliance of DO concentration (g/m<sup>3</sup>) with consent conditions in the primary and secondary oxidation ponds in 2017-2018, between the hours of 11:00 and 14:00. Data was collected from the pond outlet

Condition 5 of consent 5079-2 requires DO concentrations in the aerobic ponds to be maintained above 0 g/m<sup>3</sup> for a minimum of three hours over a 24 hour period ending at 06:00 New Zealand Standard Time (NZST). Condition 6 also requires that STDC monitors the DO concentrations on a continuous basis and supplies the results to the Council.

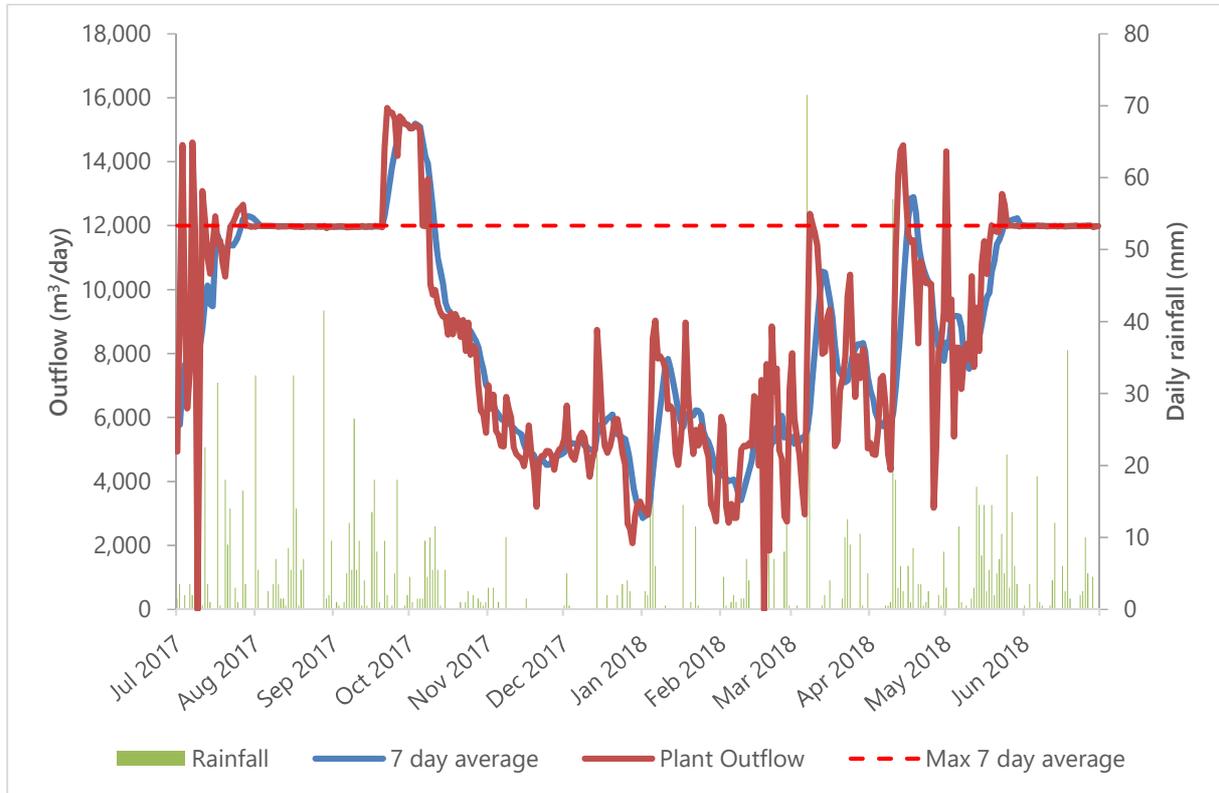
The purpose of consent 5079-1 is to discharge no more than 12,000 m<sup>3</sup>/day (based on a seven day average) from the HWWTP to the outfall (this is now required by Condition 2 in consent 5079-2, which commenced on 26 June 2018). There were four separate exceedance events in relation to this limit in the 2017-2018 monitoring year. The first exceedance, which occurred in late July 2017, was associated with winter rains and lasted 7 days. The remaining three periods of exceedance occurred in September/October 2017 (20 days), April 2018 (4 days) and May 2018 (7 days), after continued heavy rainfall in spring 2017 and autumn 2018. The total number of days where the seven day average was above the consent limit was 38.

Figure 3 Daily discharge volumes (m<sup>3</sup>/day) from the HWWTP and daily rainfall data (mm) from a Council rainfall station located approximately 5 km east of the site (2017-2018)

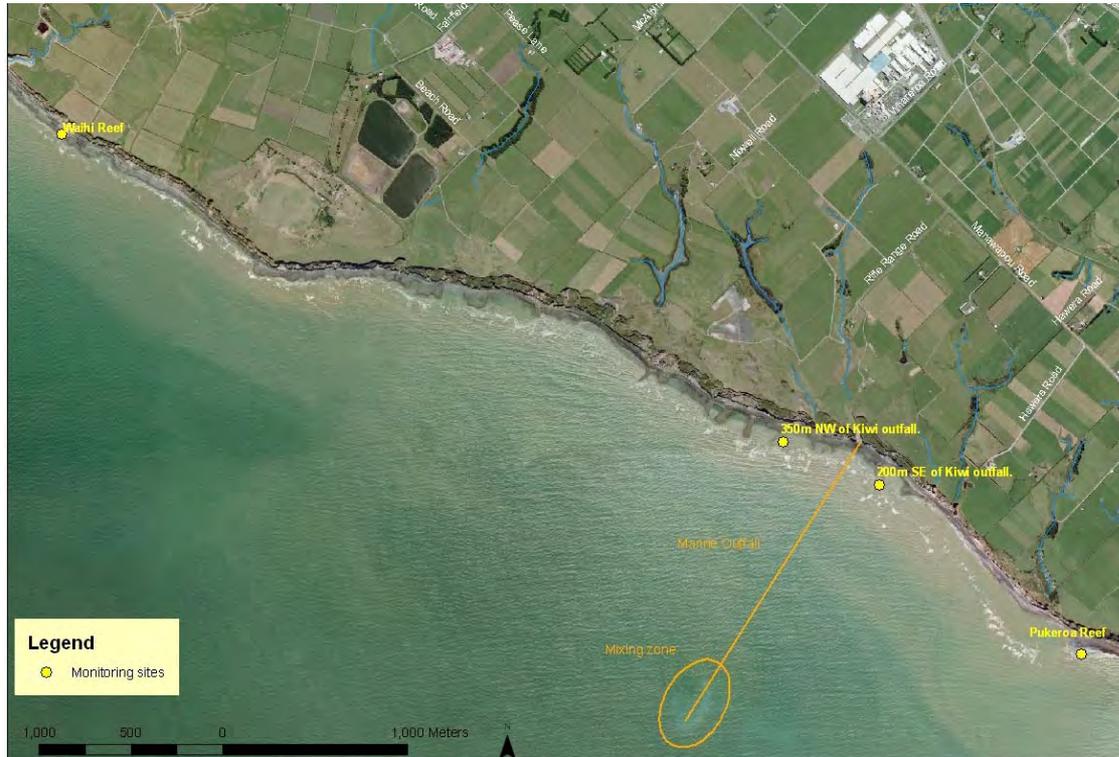
Figure 4 Map of sampling sites in relation to the outfall

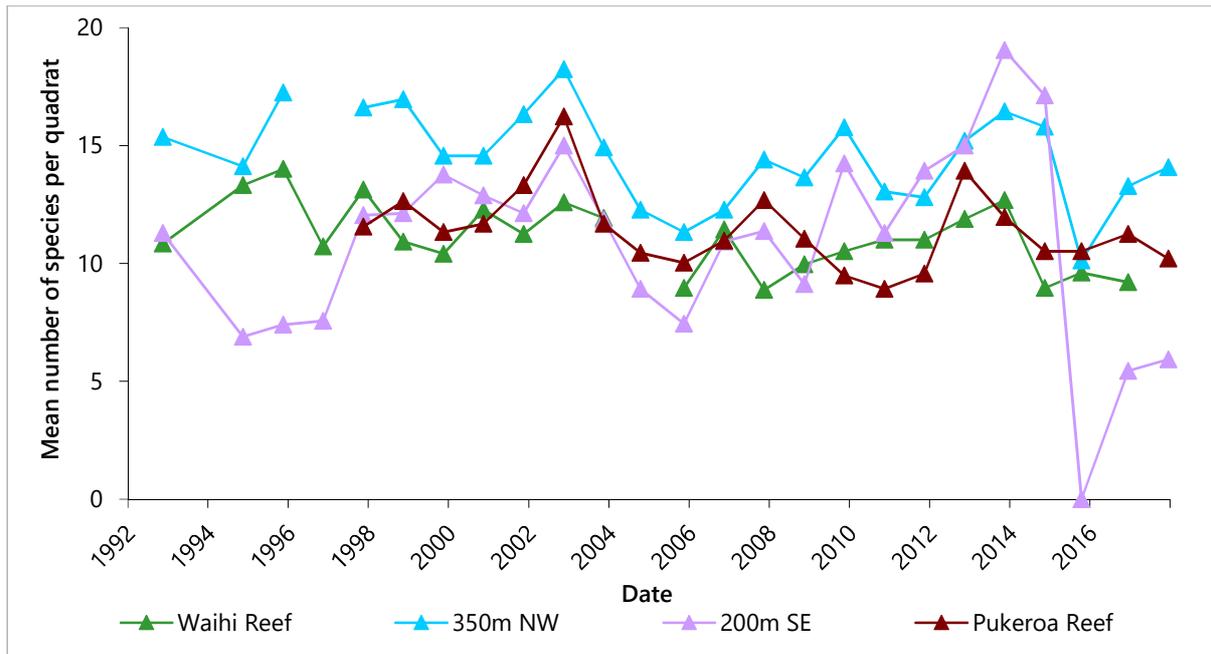
The potential impact sites located 350 m NW of the outfall and at Pukeroa Reef were found to have significantly greater species richness and diversity than Waihi Reef (the control site) during the summer survey, while the remaining potential impact site located 200 m SE of the outfall showed signs of recovery after having been buried by a slip in 2015. The control site was not assessed during the spring survey due to unsuitable survey conditions. There is no evidence of the potential impact sites declining in species richness or diversity over time, relative to the control site.

Figure 5 Mean number of species per quadrat for spring surveys (1992-2018)

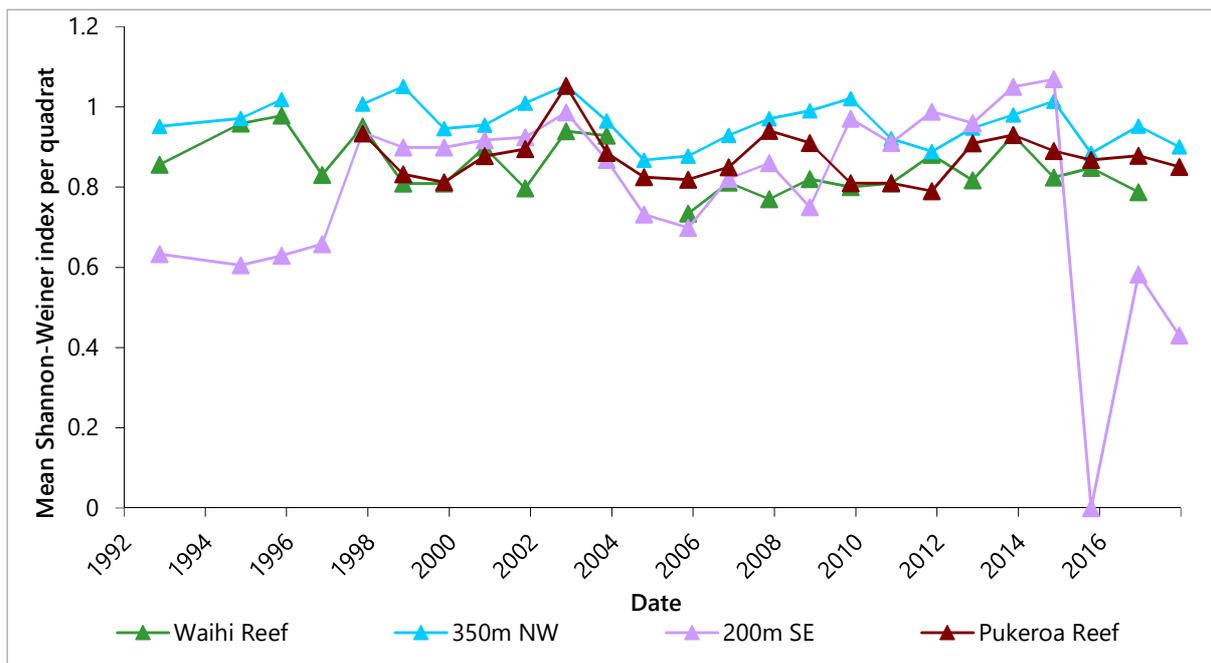
Figure 6 Mean Shannon-Weiner indices per quadrat for spring surveys (1992-2018)

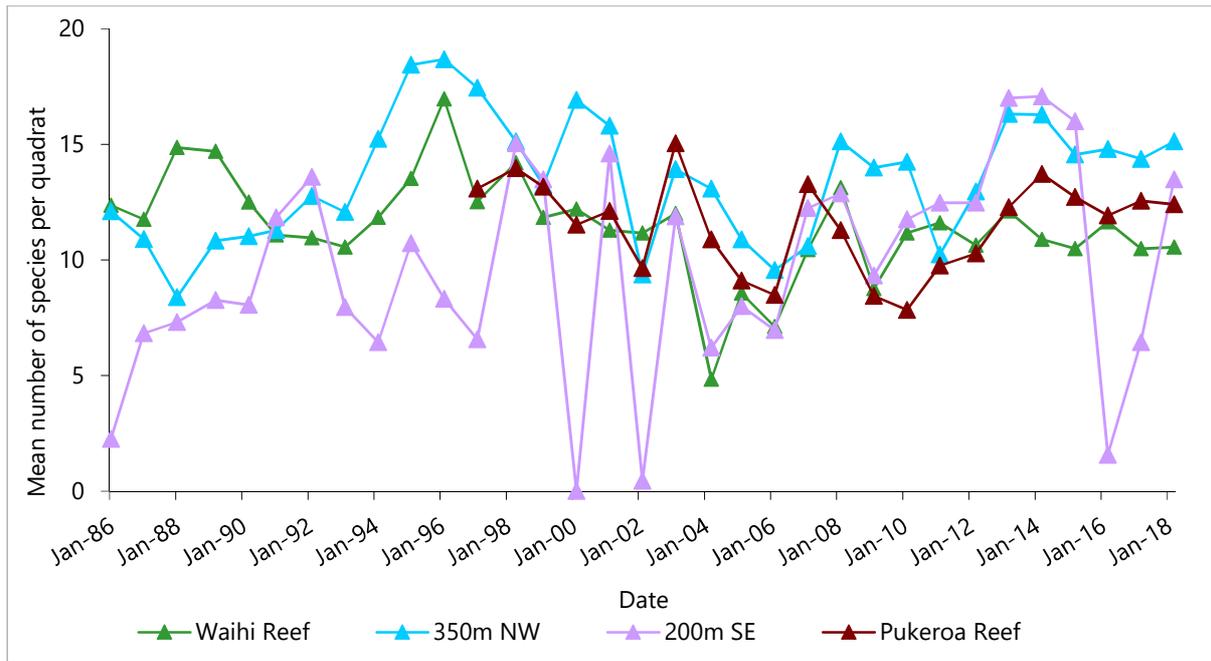
Figure 7 Mean number of species per quadrat for summer surveys (1986-2018)

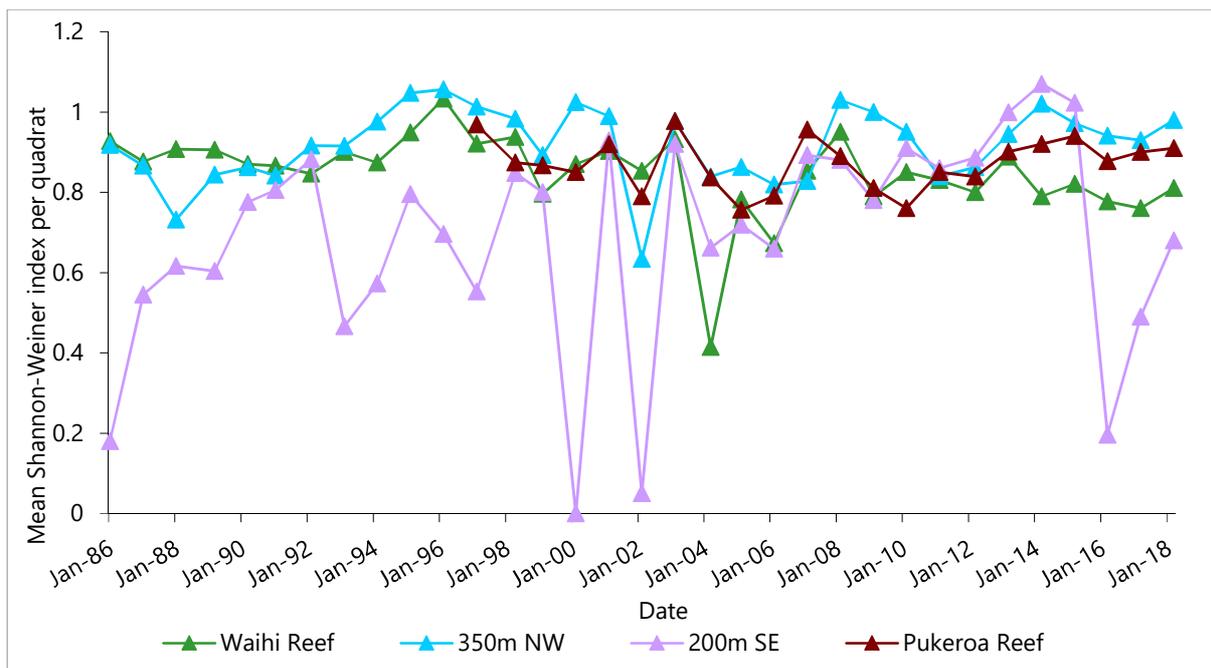
Figure 8 Mean Shannon-Weiner Indices per quadrat for summer surveys (1986-2018)

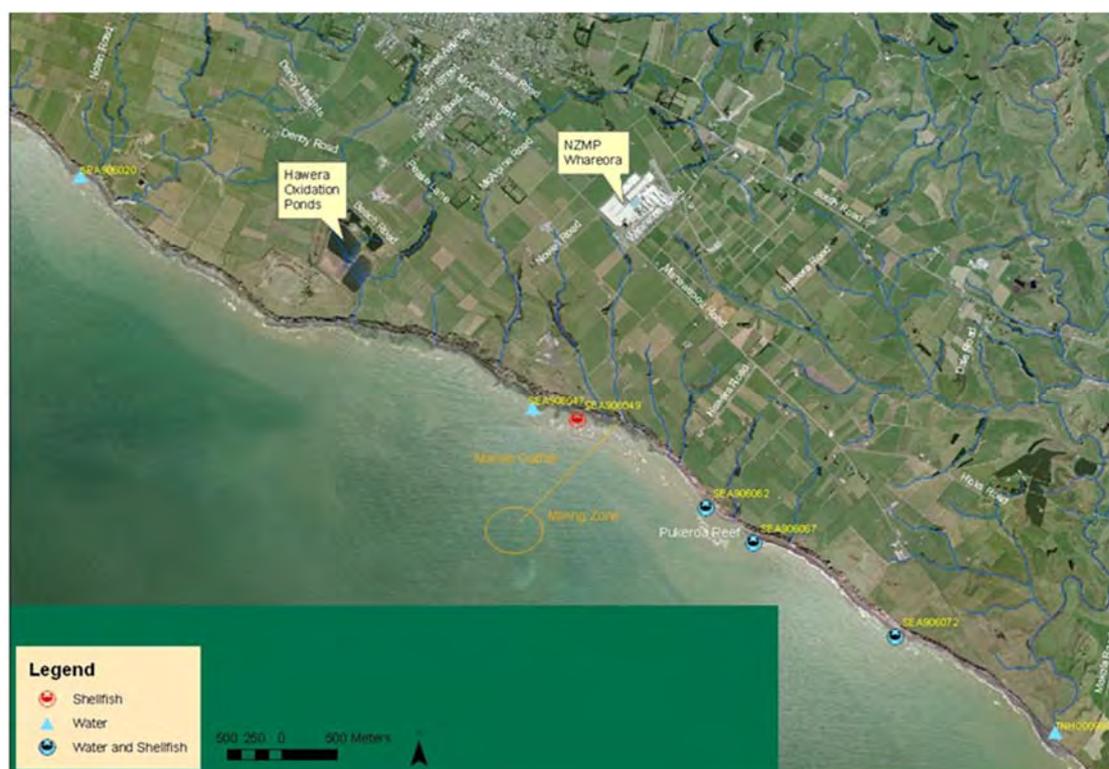
Figure 9 Shoreline water sampling and shellfish collection sites

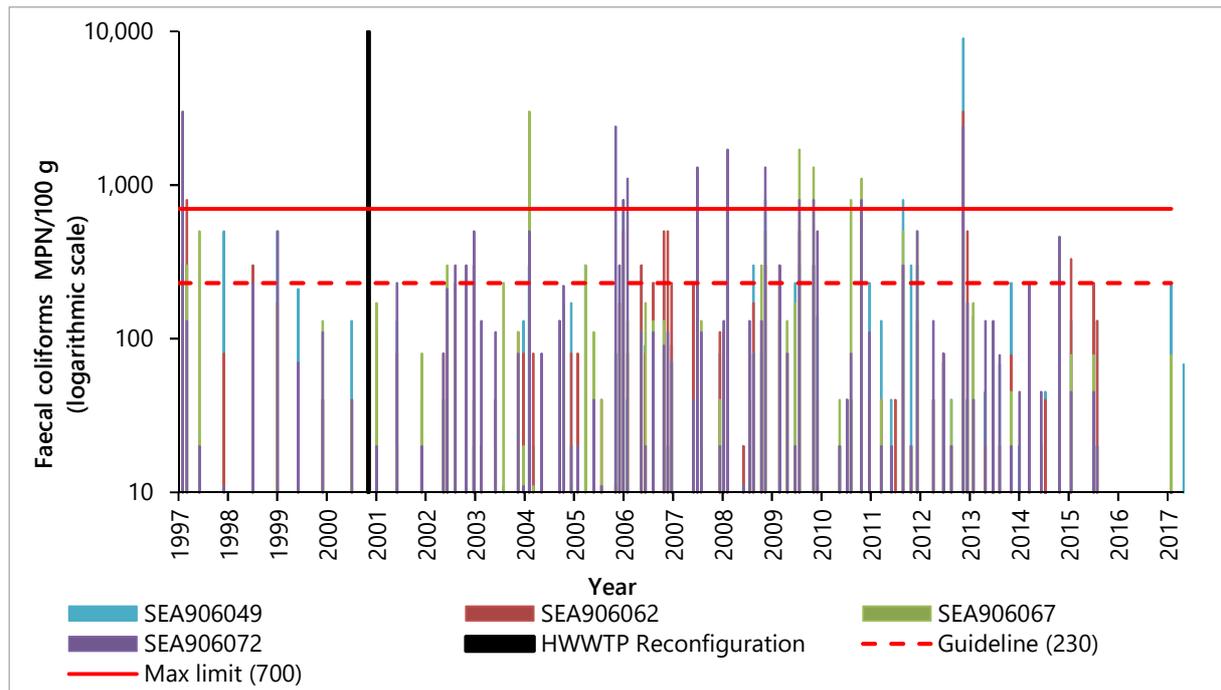
The annual median counts at all four sites have been within the guideline limit (230 MPN/100 g) since 2001. However, since 2001, six samples have exceeded the maximum faecal coliform limit (700 MPN/100 g) at SEA906049 (7%), three at SEA906062 (3%), seven at SEA906067 (8%), and ten at SEA906072 (12%). These exceedances have typically followed wet weather events, when faecal coliform levels in coastal seawater have increased due to run-off from the numerous local, small coastal streams and the nearby Tangahoe River catchment (TRC, 2004).

Figure 10 Shellfish (mussel) tissue faecal coliform bacteria numbers from surveys of coastal sites adjacent to the outfall (1997-2018)

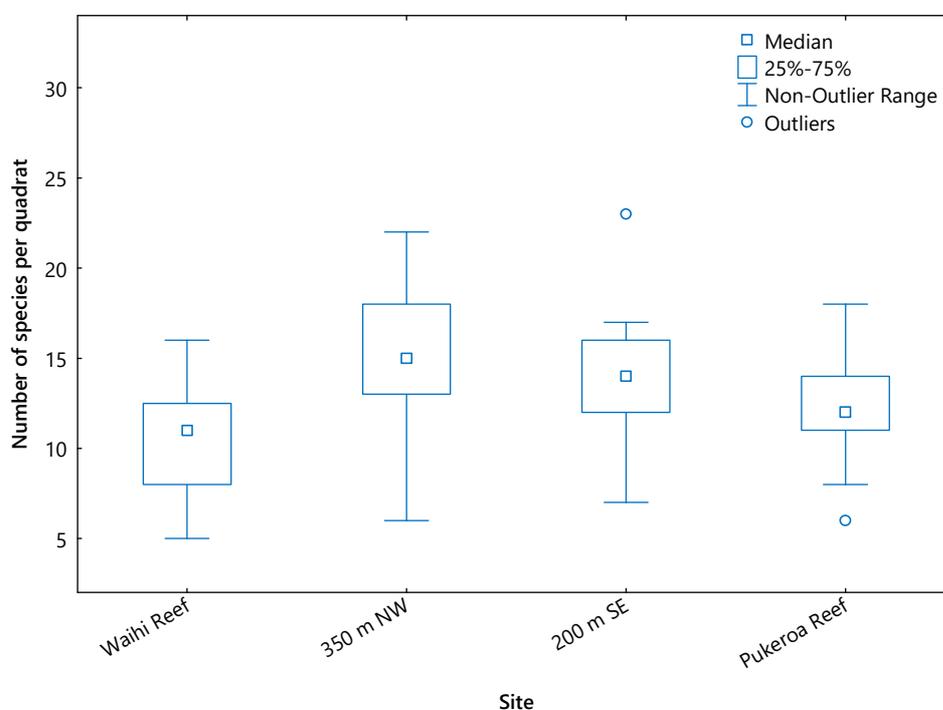
Figure 2 shows the total number of species per quadrat as a box and whisker plot. The notched area of the box represents the median plus and minus a 95% confidence interval for the median. This form of graphical representation allows a quick comparison to be made between sites. Generally, if the notched areas of the boxes for the different sites do not overlap, one would expect to obtain a significantly different result with ANOVA.

Figure 2 Box and whisker plots of the number of species per quadrat at each site, for the summer 2017-2018 survey

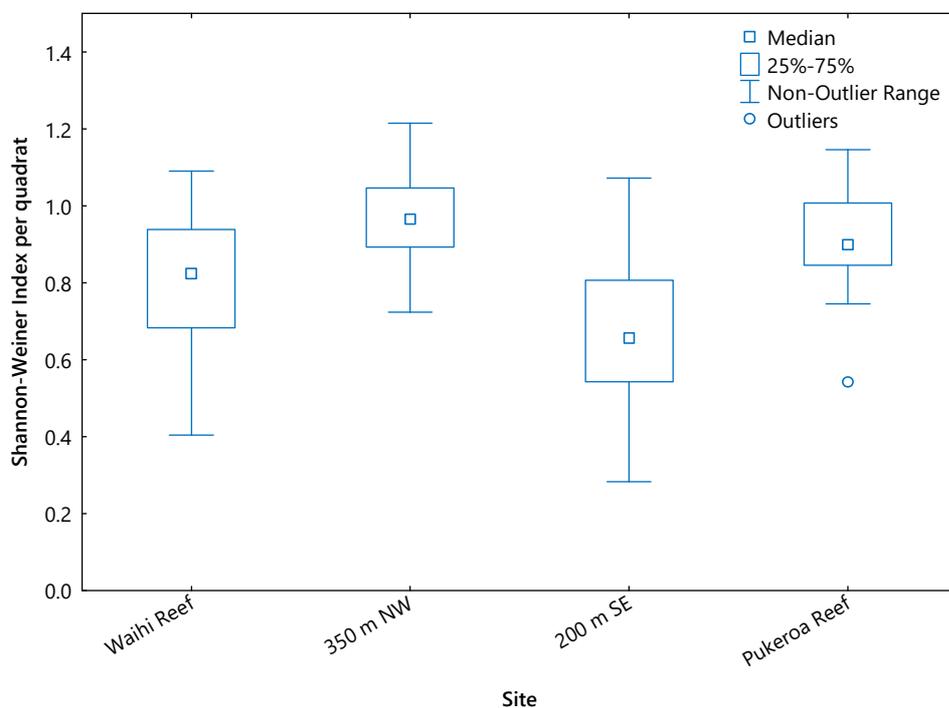
Figure 3 shows the distribution of Shannon-Weiner Indices recorded at each site as box and whisker plots.

Figure 3 Box and whisker plots of Shannon-Weiner Indices at each site

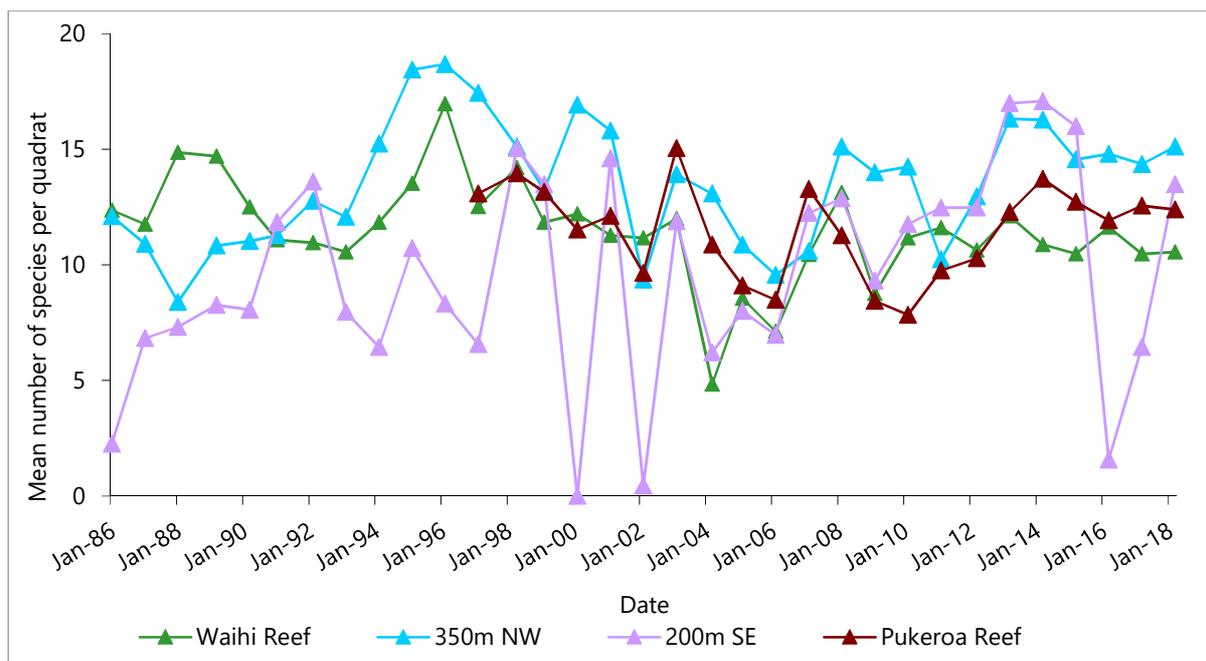
Figure 4 Mean number of species per quadrat for summer surveys (1986-2018)

Prior to the installation of the long marine outfall in August 1997, both the number of species and the Shannon-Weiner Index per quadrat at the impact site 200 m SE were generally lower than at the control site at Waihi Reef (Figures 4 & 5). Since then (1997), sites have shown interannual variability in both number of species and Shannon-Weiner Index, but there has been no noticeable difference in trends between the impact site and the control sites over this period, with the exception of years with heavy sand inundation or slips (e.g. 2000, 2002 and 2016 at 200 m SE, Figures 4 & 5).

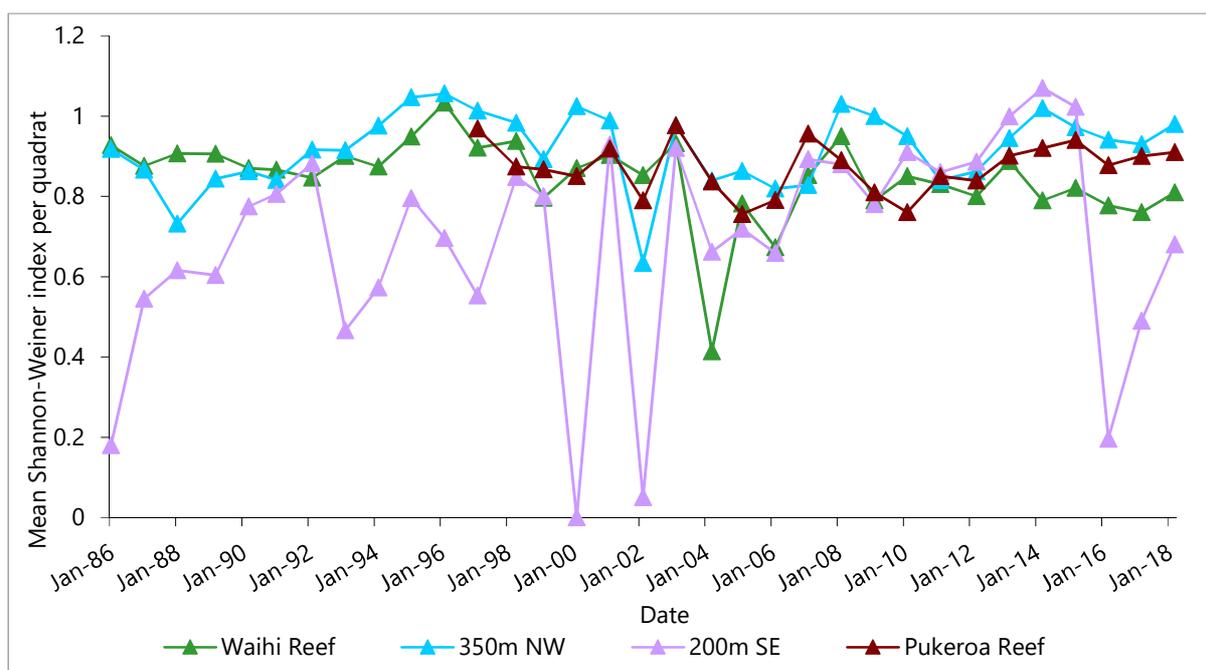
Figure 5 Mean Shannon-Weiner Indices per quadrat for summer surveys (1986-2018)

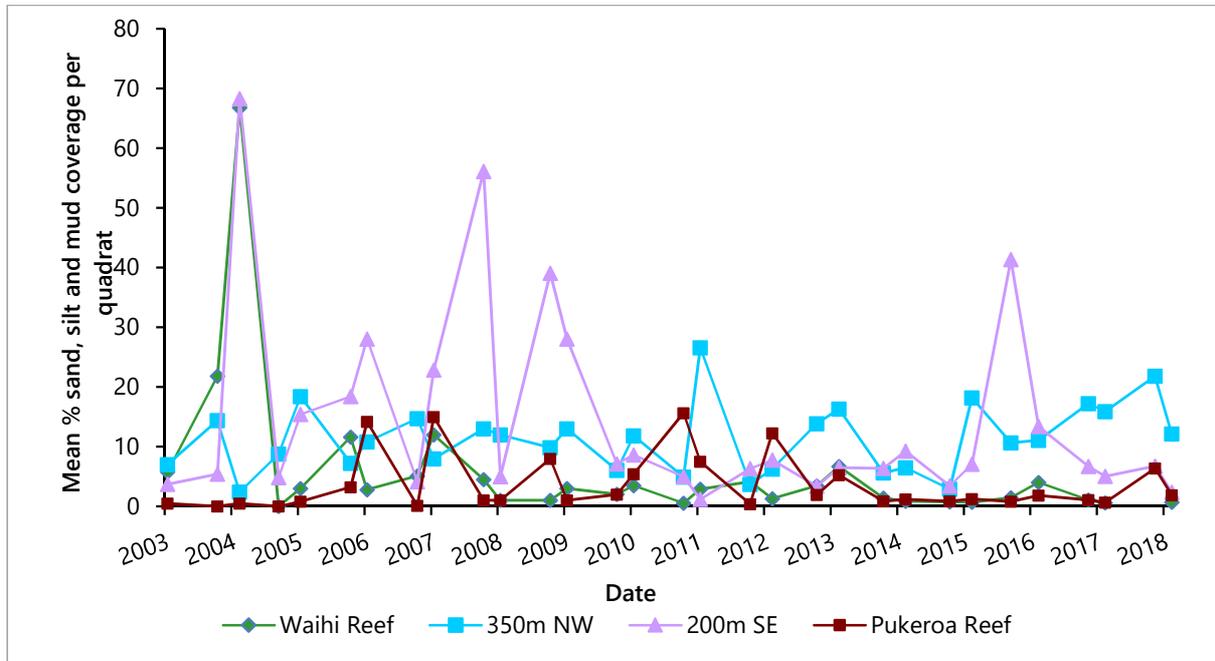
Over time, sand cover has generally remained low across the sites (Figure 6). Occasionally, however, the reefs experience events of sand inundation where coverage increases substantially. Over the past ten years, the sites worst affected by inundation events have been those 200 m SE and 350 m NW of the outfall.

Figure 6 Mean percentage sand, silt and mud cover for summer and spring surveys (2003-2018)

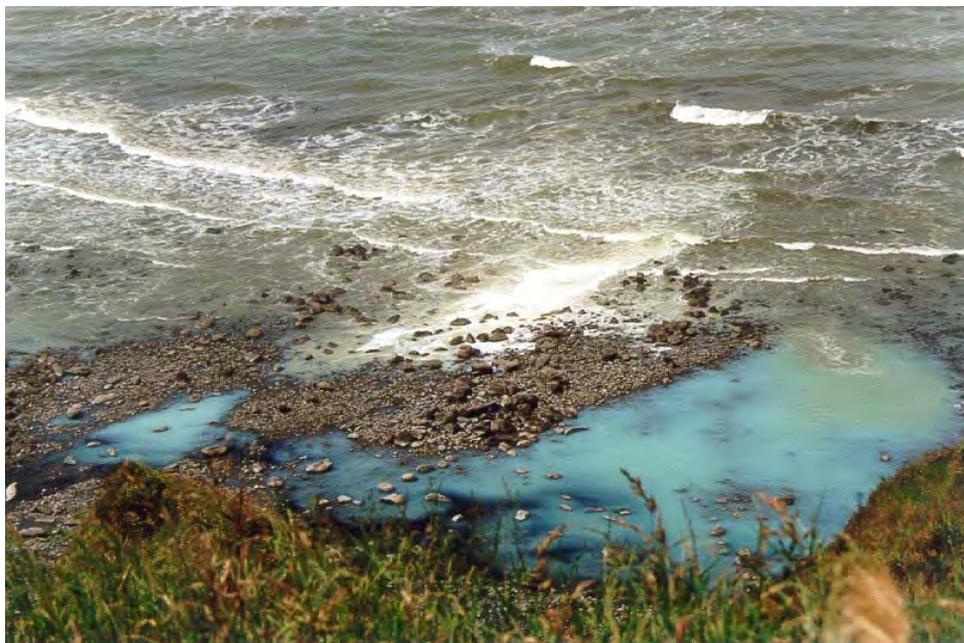
Previous surveys have shown that the dairy factory wastewater discharged through the near-shore outfall prior to 1997 (Photo 1) was having significant adverse effects on the local intertidal community. The adverse effects recorded included the coating of rocks and tidal pools with fats, significant coverage by filamentous bacterial growths and a significant decrease in ecological diversity. The nature and magnitude of adverse effects varied with distance from the outfall, and were most apparent at the sites 30 m and 200 m southeast of the outfall (note that the former site is no longer surveyed, as of 2007). In 1997 the dairy company installed a long outfall to discharge the wastewater nearly 2 km offshore in order to mitigate the adverse effects occurring along the coastline. Numerous spring and summer intertidal surveys have now been undertaken along the Hawera coastline subsequent to installation of the long outfall. Results show a general improvement in the health of intertidal communities following installation of the outfall. In February 2001, the Hawera Oxidation Ponds municipal wastewater was also connected to the long outfall.

Photo 6 Discharge from the dairy factory near-shore outfall prior to 1997

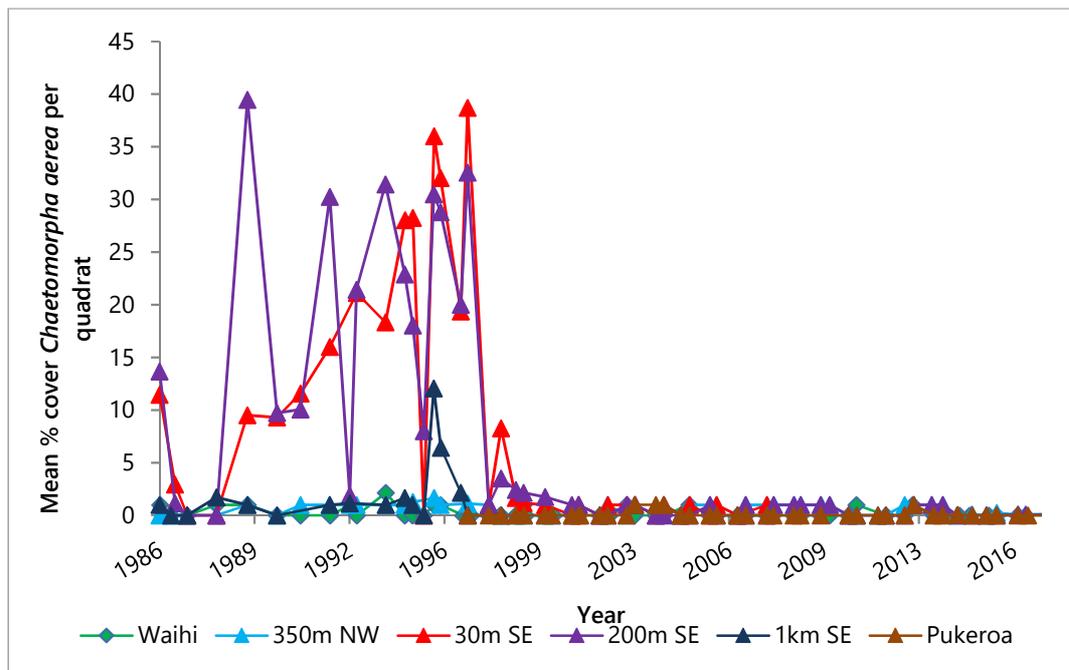
Figure 7 Mean percentage cover per quadrat of *Chaetomorpha aerea*, 1986-2018

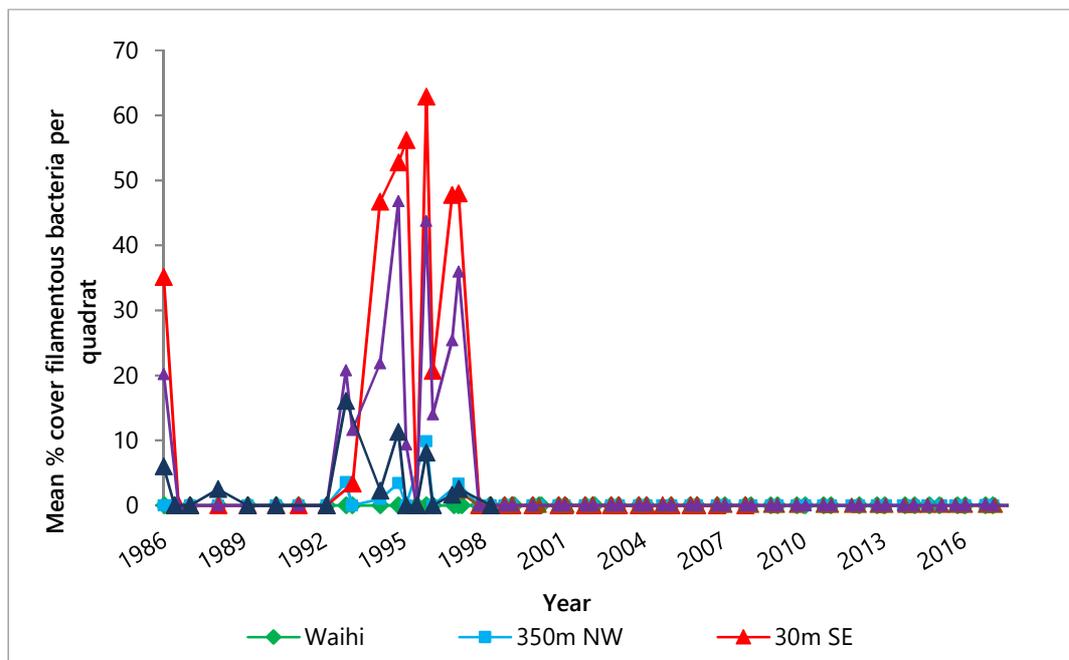
Figure 8 Mean percentage cover per quadrat of filamentous bacteria, 1986-2018

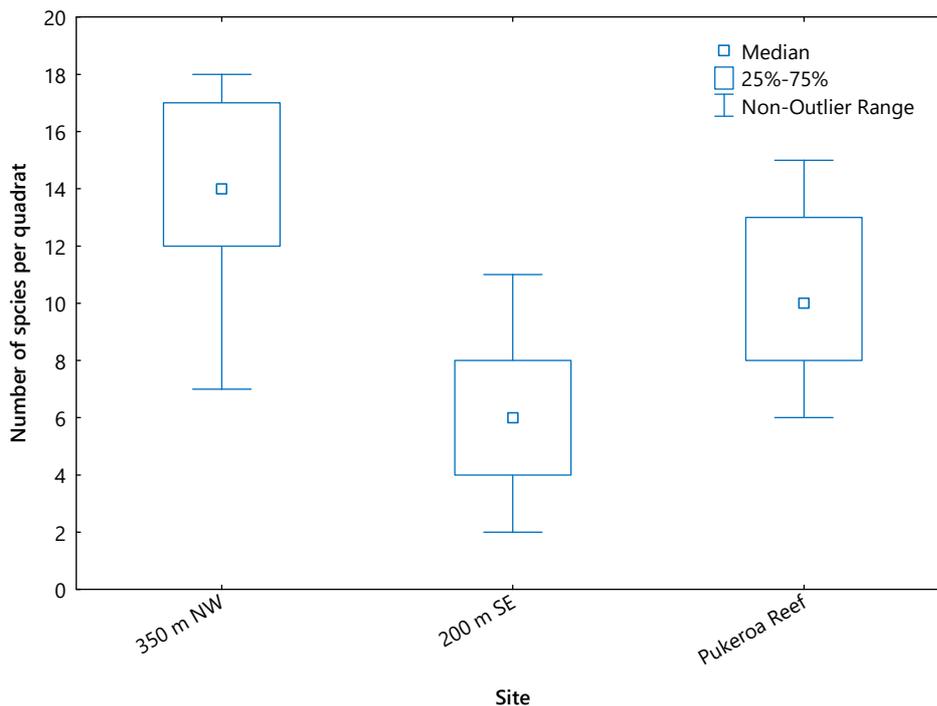
Figure 2 shows the total number of species per quadrat as a box and whisker plot.

Figure 2 Box and whisker plots of the number of species per quadrat at three sites for the spring 2017-2018 survey

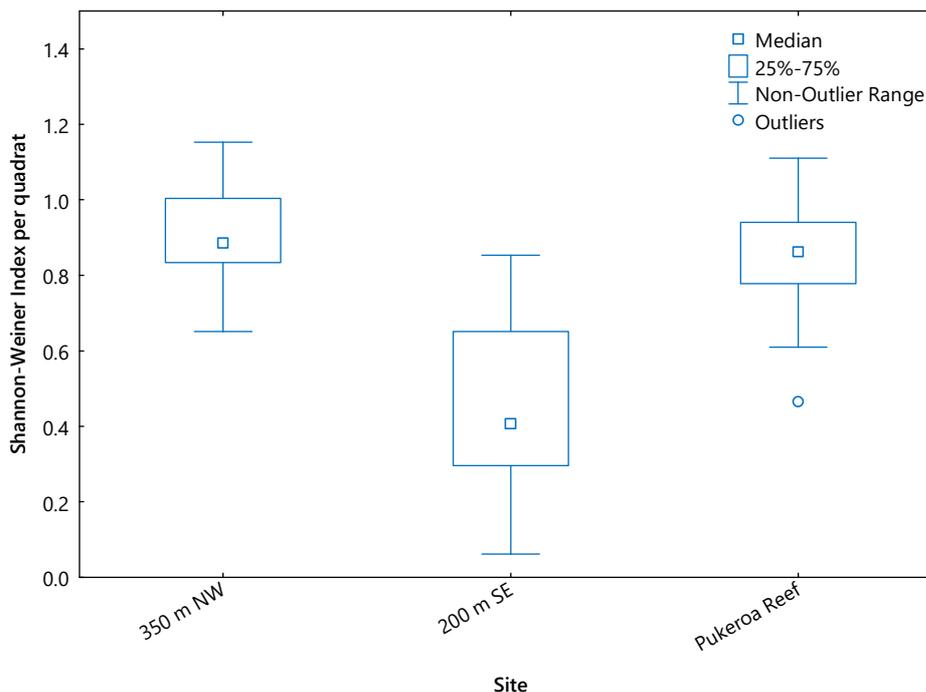
Figure 3 shows the distribution of Shannon-Weiner Indices recorded at each site as box and whisker plots.

Figure 3 Box and whisker plots of Shannon-Weiner Indices at each site

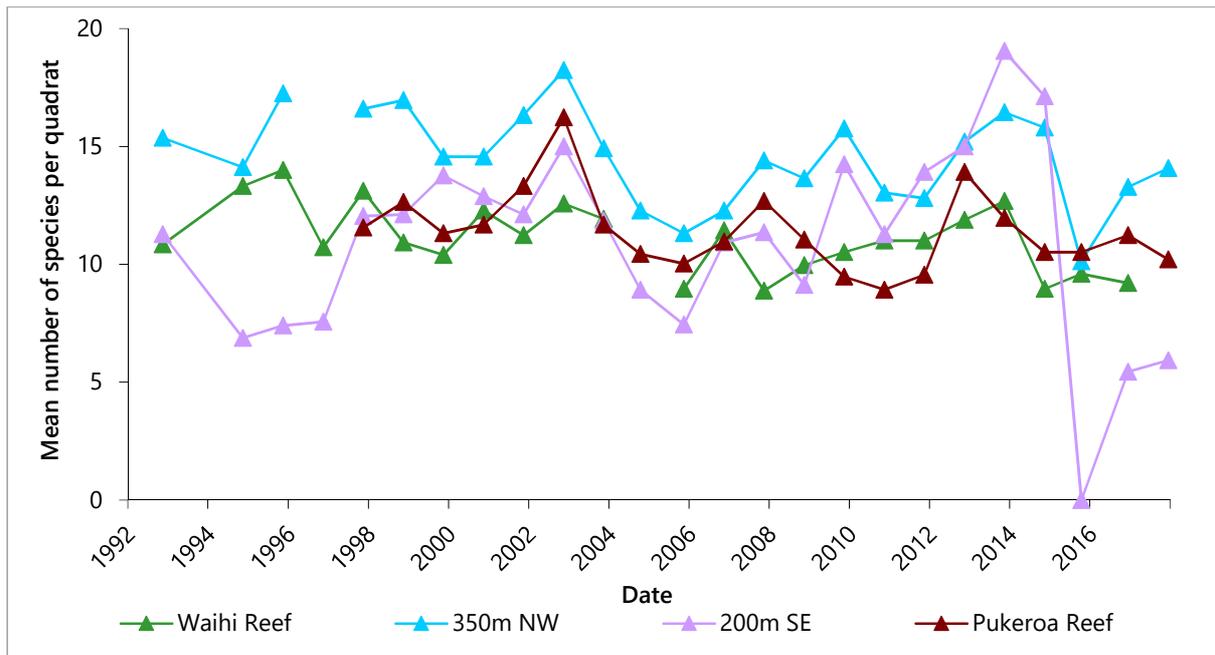
Figure 4 Mean number of species per quadrat for spring surveys 1992-2017

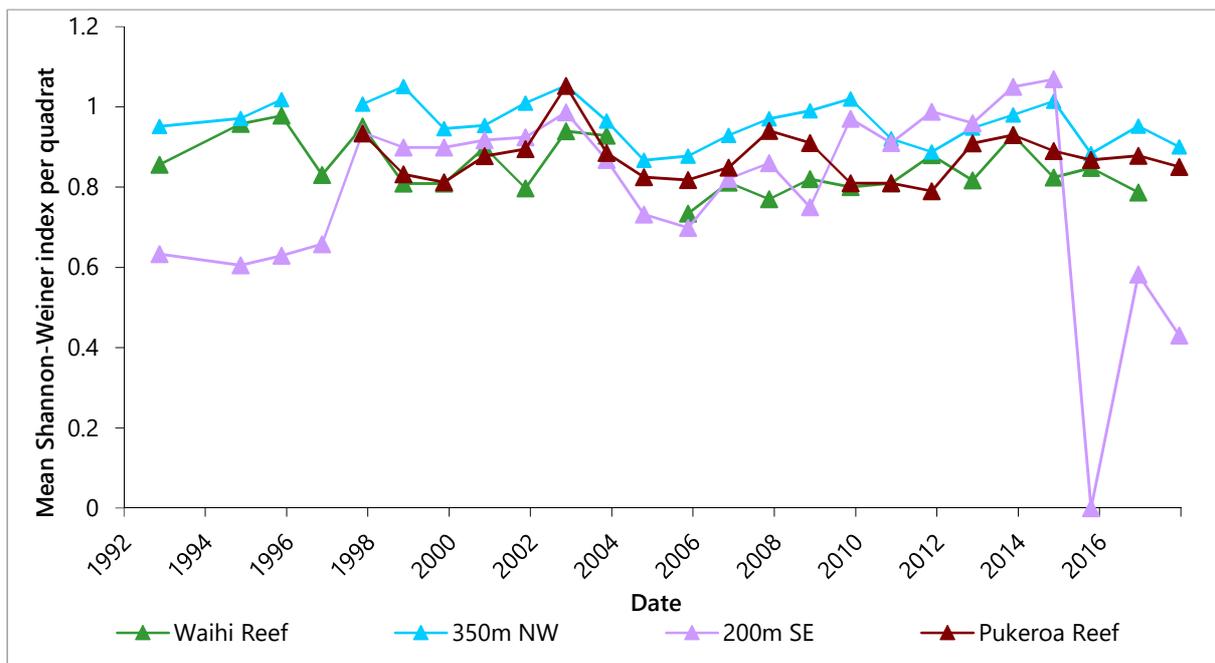
Figure 5 Mean Shannon-Weiner Indices per quadrat for spring surveys 1992-2017

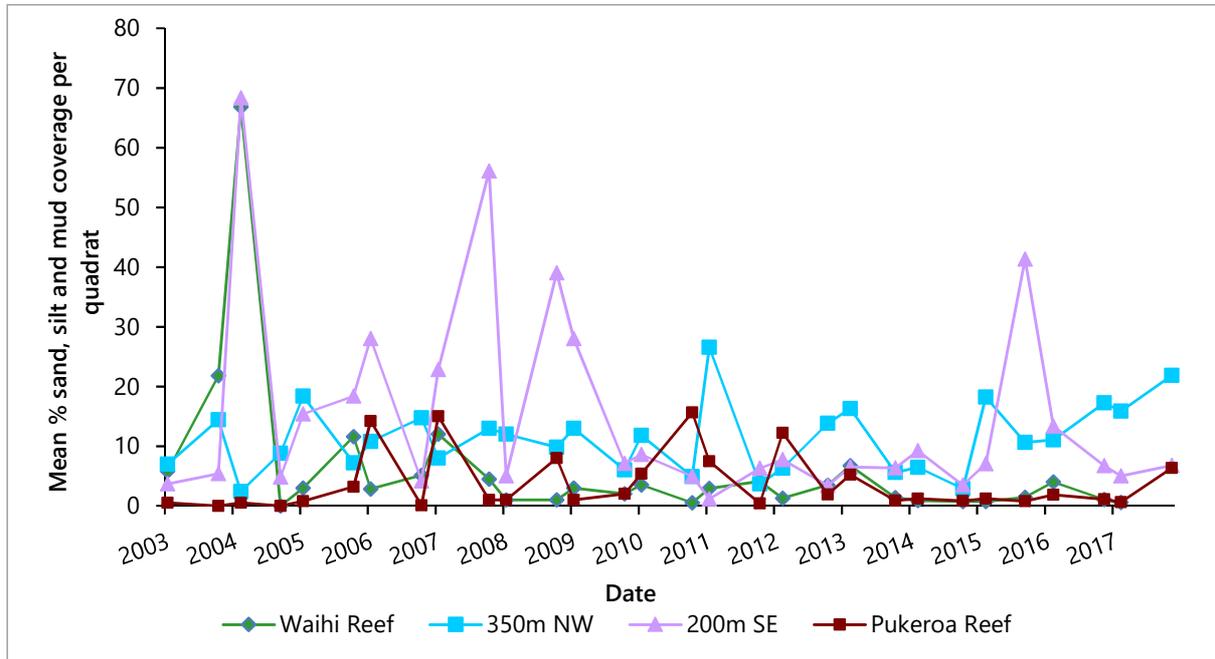
Over time, sand cover has generally remained low across the sites (Figure 6). Occasionally, however, the reefs experience events of sand inundation, where coverage increases substantially. Over the past ten years, the sites worst affected by inundation events have been those 200 m SE and 350 m NW of the outfall.

Figure 6 Mean sand cover per quadrat for spring surveys 1992-2017

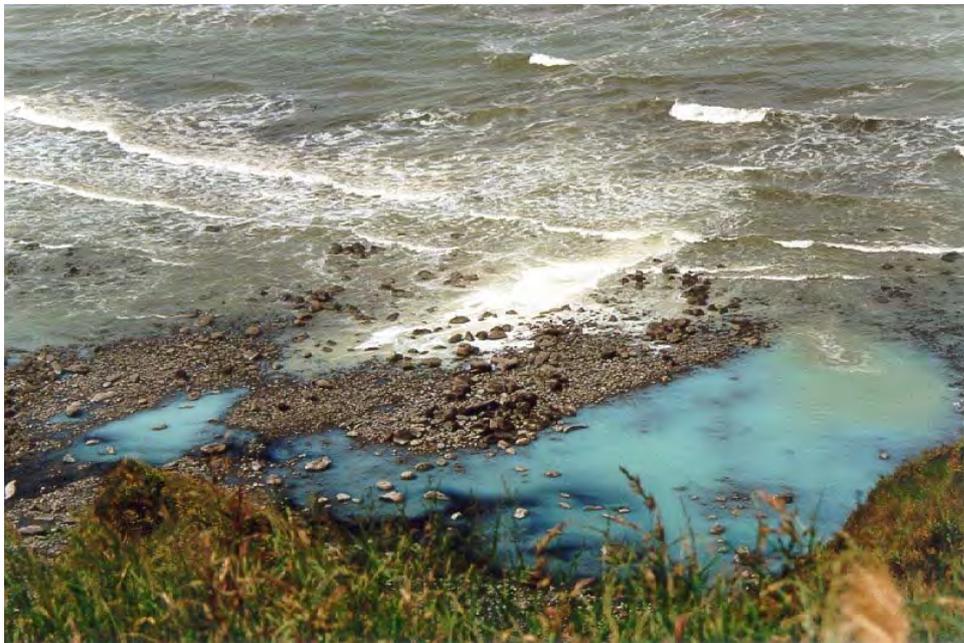
Previous surveys have shown that the dairy factory wastewater discharged through the near-shore outfall prior to 1997 (Photo 1) was having significant adverse effects on the local intertidal community. The adverse effects recorded included the coating of rocks and tidal pools with fats, significant coverage by filamentous bacterial growths and a significant decrease in ecological diversity. The nature and magnitude of adverse effects varied with distance from the outfall, and were most apparent at the sites 30 m and 200 m southeast of the outfall (note that the former site is no longer surveyed as of 2007). In 1997 the dairy company installed a long outfall to discharge the wastewater nearly 2 km offshore in order to mitigate the adverse effects occurring along the coastline. Numerous spring and summer intertidal surveys have now been undertaken along the Hawera coastline subsequent to installation of the long outfall. Results show a general improvement in the health of intertidal communities following installation of the outfall. In February 2001 the Hawera Oxidation Ponds municipal wastewater was also connected to the long outfall.

Photo 5 Discharge from the dairy factory near-shore outfall prior to 1997

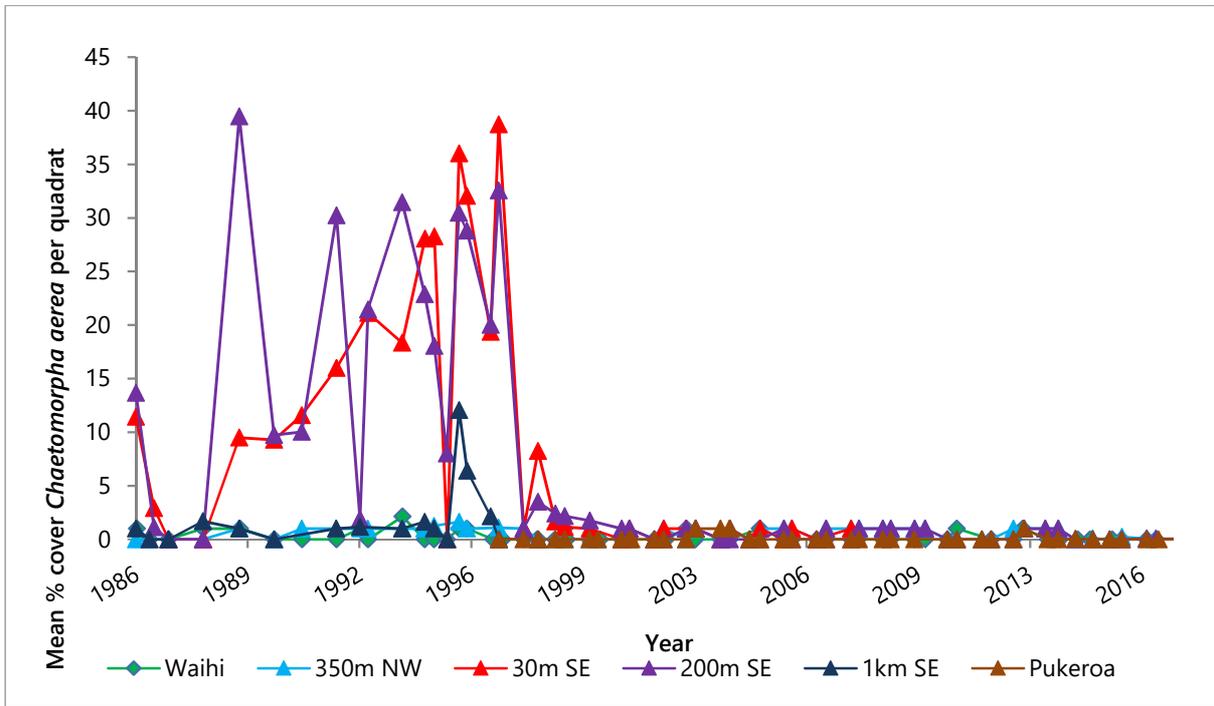
Figure 7 Percentage cover per quadrat of *Chaetomorpha*, 1986-2017
