South Taranaki District Council  
Hawera Municipal Oxidation Ponds  
Monitoring Programme  
Annual Report  
2017-2018

Technical Report 2018-58

Taranaki Regional Council  
Private Bag 713  
STRATFORD  
April 2019

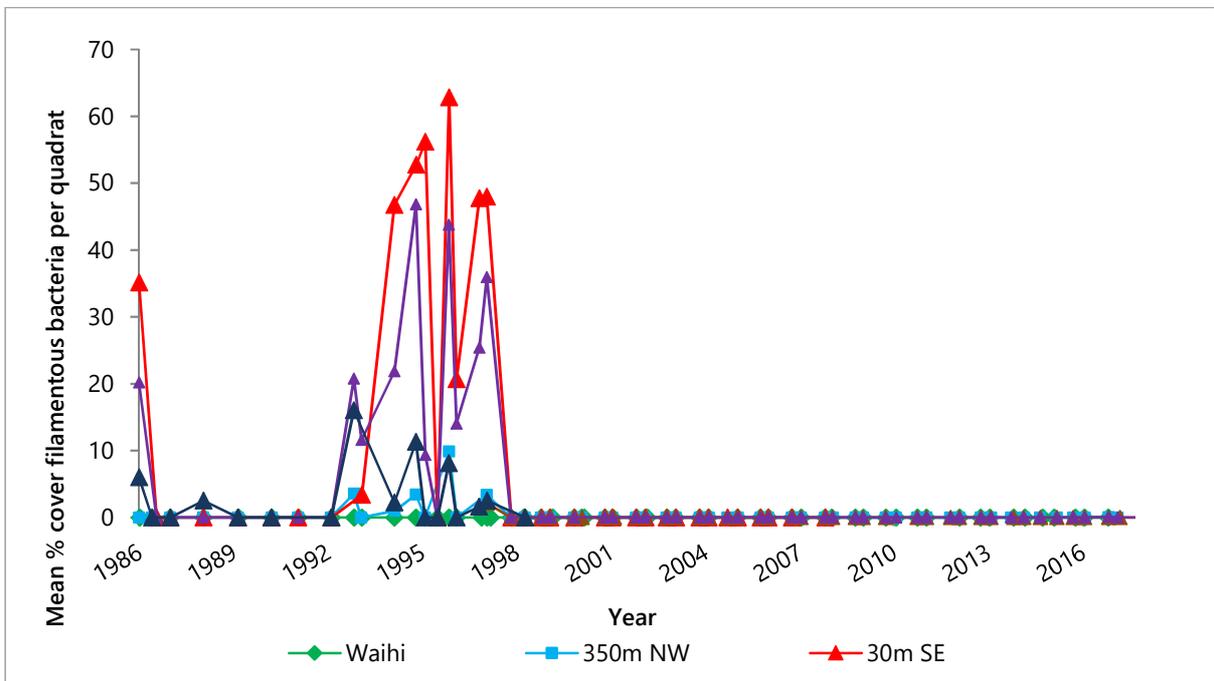
Figure 8 Percentage cover per quadrat of filamentous bacteria, 1986-2017
