## Memorandum

### Mud flats adjacent to Patea Freezing Works

Following a fire and possible asbestos contamination on 6 February 2008, I visited the mud flats adjacent to the old Patea Freezing Works site on Thursday 8 May 2008, at 7:30, around two hours after low tide.

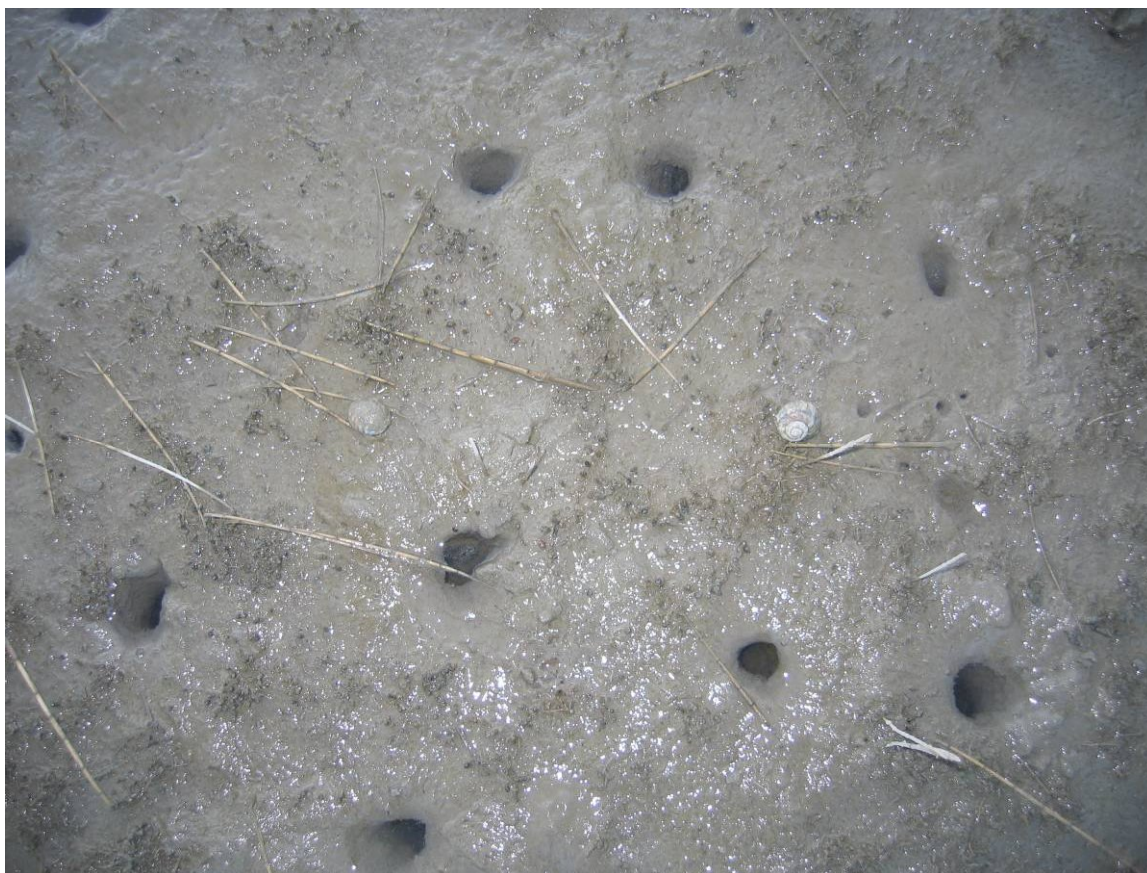
There were numerous crab holes across the entire mud flats, including the higher areas (Photograph 1).

**Photograph 1** Crab holes on mud flats

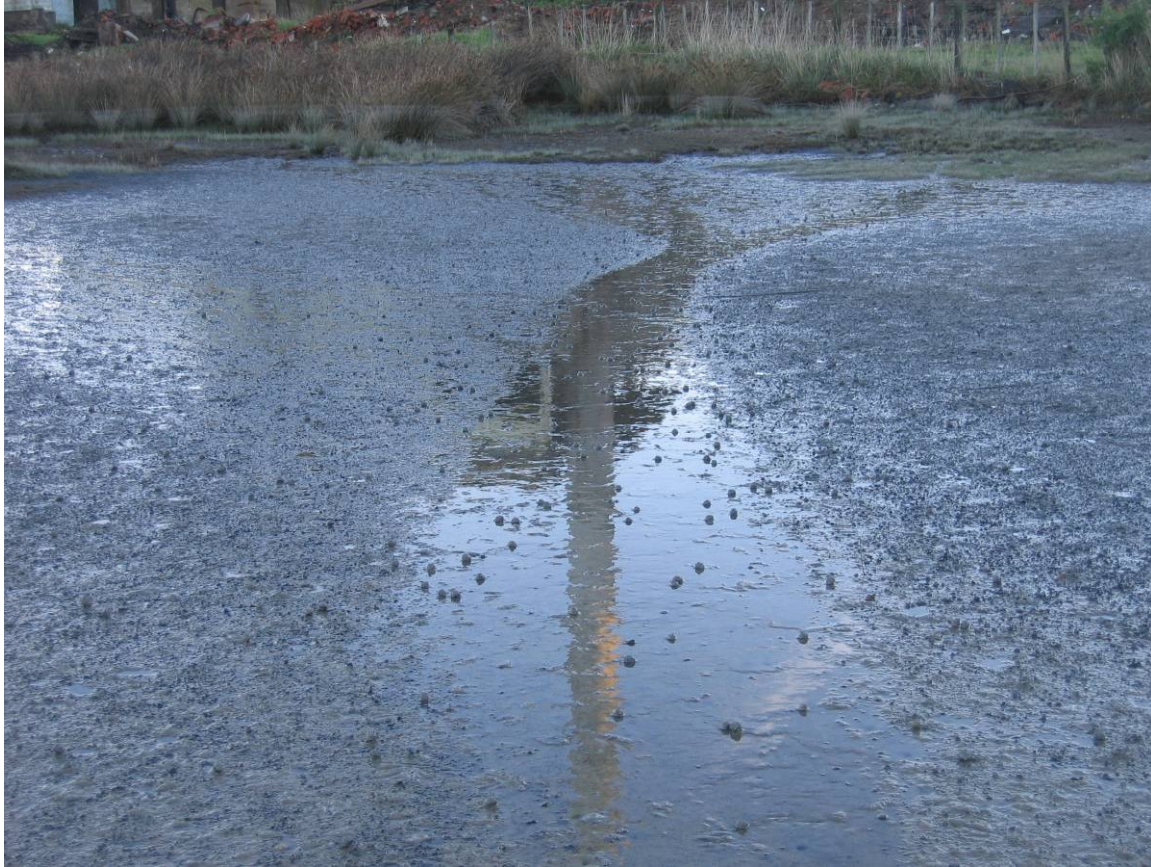
The mud snail, *Amphibola crenata*, was abundant across the lower areas of mud flat. Photograph 2 shows large numbers of the snails in one of the small streams leaving the Patea Freezing Works site.

**Photograph 2** The mud snail, *Amphibola crenata*
